# National Transportation Safety Board

ERA22FA137

Aircraft Performance Study

Location: Hilltown Township, Pennsylvania  
Date: February 24, 2022  
Time: 16:56 Eastern standard time (EST)  
21:56 UTC  
Airplane: Beech 35-C33, N6129V

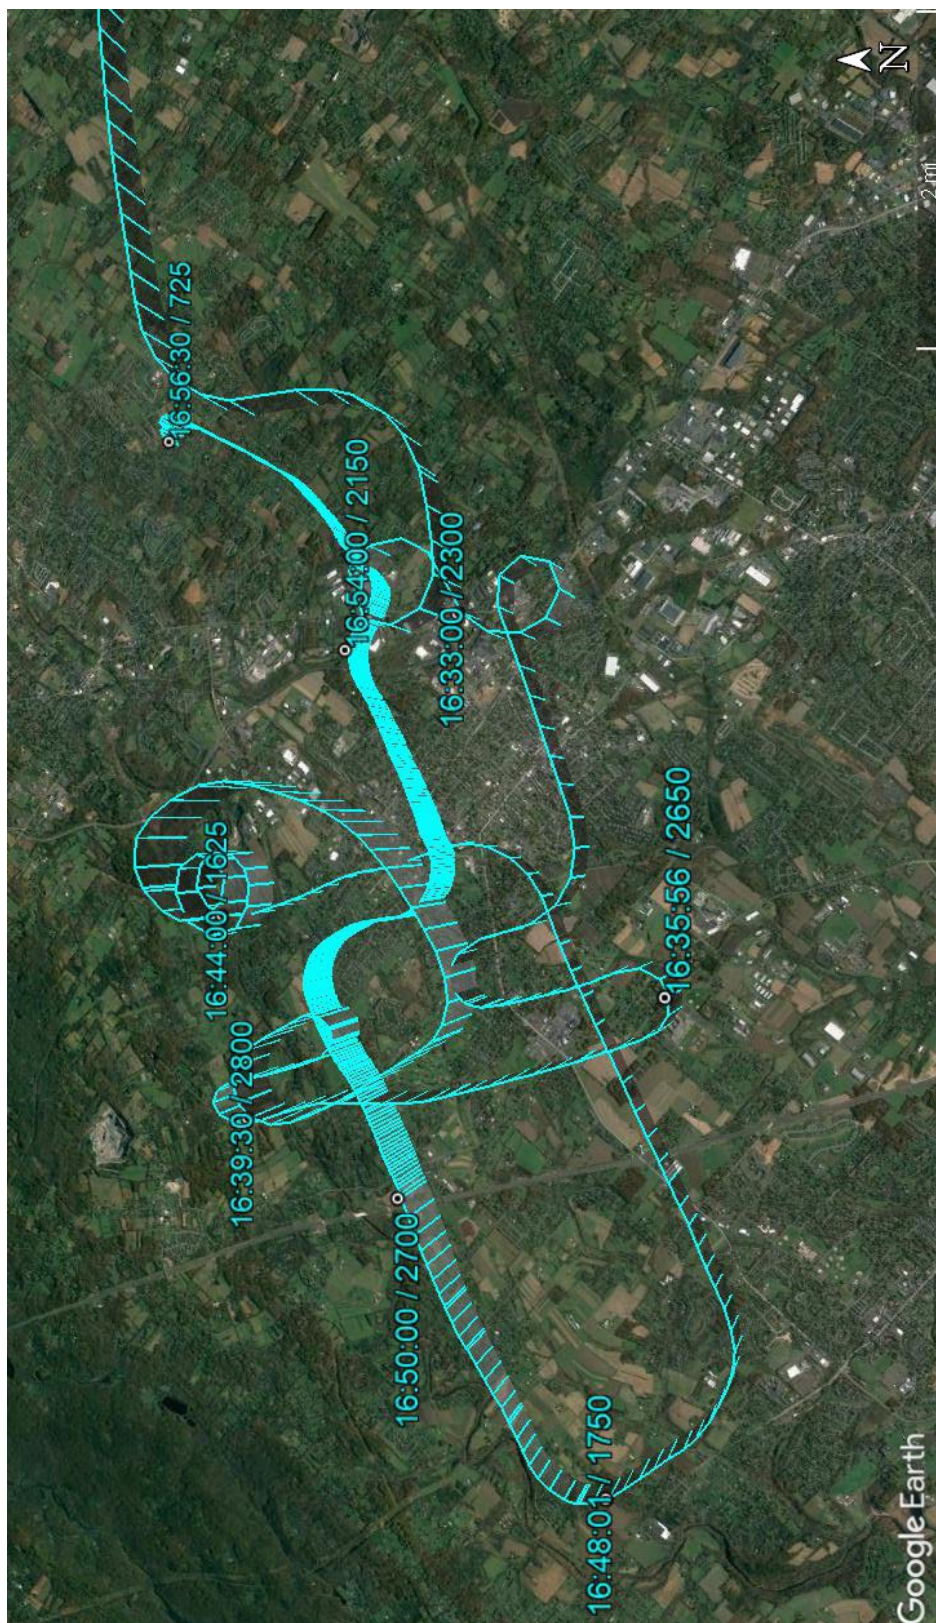
The airplane took off from KDYL and the pilots were practicing maneuvers in the area, as shown in Figure 1. The airplane's altitude varied between 1,400 ft msl and 4,000 ft msl and calibrated airspeed (in this case, nearly equal to groundspeed) varied between 50 and 150 kts, as shown in Figure 2.

**Figure 1.** ADS-B flight path with selected times and altitudes (msl) annotated.

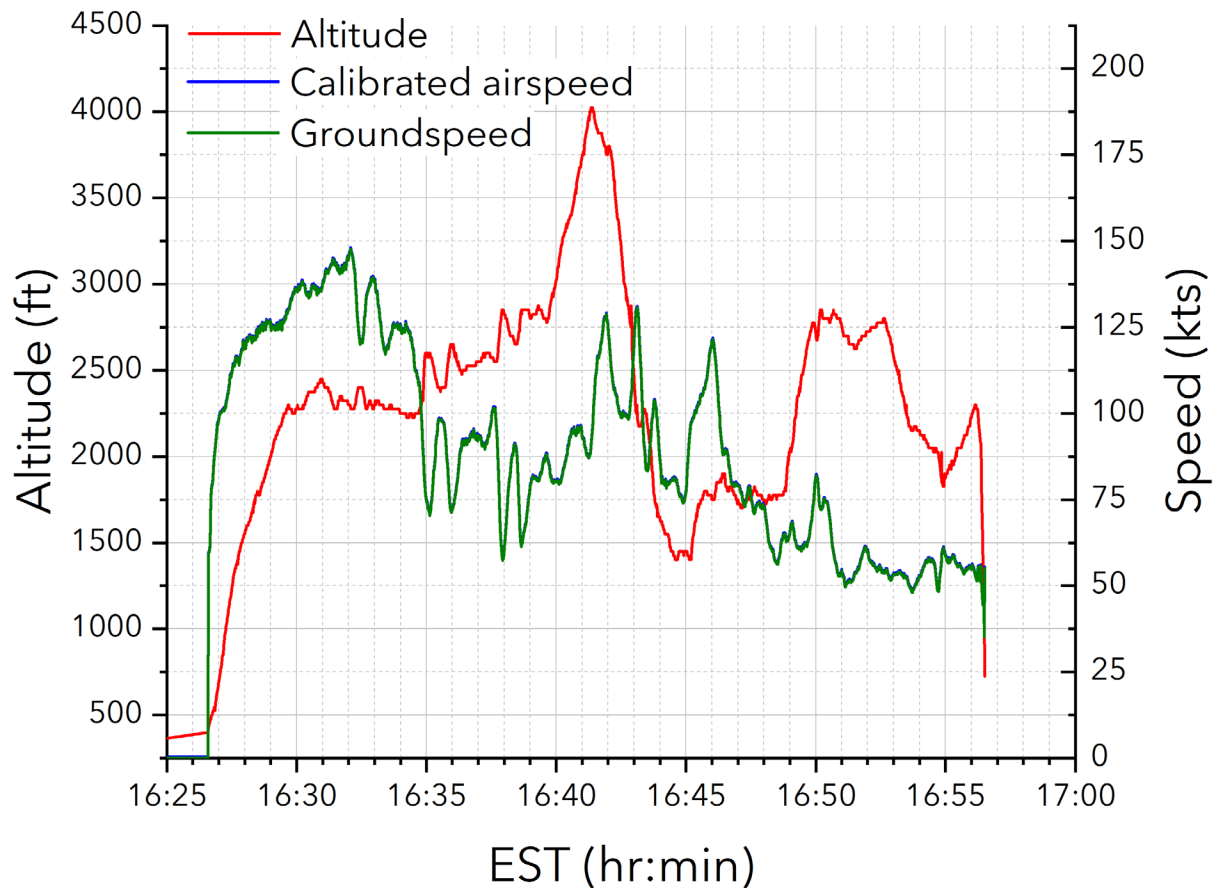
**Figure 2.** Airplane altitude (msl) with calculated groundspeed and calibrated airspeed. Due to meteorological conditions, groundspeed and calibrated airspeed were approximately equal.

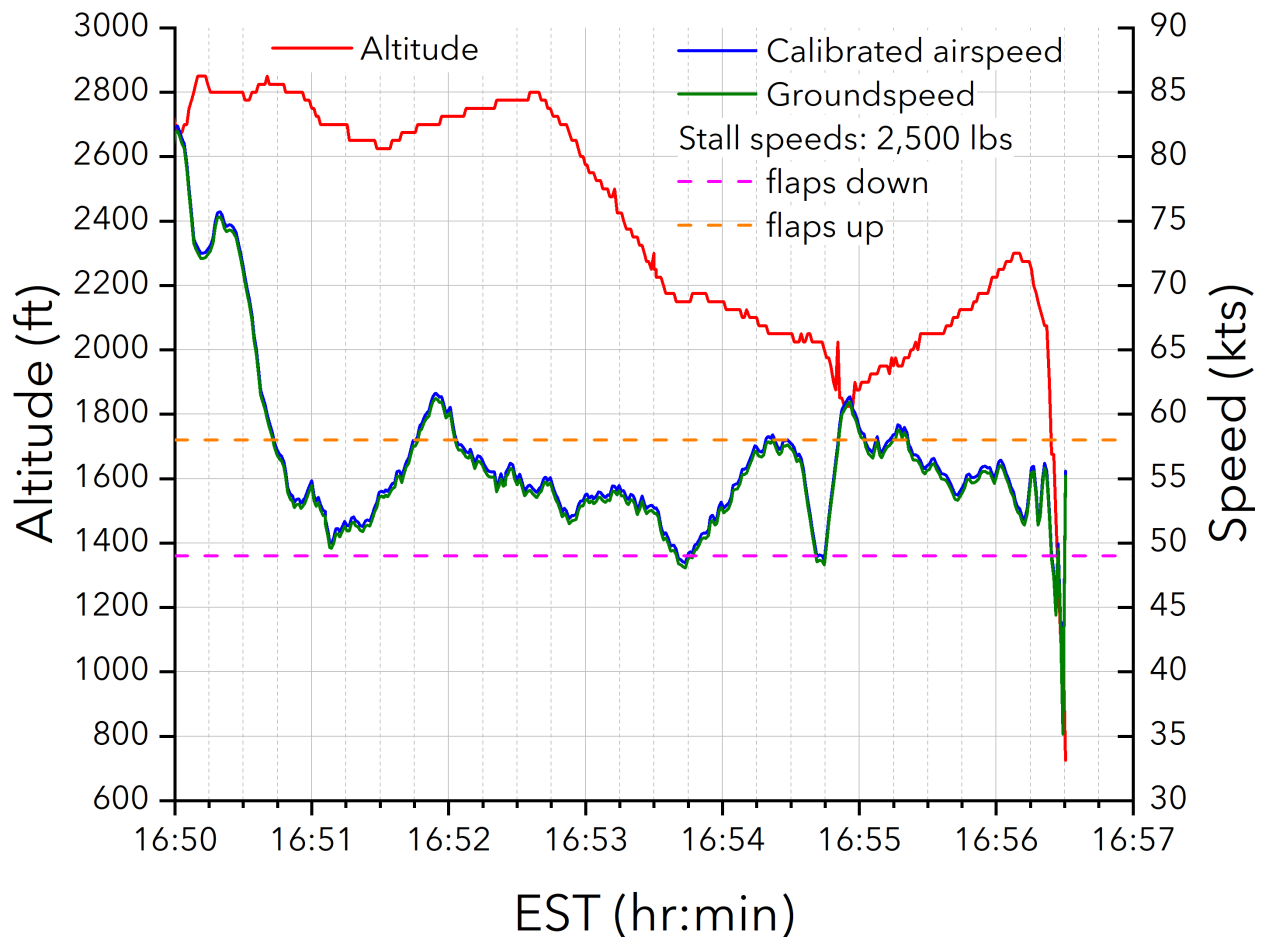
For 2,500 lbs, an estimate of the airplane's weight, the airplane's wings-level, power-idle, no-flaps stall speed is 58 kts [1]. With flaps the stall speed is 49 kts. Figure 3 shows the last six minutes of flight. The airplane was mostly below the flaps-up stall speed and briefly dipped below the stall speed with flaps a few times but would quickly regain airspeed.

**Figure 3.** Airplane altitude (msl) with calculated groundspeed and calibrated airspeed. Due to meteorological conditions, groundspeed and calibrated airspeed were approximately equal. Stall speeds for flaps up and flaps down are shown as dotted lines.

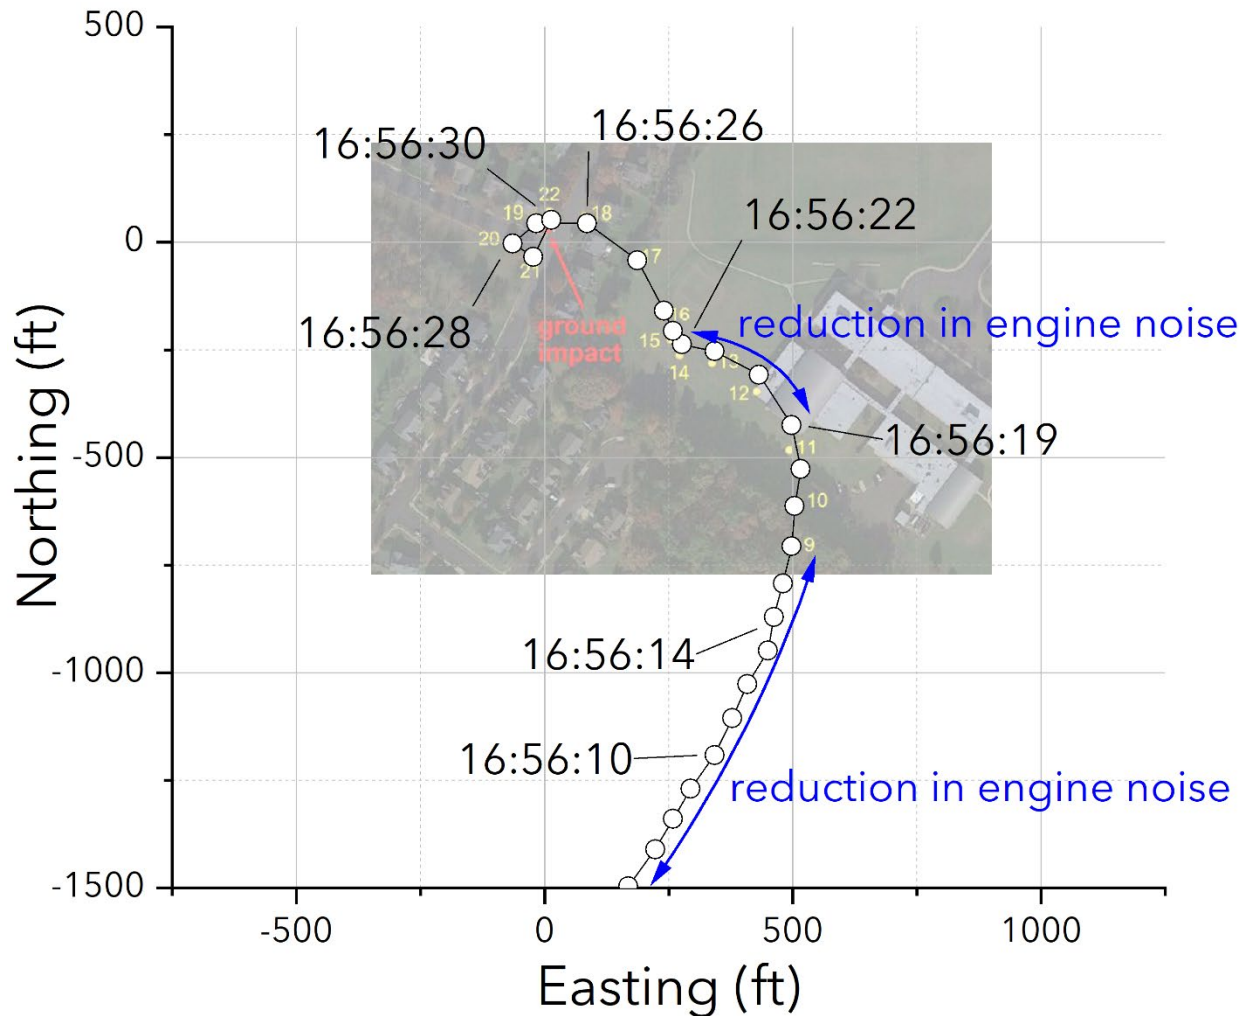
A Video Study of a video from a camera on a residential building near the point of impact was completed [2]. Images of the end of flight were used to correlate the video with the ADS-B flight path. A sound spectrum analysis of the noise of the engine found that at two periods of reduced engine noise during the final 30 seconds of flight. Figure 4 shows the time correlation with the video study and the times when the reduction in engine noises were heard.

**Figure 4.** End of ADS-B flight in Northing and Easting with selected times annotated. Overlaid onto image from video study for time correlation. Time periods of reduced engine noise are highlighted.

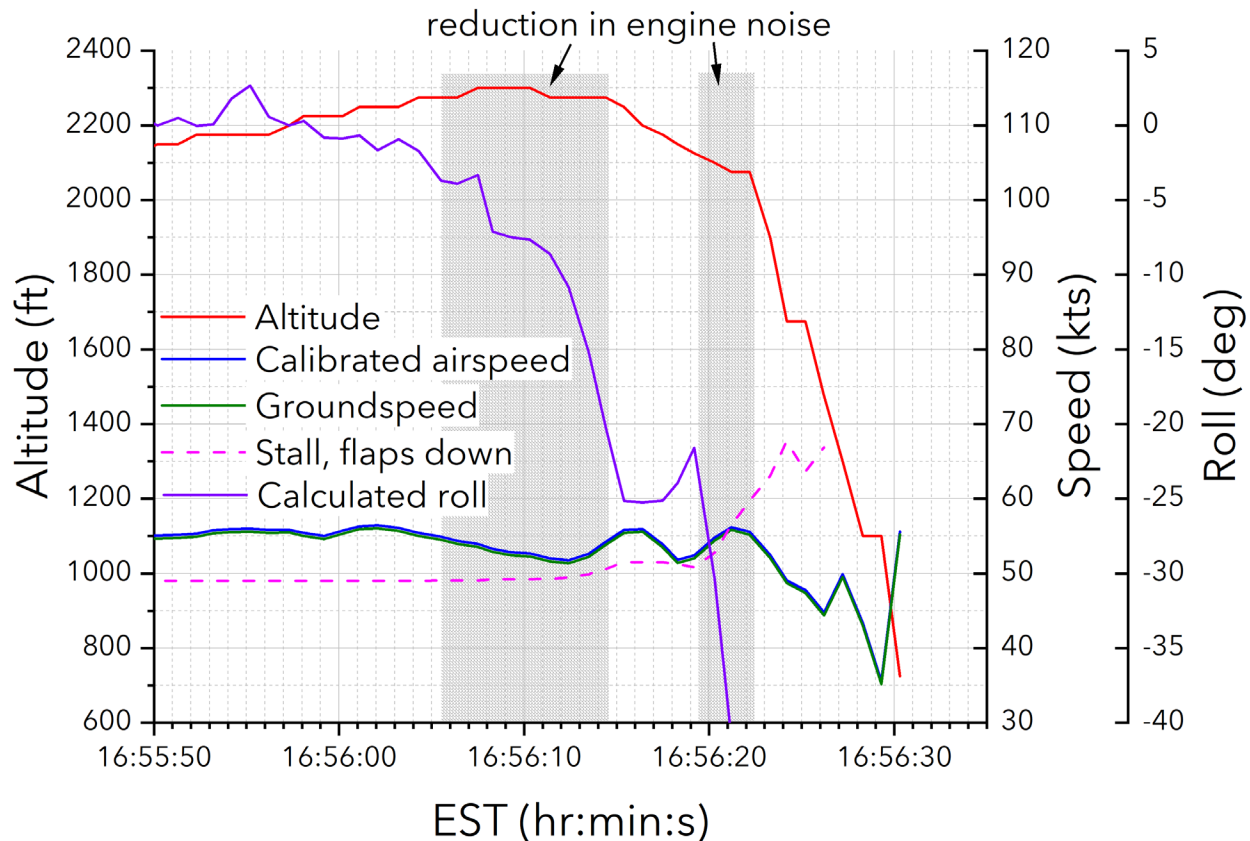
Figure 5 shows the times of reduced engine noise on the last 40 seconds of altitude and speed data. Roll was calculated from flight parameters and a basic aerodynamic model of the airplane. The airplane was near wings level leading into the first period of reduced engine noise. During that time the airplane rolled left to 20°. The left roll was arrested during the 4-5 seconds normal engine sounds were heard but about 150 ft of altitude was lost. During the second period of reduced engine noise, the airplane continued to roll rapidly left and the banked stall speed exceed the airspeed. The airplane descended rapidly left wing down in a tightening spiral. The wreckage was found directly underneath the last two ADS-B returns.

**Figure 5.** Airplane altitude (msl) with calculated groundspeed and calibrated airspeed, and calculated roll. The stall speed as a function of the roll angle is a dotted pink line. The two grey boxes are highlighting time periods of reduced engine noise.

The airplane's maneuvers during the final portion of flight were below the airplane's flaps up, power idle stall speed and twice briefly below the flaps down stall speed. During the final 30 seconds of flight, the airplane rolled left during times that corresponded with periods when engine noise was reduced. The airplane's rapid left roll and loss of altitude was consistent with an aerodynamic stall.
