**WRECKAGE EXAMINATION**  
**NTSB Accident Number**  
**ERA22FA137**

| Location: | Hilltown Twp, PA |
| Aircraft: | Beech 35-C33 |
| Registration | N6129V |

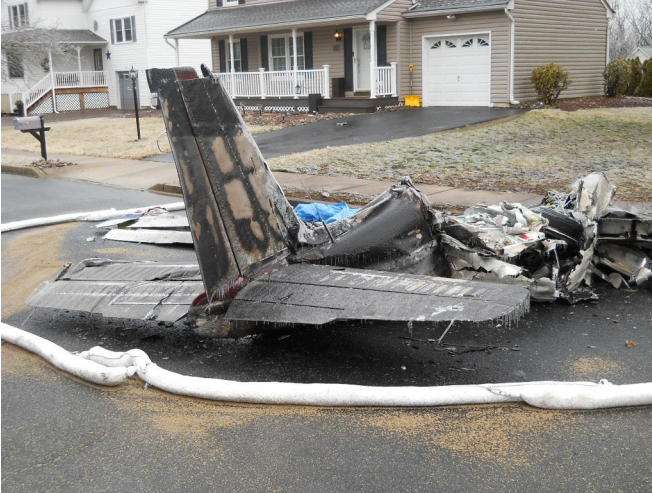
The wreckage came to rest upright, oriented about a 125° magnetic heading, and no debris path was observed. The cockpit and cabin were mostly consumed by fire. Both wings separated from the airplane, but their respective flaps and ailerons remained attached. The empennage remained intact with the rudder and elevator still attached. The flaps and landing gear were retracted. Flight control continuity was confirmed from all flight control surfaces to the cockpit area. Measurement of the two elevator trim actuators corresponded to a 5° trim tab down (nose-up) position.

The engine came to rest upright, separated from the airframe. The three propeller blades separated from the hub. One blade was consumed by fire about 12 inches outboard of the root. Another blade exhibited fire damage, s-bending, chordwise scratching and leading-edge gouging. The third propeller blade exhibited s-bending, chordwise scratching and leading-edge gouging.
