# NATIONAL TRANSPORTATION SAFETY BOARD

## Video Study

**NTSB Case Number:  
ERA22FA137**

Location: Hilltown Township, Pennsylvania  
Date: February 24, 2022  
Time: 16:56 EST  
Aircraft: Beechcraft 35-C33

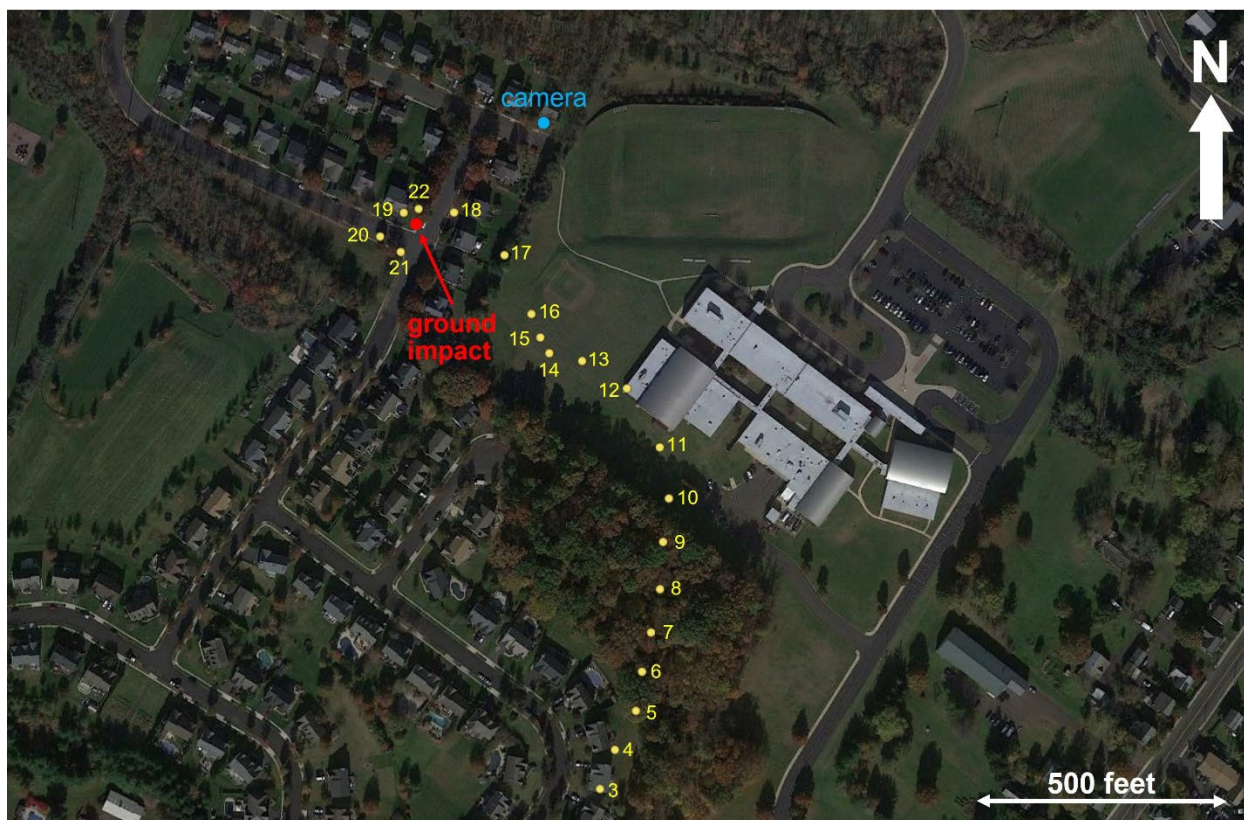
**Figure 1. Aerial View of the Accident Area (numbers are video time in seconds)**

Figure 1 shows an aerial view of the accident site. The camera was mounted on a house on Morgan Lane. The airplane impacted the ground at the intersection of Brittany Lane and Victoria Lane. The yellow markers in the figure are airplane locations recorded by ADS-B. The numbers near the markers are video time in seconds. The last ADS-B based marker is at time 22 seconds. The airplane impacted the ground at video time 22.6 seconds.

Figure 1 shows that all the way to the airplane location at time 18 seconds, the airplane distance from the camera was decreasing. The recorded sound intensity of a properly operating engine should not be decreasing as the distance from the camera was decreasing. This points to possible intermittent operation of the engine. The very low recorded sound intensity between time 11.5 seconds and time 14.5 seconds could be the result of engine combustion not taking place during these three seconds. It is also possible that there was no combustion between time zero and time 8.5 seconds.

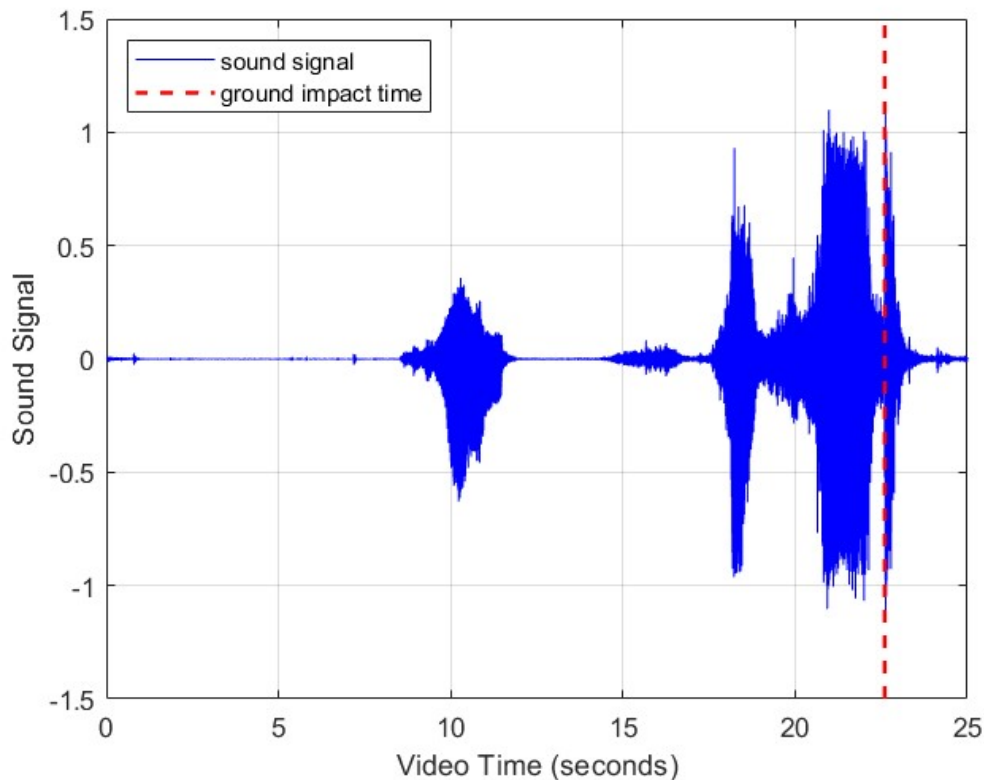
**Figure 2. Recorded Sound Signal Intensity**

Figure 2 shows the sound signal during the first 25 seconds of the video. The ground impact time is marked by the red broken line. The sound intensity was very low up to about time 8.5 seconds and stayed elevated between 8.5 seconds and 11.5 seconds. The intensity then stayed low until about 18 seconds when it increased to beyond  $\pm 0.2$  and stayed elevated until ground impact.

An alternative explanation of the low sound intensity is suggested by this being an instructional flight. The periods of low recorded sound intensity could have been the result of the pilot practicing some particular maneuver or scenario and the low sound intensity was during the periods when the engine was intentionally idling.

The above analysis of the recorded sound detected fluctuating intensity between video time zero and video time 22.6 seconds. The very low intensity up to time 8.5 seconds and between time 11.5 seconds and time 14.5 seconds indicates that there probably was no combustion or the engine was idling during these time periods. As seen in Figure 5, the rapid descent toward ground impact started at about video time 11.5 seconds when combustion stopped or the engine started idling.

Figure 2 shows that after the period of non-smooth operation between 18 seconds and 18.7 seconds, the engine operated smoothly until ground impact. However, at that time, the airplane was already descending at the average rate of 9080 feet/minute as can be seen in Figure 5.

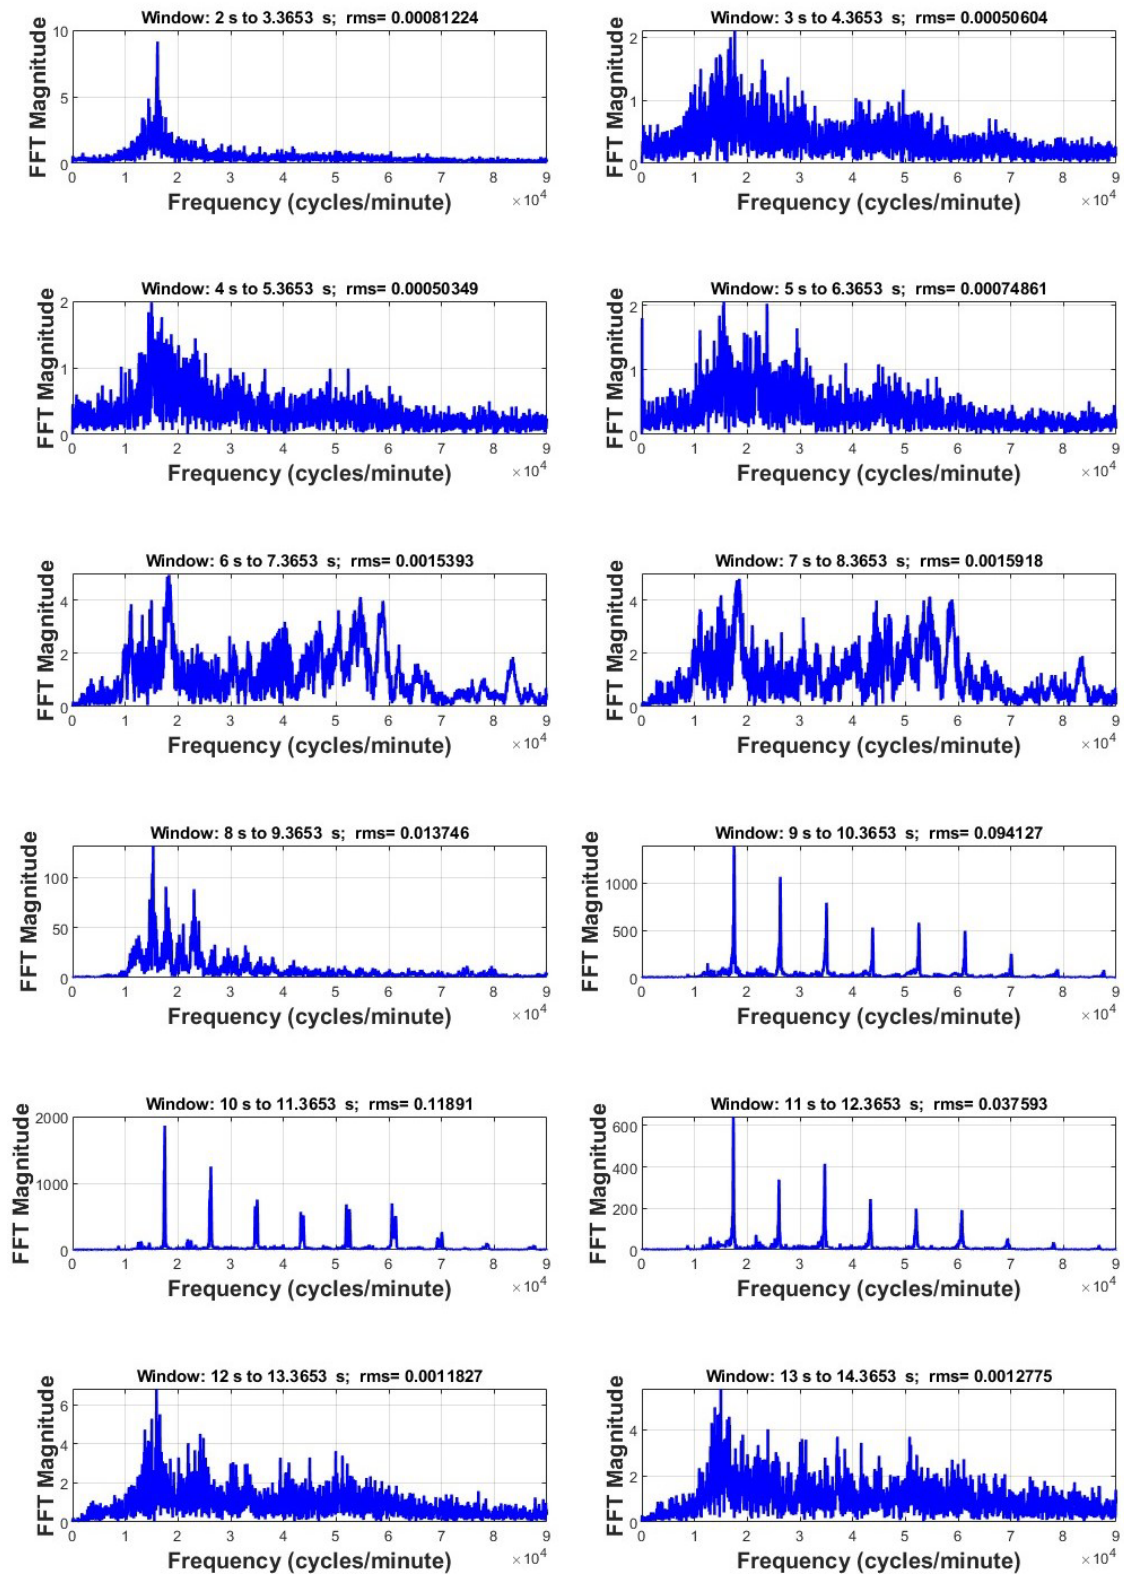
**Figure 3. Sound Spectra between 2 seconds and 14.3 seconds**

Figure 3 shows 12 spectra computed in FFT processing windows with starting times incremented by one second from two seconds to 13 seconds. The spectra at window starting times of 9, 10 and 11 seconds correspond to the elevated signal intensity period between 8.5 seconds and 11.5 seconds seen in Figure 2. These spectra are dominated by a large magnitude impulse train in frequency.

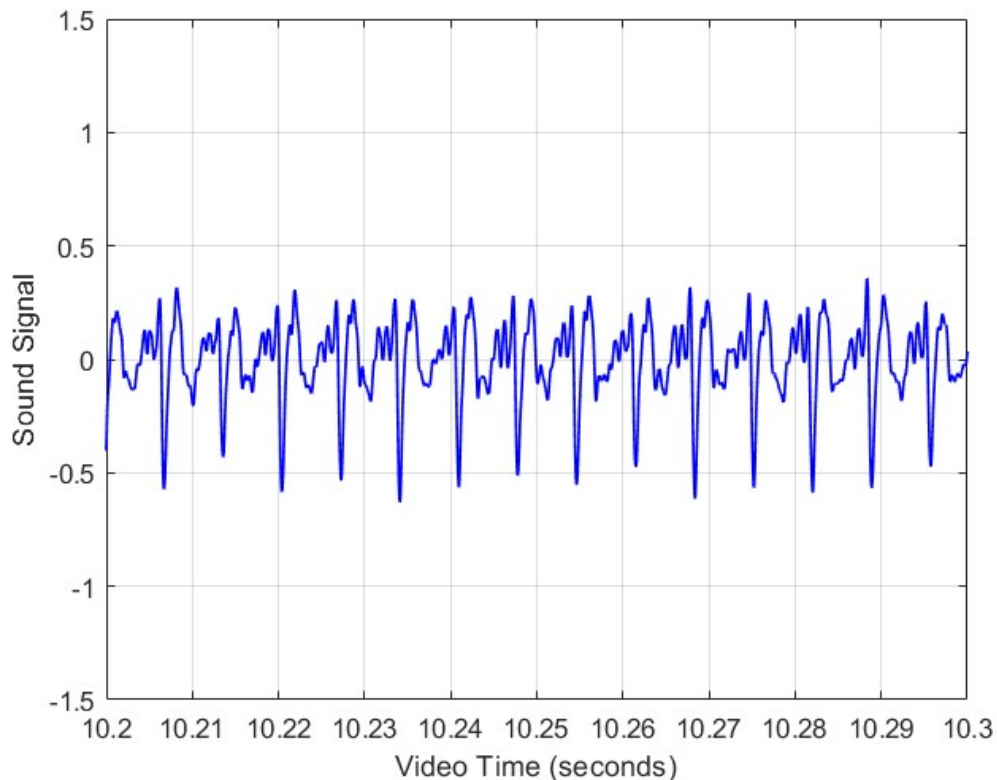
**Figure 4. Zoomed Sound Signal**

Impulse trains in frequency are generated by impulse trains in time. To investigate the time signal that generated the impulse trains in frequency, the time signal is plotted in Figure 4 between time 10.2 seconds and time 10.3 seconds. The figure shows that the time signal includes a train of impulses. The spacing between the impulses is 0.00685 seconds that corresponds to frequency of  $60/0.00685=8759$  impulses/minute.

The signal in Figure 4 is not symmetrical with respect to its mean. The negative peaks reach below -0.5 while the highest positive peak is below 0.4. This asymmetry is in effect between time 10 seconds and time 11.5 seconds, as can be seen in Figure 2. Signals like the one in Figure 4 can be the result of the microphone recording a sound at a fundamental frequency as well as some of its higher harmonics, each phase-shifted with respect to the fundamental component.

At video time 10.25 seconds, corresponding to Figure 4, the airplane speed toward the camera was about 90 feet/second. This speed was estimated based on ADS-B

latitude, longitude and altitude data. Consequently, due to the Doppler effect, the recorded sound frequency was 8.5% higher than the frequency emitted by the airplane. Therefore, the frequency component recorded as 8759 cycles per minute (cpm) was generated by the airplane at the frequency of  $8759/1.085=8073$  cpm.

The airplane propeller had three blades and in a six-cylinder, four-stroke Continental IO-470 series engine cylinder firing occurs three times per shaft revolution. Therefore, both the propeller and the engine generate sound components at a frequency that is three times the engine speed. This leads to the estimate of the engine speed of  $8073/3=2691$  rpm, at the high end of its rated speed. It is believed that the unusual sound signal in Figure 4 is due to combustion and/or exhaust noise generated by the engine that was not running smoothly rather than the propeller wake reaching the camera.

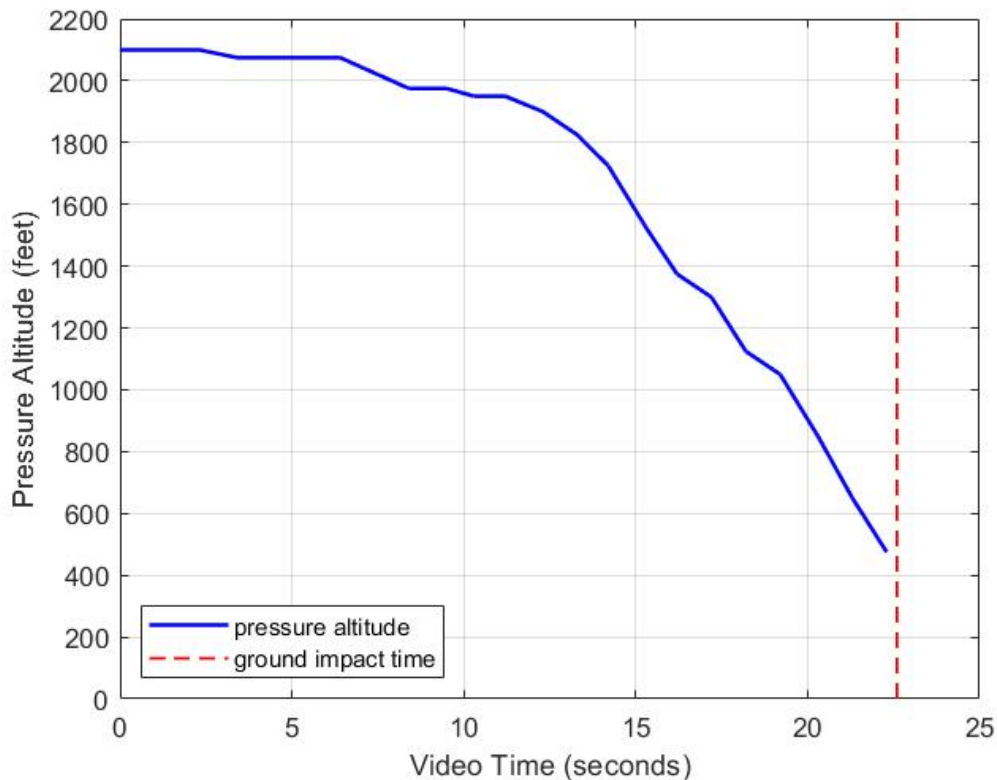
**Figure 5. Airplane Pressure Altitude (from ADS-B record)**

Figure 5 shows the pressure altitude of the airplane based on ADS-B data. The elevation of the crash location is 403 feet MSL. The airplane altitude started decreasing slowly approximately at video time zero and continued decreasing until ground impact. It is likely that the descent started at about video time zero because, as the low sound intensity between time zero and time 8.5 seconds seen in Figure 2 indicates, there probably was no combustion or the engine was idling during these nine seconds.
