# National Transportation Safety Board

ERA22FA141

## **AIRFRAME AND ENGINE EXAMINATION REPORT**

Location: St. Augustine, Florida  
Date: March 2, 2022  
Time: 17:02 (local)  
Airplane: Extra 300NG

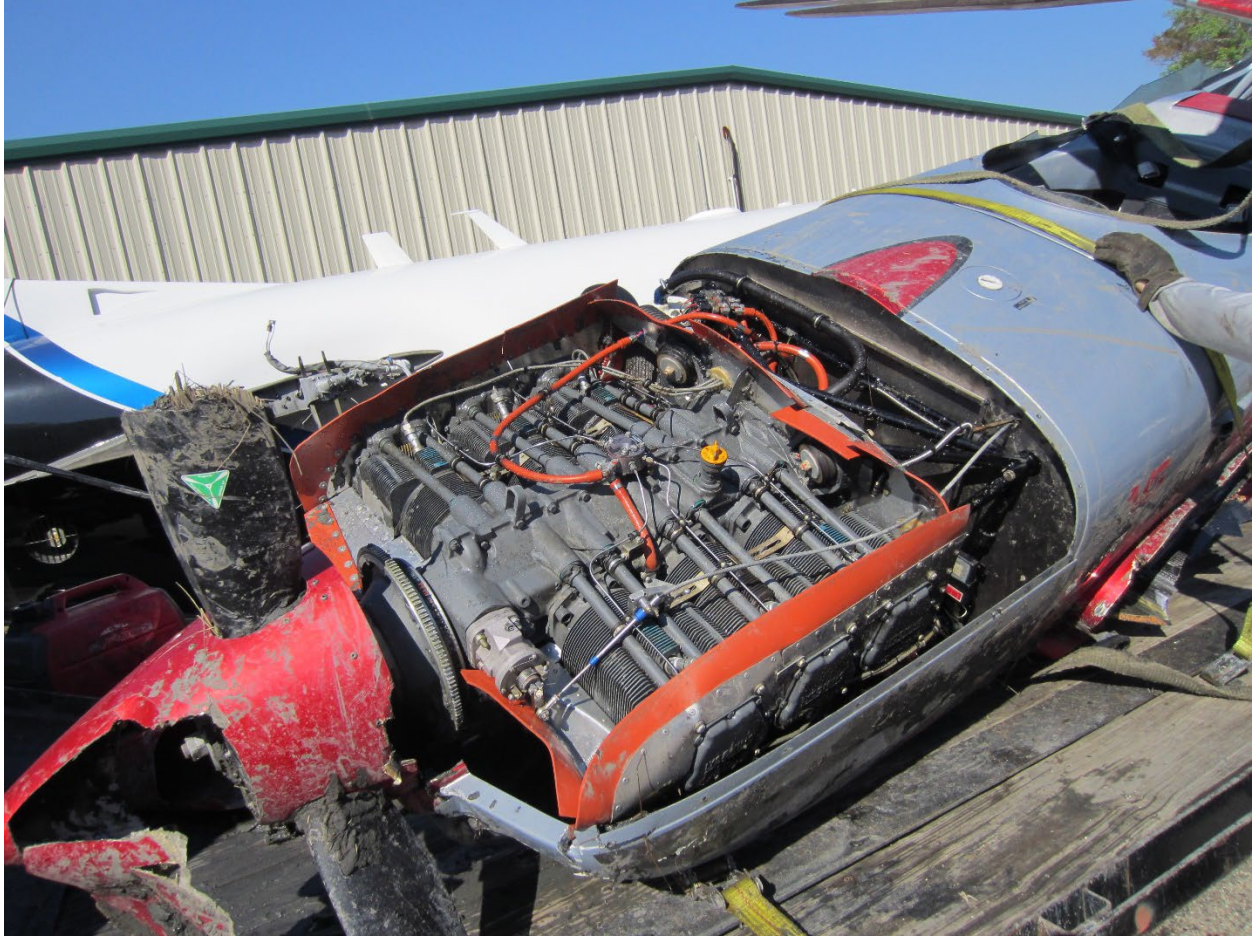
**Figure 1 Top view of the engine after recovery.**
