# NATIONAL TRANSPORTATION SAFETY BOARD

### Survival Factors Specialist's Factual Report

ERA22FA141

Location: St Augustine, Florida  
Date: March 2, 2022  
Time: 1702 EST  
Aircraft: Extra NG, N100NG

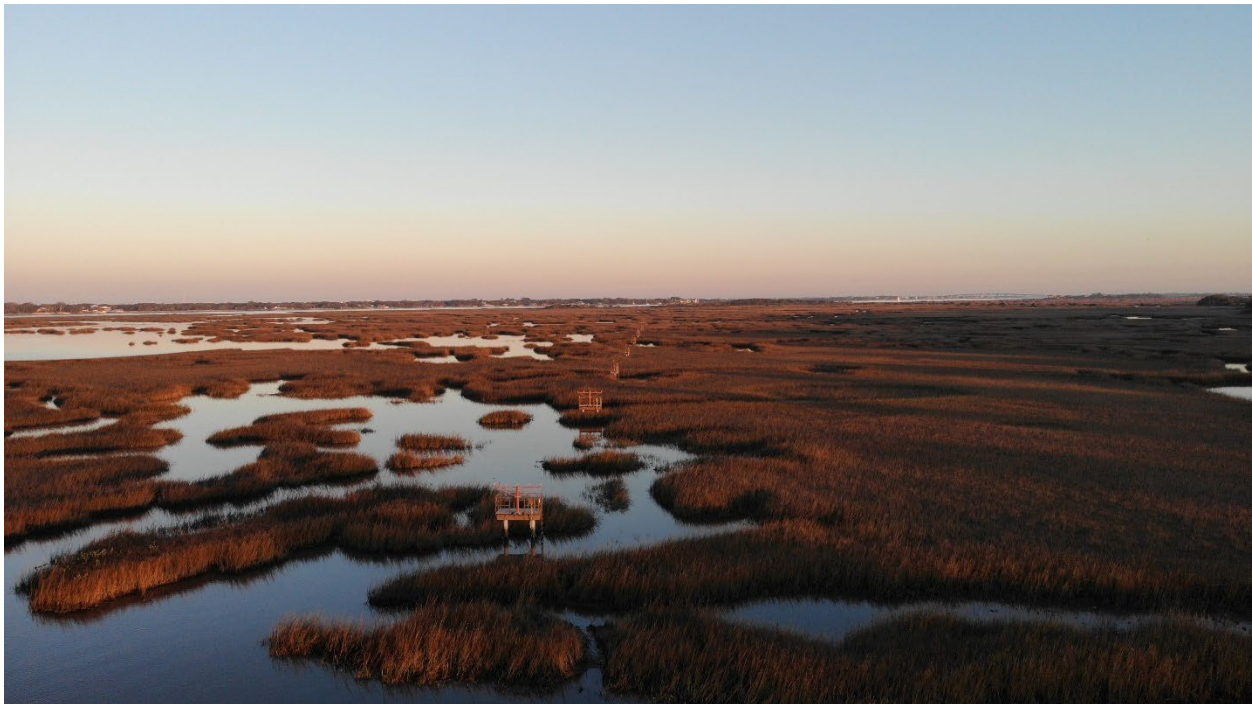
At 1715 a witness stated the aircraft went off of the left of the runway about ¼ mile down. There was still no visual at this time. A few minutes later, around 1717, the pilot told the tower she was completely wedged between the ground of mud and the canopy of the aircraft.

River Boat 9 (RB9) was dispatched with a crew to launch at the boat ramp. Upon arriving, RB9 was advised to attempt to make access into the marsh and locate the aircraft. RB9 attempted to make way into the creek that would lead to the approximate location of the downed aircraft, just south of the runway, but immediately began to hit bottom due to low tide and multiple oyster beds in the area. RB9 tried to make entry again at a different creek entrance but again struck bottom. RB9 tried to gain access again at the original creek mouth and was able to make some progress due to incoming tide with the motor tilted up as far as it could but the water depth was too low coupled with other natural obstructions to get passed the entrance.

**Figure 2** – end of runway looking into marsh

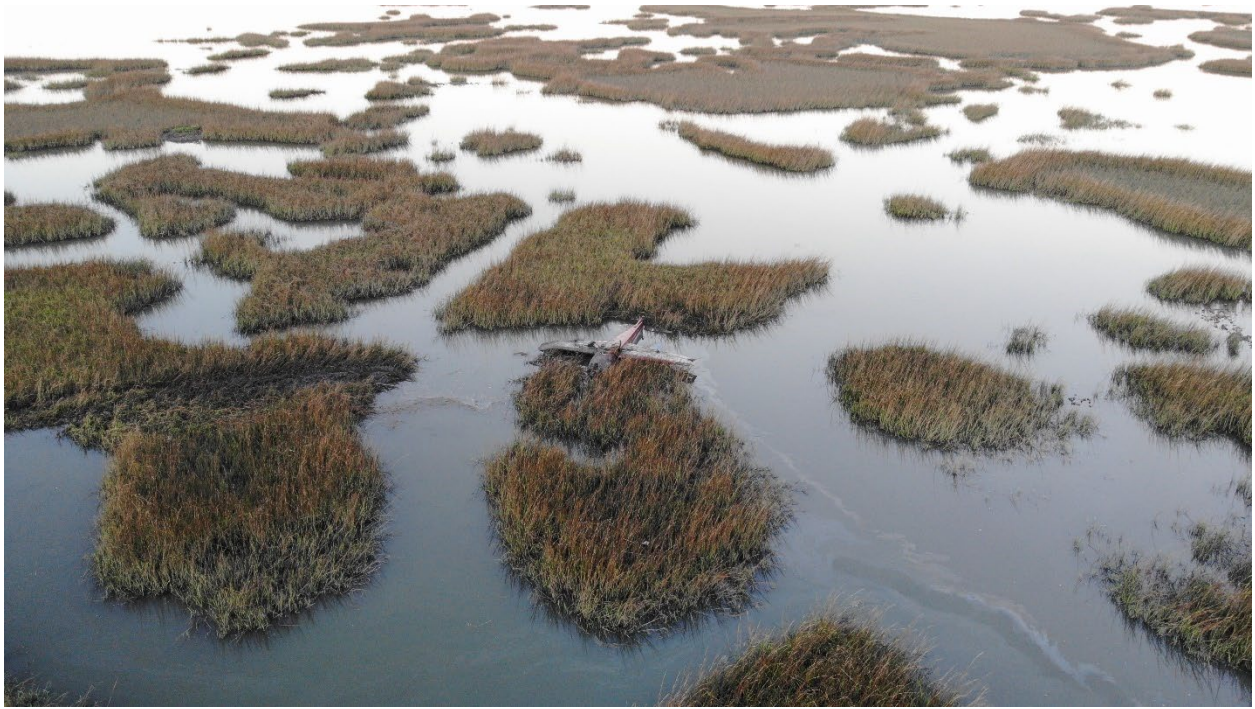
By about 1743 both airboats were able to reach the aircraft wreckage. The aircraft was submerged in the water. The crew stated it was extremely difficult to move about as the water was waist high and the mud made it extremely difficult to move in. The firefighters stated the aircraft was stuck in the mud and the pilot was trapped upside down in the mud and still restrained in the pilot seat. The crews began the extrication process using an angle grinder to cut access holes for the cutters and spreaders to be able to cut the plane from around her. While crews were cutting the tide was rising fast and they were no longer able to see the pilot. At about 1752 the pilot was extricated and placed on an airboat and taken to the ramp where CPR was performed. The pilot was transported via emergency services to the local hospital at about 1808 and later died.

**Figure 3-** aircraft inverted in the marsh
