**Wreckage Examination  
NTSB Accident Number  
ERA22FA161**

| Location: | Dahlonega, GA |
| Date: | March 19, 2022 |
| Aircraft: | Cessna 172H |

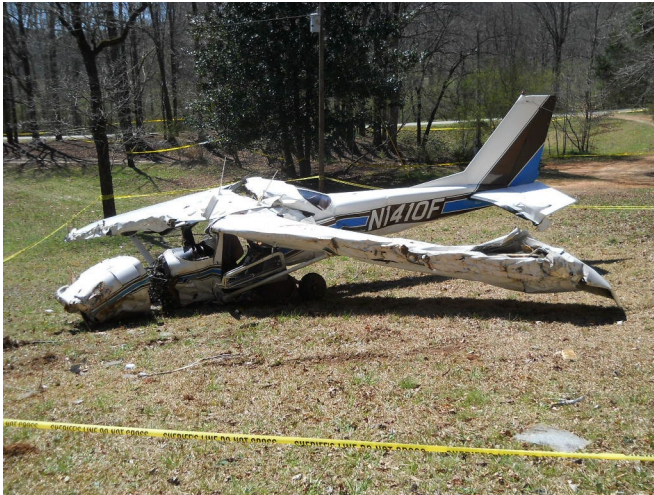
The wreckage came to rest upright, oriented about a 120° magnetic heading. Both wing tanks were breached, and a strong odor of fuel was present at the accident site. Additionally, the fire department had placed sediment below the right wing to absorb fuel on the ground. An approximate 65-ft debris path was observed along a magnetic course of 270°, beginning with tree scars about 50 ft up. A branch was recovered along the debris path; it exhibited an approximate 45° cut with gray paint transfer. An approximate 3-ft by 2-ft, by 1-ft deep crater was observed along the path, about 10 ft from the wreckage. The wreckage remained intact. Both wings exhibited leading edge damage with the left wing exhibiting more at the

outboard half. The flaps and ailerons remained attached to their respective wing. The empennage remained intact and canted left; it was undamaged except for left horizontal stabilizer leading edge damage. Flight control continuity was confirmed from all flight control surfaces to the cabin area. Measurement of the flap actuator corresponded to a flaps retracted position. Measurement of the elevator trim jackscrew corresponded to a 10° trim tab up position; however, the trim wheel in the cockpit was set at the neutral/takeoff position. The cockpit area was crushed, but the pilot's 4-pt harness remained latched and was cut by rescue personnel.

The engine remained attached to the airframe and the propeller remained attached to the engine. Both propeller blades exhibited chordwise scratching and leading-edge gouging. The engine was retained for further examination.
