# National Transportation Safety Board

ERA22FA161

## **SECURITY CAMERA RECORDING**

Location: Dahlgonega, GA  
Date: March 19, 2022  
Time: 1852 eastern daylight time (EDT)  
Airplane: Cessna 172H; N1410F

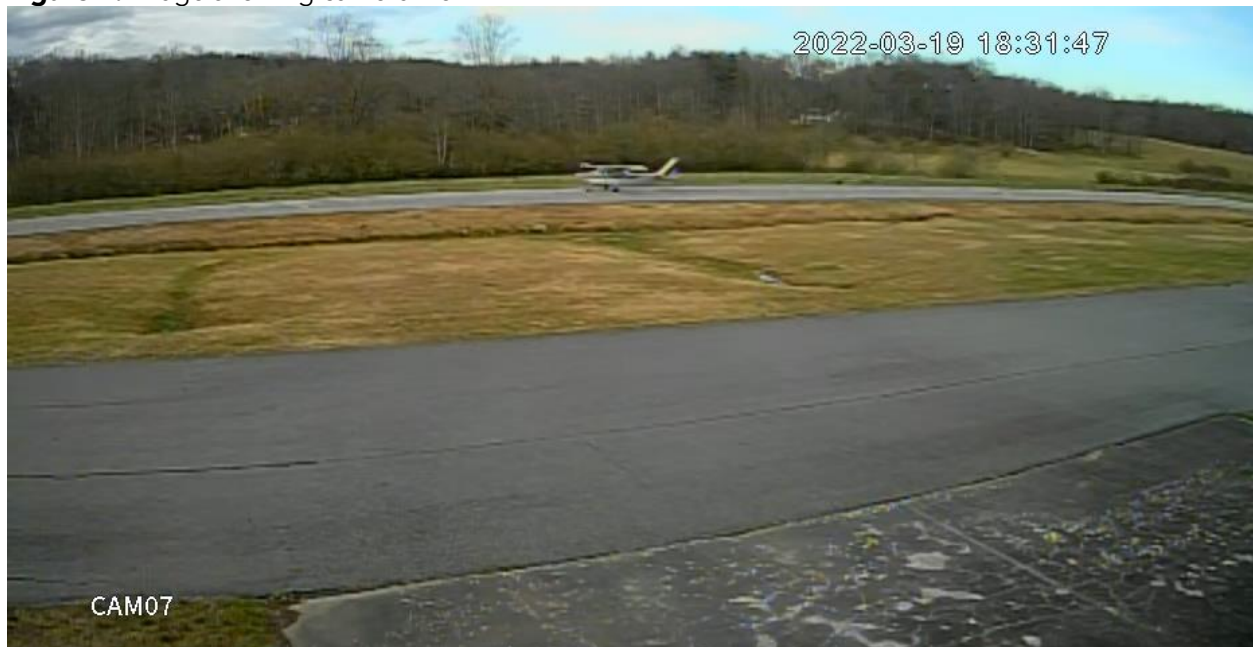
**Figure 1.** Image showing camera view.

The recording shows a portion of a taxiway and a portion of the runway in which the aircraft attempted to land. At 21:10, the accident aircraft comes into the field of view from the right of the image. By 23:12, the aircraft was approximately centered in the field of view. By 25:00, the accident aircraft had crossed out of the field of view to the left of the image.
