# Jacksonville Sheriff's Office Statement Form

ASW 19B  
19KW

## NATIONAL TRANSPORTATION SAFETY BOARD

#### Memorandum of Record of Conversation

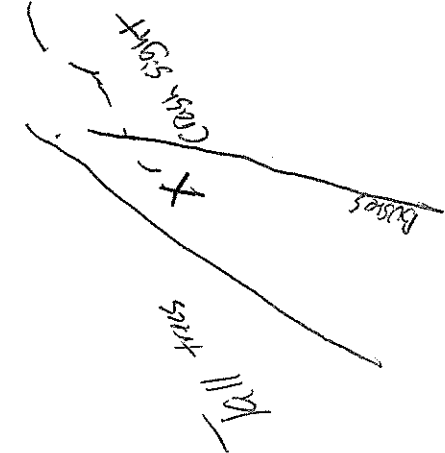
Glider take off

Brew off and high pitch Aot  
seen from glider  
200' AGL  
Screaming  
heard.
