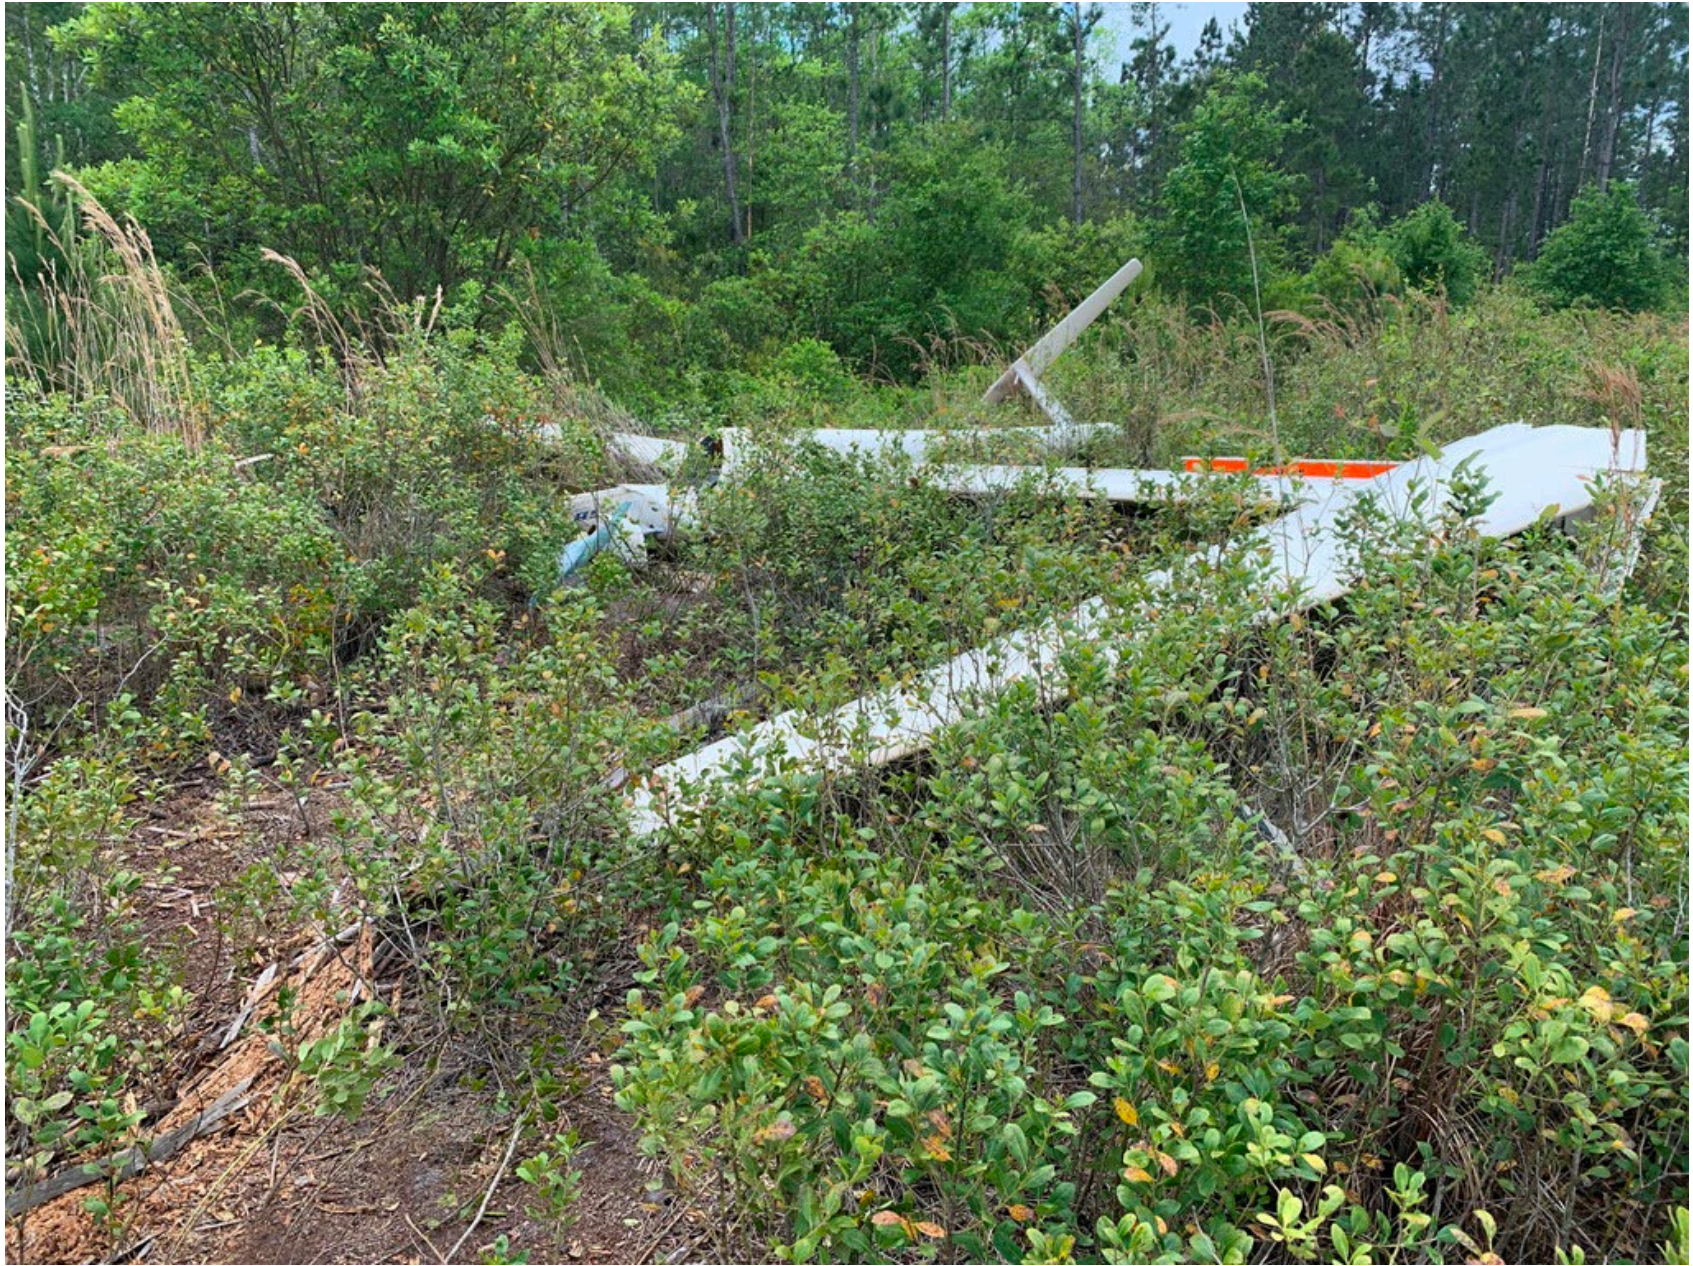
**Photo 1 – Left side view of glider at accident site**

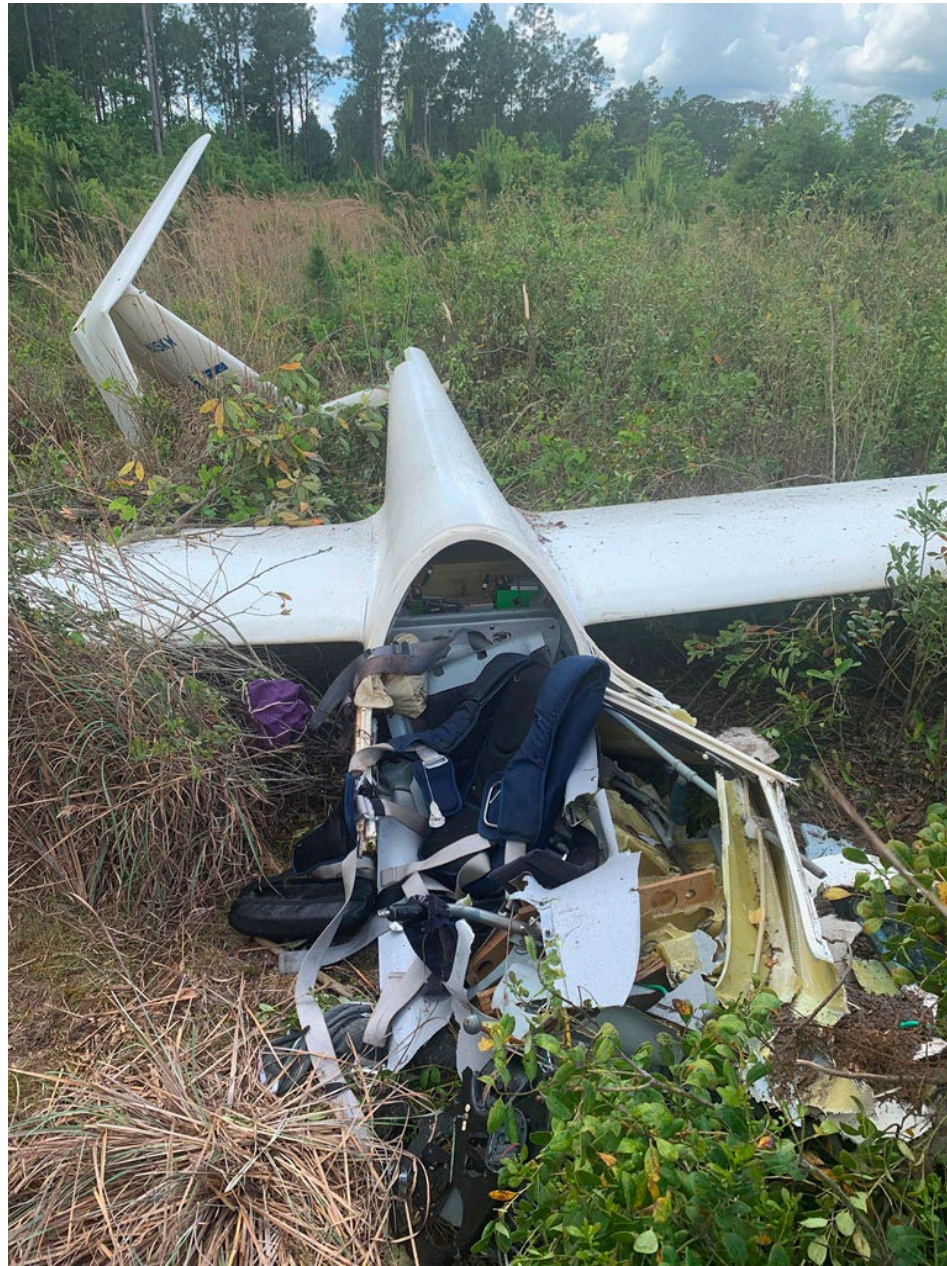
**Photo 2 - Front view of glider at accident site**

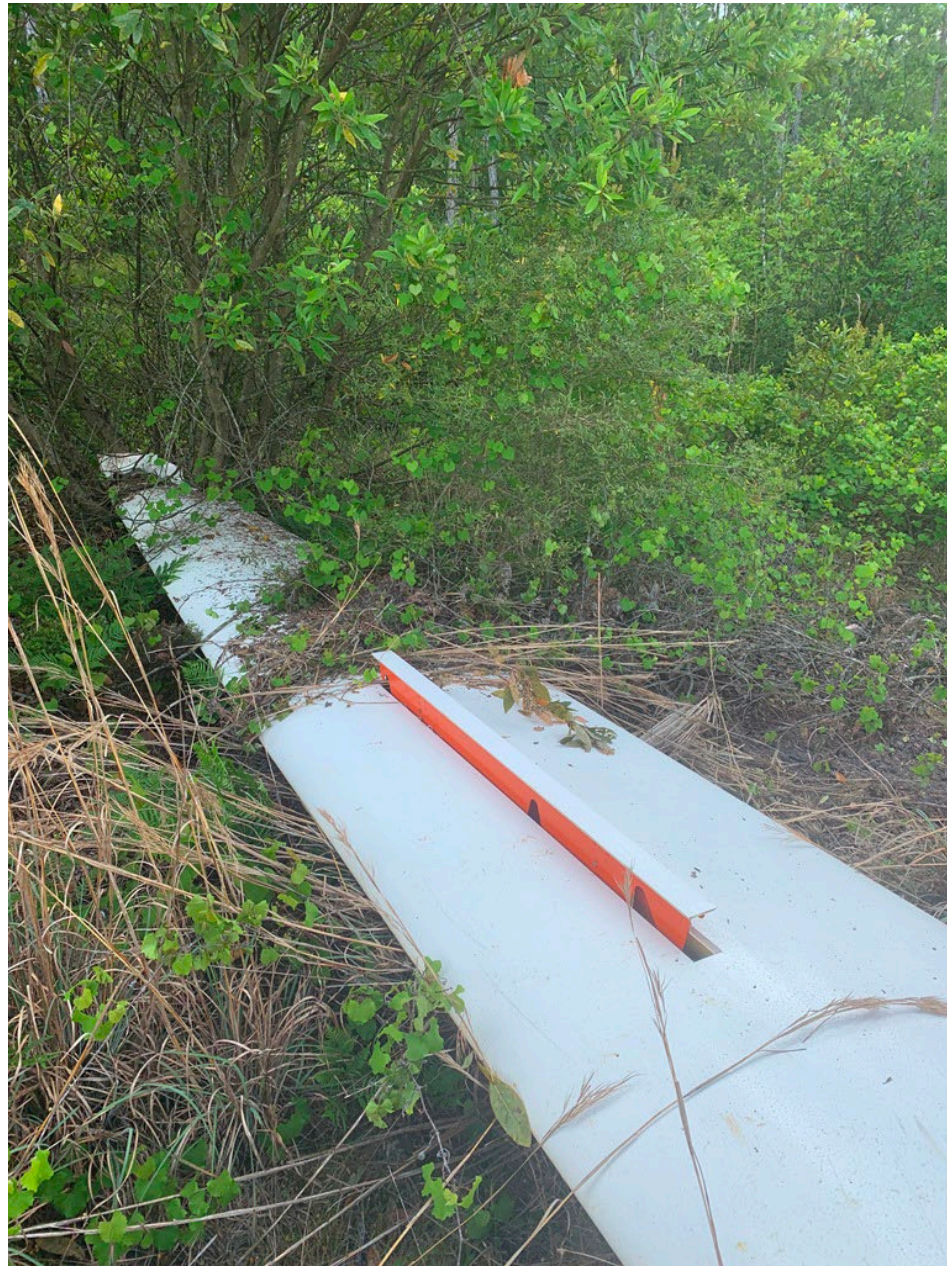
**Photo 3 - Right wing with speed brake deployed**

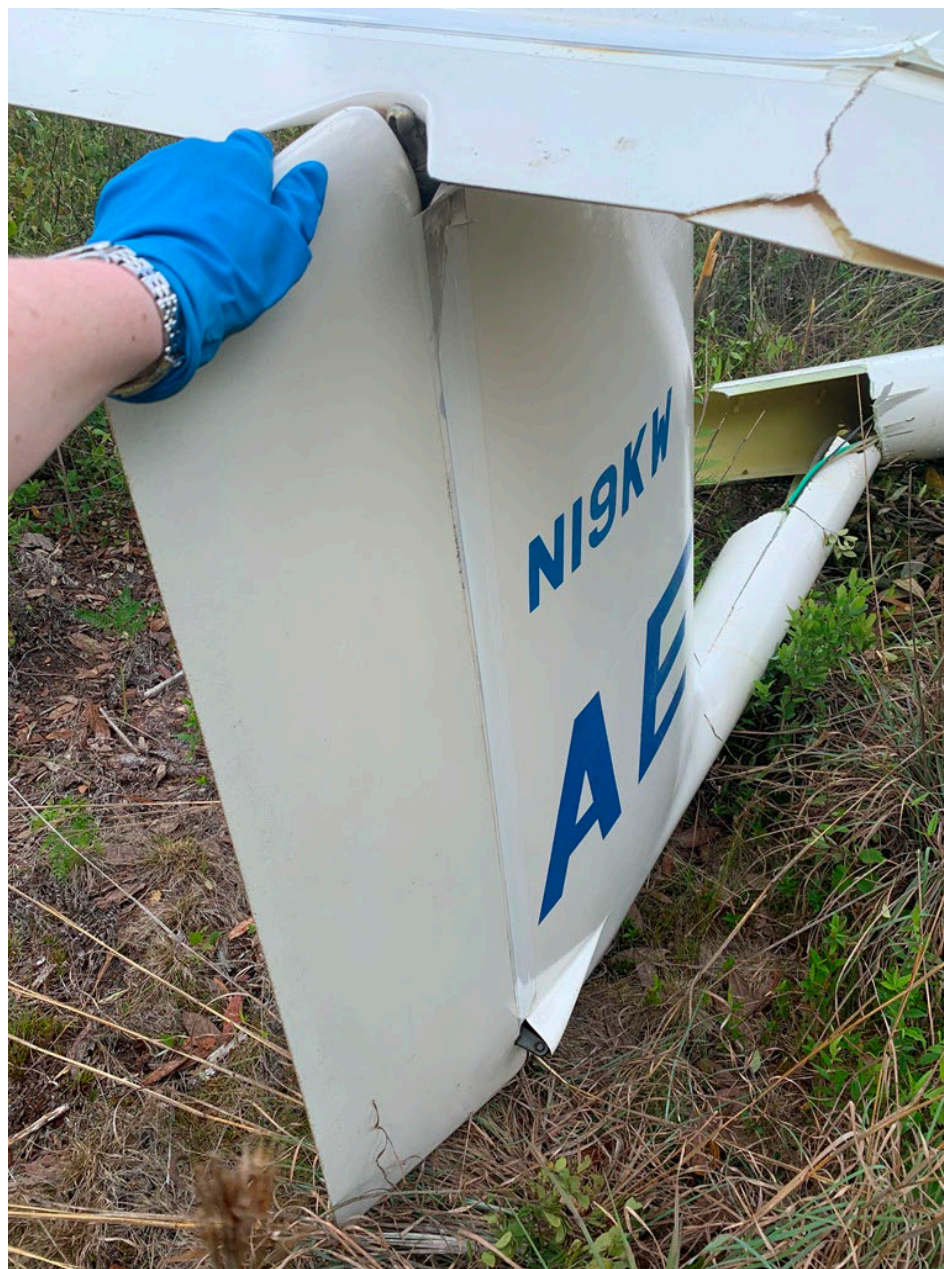
**Photo 4 -Tail section with up end of the elevator connection visible between elevator and horizontal stabilizer**

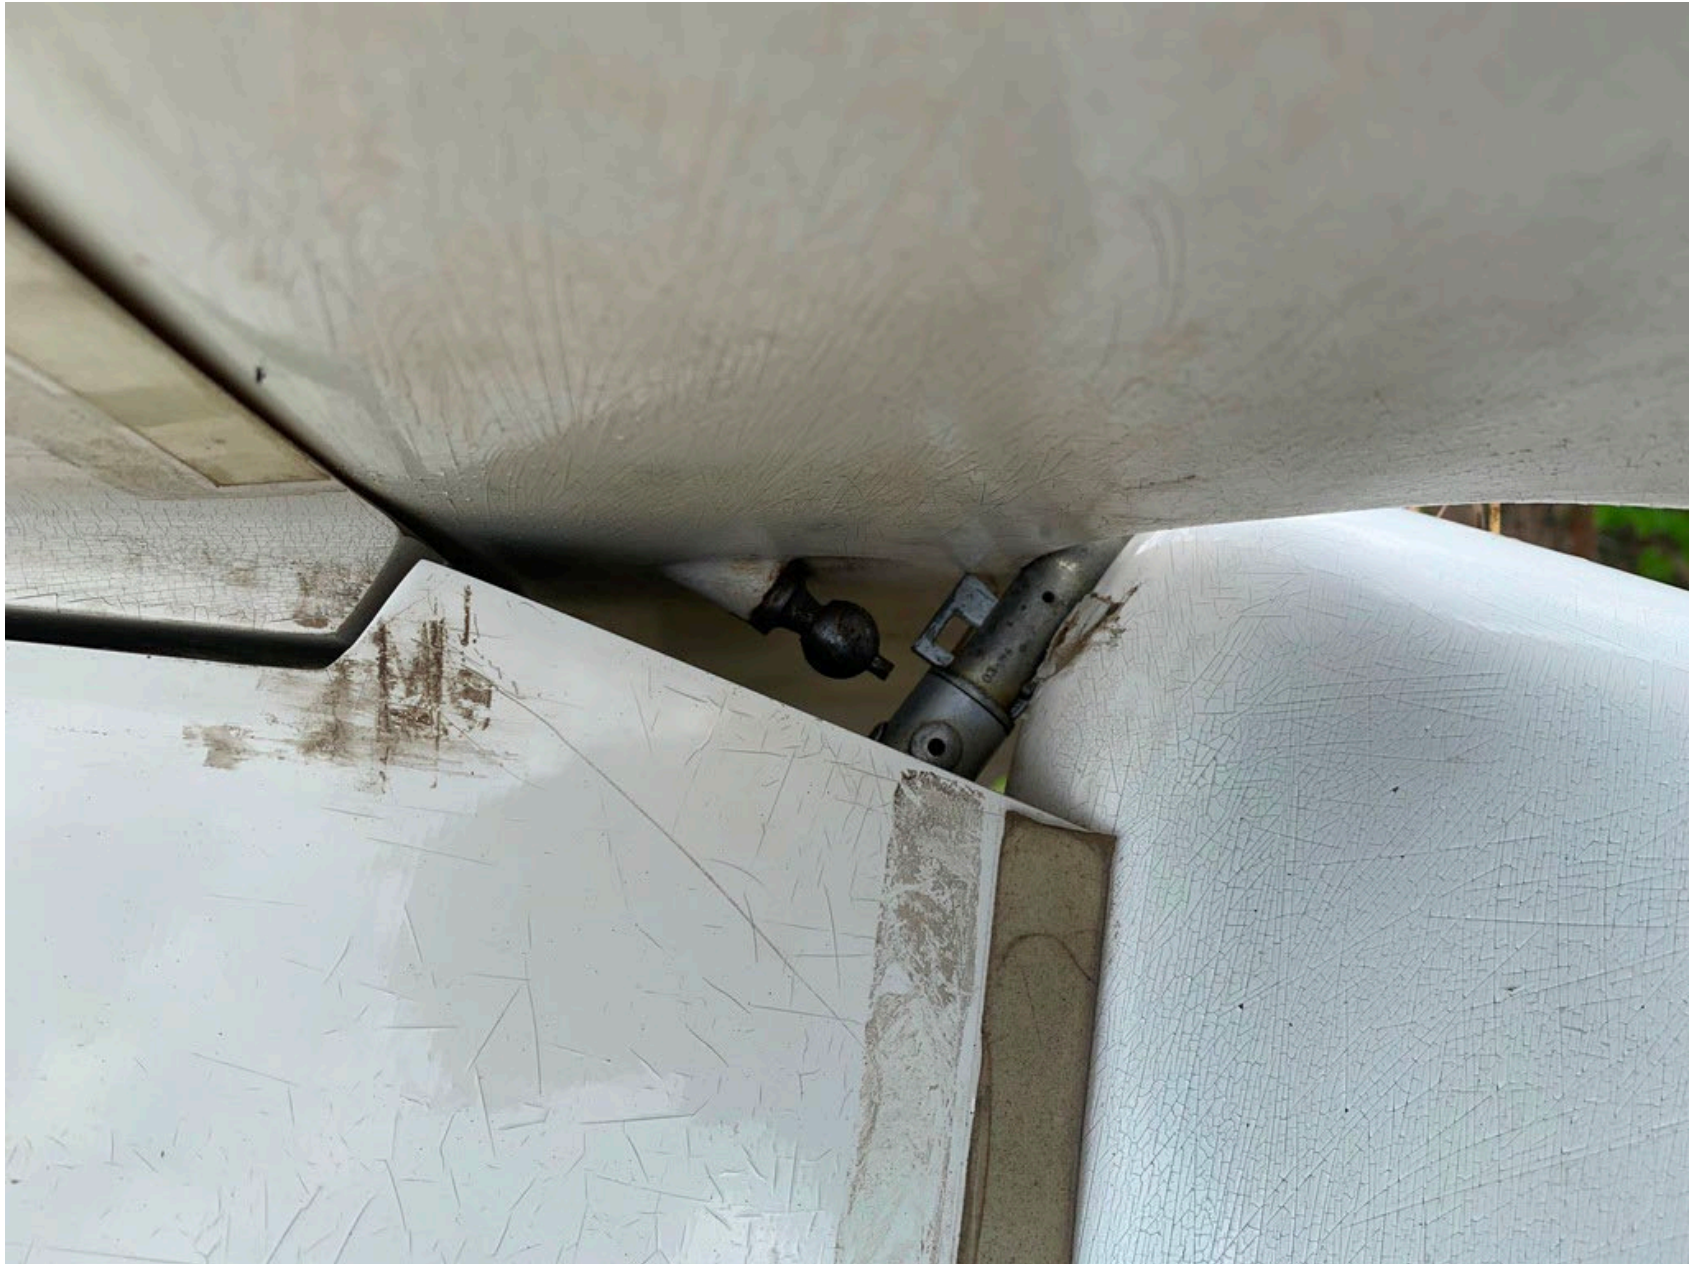
**Photo 5 - Left side view of elevator connection (not connected)**

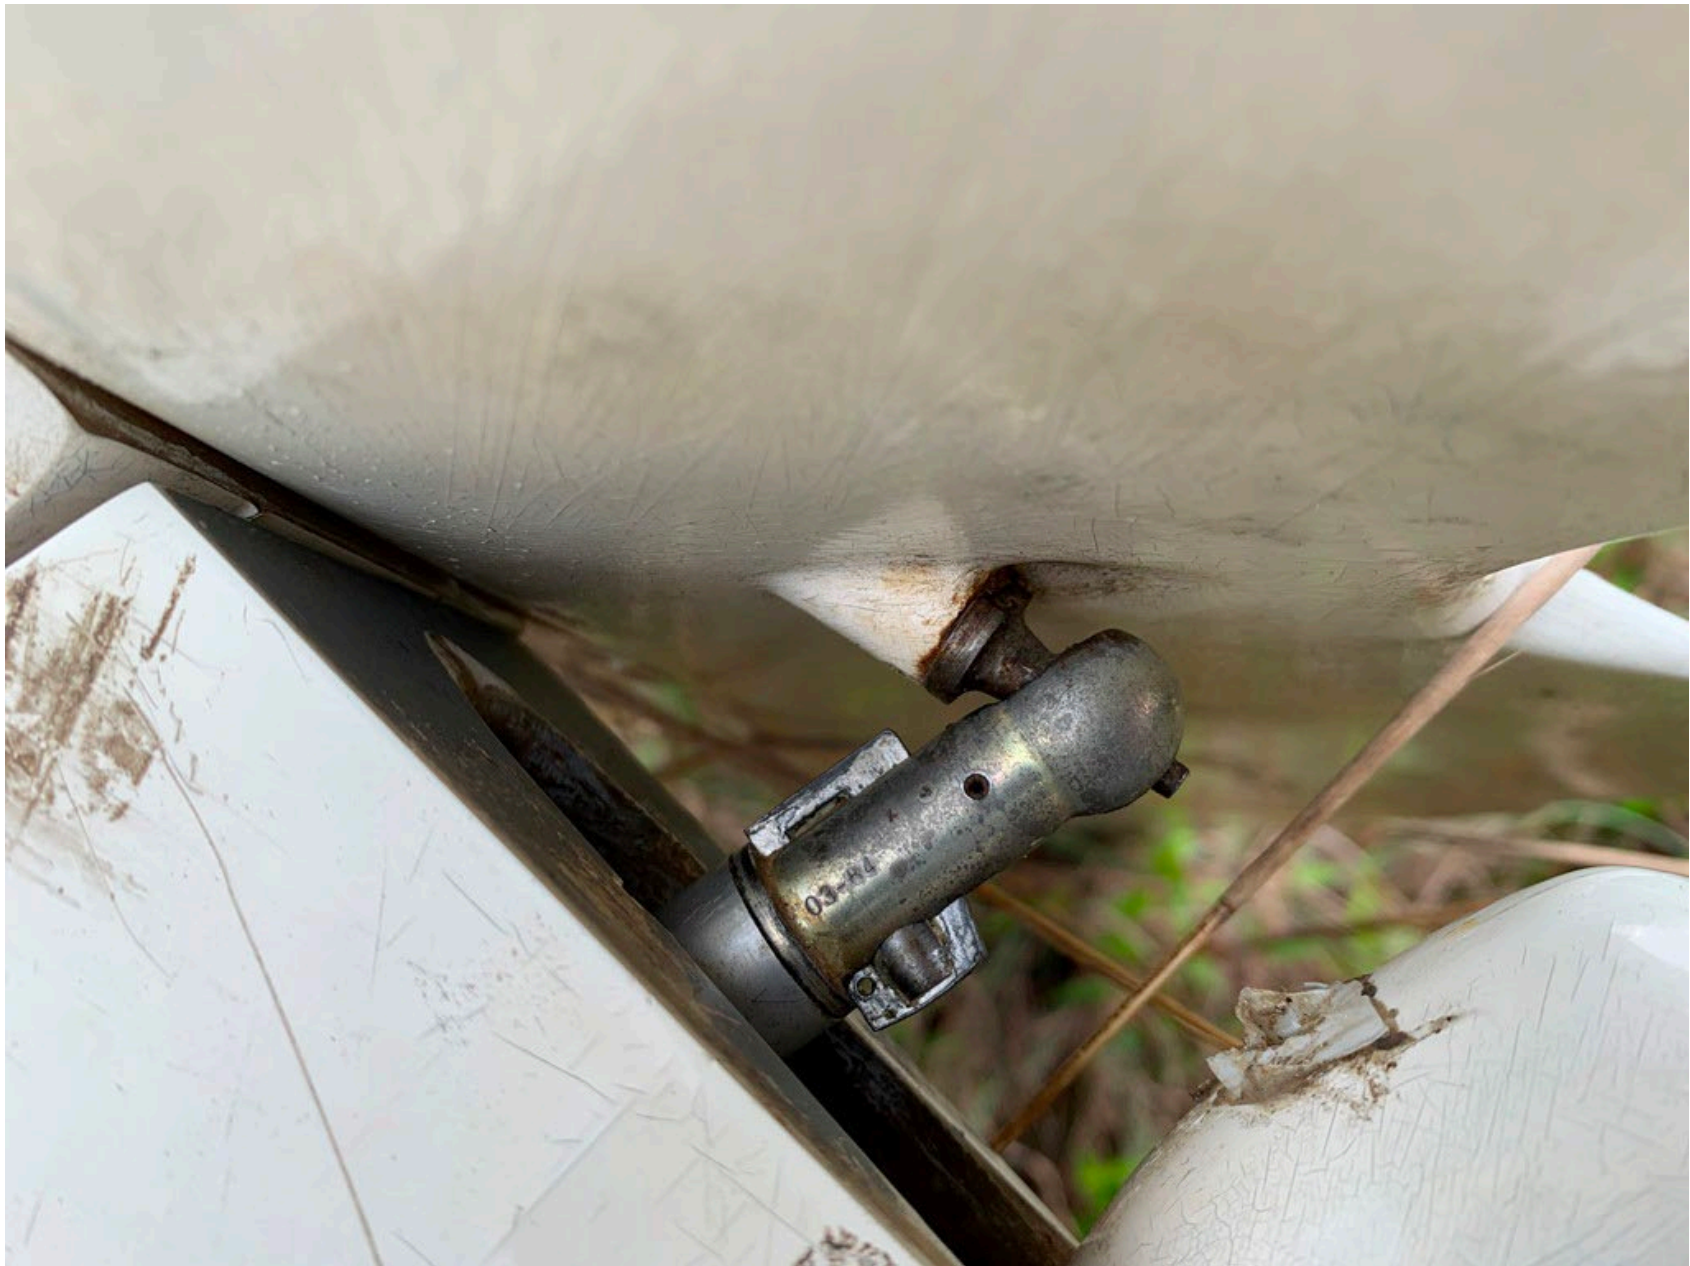
**Photo 6 - Left side view of elevator connection (connected by NTSB IIC). Note: the drill hole for the spring clip is visible below the number stamps.**
