**Date of Accident:** April 21, 2022

**NTSB File No.:** ERA22FA199

**Aircraft:** Cessna 340

**PROPELLER EXAMINATION REPORT**

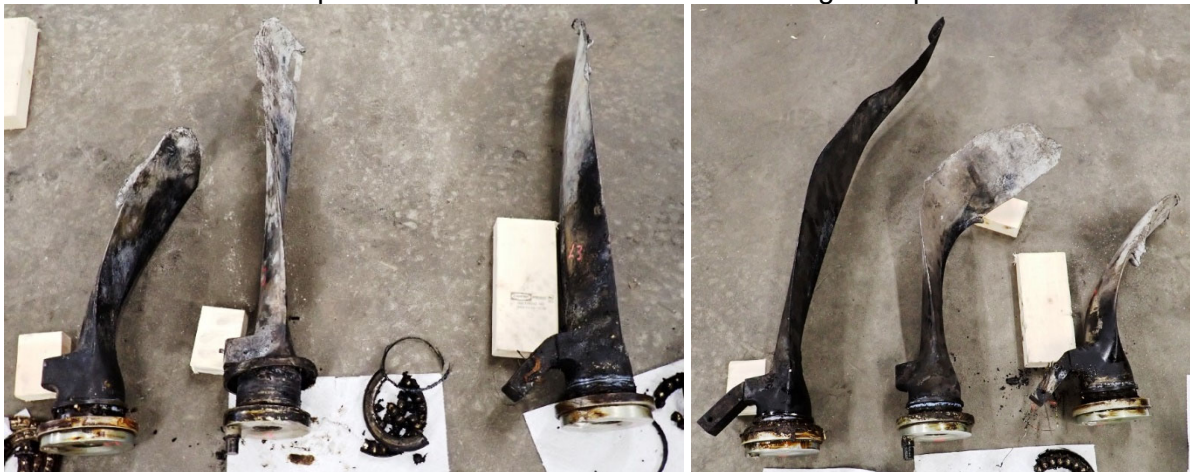
Both propellers exhibited similar impact damage. All three blades on both propellers were partially consumed in the post-crash fire. Photo #1 shows the relative damage between the left and right blades. Blade damage included visible chordwise/rotational scoring on some blades in each propeller, bending in the aft/drag direction, twisting towards low pitch, bending opposite rotation, and leading edge gouging that is consistent with impact while rotating with power ON. There was no damage to indicate either propeller was feathered at the time of impact.

Photo #1 – Propeller blade damage comparison  
Left Propeller                      Right Propeller

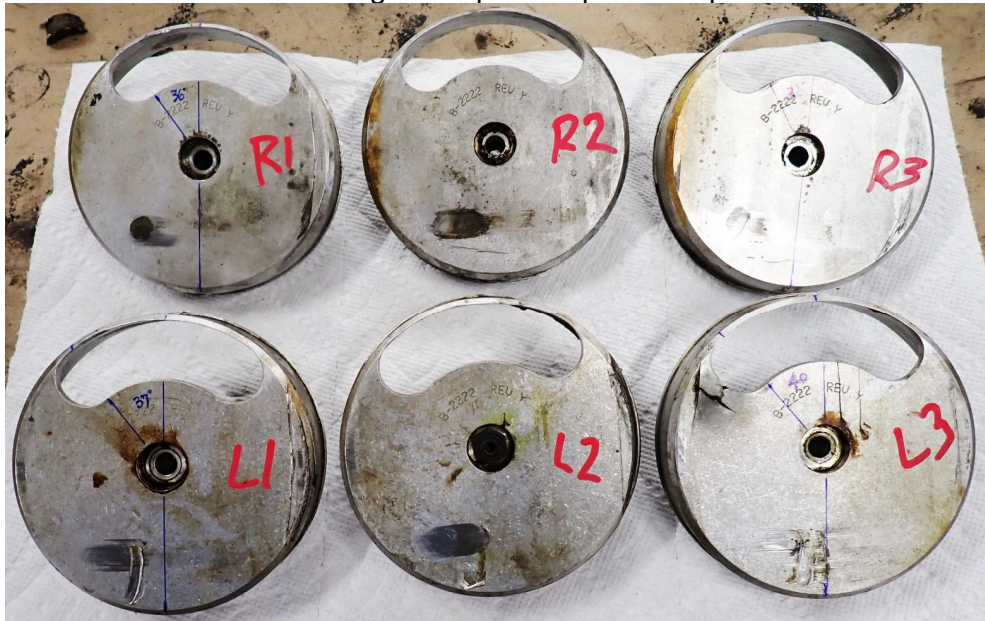
Internal damage on the preload plates (Photo #2) and fork slots (Photo #3) indicated the blade angle on both propellers was in the low pitch range at impact.

Photo #2 – Right/Left preload plate comparison

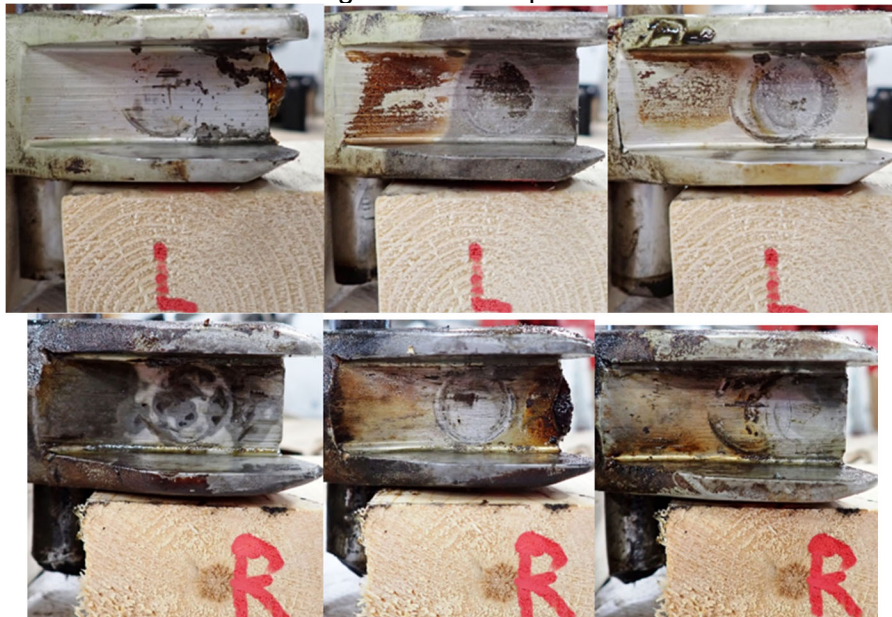
Photo #3 – Left/Right fork slot impact mark similarities

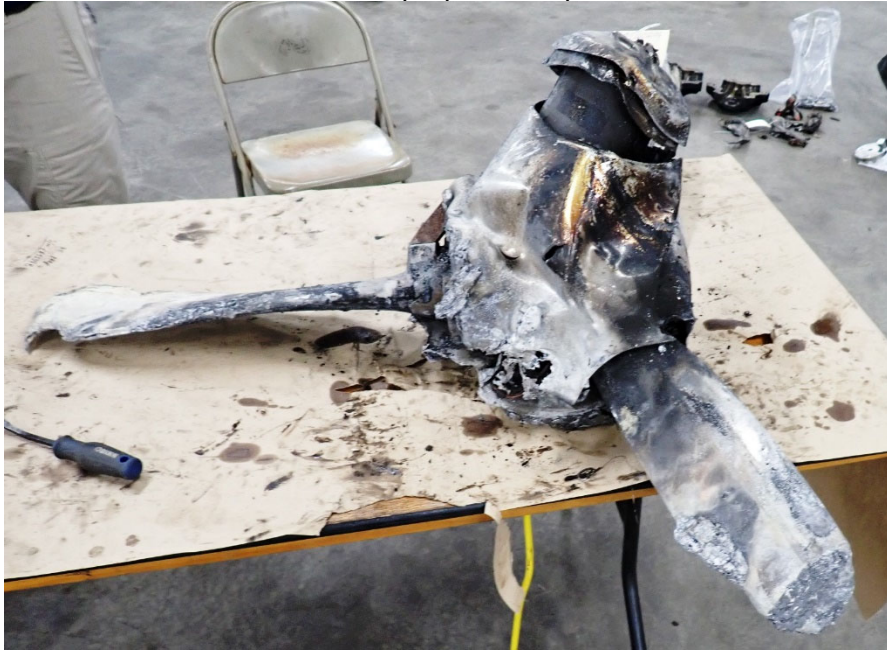
**As Received Condition:** The left propeller impact-separated from the propeller crankshaft flange during the impact sequence, was recovered and presented for examination at Atlanta Air Salvage as shown in Photo #4. The propeller was heavily damaged in the post-crash fire with extensive sooting and charring. All three blades were partially consumed. Two blades were in a low pitch position and one appeared to be in the feathered position. The spinner dome and bulkhead were crushed, torn and partially consumed. All six mounting studs and one of the two dowel pins had pulled from the hub. The hydraulic unit remained attached to the assembly via the pitch change rod but had separated from the hub mounting boss.

Photo #4 - Left propeller as-presented

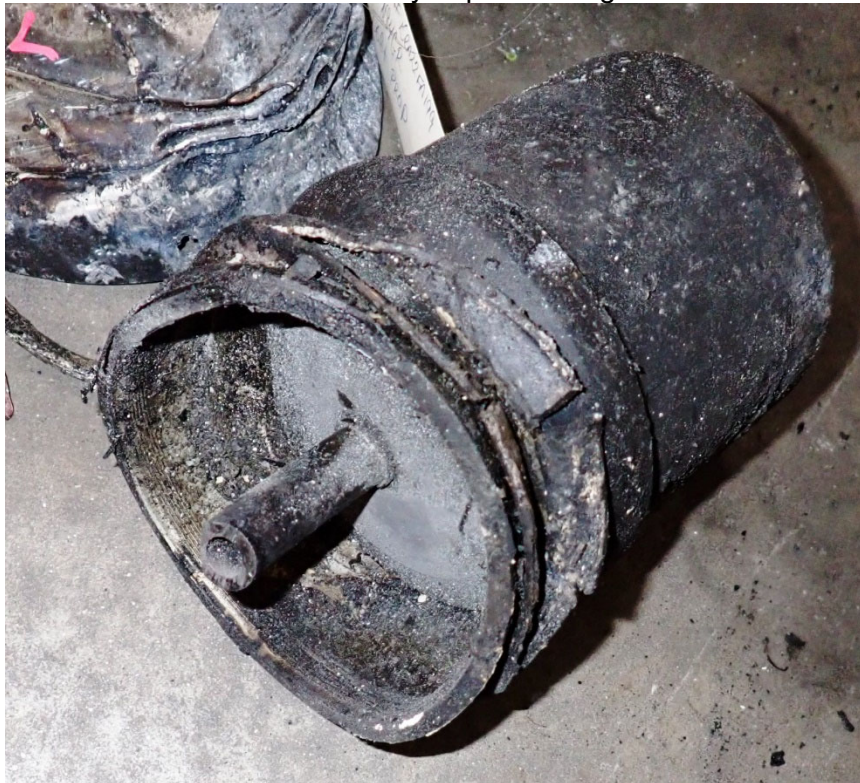
**Cylinder:** The cylinder was crushed to one side but remained intact (Photo #5).

Photo #5 - Left propeller hydraulic unit (cylinder, piston, feathering spring)  
cut from assembly at pitch change rod

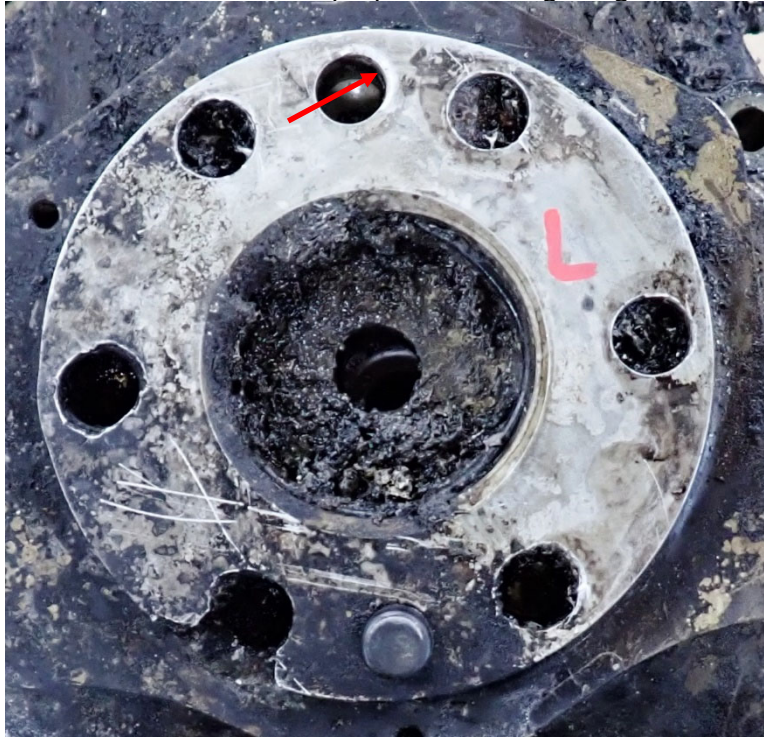
**Engine/Propeller Mounting:** All six propeller mounting studs and one down pin were pulled from the hub during the impact sequence. One dowel pin hole exhibited deformation in the direction of rotation (Photo #6).

Photo #6 - Left propeller mouting flange

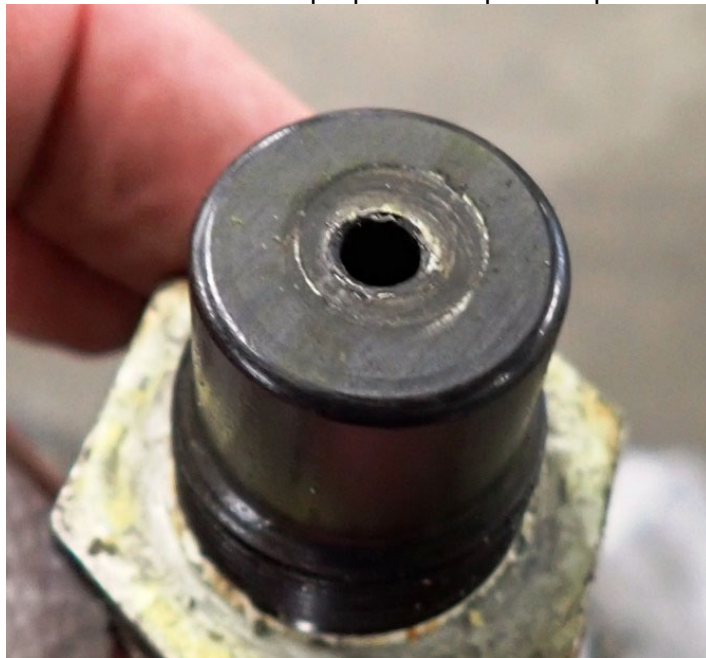
**Pitch Stops:** The low pitch stop had an impact mark where the pitch stop cap screw forcefully contacted the assembly (Photo #7). The feather stop and start lock assemblies were not removed and thus not observed.

Photo #7 - Left propeller low pitch stop

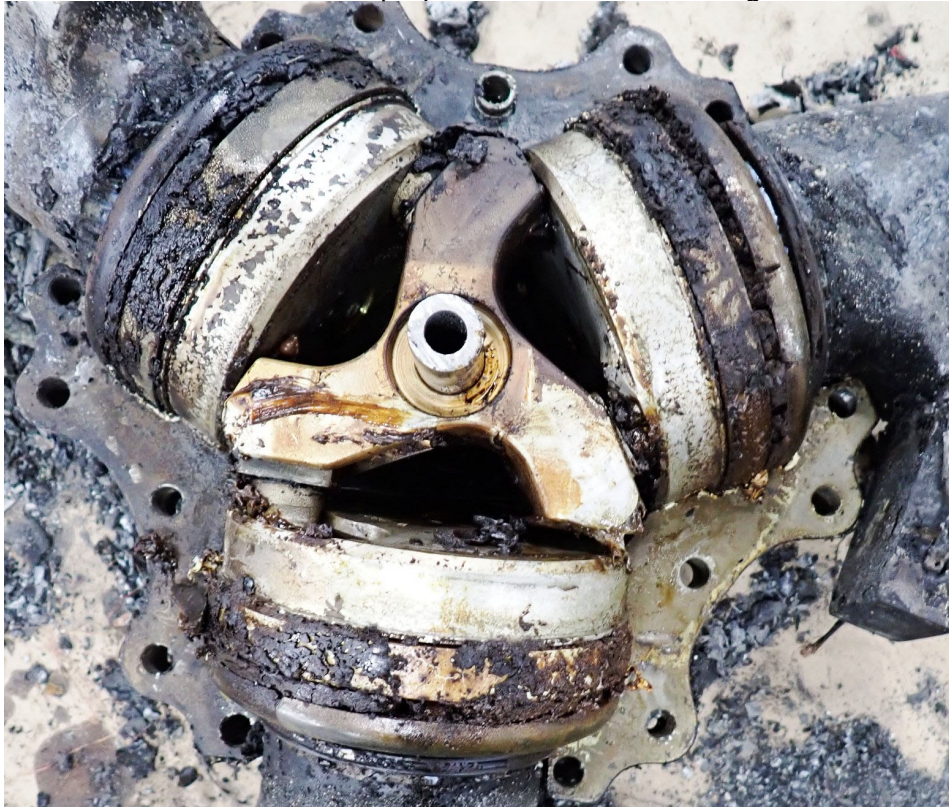
Photo #8 - Left propeller internal heat damage

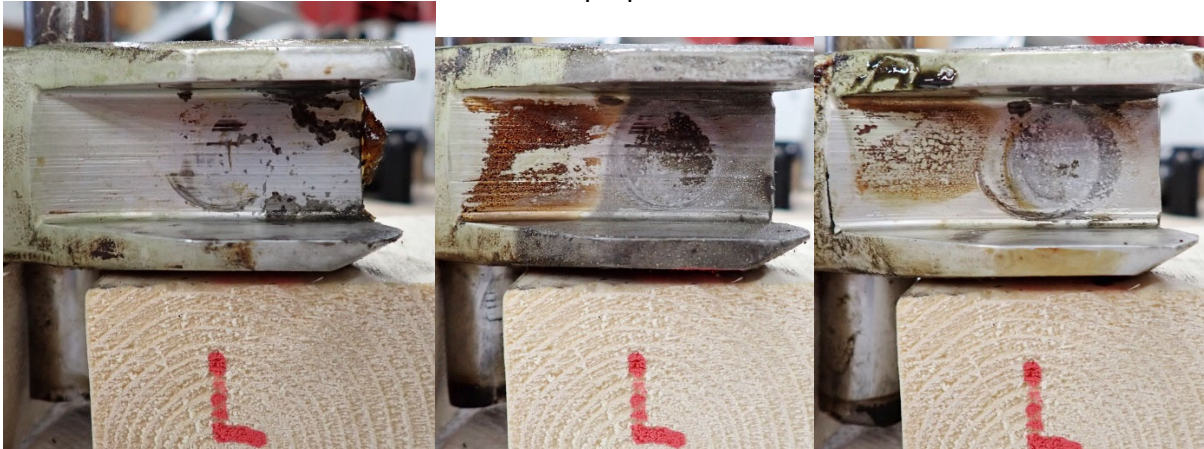
**Fork:** The fork remained intact and attached to the pitch change rod. There were pitch change knob block impact marks in the low pitch range of travel (Photo #9).

Photo #9 - Left propeller fork slots

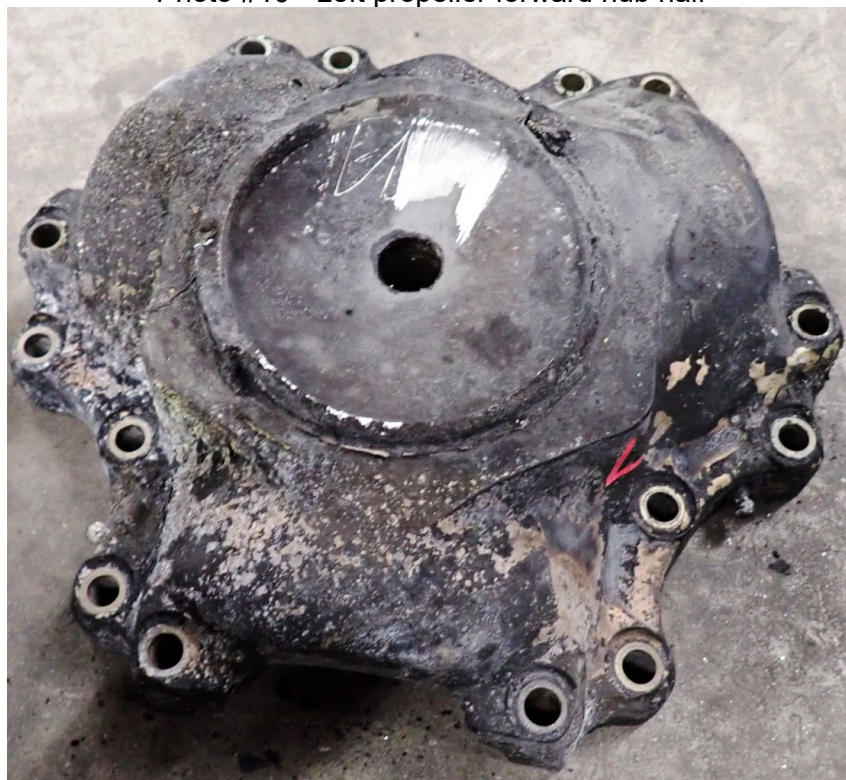
**Hub Assembly:** The hub unit remained intact with no remarkable cracks or fractures in the blade retention areas. The cylinder mounting boss was fractured which is common under impact loads (Photo #10). All the hub thru-bolts were present and secure. Once the hub was opened there were signatures of heat exposure to the internal components; bearing grease dark and hardened, ball bearing spacers melted (Photo #8). The blade retention bearings appeared intact. The aft hub internal surface had fractures and marring in the blade retention pockets indicating predominate impact loads were in the aft/trailing edge direction (Photo #11).

Photo #10 - Left propeller forward hub half

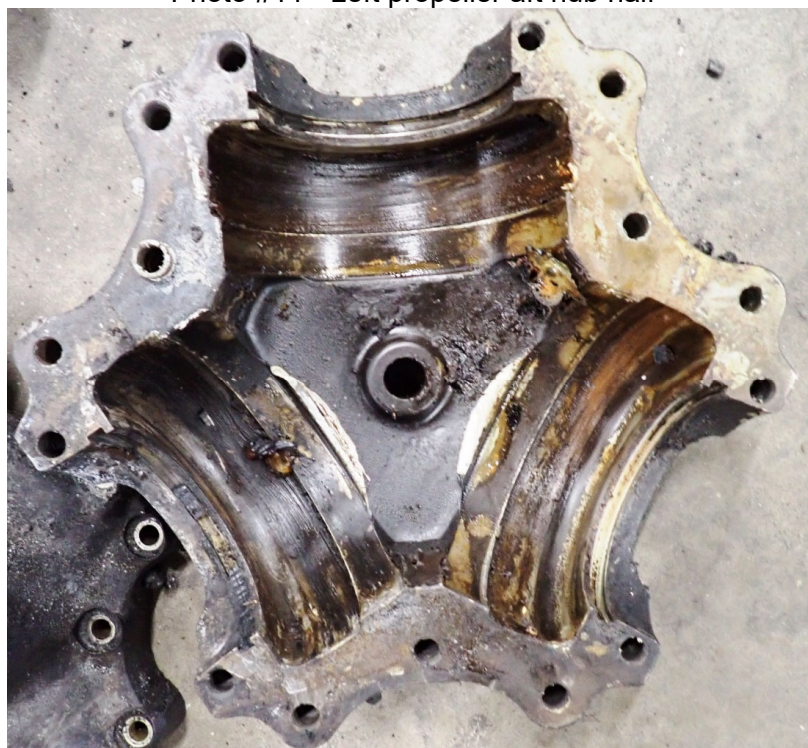
Photo #11 - Left propeller aft hub half

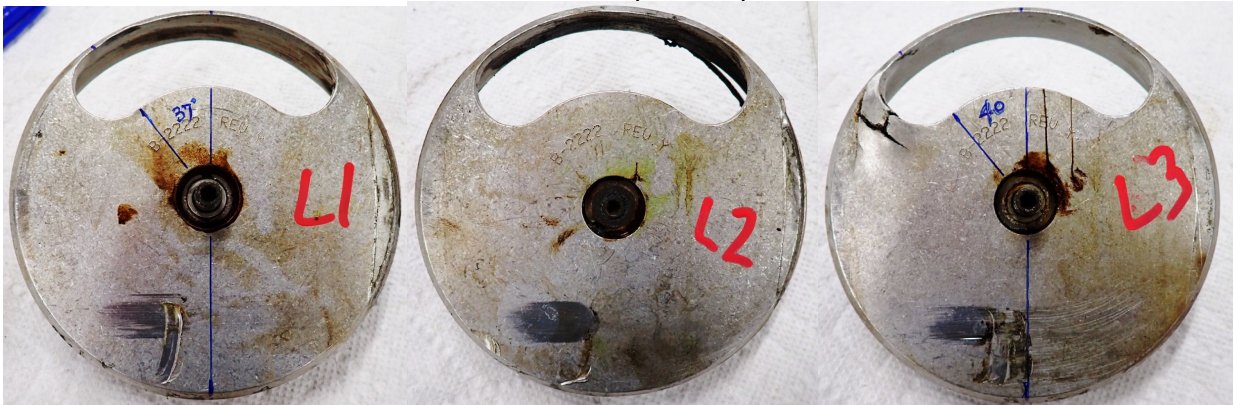
**Preload Plates:** See Photo #12. All three preload plates exhibited damage to the aft corner and retention lip. Plate L3 had remarkable damage to the low pitch end of the knob slot indicating forceful rotation of the blade towards low pitch during the impact sequence. Plates L1 and L3 had knob contact marks between 37-40° forward of the split line suggesting blade angle was 8-11° or approximately near the low pitch stop angle. All fork/fork bumper damage to the plate faces were in the low pitch quadrant, forward of the split line.

Photo #12 - Left preload plates

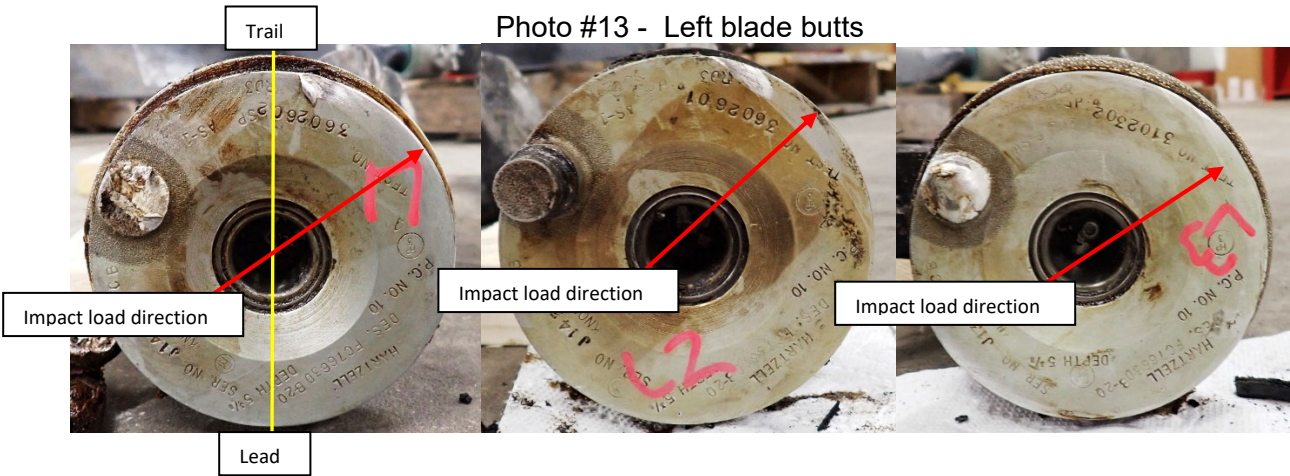
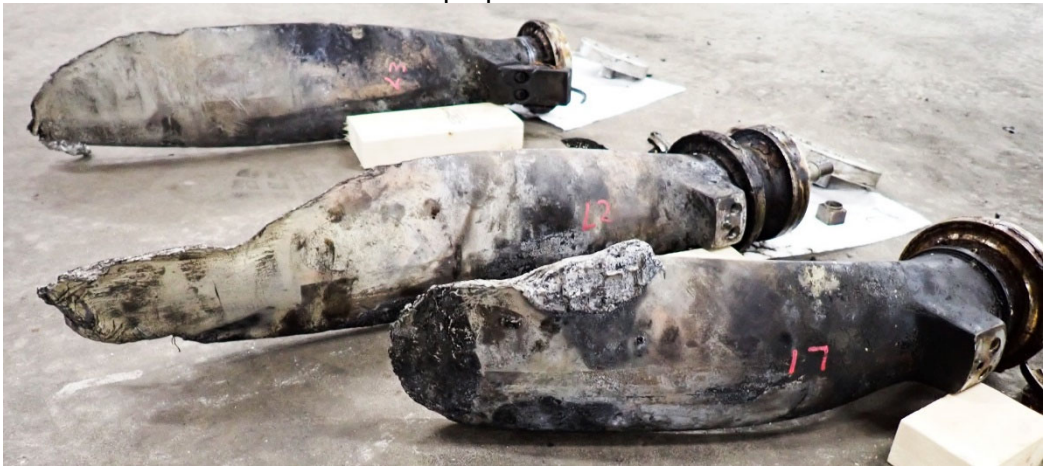
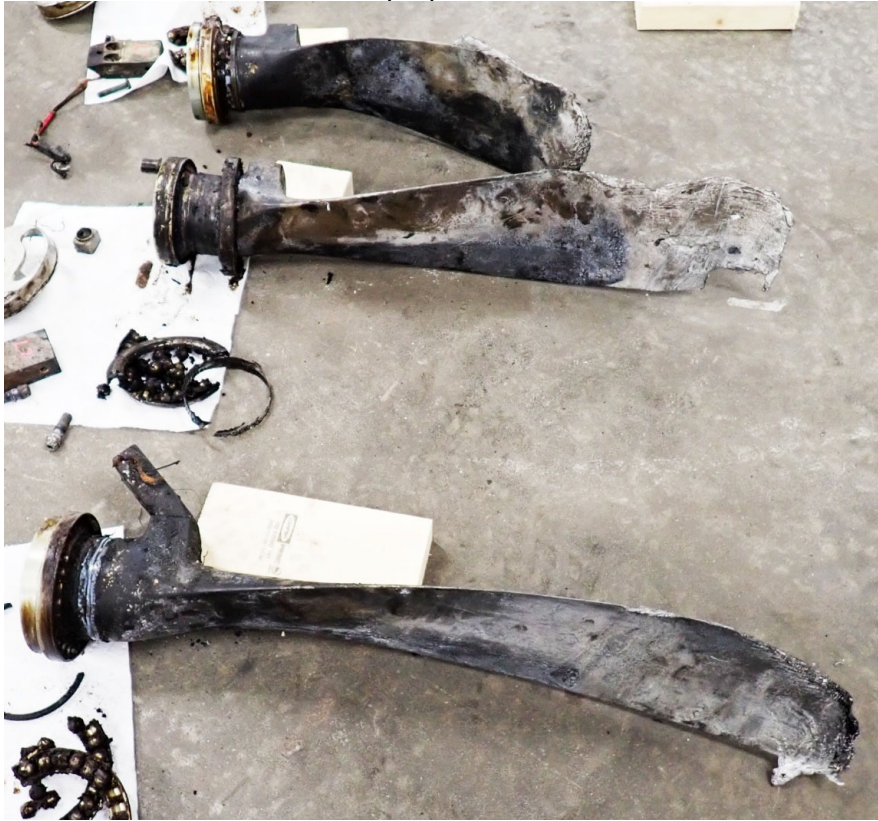
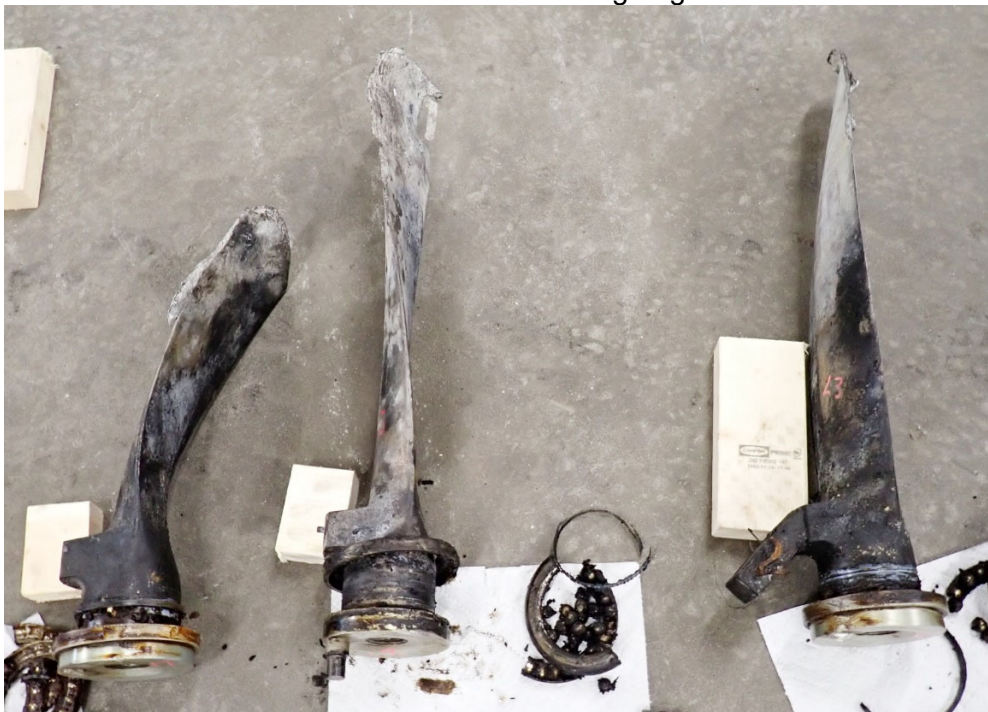
**Propeller Blade Properties:** See Photos #13 through #16. All three blades were partially consumed near the tips by the post-crash fire and exhibited remarkable heat exposure damage. It could not be determined if there were any tip fracture damage. Blades L1 and L3 pitch change knobs fractured from the butts; fracture surfaces exhibited shear/overload failure which is common under impact loads. Impact crescent marks on the blade butts were in the aft/trailing edge quadrant indicating impact loads were in the helical direction. Chordwise/rotational scoring was evident on all three blades. Compound bending and twisting was also evident in the aft/low pitch directions. The deice boots were consumed along with some deice wires.

Photo #13 - Left blade butts

Photo #14 - Left propeller blades camber side

Photo #15 - Left propeller blades face side

Photo #16 - Left blades trailing edge view

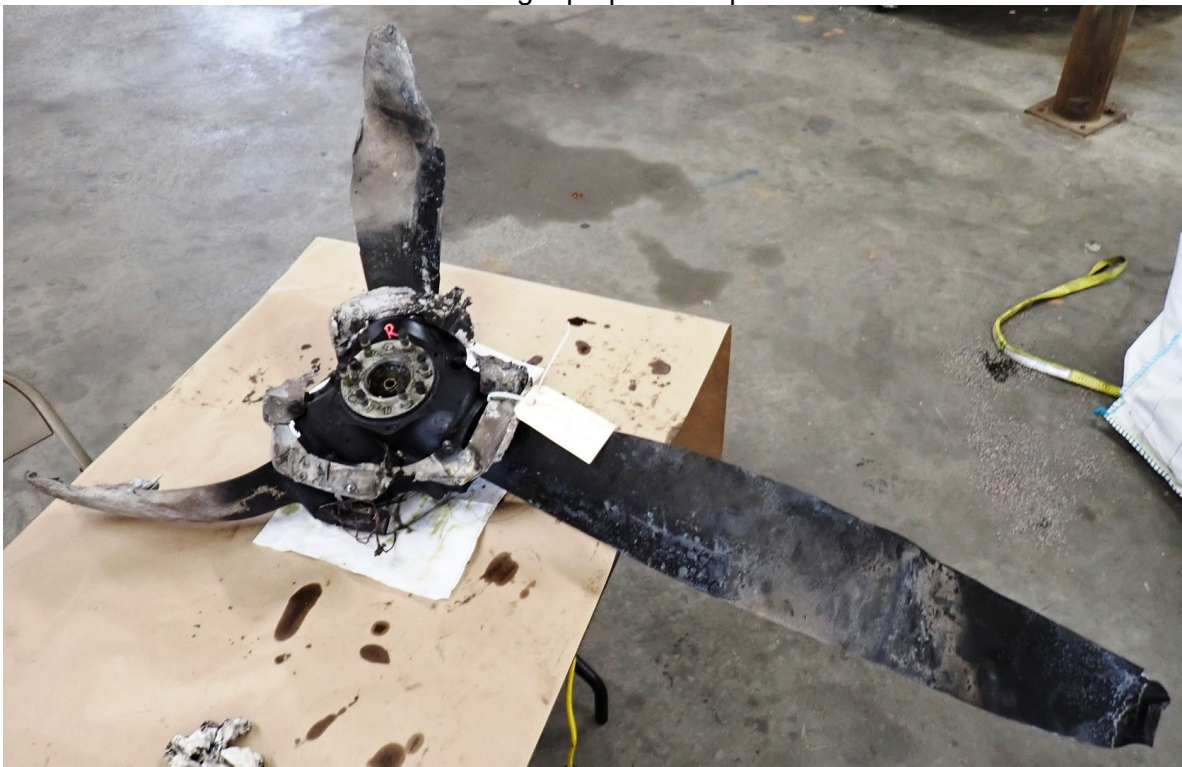
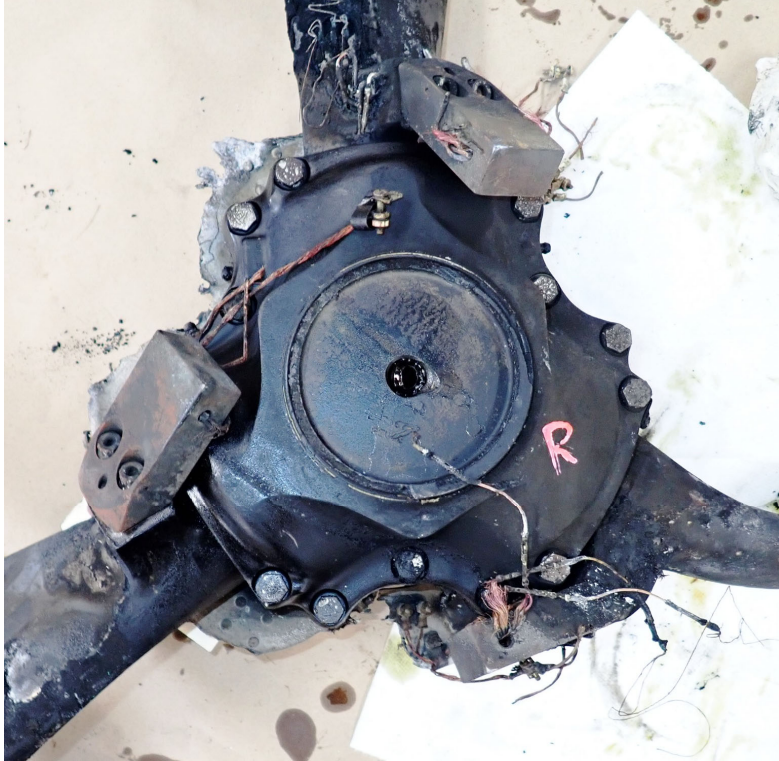
**As Received Condition:** The right propeller remained attached to the propeller crankshaft flange during the impact sequence, was recovered, removed from the engine and presented for examination at Atlanta Air Salvage as shown in Photo #18. The propeller was heavily damaged in the post-crash fire with extensive sooting and charring. All three blades were partially consumed. All three blades were in a low pitch position. The spinner dome and bulkhead were mostly consumed. All six mounting studs and both dowel pins remained in the aft hub. The hydraulic unit impact separated and was not recovered and/or presented for examination.

Photo #17 - Right propeller as-presented

Photo #18 - Right propeller as-presented, facing front hub

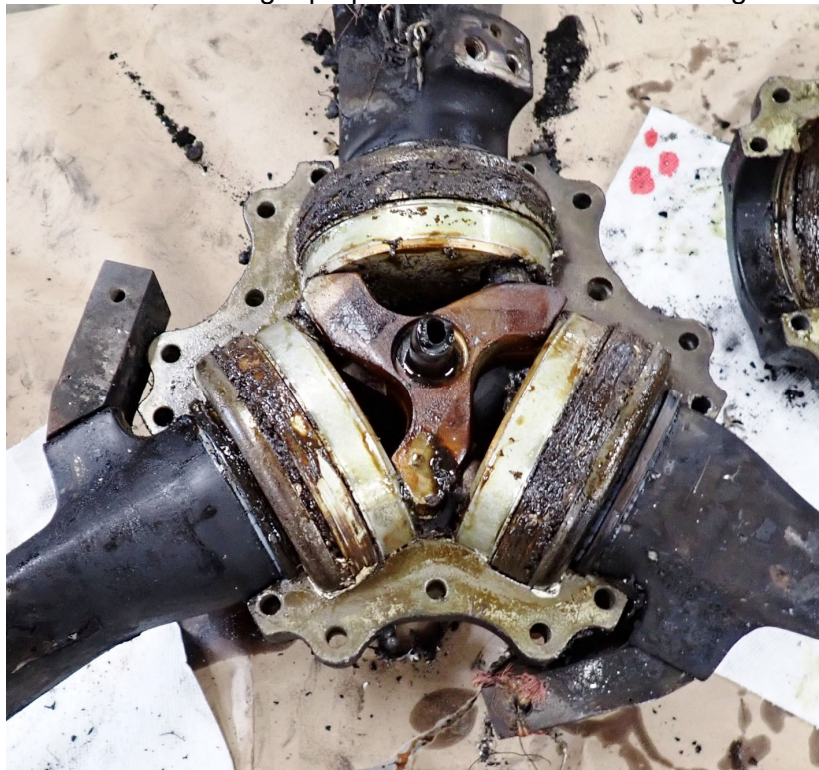
opened there were signatures of heat exposure to the internal components; bearing grease dark and hardened, ball bearing spacers melted (Photo #20). The blade retention bearings appeared intact. The aft hub internal surface had marring in the blade retention pockets indicating predominate impact loads were in the aft/trailing edge direction (Photo #23).

Photo #19 - Right propeller internal hub heat damage

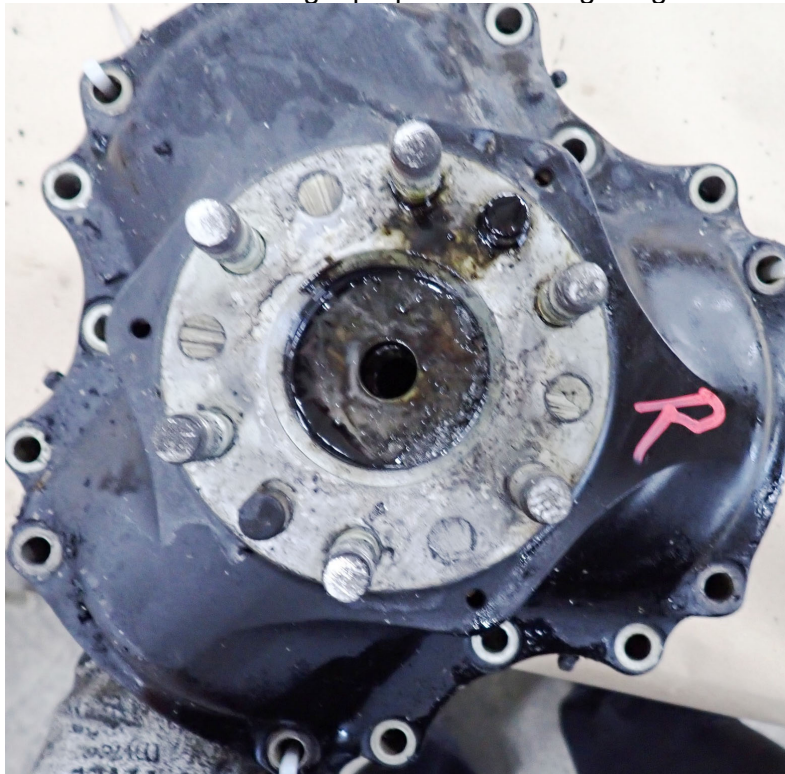
**Engine/Propeller Mounting:** All six propeller mounting studs and both dowel pins remained attached to the aft hub (Photo #21).

Photo #20 - Right propeller mounting flange

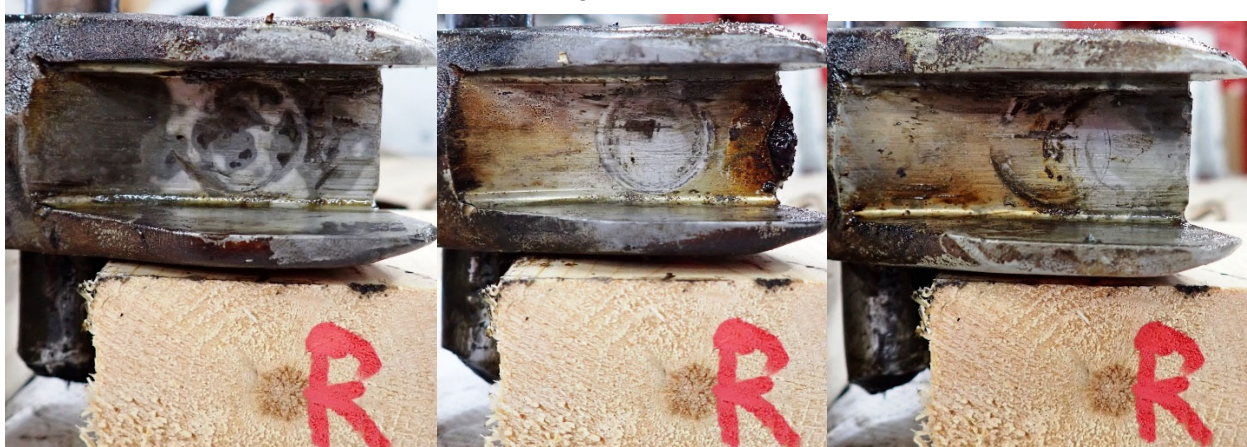
**Fork:** The fork remained intact and attached to the pitch change rod. There were pitch change knob block impact marks in the low pitch range of travel (Photo #22).

Photo #21 - Right propeller fork slots

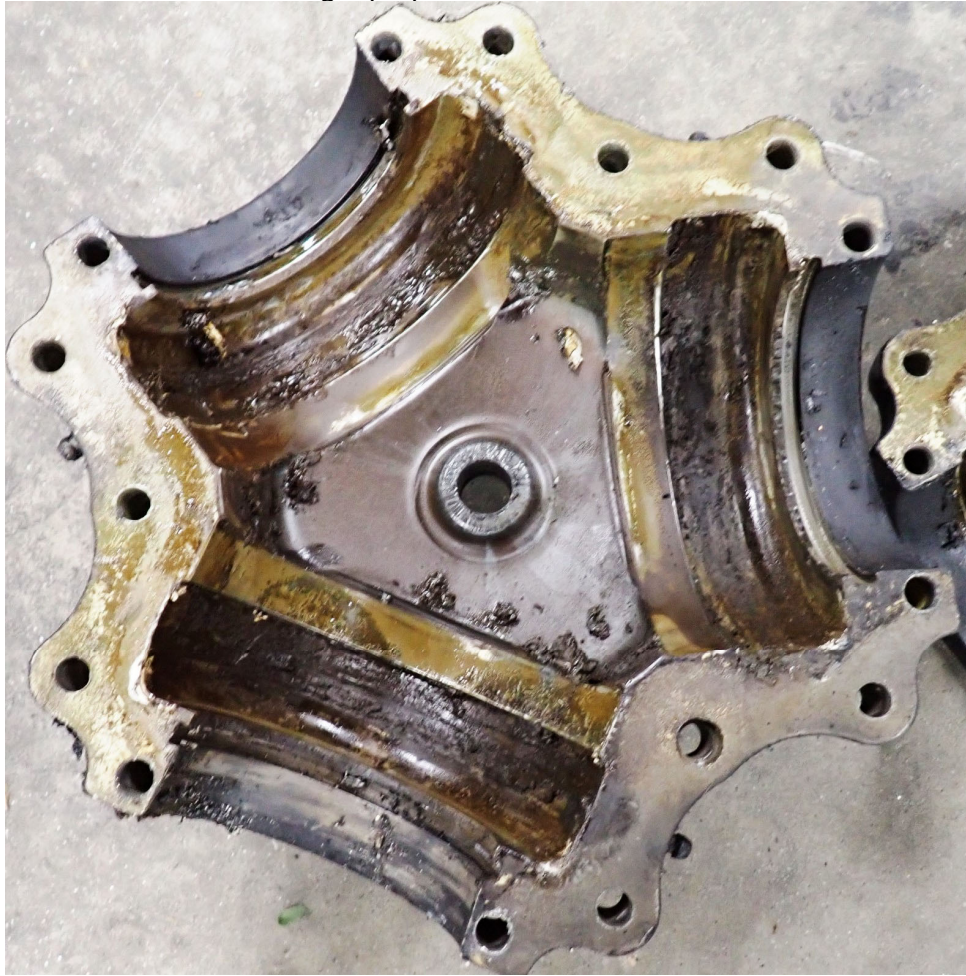
Photo #22 - Right propeller aft hub half internal surface

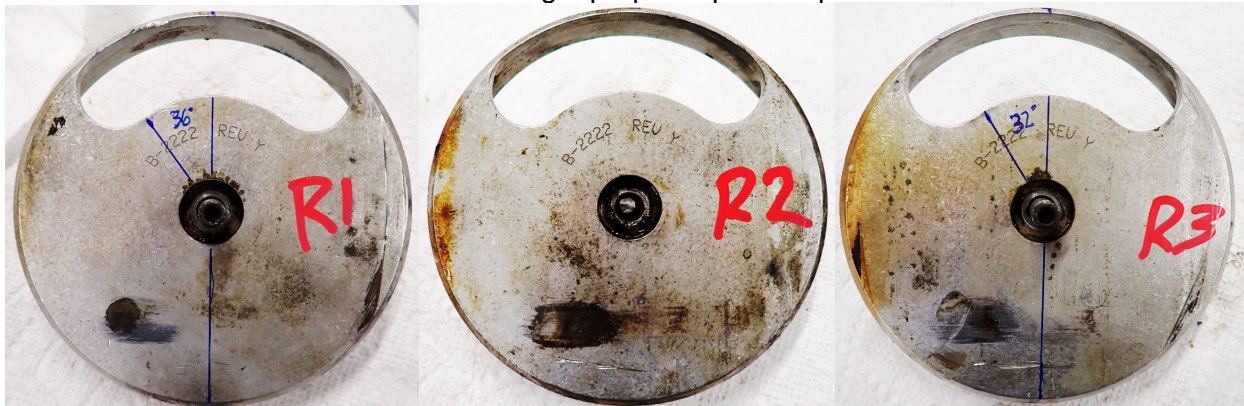
**Preload Plates:** See Photo #24. All three preload plates exhibited damage to the aft corner and retention lip. Plates R1 and R3 had knob contact marks between 32-36° forward of the split line suggesting blade angle was 12-16° or approximately near the low pitch stop angle. All fork/fork bumper damage to the plate faces were in the low pitch quadrant, forward of the split line.

Photo #23 - Right propeller preload plates

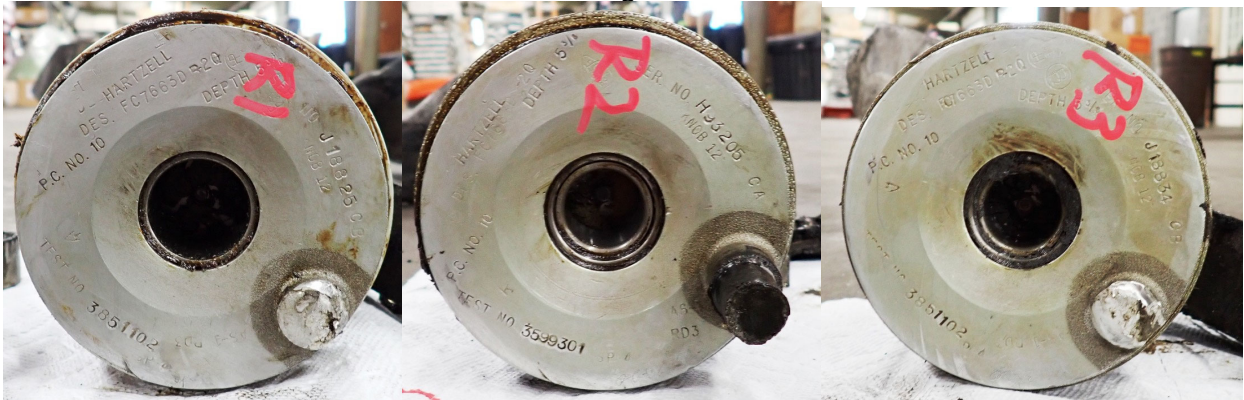
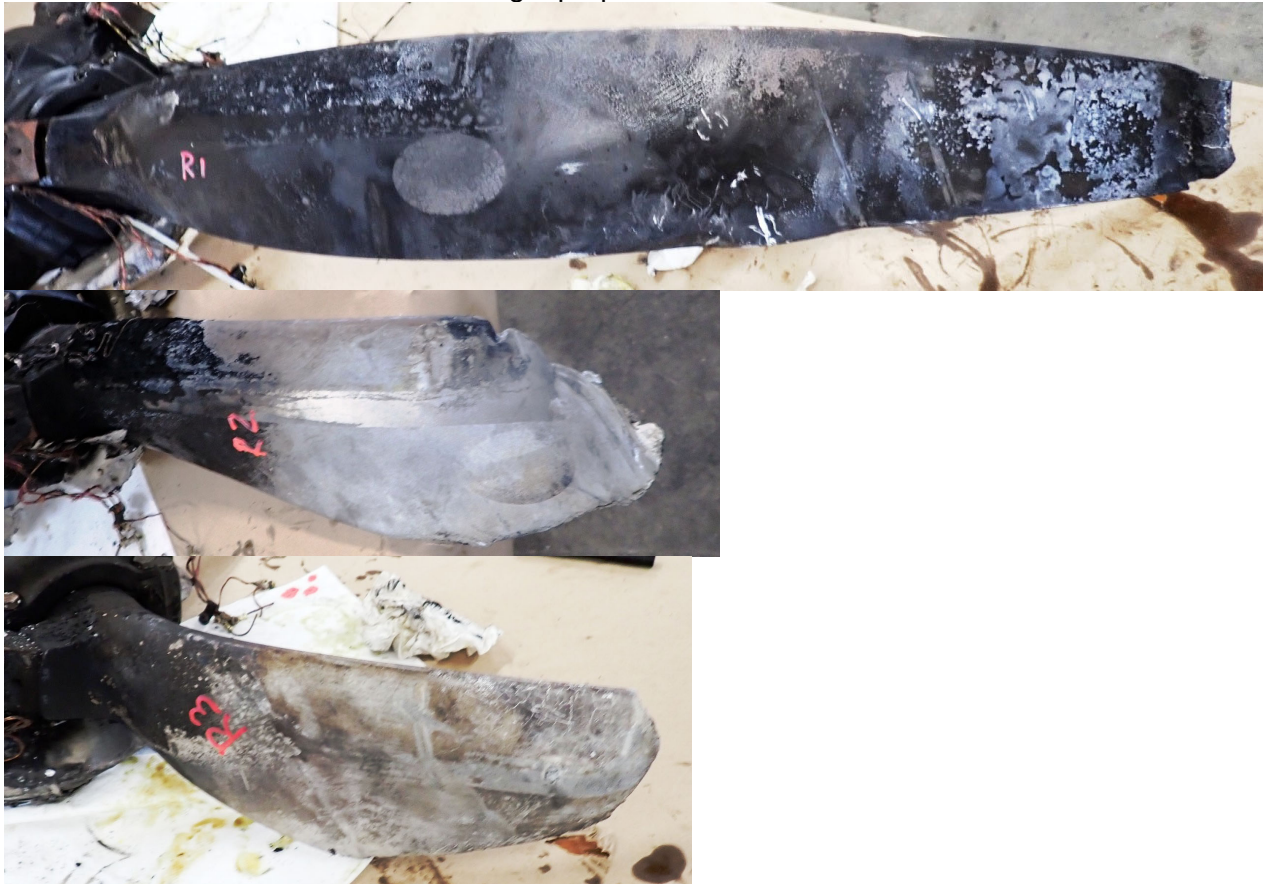
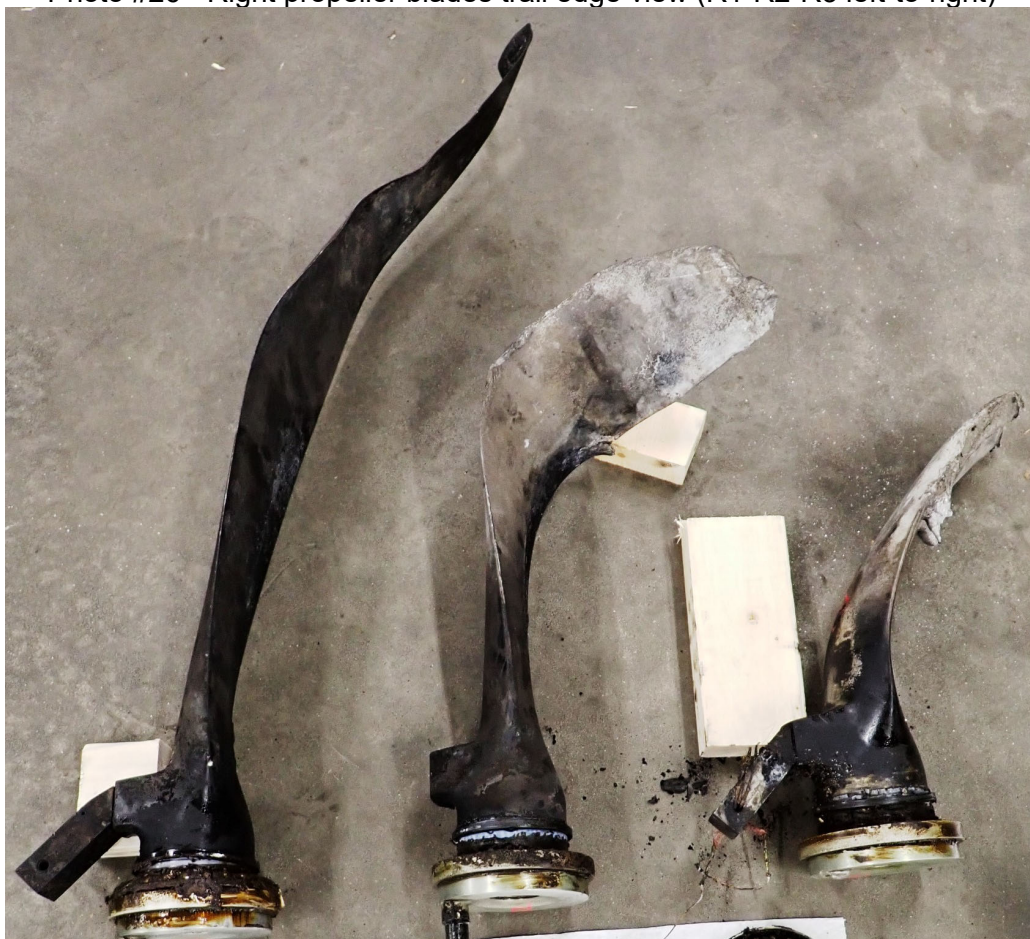
**Propeller Blade Properties:** See Photos #25 through #27. All three blades were partially consumed by the post-crash fire and exhibited remarkable heat exposure damage. Blade R1 was the most intact but had some material consumed near the tip. It could not be determined if there were any tip fracture damage on R2 and R3. Blade R2 had a remarkable leading edge gouge. Blades R1 and R3 pitch change knobs fractured from the butts; fracture surfaces exhibited shear/overload failure which is common under impact loads. Chordwise/rotational scoring was evident on R1. Compound bending and twisting was also evident in the aft/low pitch directions. Blade R2 had remarkable bending opposite rotation. The deice boots were consumed along with some deice wires.

Photo #24 - Right blade butts

Photo #25 - Right propeller blades camber side

Photo #26 - Right propeller blades trail edge view (R1-R2-R3 left-to-right)
