ERA22FA199

## INVESTIGATION PHOTOGRAPHS

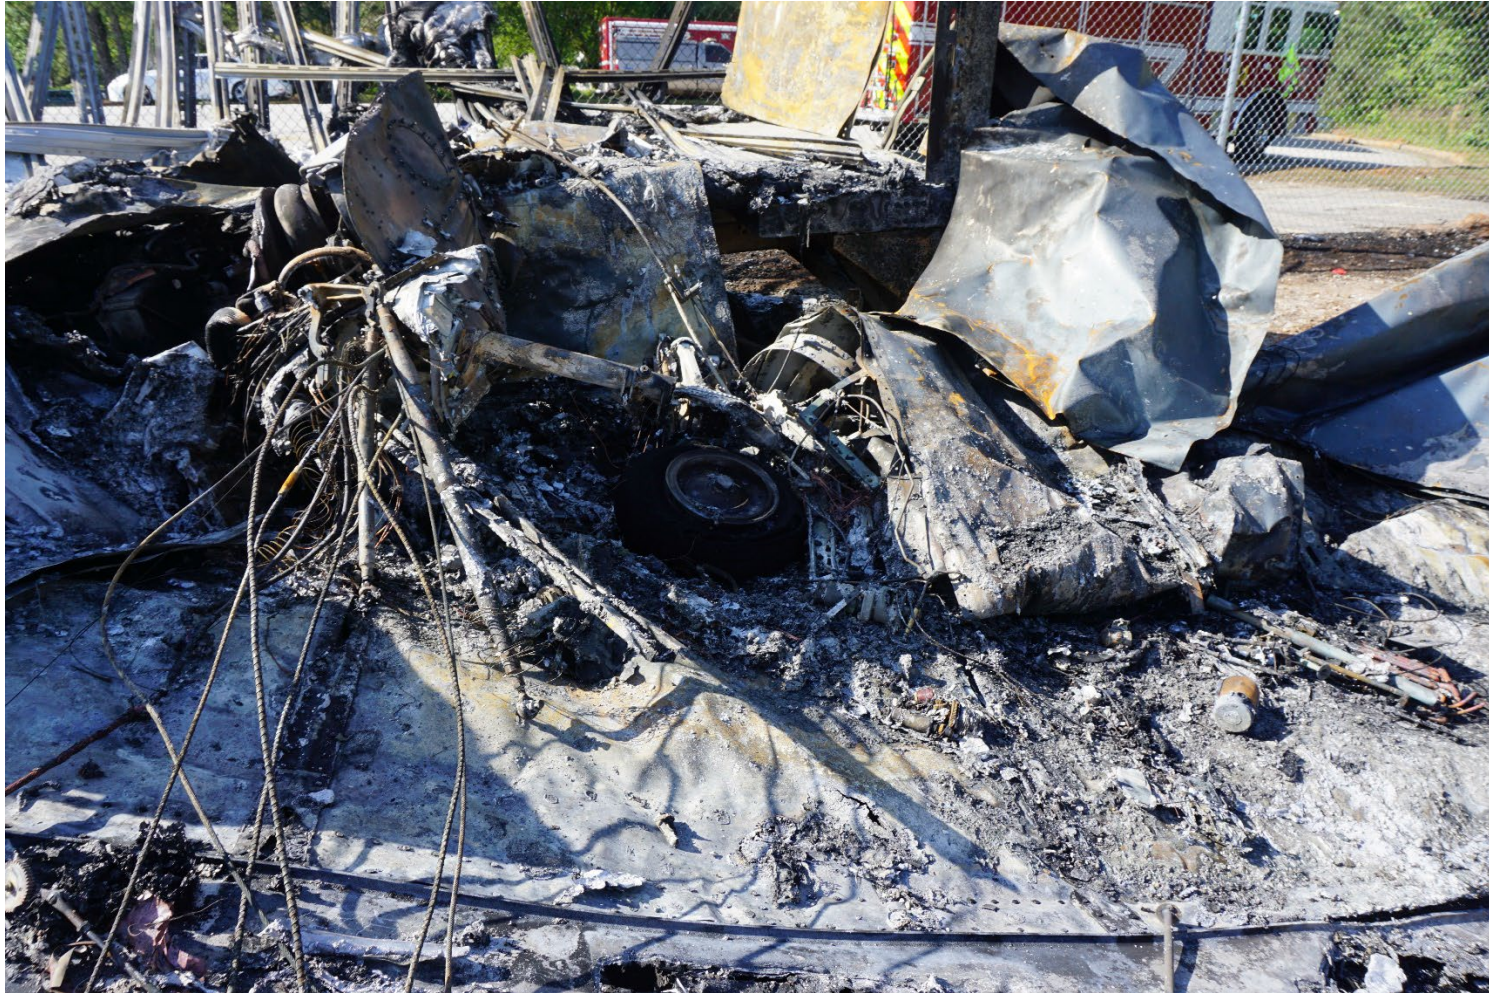
**Photograph 1- Fire damaged airplane hull.**

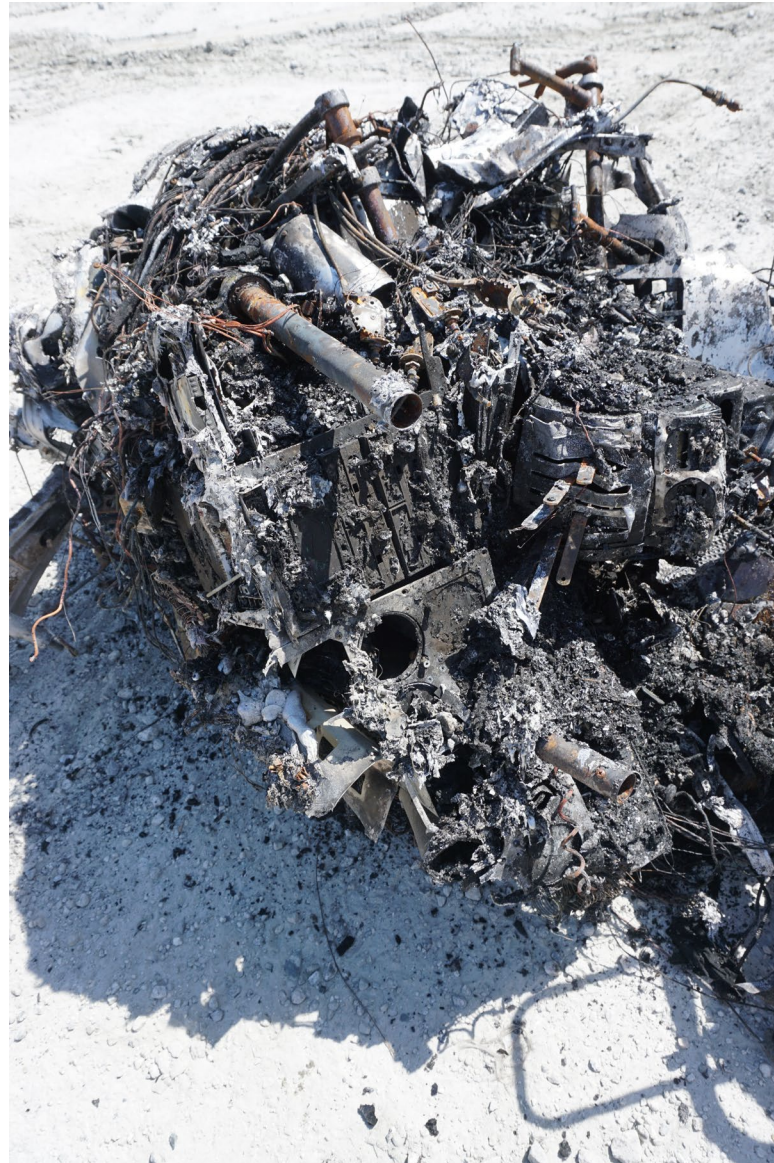
**Photograph 2 - Fire damage cockpit and instrument panel**

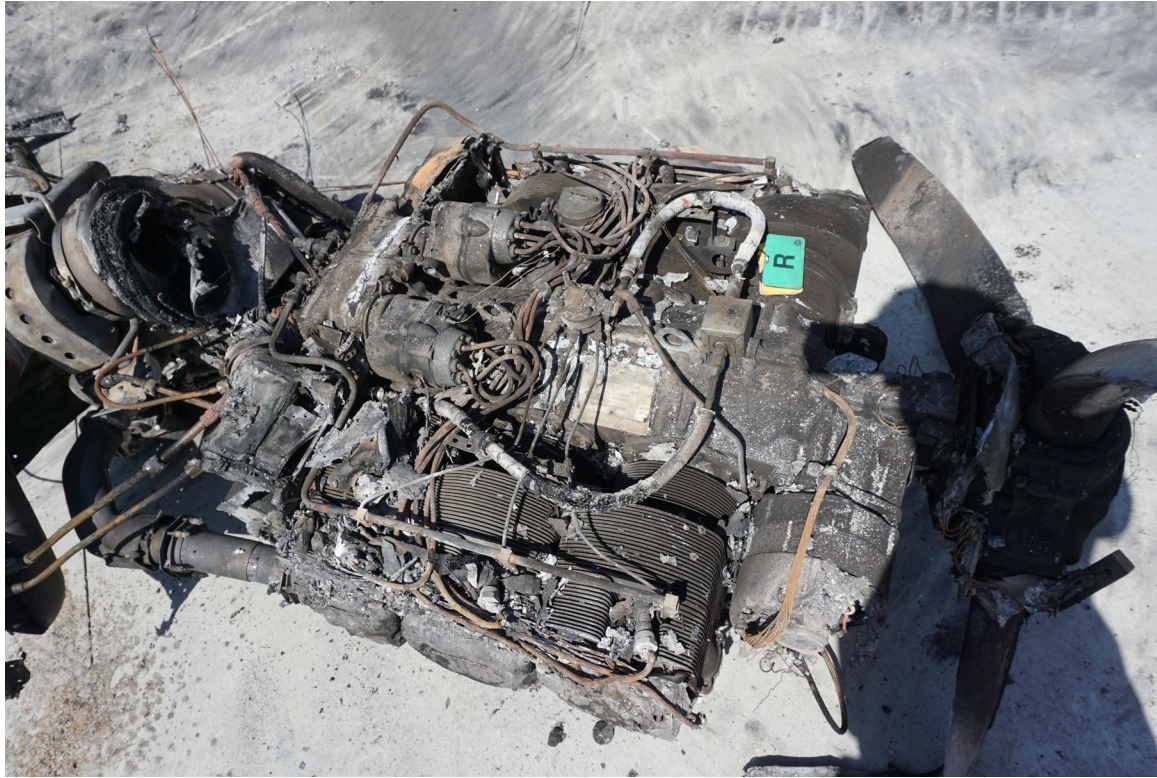
**Photograph 3 - Right engine showing fire damage**

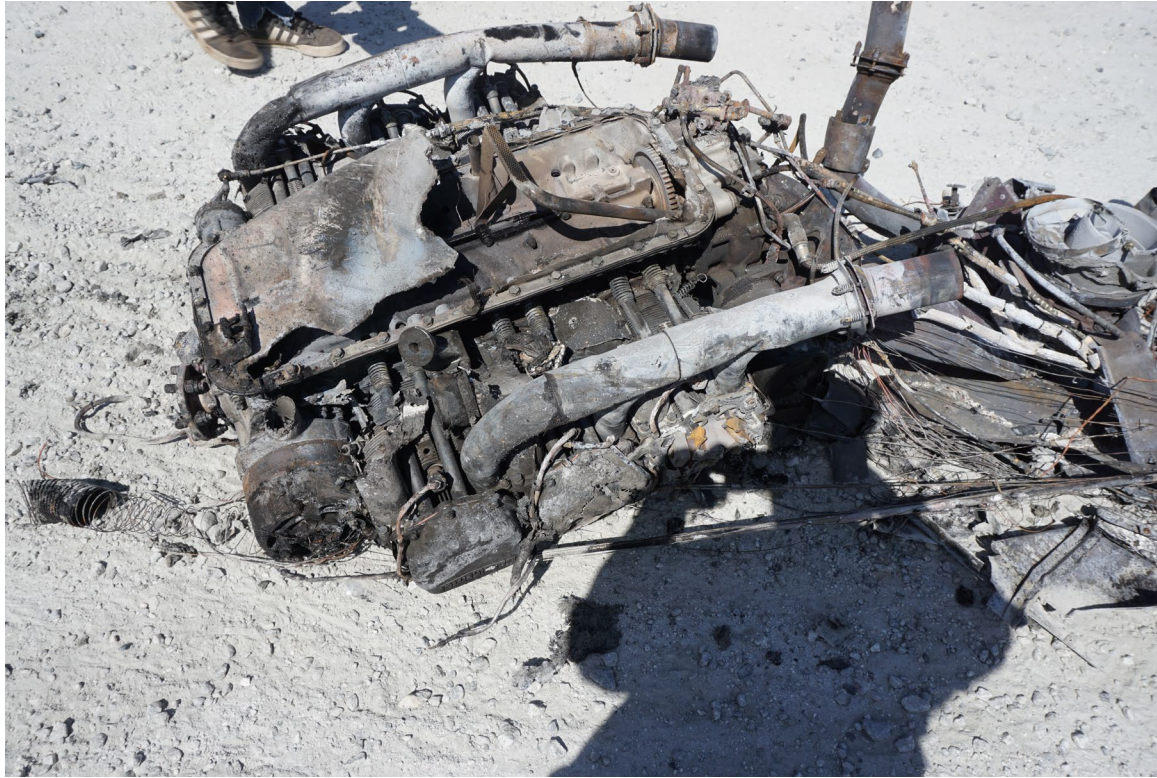
**Photograph 4 - Left engine showing fire damage**

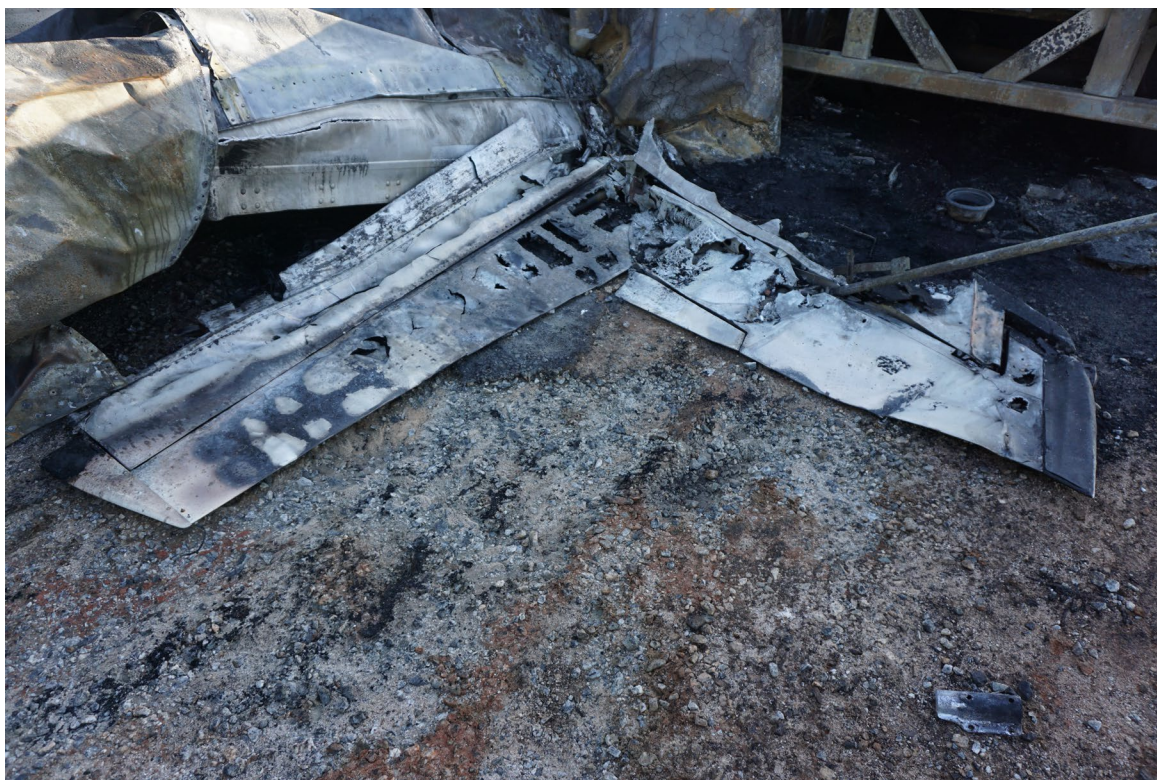
**Photograph 5 - Fire damaged vertical and horizontal stabilizer**
