ERA22FA223

## INVESTIGATION PHOTOGRAPHS

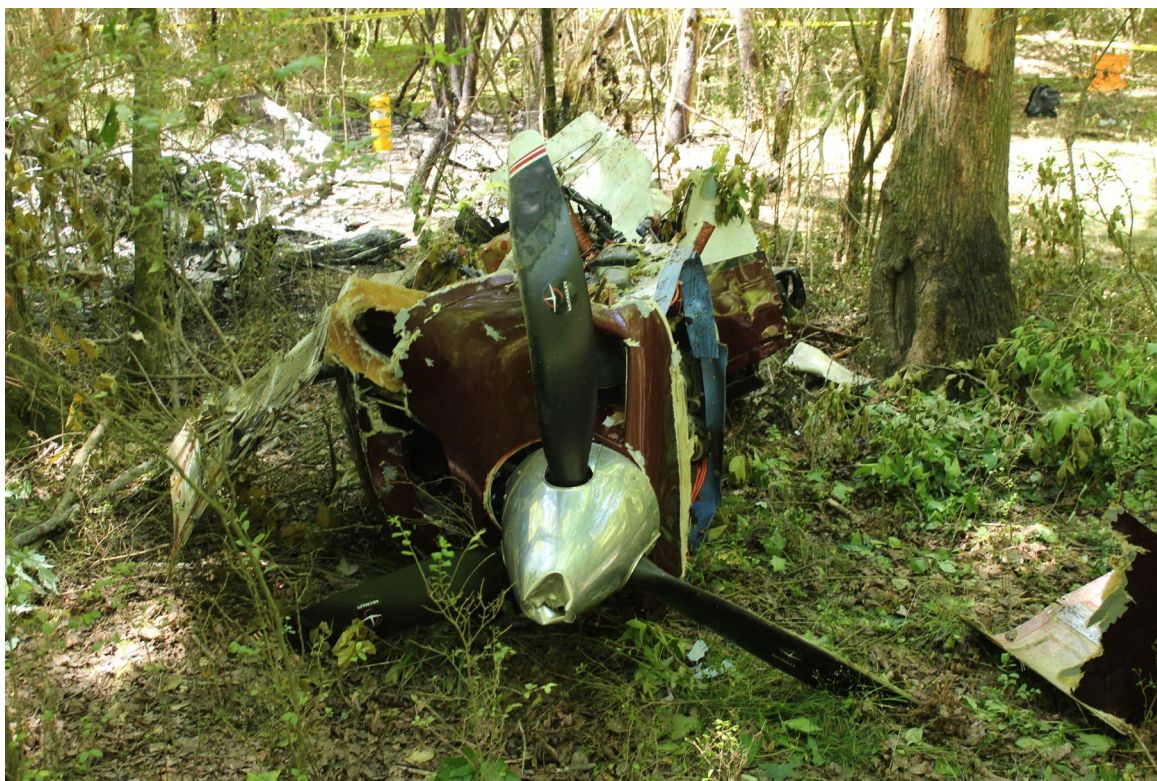
**Photograph 1 - View of propeller and engine where it came to rest.**

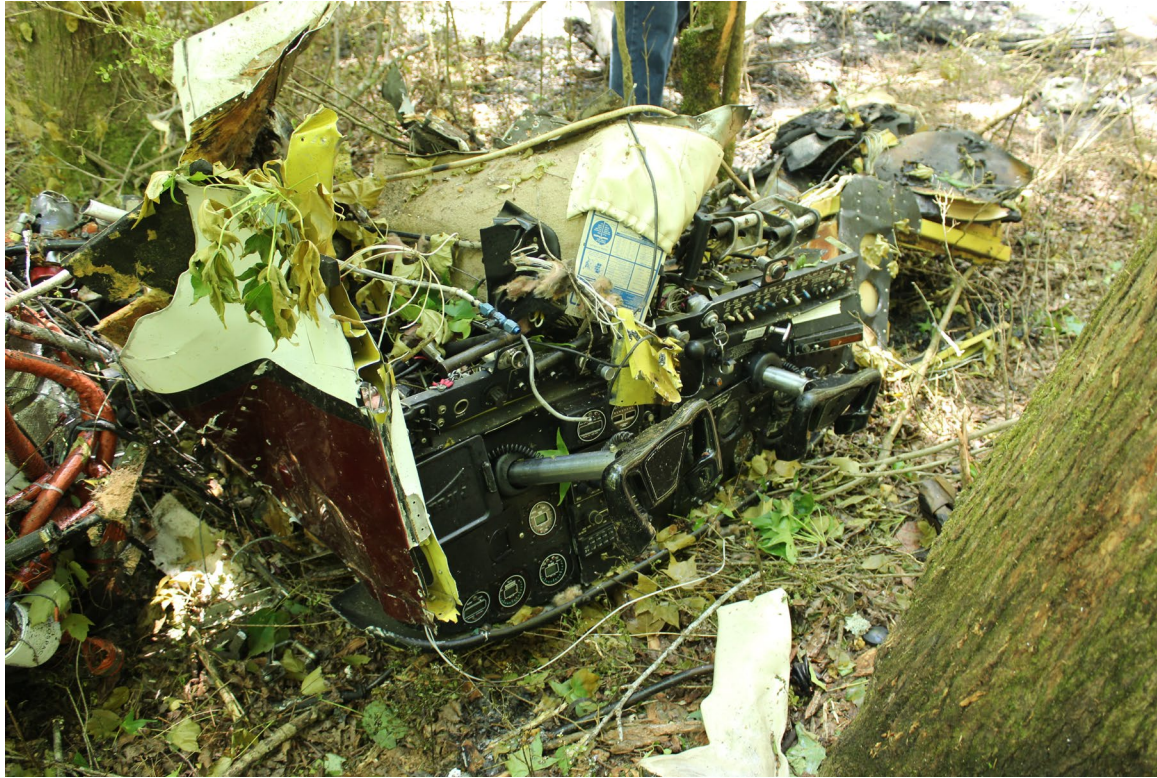
**Photograph 2 - View of the instrument panel.**

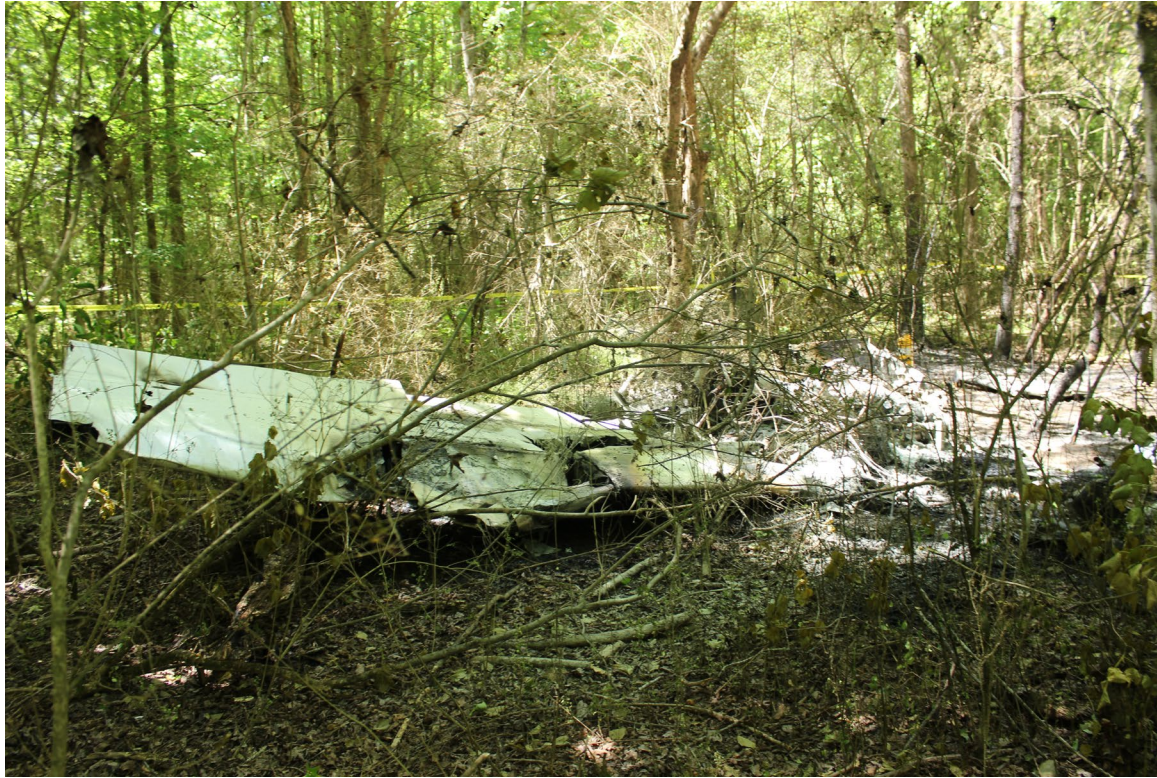
**Photograph 3 - View of the main wreckage.**

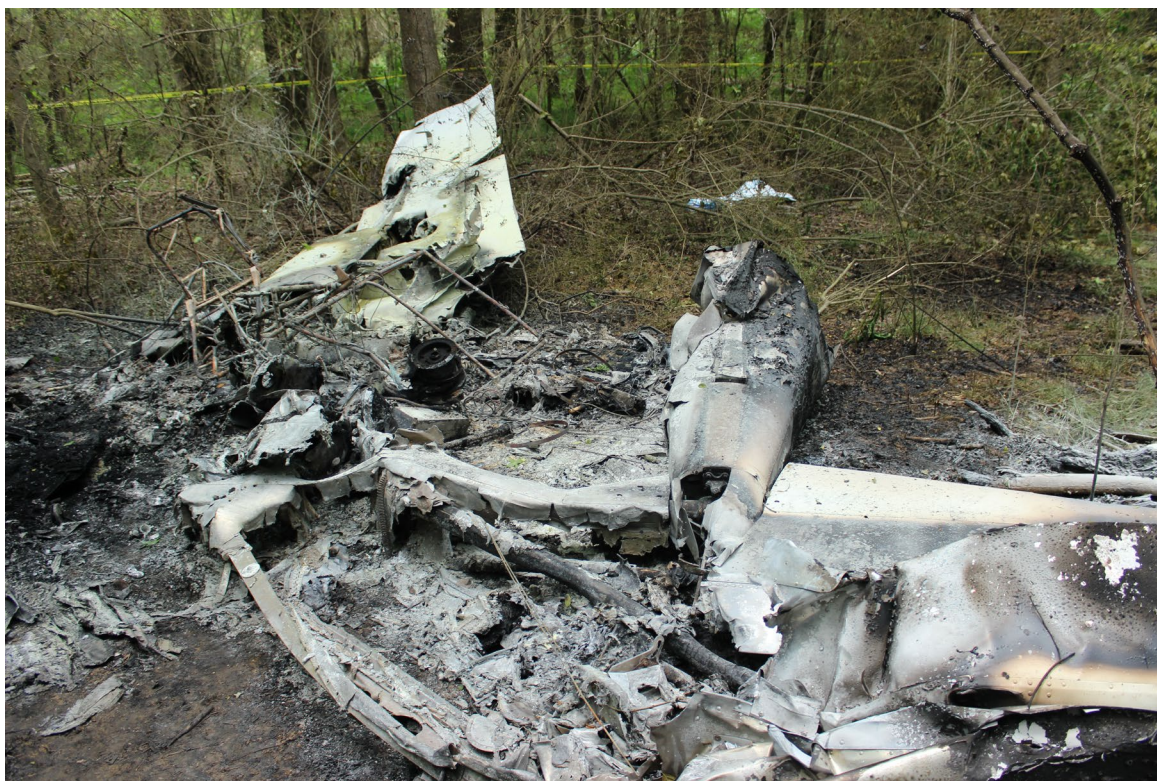
**Photograph 4 - View of empennage and main wreckage.**
