# National Transportation Safety Board

ERA22FA223

## **AIRFRAME AND ENGINE EXAMINATION**

Location: Athens, Georgia  
Date: May 11, 2022  
Time: 1853 EDT  
Airplane: Piper PA-24, N8007P

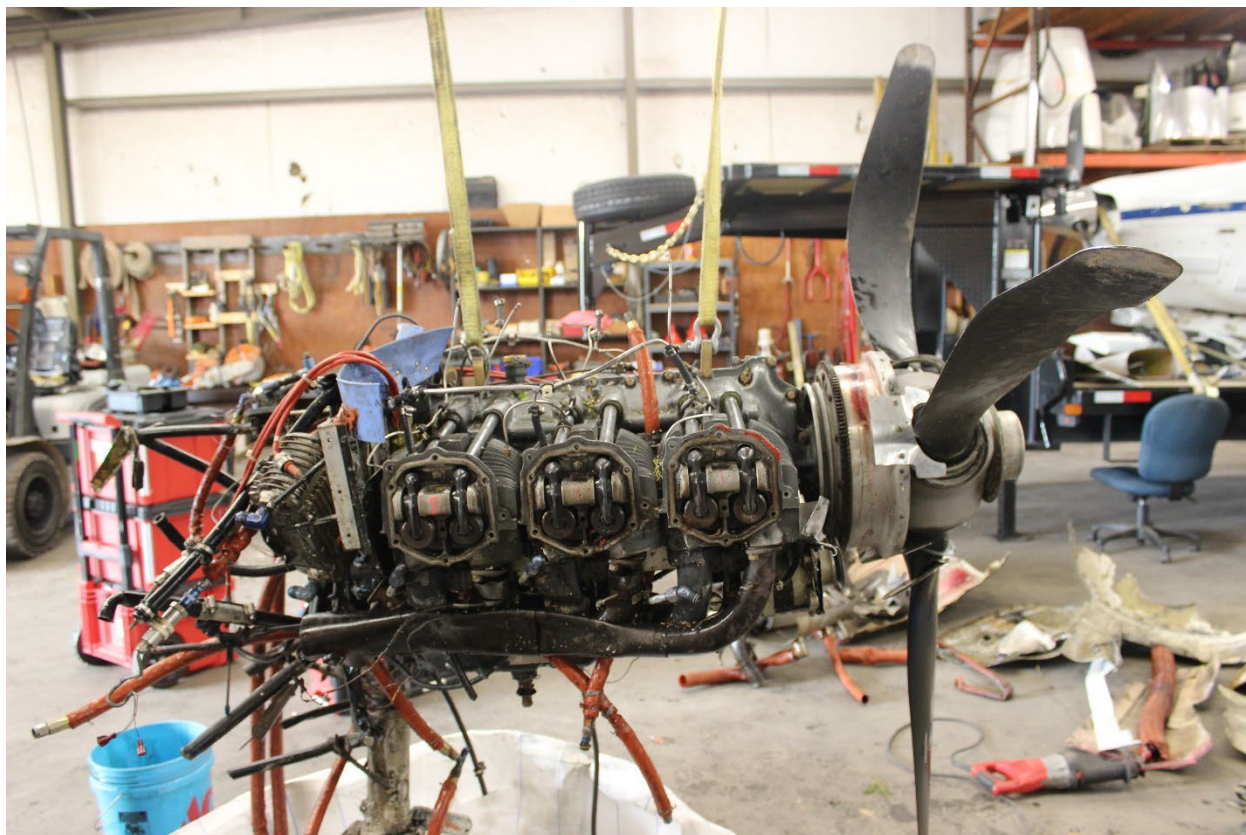
The engine was manually rotated and internal continuity was confirmed. The turbocharger system remained attached, the left turbocharger vane spun freely, the right turbocharger vane was impact damaged. The engine was an IO-540-C1B5 equipped with a twin-turbo Rayjay STC. The cylinders were examined using a lighted borescope, no anomalies were noted.

**Photo 1 View of the engine suspended for examination.**

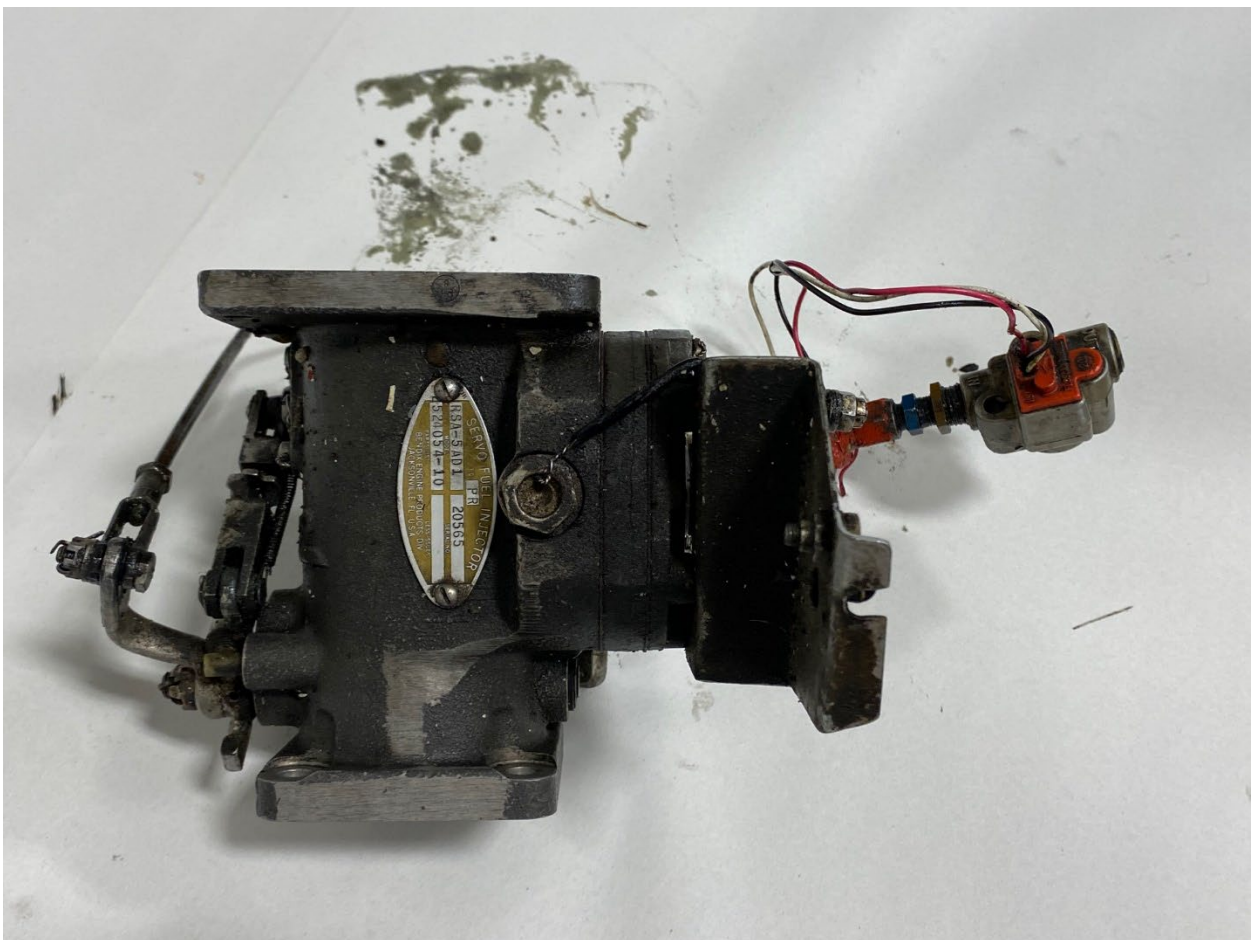
The fuel servo remained attached to the airframe box and engine sump housing, and was minimally damaged. The mixture control cable was pulled away from the control lever at the unit. The throttle cable remained attached to the unit but was fractured aft about 8 inches. Excessive fuel staining was present on the unit, it was retained for further testing.

The fuel servo was retained for further testing. The fuel servo was examined and placed on a test bench. Initially the fuel servo test results were slightly rich. When the test was repeated the second check was in normal range.

**Figure 2 View of the fuel servo. (Photo provided by Precision Airmotive)**
