# National Transportation Safety Board

ERA22FA233

## **AIRFRAME AND ENGINE EXAMINATION FACTUAL REPORT**

Location: Wayne, Nebraska  
Date: May 20, 2023  
Time: 1842 Local  
2342 UTC  
Airplane: Cessna 140, N76075

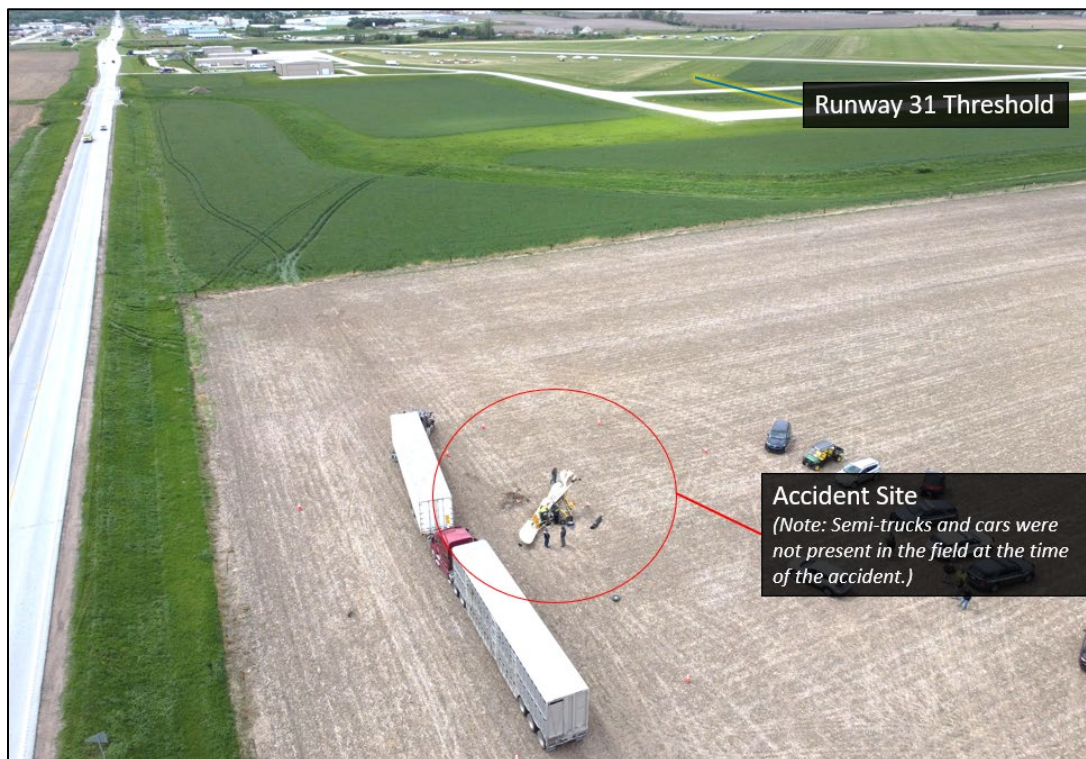
The airplane came to rest in an open field about 1,600 ft from the runway 31 threshold which was marked by yellow cones. The airplane impacted terrain in a near vertical nose down attitude. There was no evidence of fire and both wings contained fuel. Figure 1 provides an overview of the accident site and a view of the landing runway. Note, the semi-trucks and cars positioned in the farm field were not present at the time of the accident.

Figure 1: Overview of the accident site and landing runway.

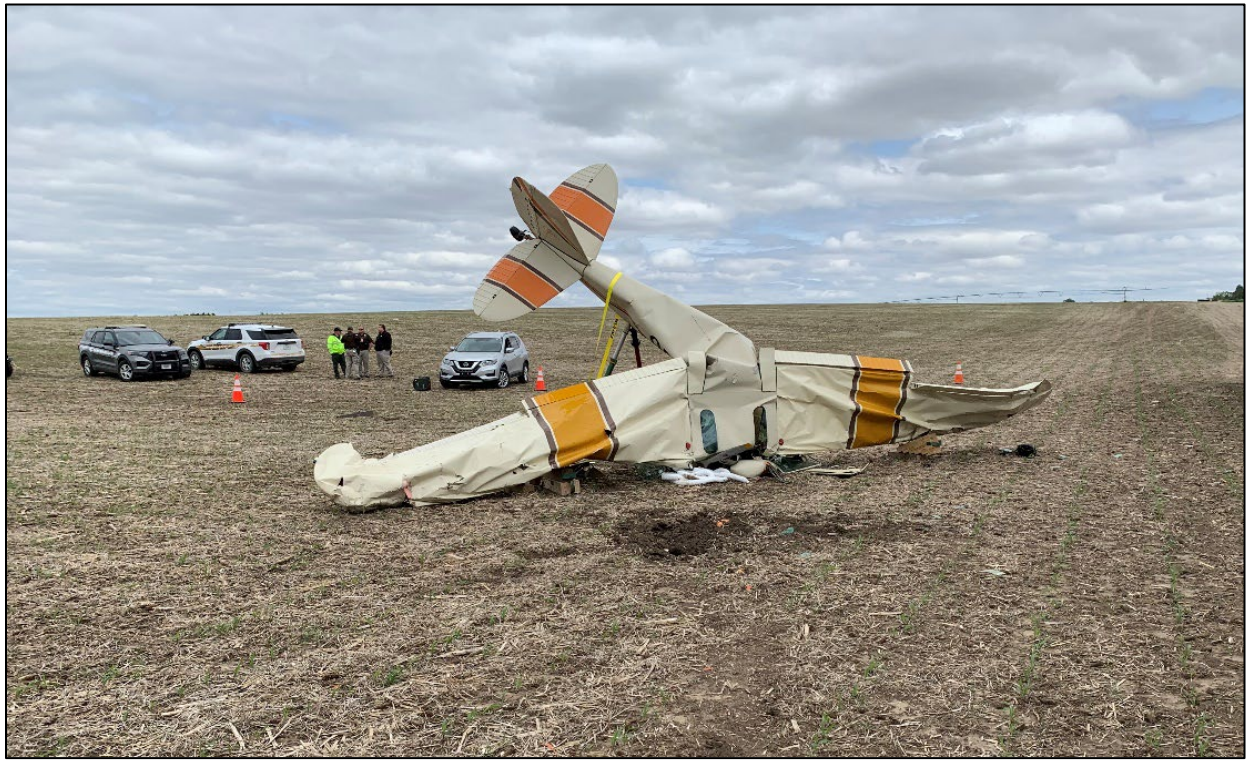
**Photo 1: View of the airplane at the accident site.**

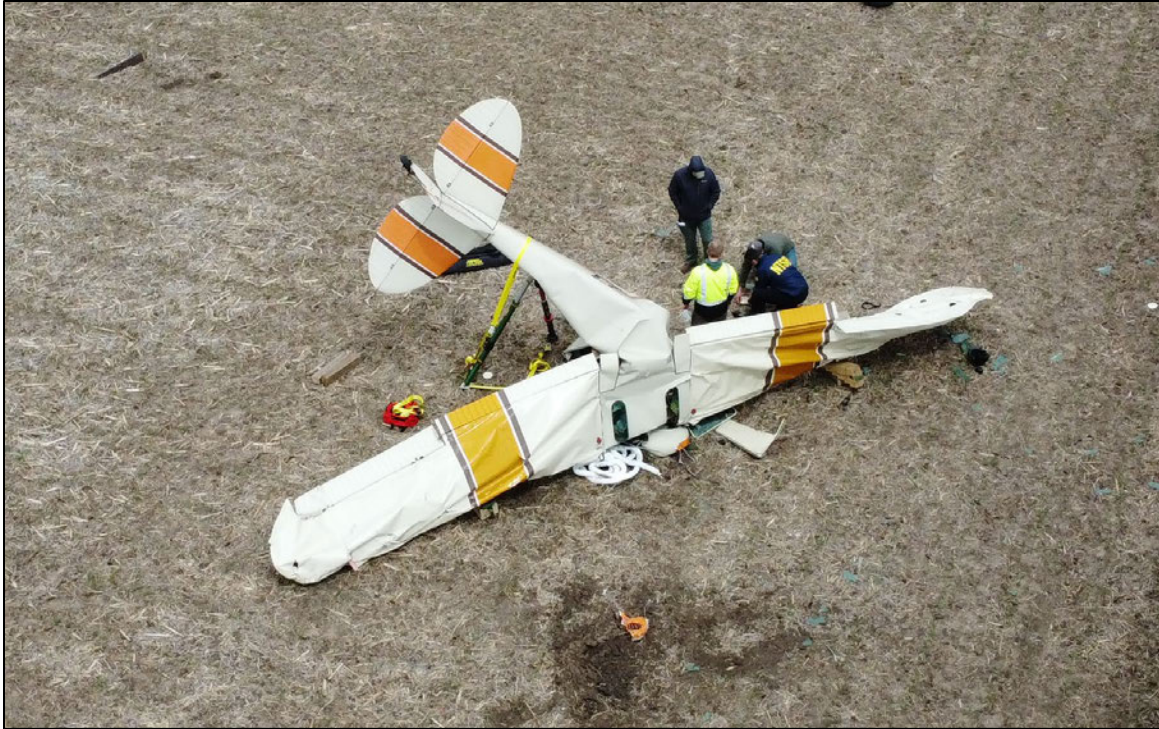
**Photo 2: View of the airplane at the accident site (Photograph Courtesy of Sheriff's Office)**

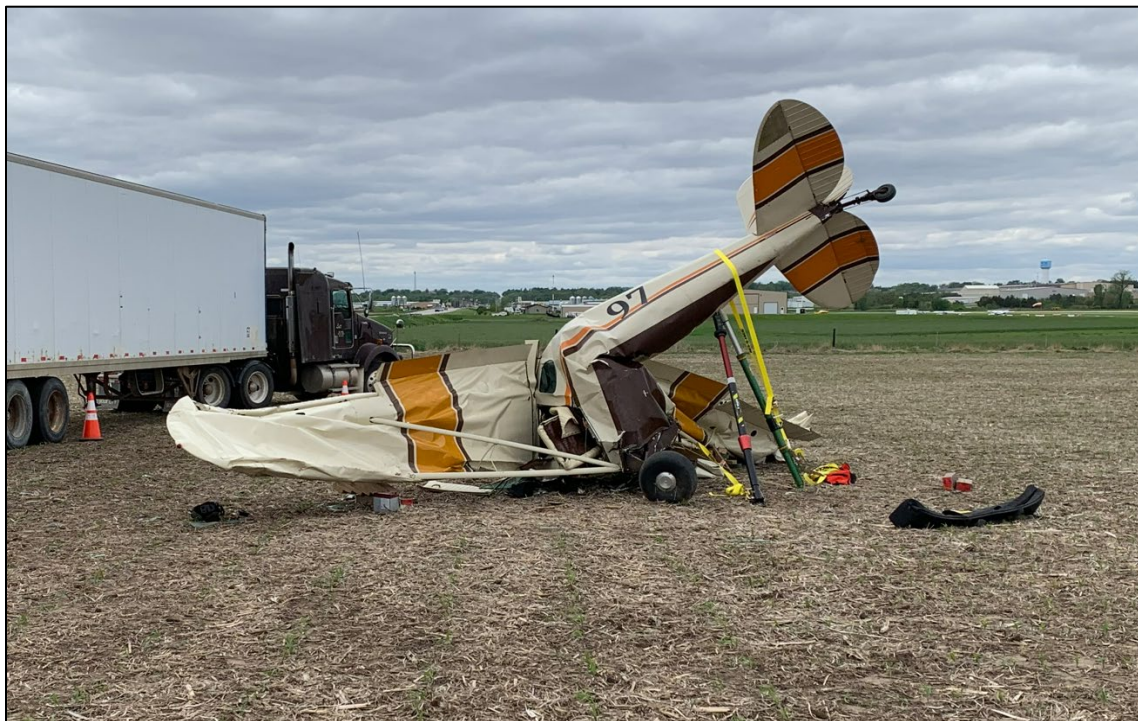
**Photo 3: View of the airplane at the accident site.**

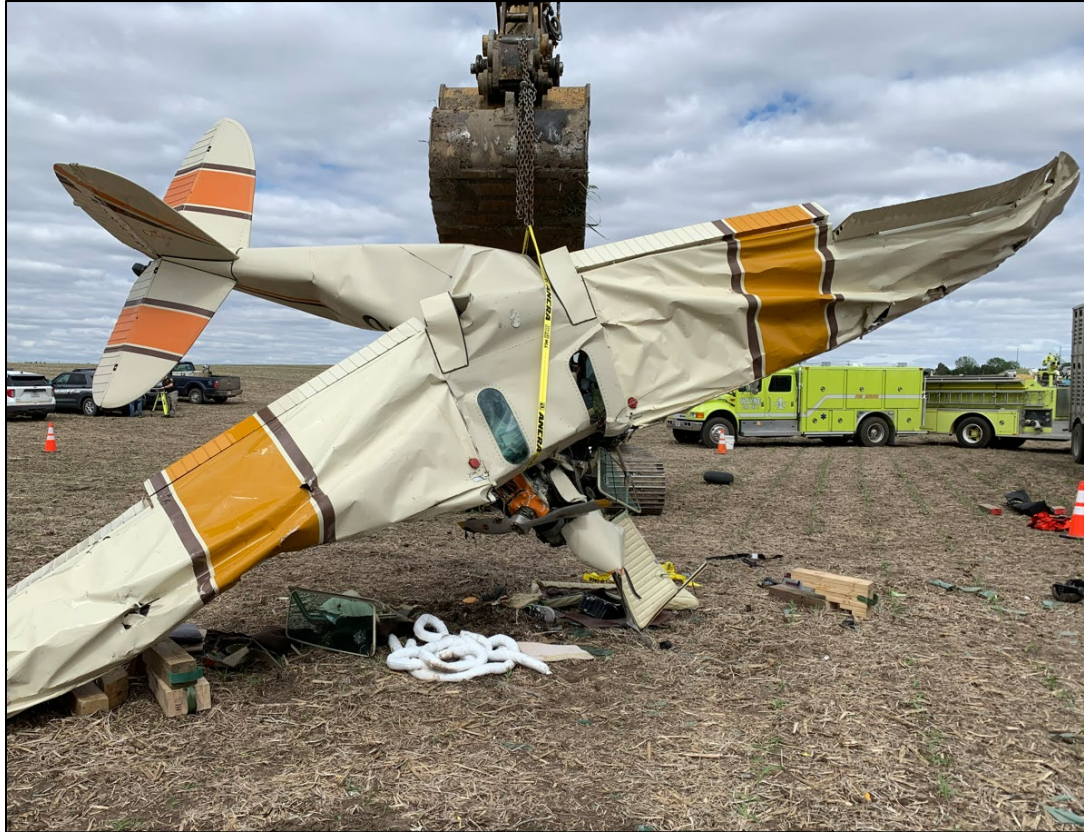
**Photo 4: View of the airplane during recovery operations.**

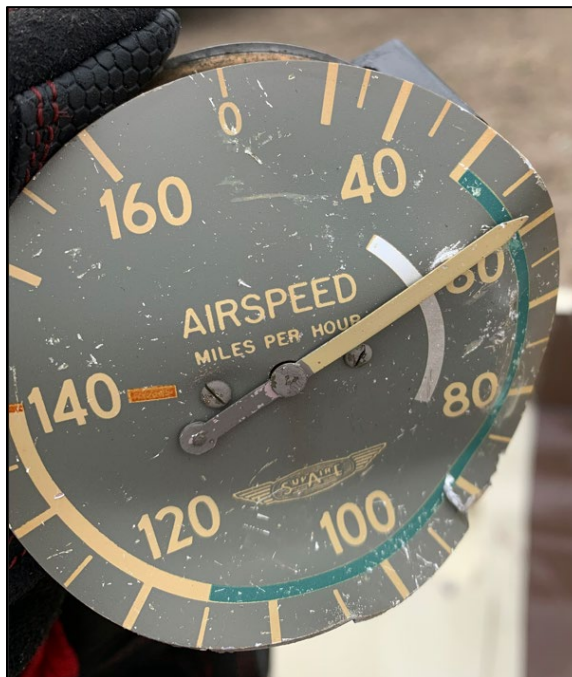
The fuel selector valve shaft was bent, and the fuel selector handle could not be rotated out of the right tank position. Both wing tanks contained fuel. The seat belt center bracket fractured. The seat 1 outboard lap belt attach bracket separated from the fuselage structure. No shoulder harness was found installed on either side of the cockpit. A key switch was not installed, both magneto switches were in the OFF position. A rub mark was observed under the airspeed needle at 57 MPH. A pilot helmet was located in the debris.

**Photo 5: View of the airspeed indicator as found indicating about 57 MPH.**

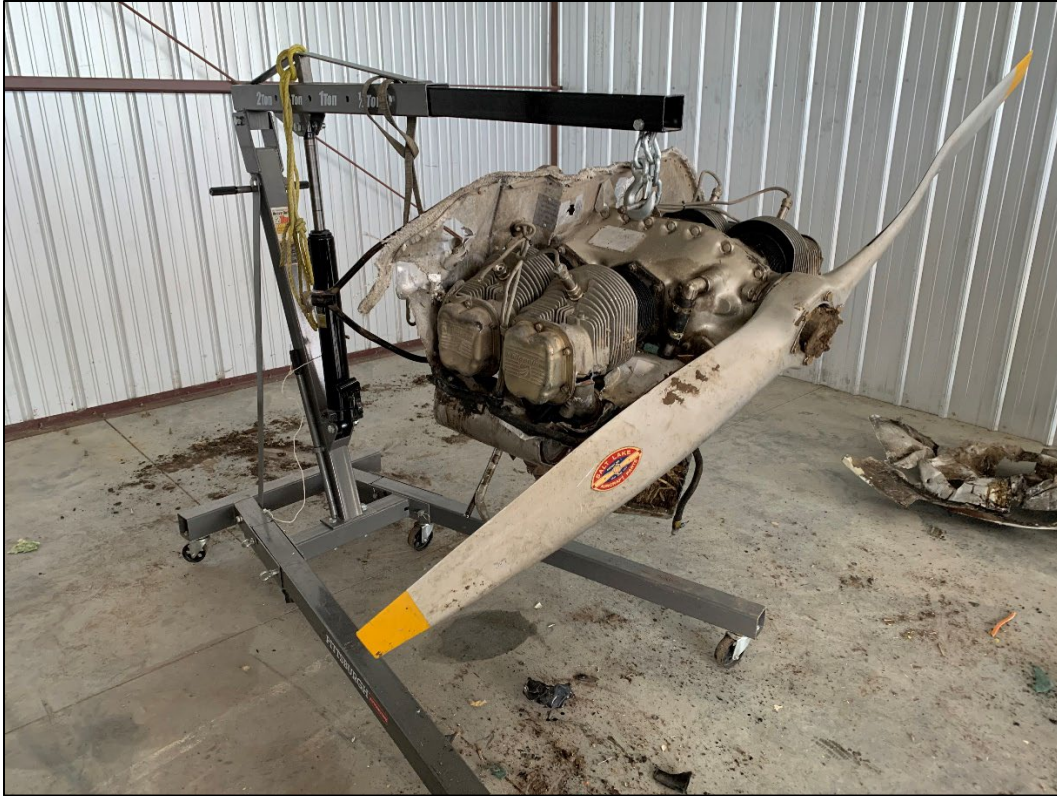
The engine was a Continental C-85-12, serial number 23740-6-1. It had crushed inward into the cockpit area and remained attached to its mounts. The engine was removed from the airframe and examined.

**Photo 6: View of the engine after removal from the airframe.**

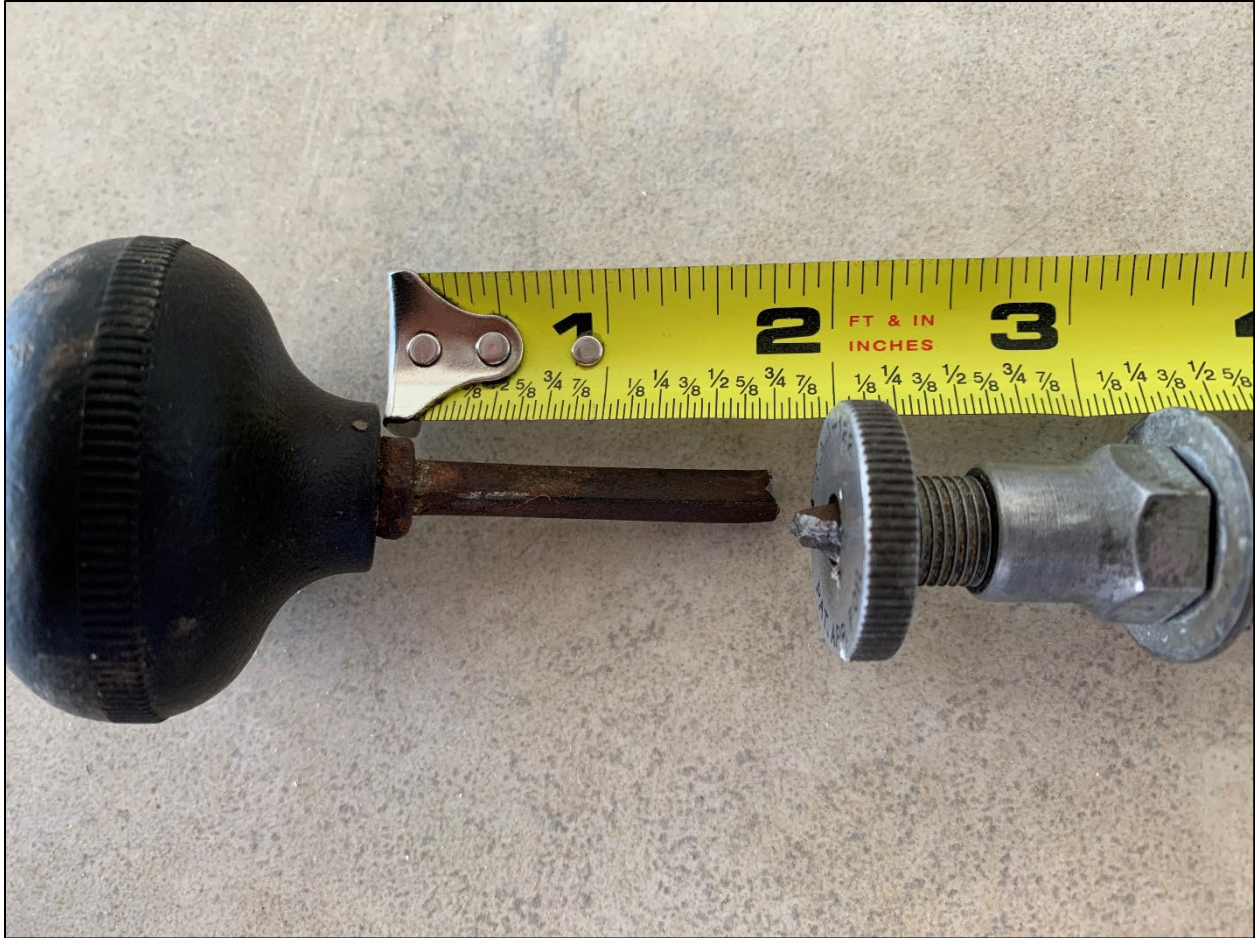
The carburetor and throttle body had separated from the engine and remained partially attached via a metal bracket. It contained fuel and was free of obstruction or debris. The carburetor air duct heat baffle was found in an OFF position, which corresponded to the OFF position the lever arm was located in at the cockpit. The fuel was negative for water when tested with water finding paste. The mixture control at the carburetor was safety wired to a full rich position. The cockpit throttle lever was found extended about 1 ¾ inches and had fractured.

**Photo 7: View of the throttle lever as found and view of its fracture area.**

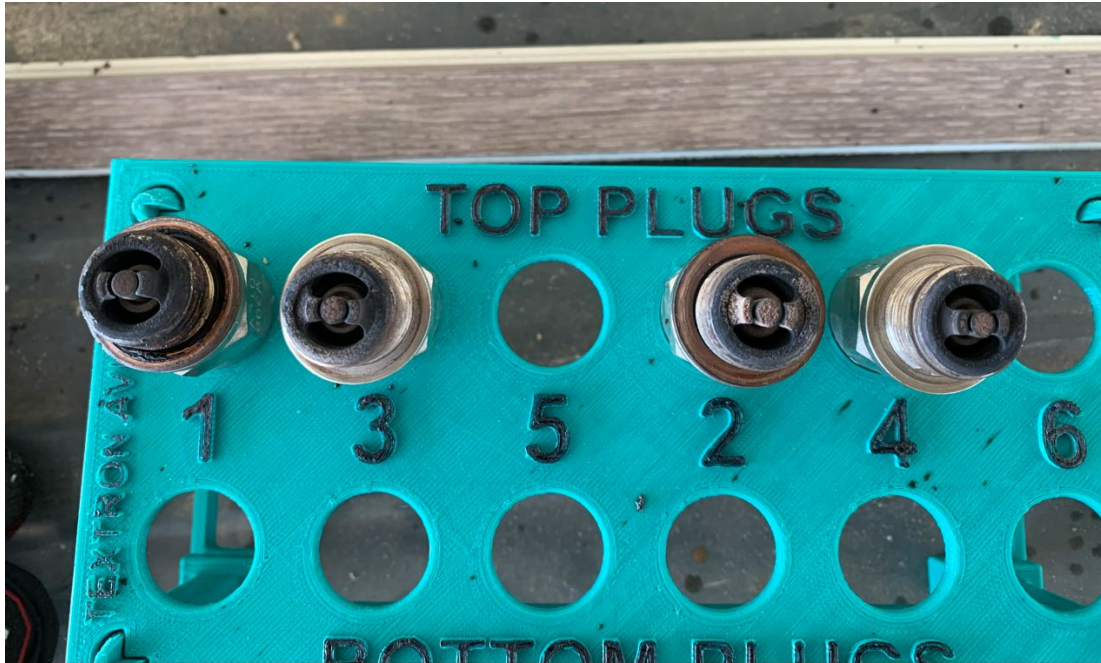
The rocker covers were removed, and all valves appeared normal. The top spark plugs were removed. They displayed normal to normal worn out appearances. They were all dark in color and were sooted with a carbon appearance, consistent with carbon fouling when compared to the Champion Check-A-Plug chart.

**Photo 8: View of the top spark plugs.**

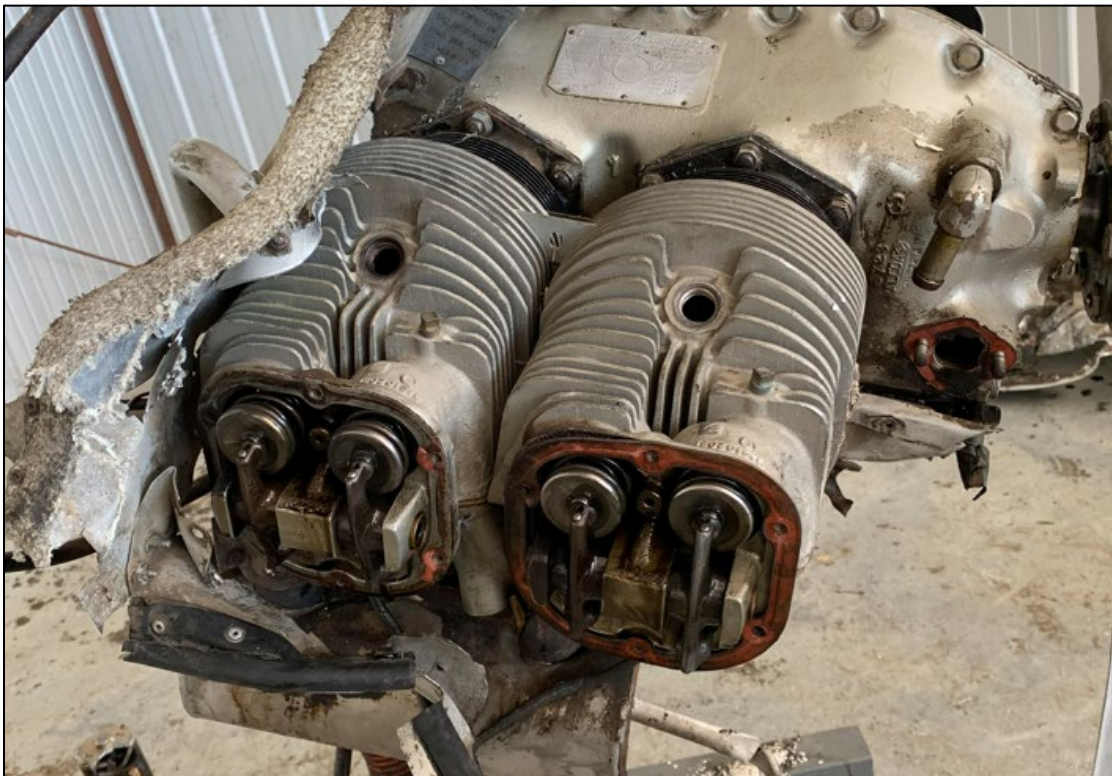
**Photo 9: View of the right side of the engine with the cylinder covers removed for examination.**

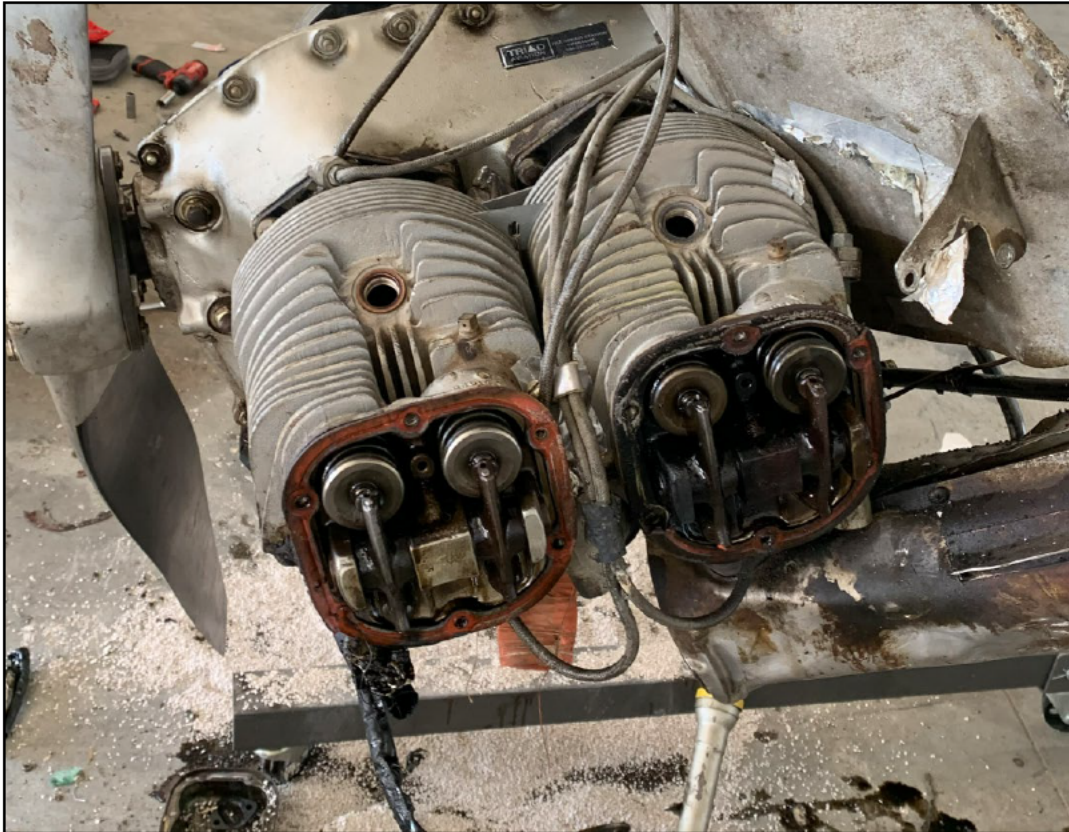
**Photo 10: View of the left side of the engine with the cylinder covers removed for examination.**
