# National Transportation Safety Board

ERA22FA243

## WRECKAGE EXAMINATION SUMMARY

Location: Myrtle Beach, SC  
Date: May 28, 2022  
Time: 1414 EDT  
1814 UTC  
Airplane: Piper PA12

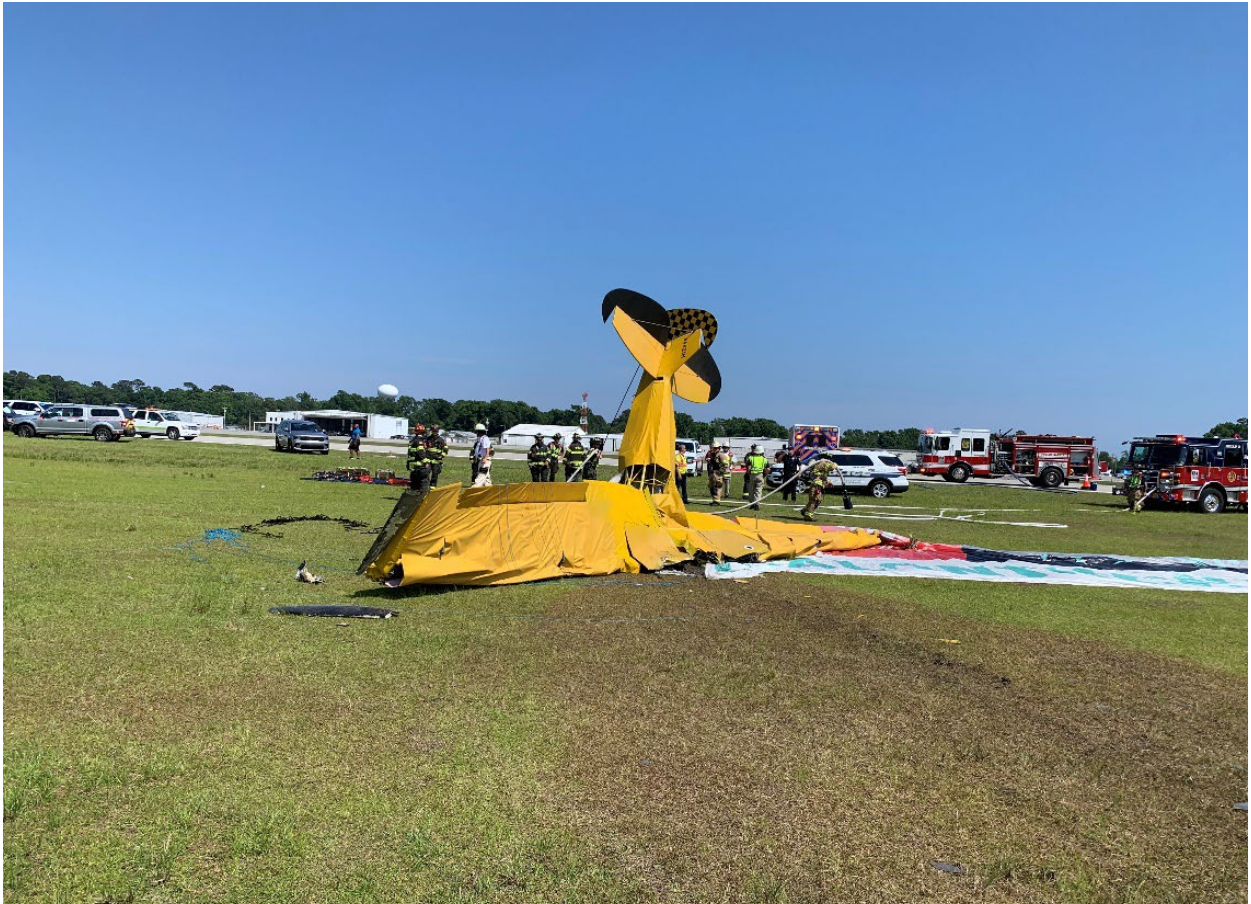
The airplane impacted in a nose down attitude and both wings exhibited accordion crushing. The propeller was fractured off at the engine shaft and was located about 2 ft underground. One propeller blade exhibited chordwise paint abrasion, “S” bending and longitudinal twisting toward the blade face. The other propeller blade exhibited chordwise paint abrasion. Both fuel tanks were breached. Flight control continuity was established to all flight controls. The instrument panel was located under the engine and all instruments were damaged with no useful information able to be used.

Figure 1: Main Wreckage

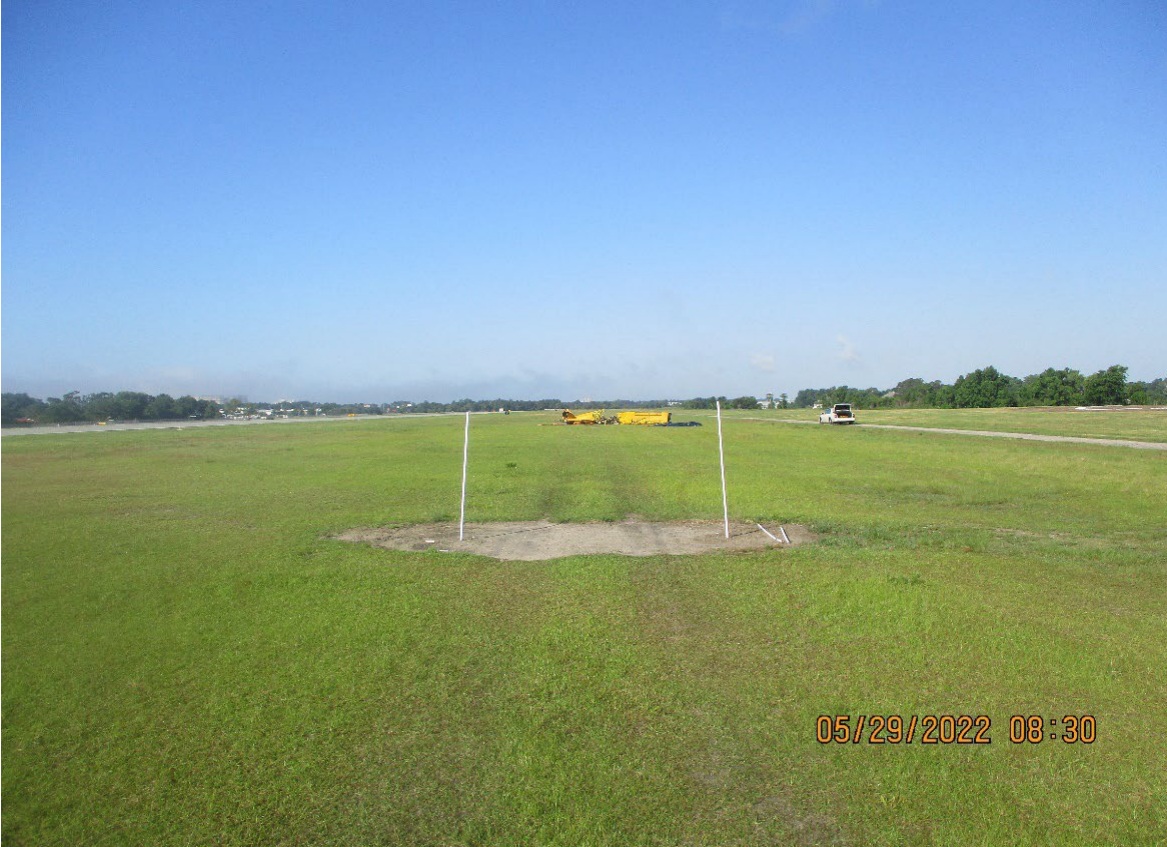
The accident site was located 126 ft to the right side of runway 23, midfield, and about 300 ft away from the banner pick up zone.

Figure 2: Banner pick up spot with wreckage in the background
