# National Transportation Safety Board

ERA22FA257

## **ONBOARD IMAGE AND PARAMETRIC DATA RECORDER**

Location: Fairfield, NJ  
Date: June 4, 2022  
Time: 12:01 EDT  
Helicopter: Bell Helicopter B407, N98ZA

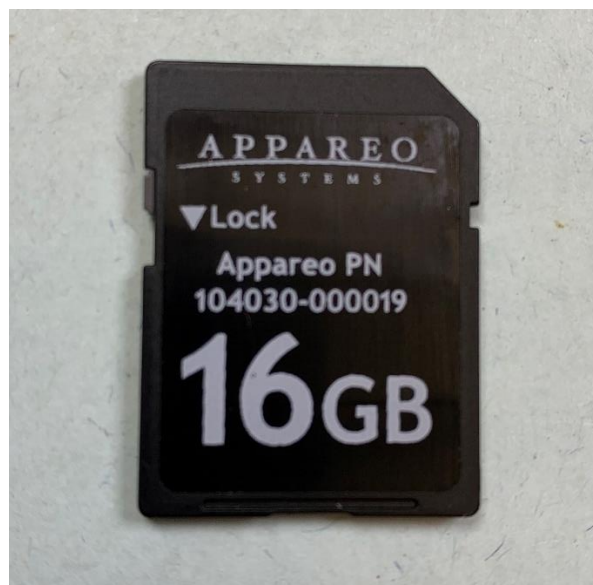
The device contained an internally mounted 16 GB SD card. The SD card was in good condition and is shown in Figure 1.

**Figure 1.** The device's internally mounted, externally removable SD card.

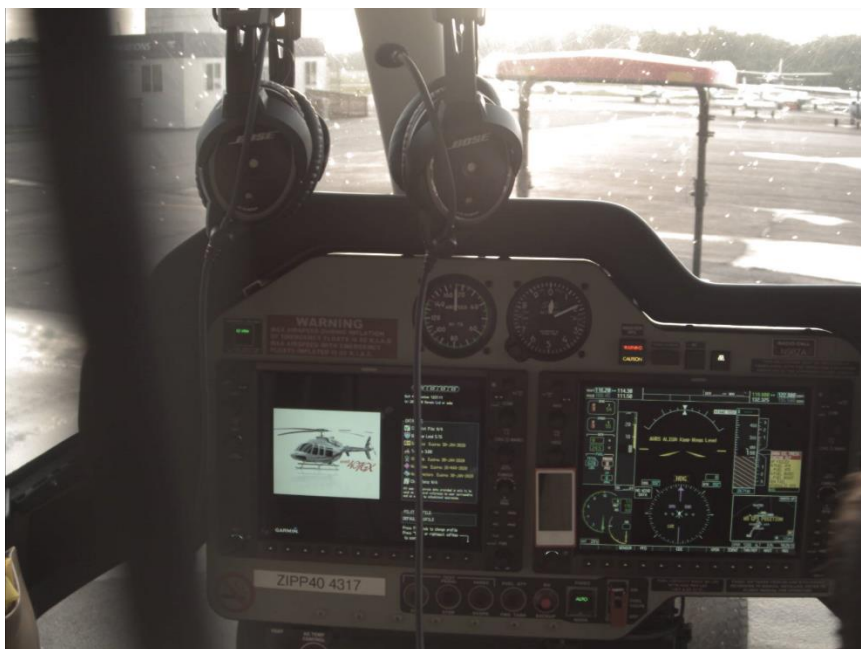
The Vision 1000 recorder captured a field of view represented in Figure 2. Figure 2 is a screen capture from the device while no personnel was present in the image. The recorder also captured a two-channel audio recording of the helicopter's operations. One audio channel recorded sounds from the device's internal cockpit area mic, which was a record of the ambient sounds of the helicopter operating. The second audio channel recorded wired audio from the helicopter's audio panel. This included the pilot's comments when they reached the audio panel's squelch threshold, as well as air traffic control (ATC) communications that were passed through the helicopter's audio panel. Commentary transcribed from personnel onboard the accident aircraft are transcribed below in **bold font**.

**Figure 2.** The field of view of the Appareo Vision 1000 device, as installed on the accident helicopter N98ZA.

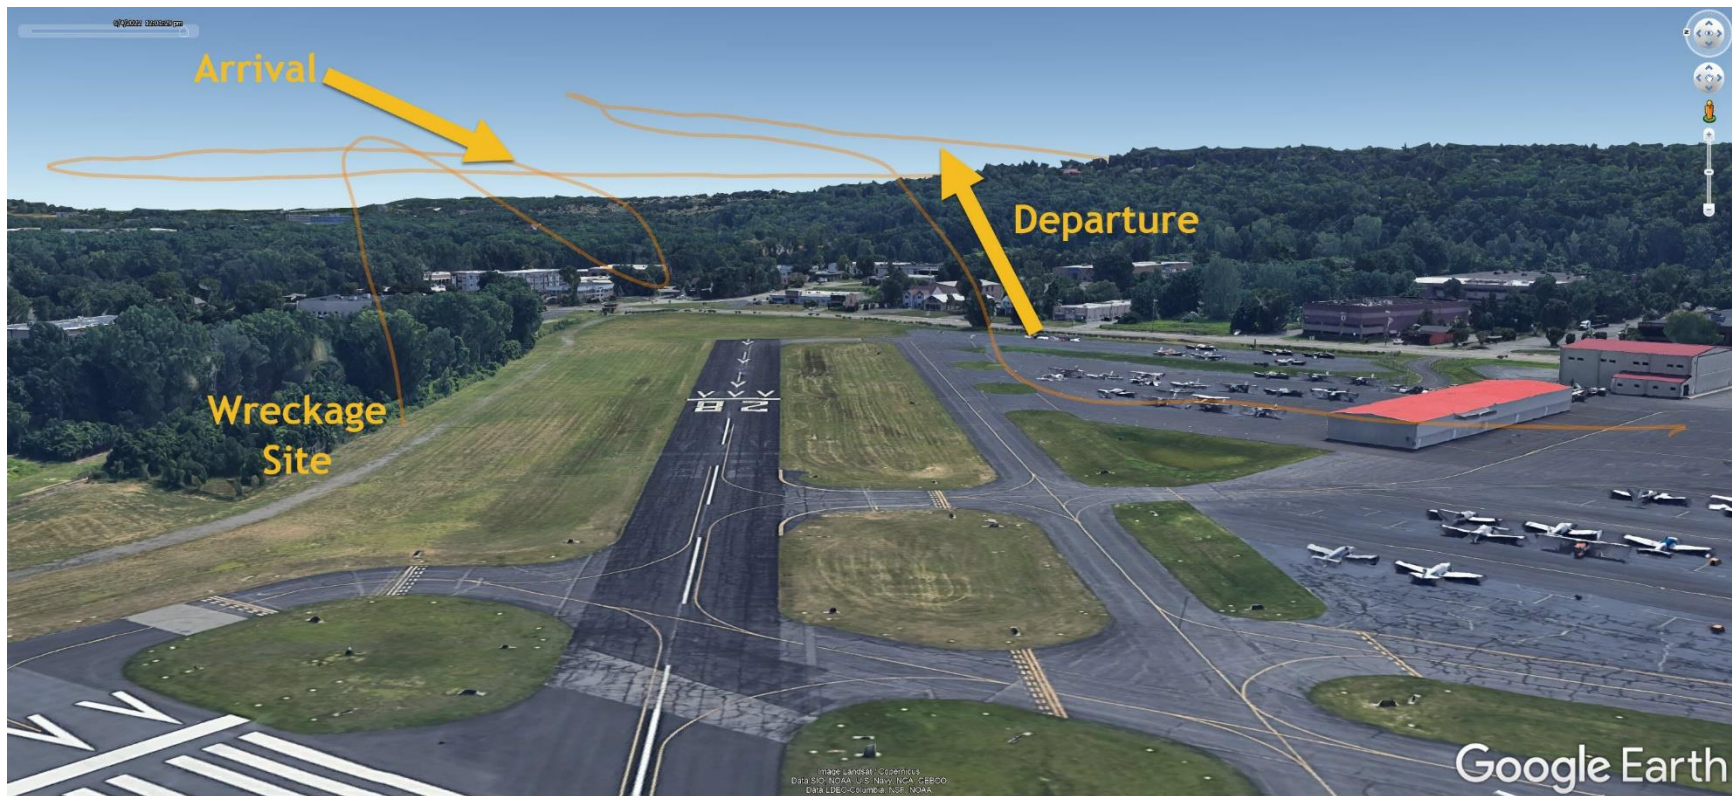
Figure 3 is a KML of the aircraft's departure and arrival route shown in a 3-D representation on Google Earth. Note that weather and lighting conditions may not be accurately depicted in Google Earth imagery.

**Figure 3.** A Google Earth overlay of the helicopter's departure and arrival sequence. The approximate site of the wreckage is shown.
