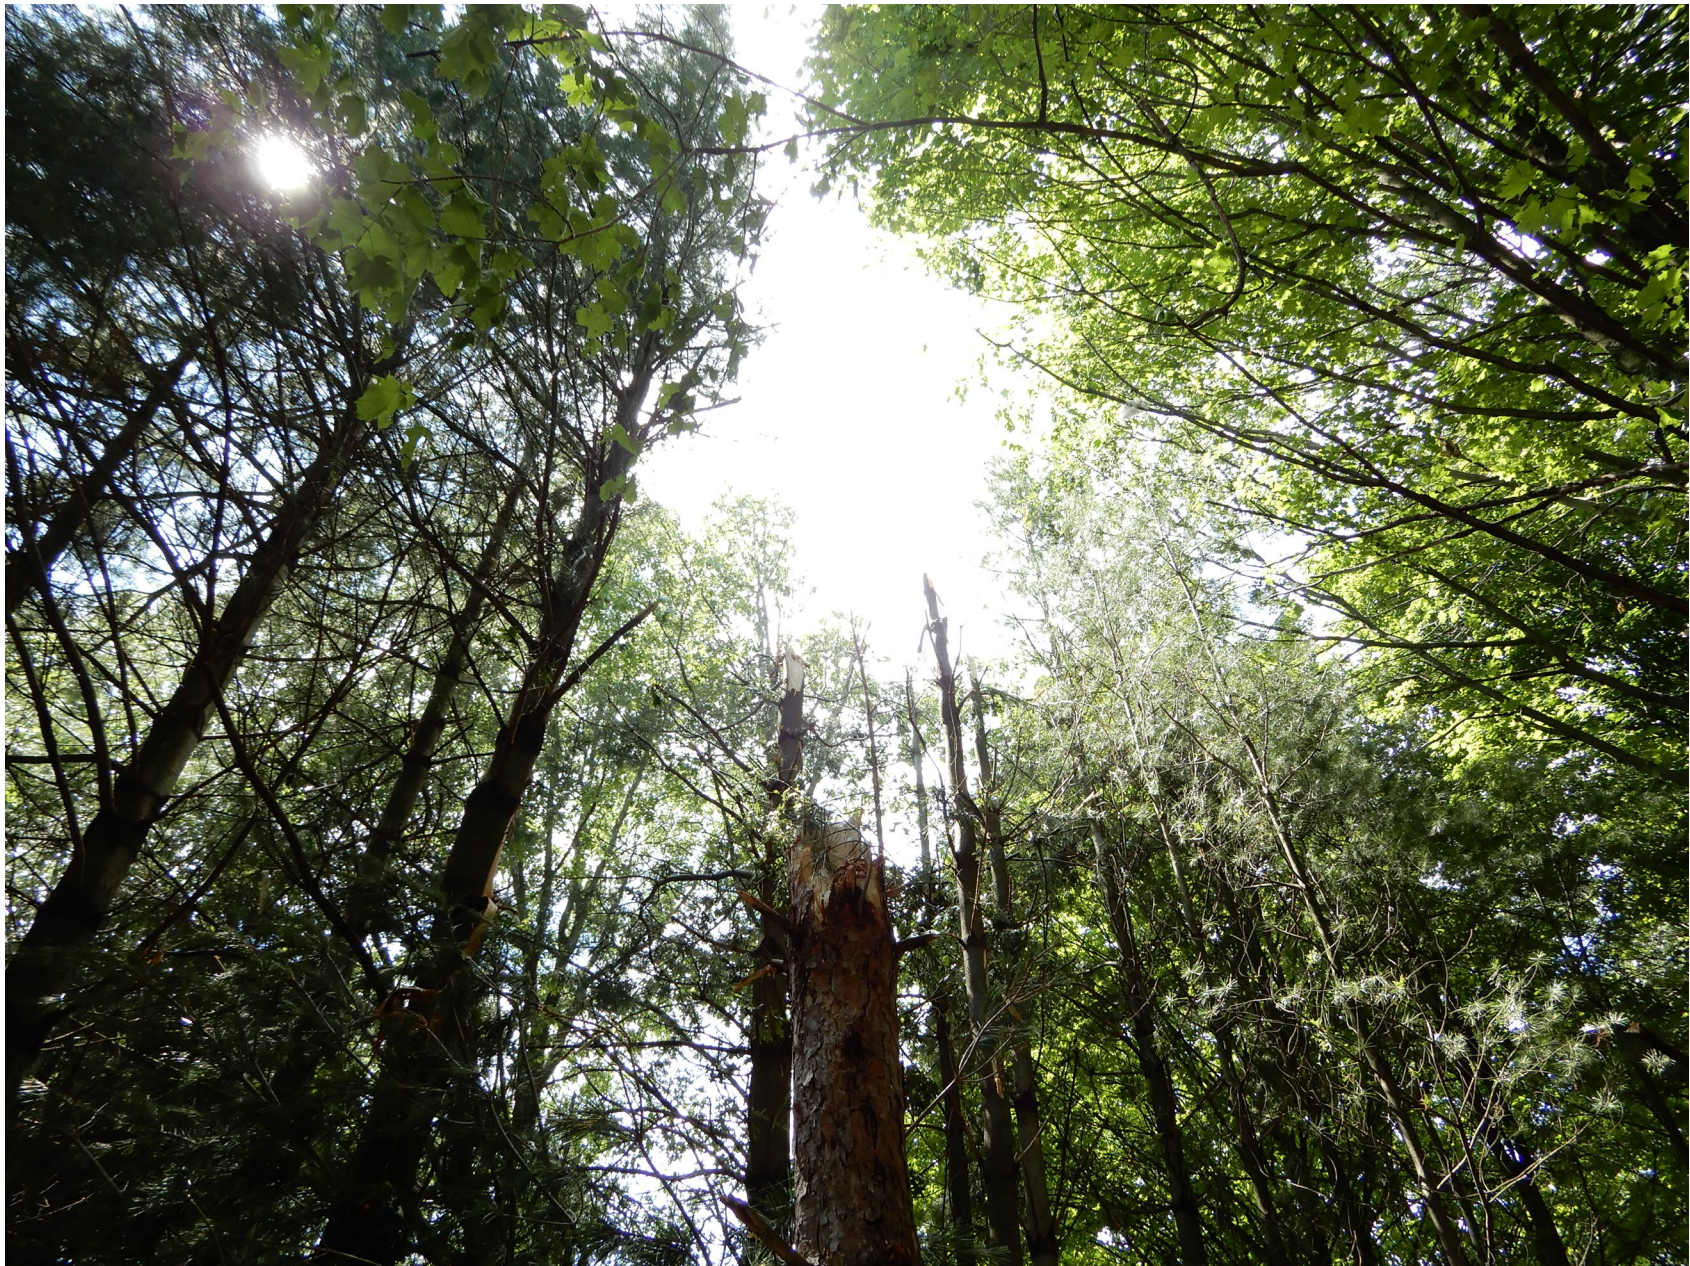
**Photo 1 – Tree Impact Damage (NTSB Photo)**

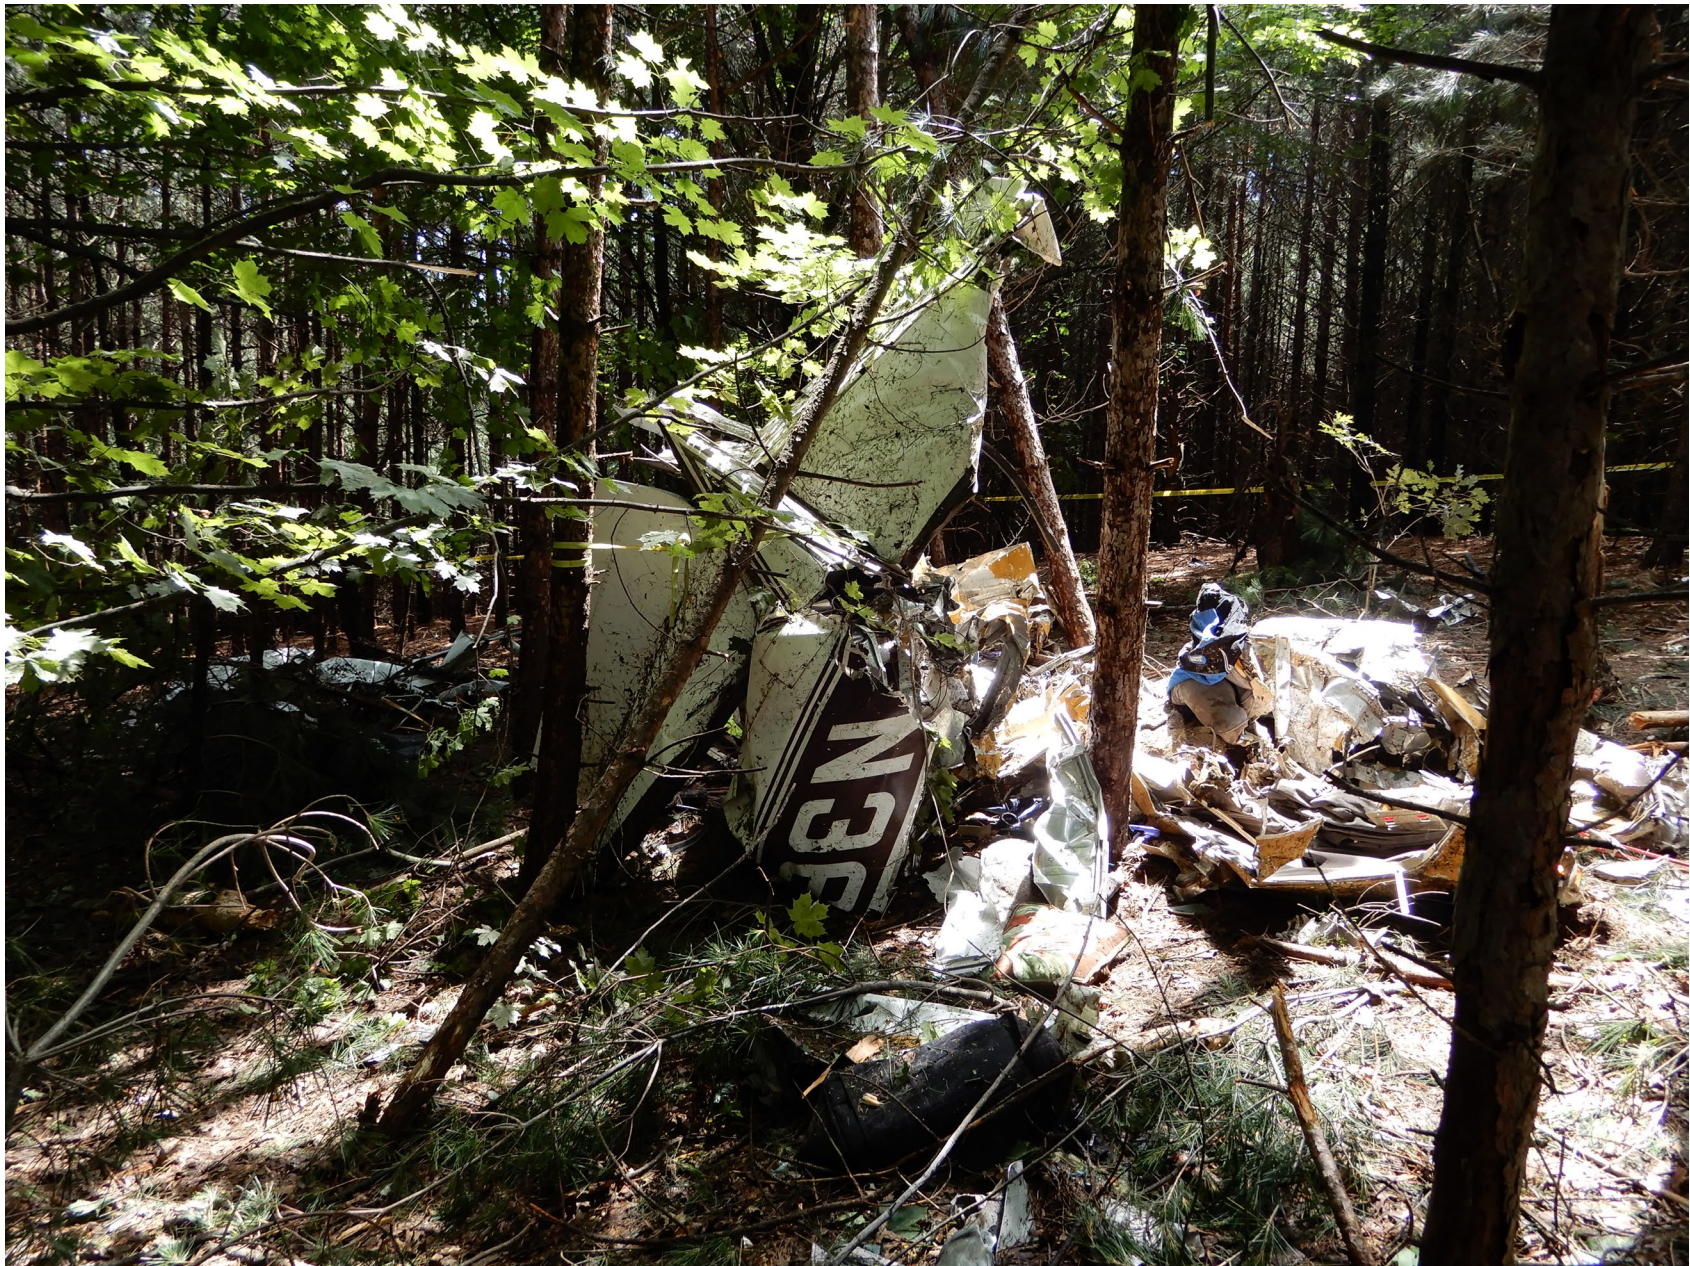
**Photo 2 – Main Wreckage (NTSB Photo)**

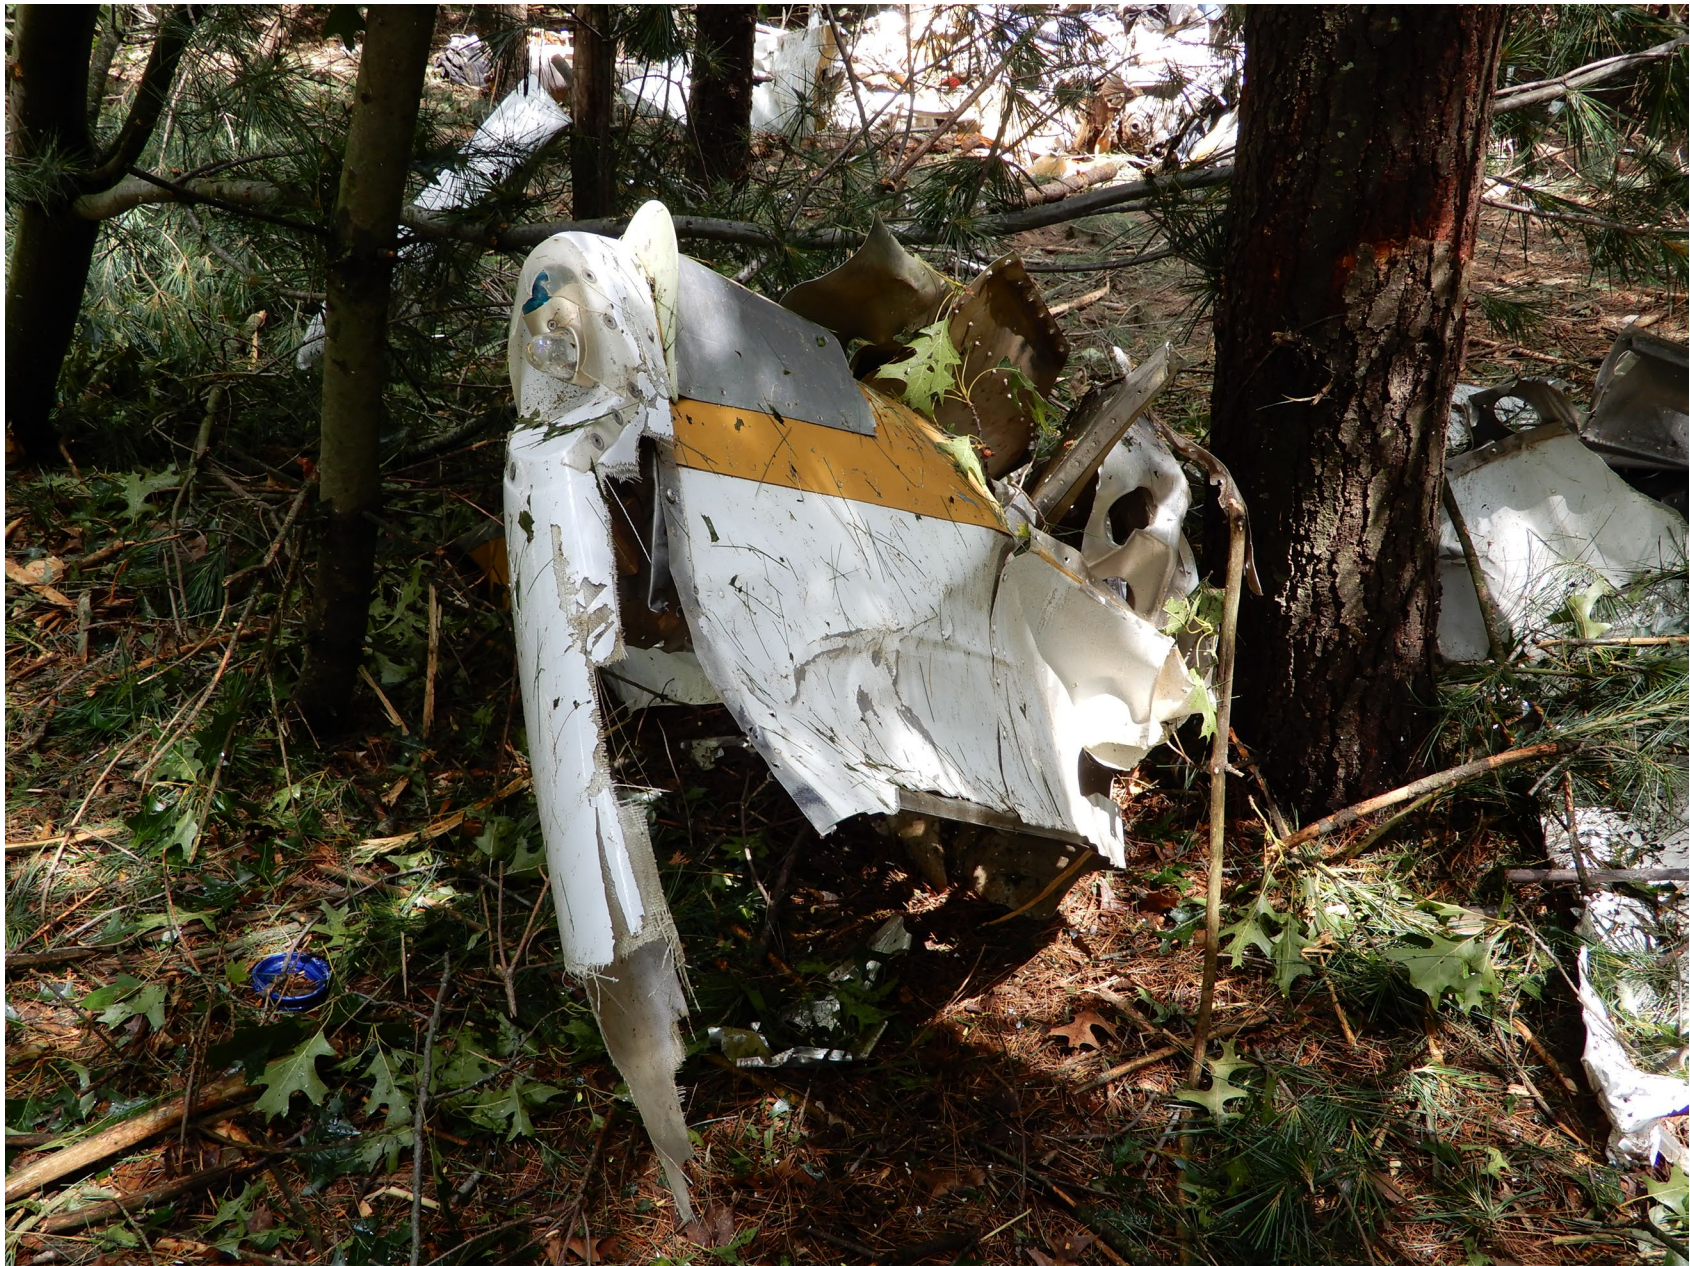
**Photo 3 – Right Wing (NTSB Photo)**

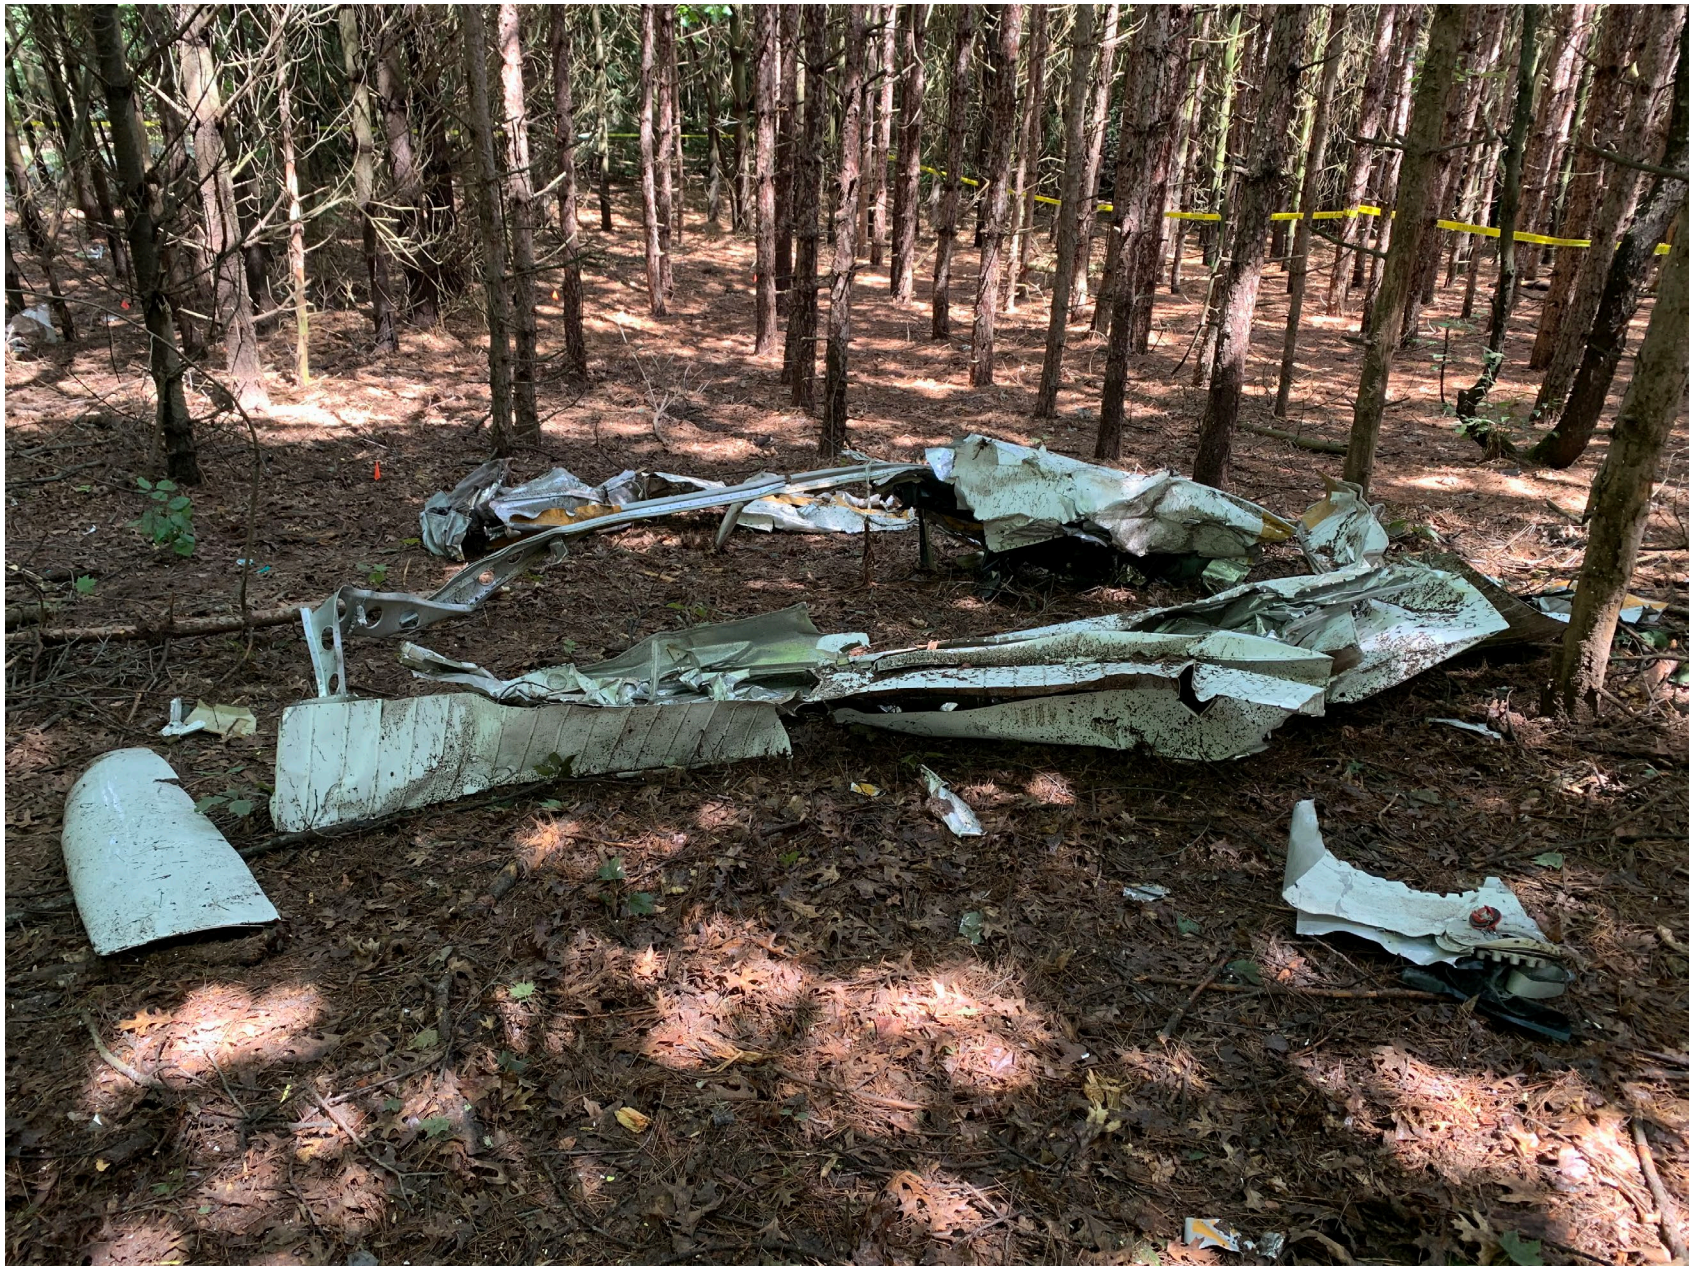
**Photo 4 – Left Wing Fragments (NTSB Photo)**

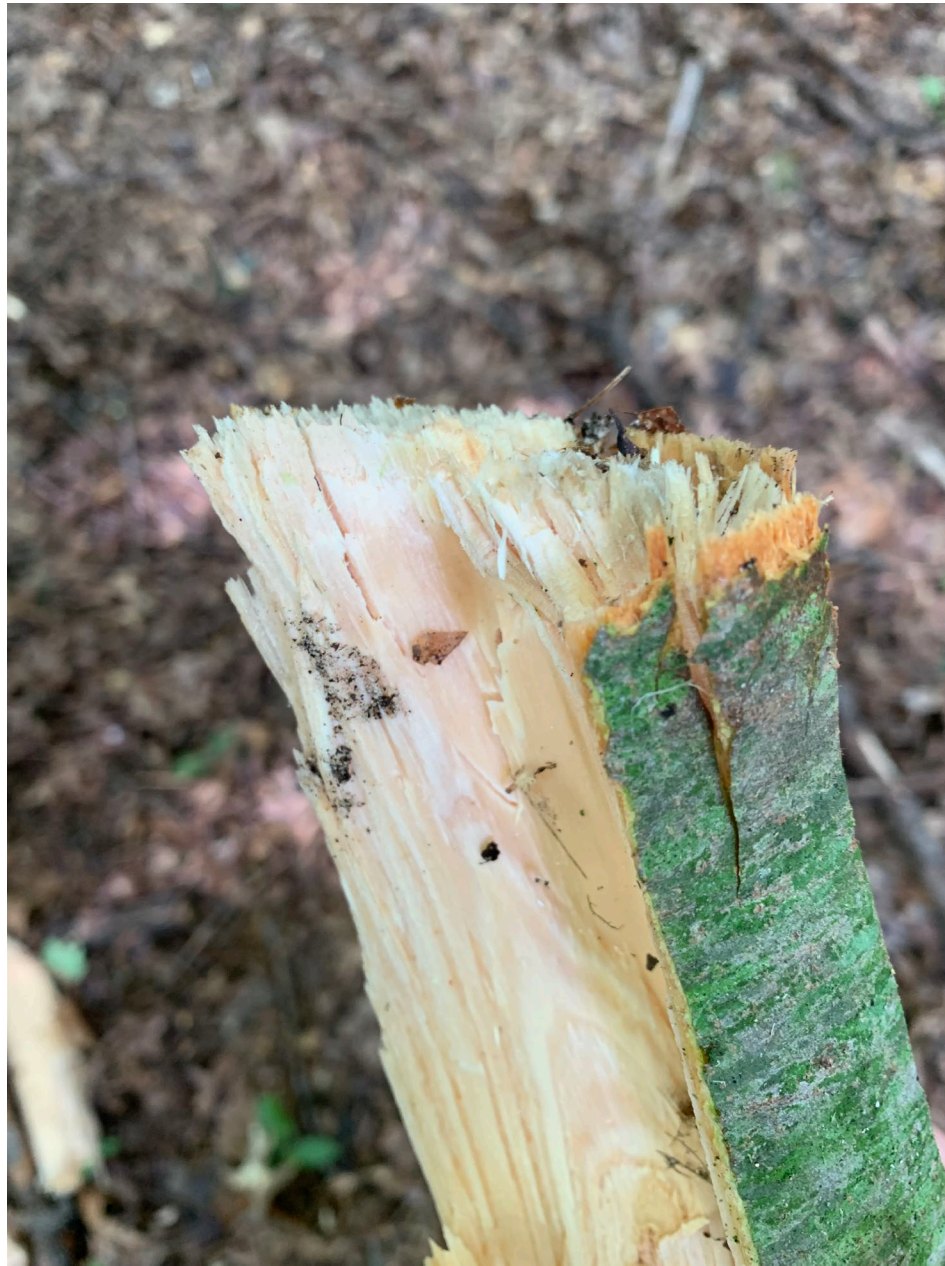
**Photo 5 – Angular-cut Tree Limb (NTSB Photo)**

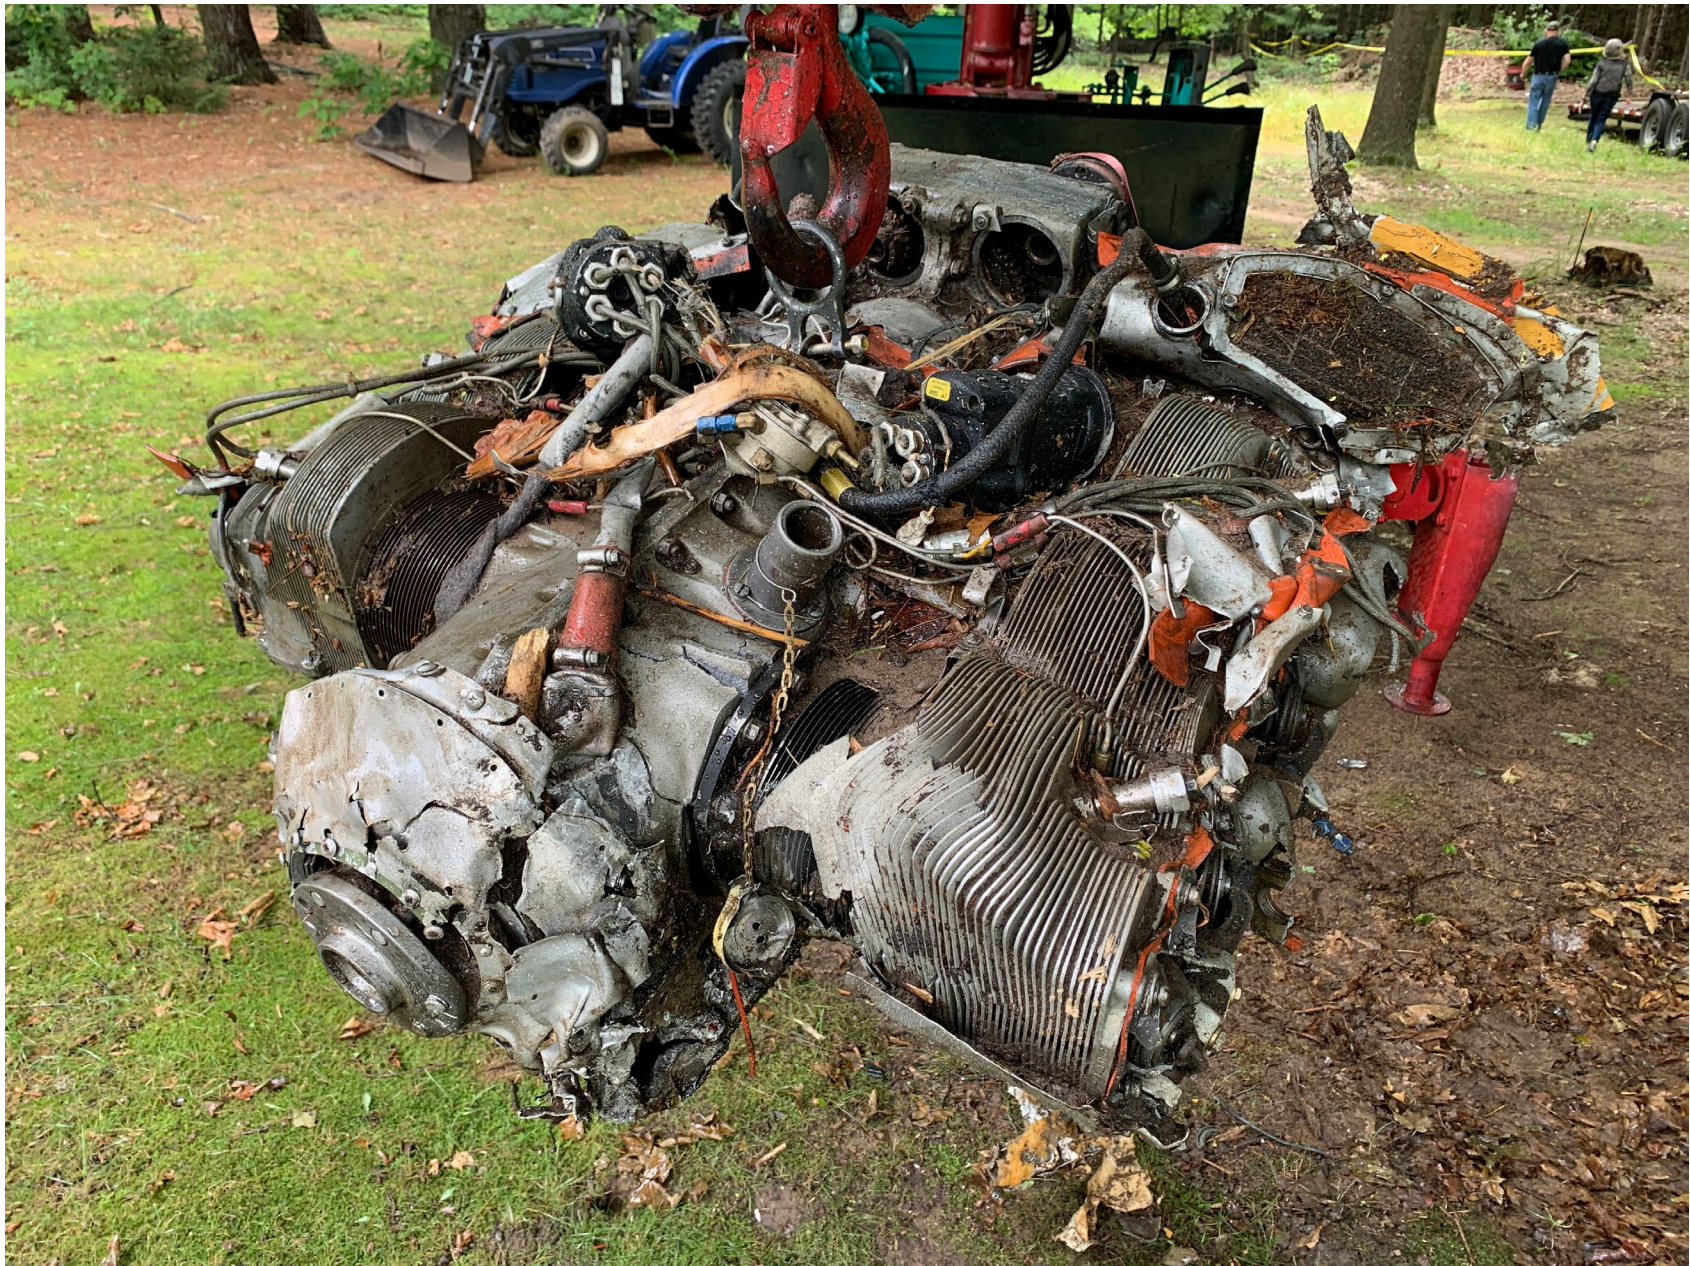
**Photo 6 – Engine (NTSB Photo)**

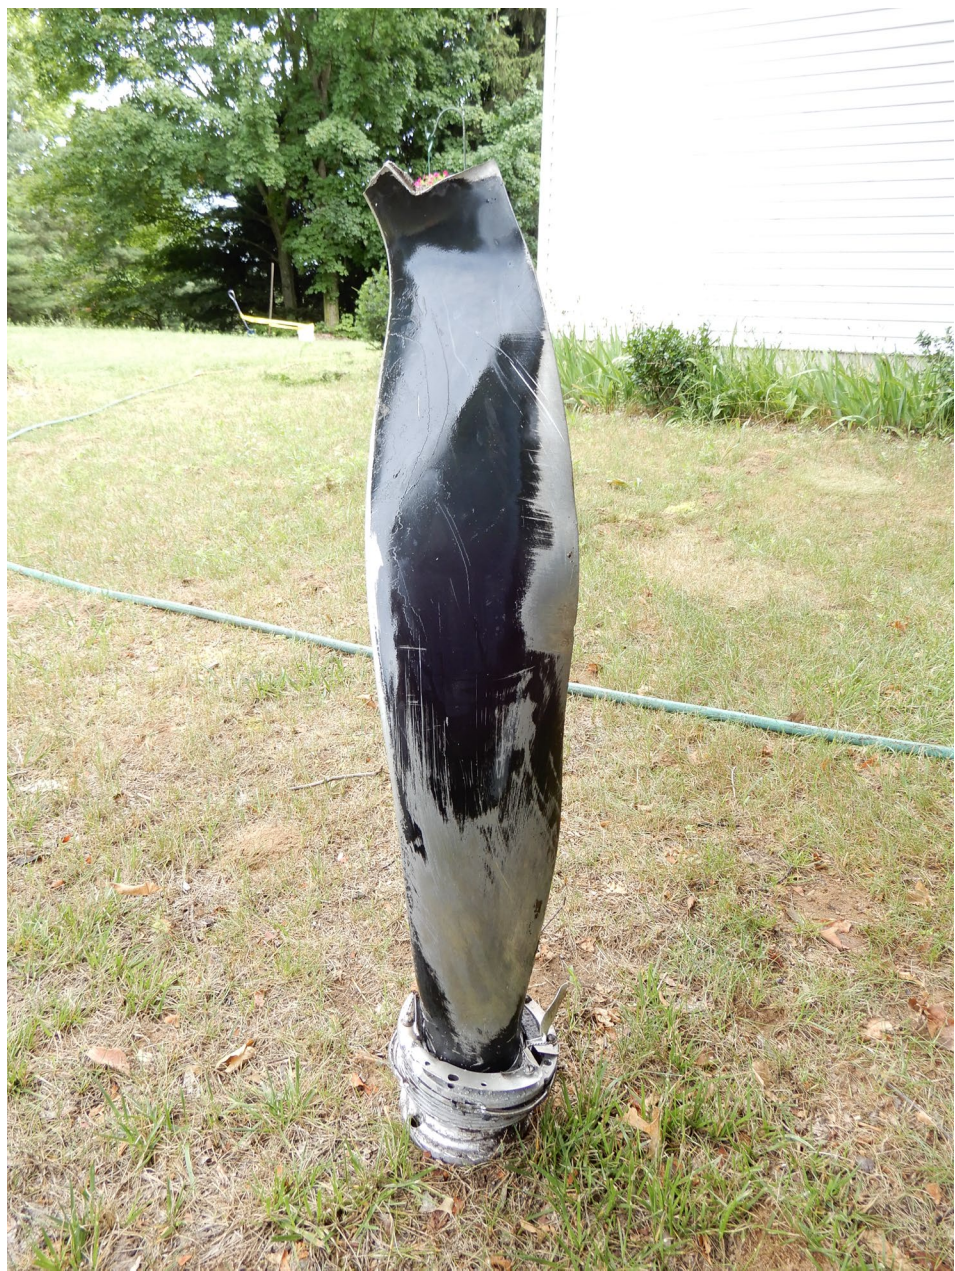
**Photo 7 – Propeller Blade (NTSB Photo)**

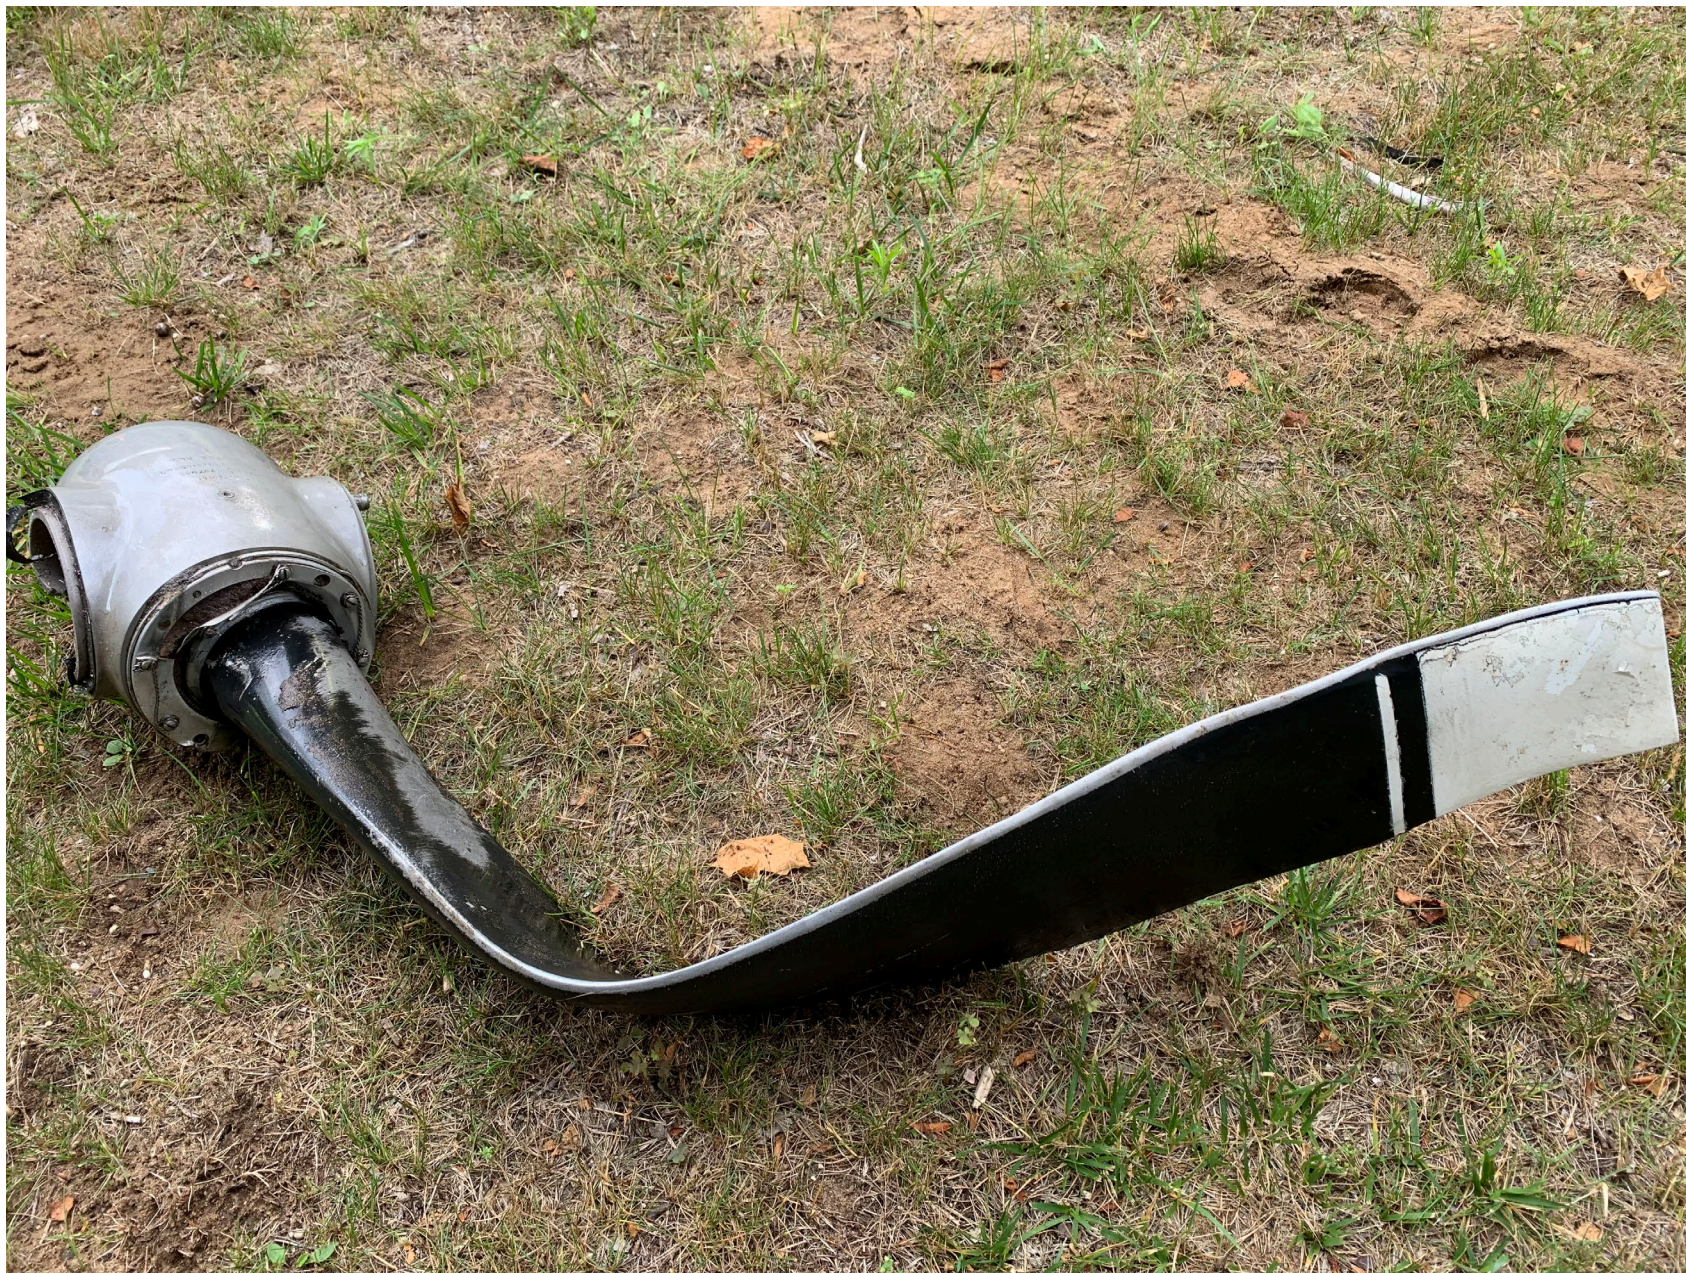
**Photo 8 – Propeller Blade (NTSB Photo)**

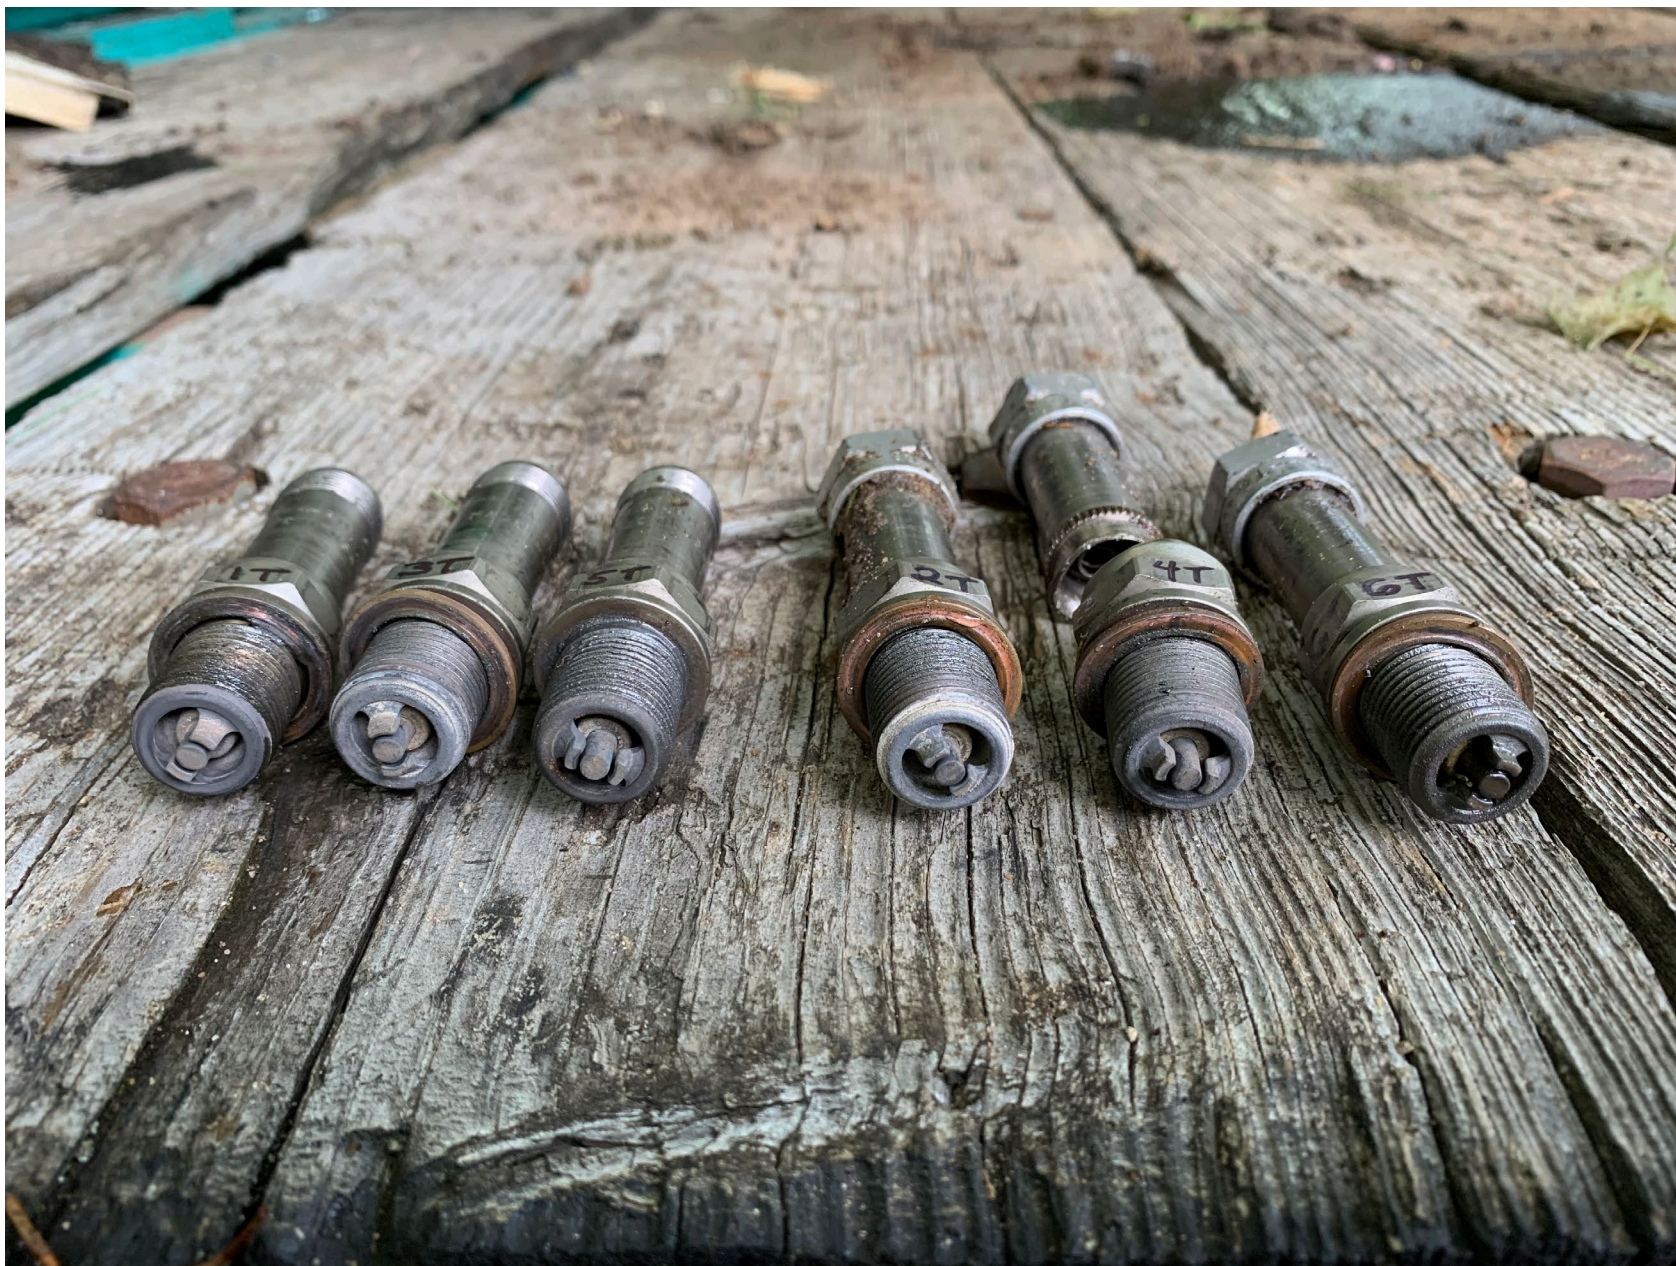
**Photo 9 – Top Spark Plugs (NTSB Photo)**

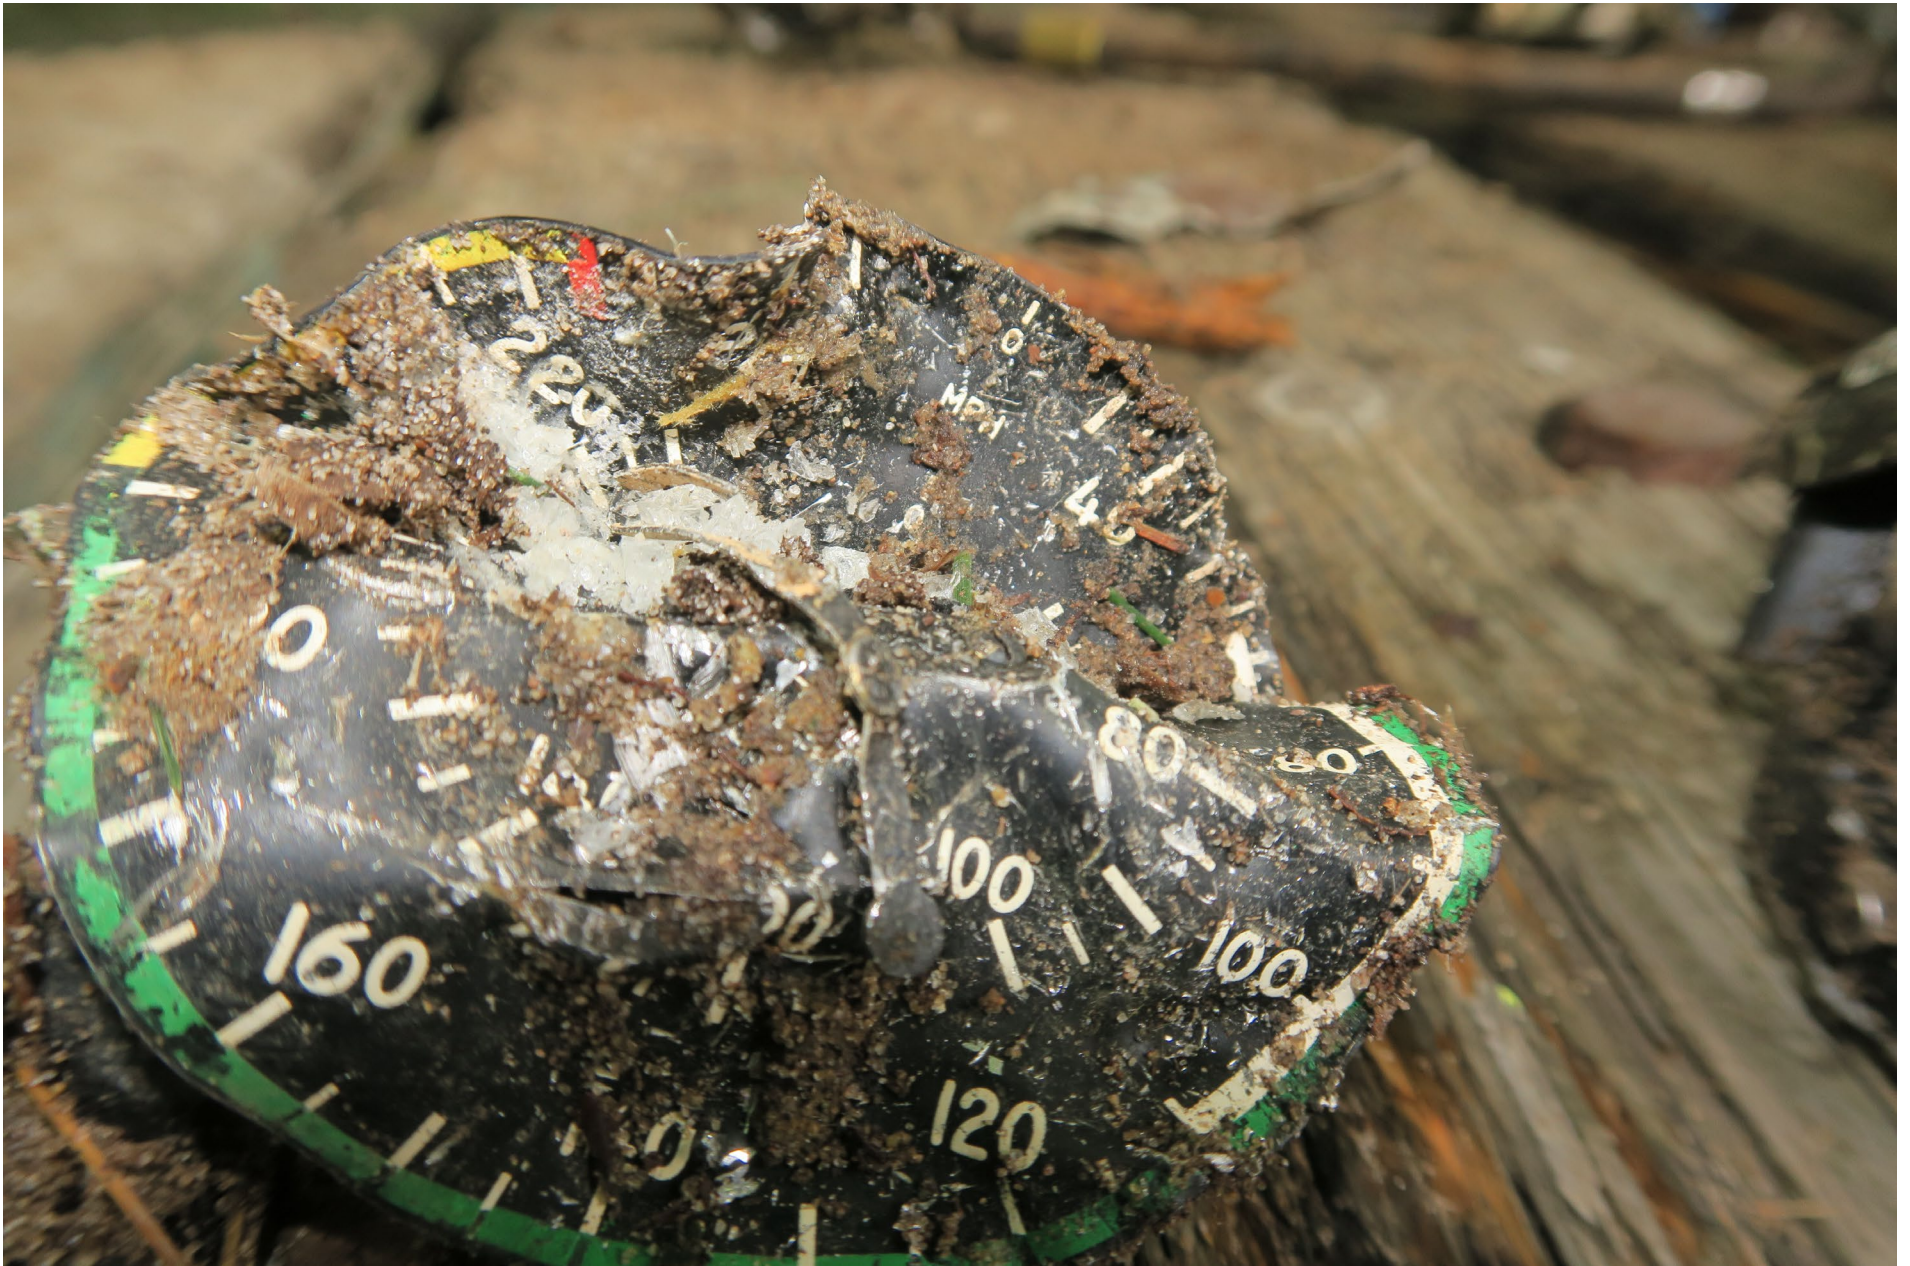
**Photo 10 – Airspeed Indicator Face (Textron Aviation Photo)**
