**Wreckage Examination  
NTSB Accident Number  
ERA22FA315**

| Date: | July 16, 2022 |
| Aircraft: | Piper PA-12 |
| Registration | N3703M |

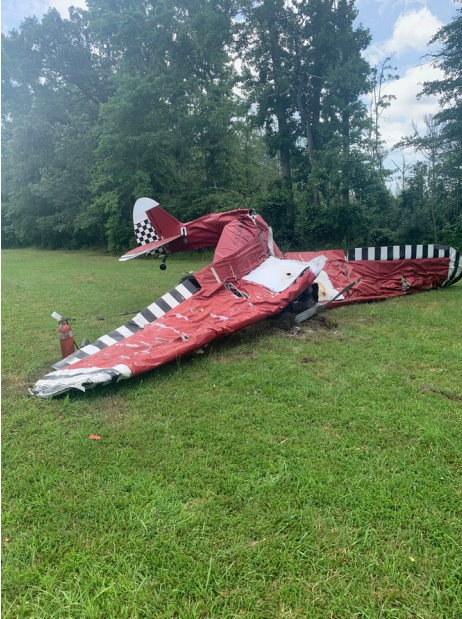
The wreckage came to rest nose-down, oriented about a 320° magnetic heading, and no debris path was observed. The wreckage remained intact. Both wings exhibited leading edge damage and buckling with the left wing exhibiting more damage than the right. The ailerons remained attached to their respective

wing. The empennage remained intact and canted right. Flight control continuity was confirmed from all flight control surfaces to the cockpit. Measurement of the horizontal stabilizer trim jackscrew corresponded to a nose down trim position. Specifically, 14 threads were observed with 17 threads being full-nose down and 1 thread being full nose up. The cockpit area was crushed, but the pilot's 4-pt harness remained latched and was cut by rescue personnel.

The engine remained attached to the airframe and the propeller remained attached to the engine. One propeller blade remained undamaged while the other exhibited s-bending and leading edge gouging.
