# National Transportation Safety Board

ERA22FA344

## **MATERIALS LABORATORY**

Factual Report 23-028

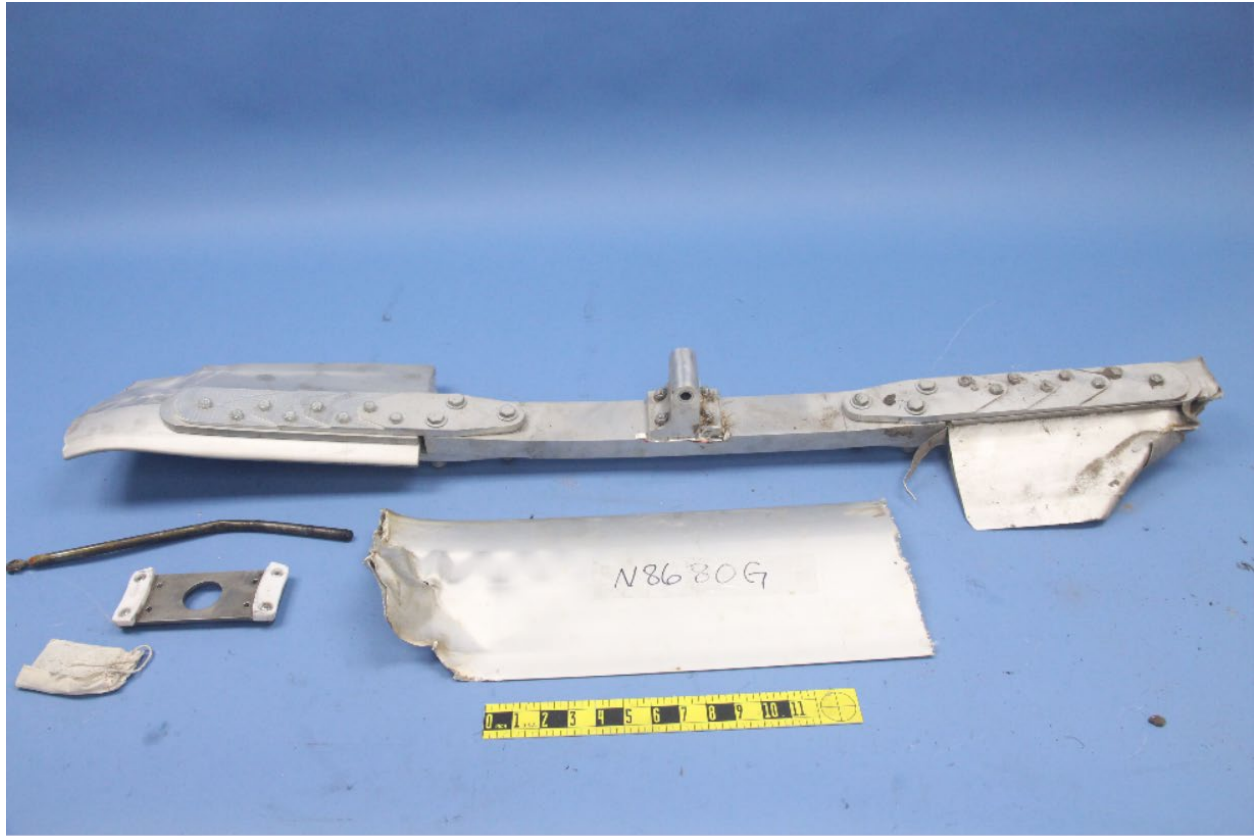
Rudder pedal push pull rod, teeter bar, rotor head with blade grips and portions of rotor blade attached and a separate portion of rotor blade (Figure 1).

**Figure 1.** Accident parts as received.

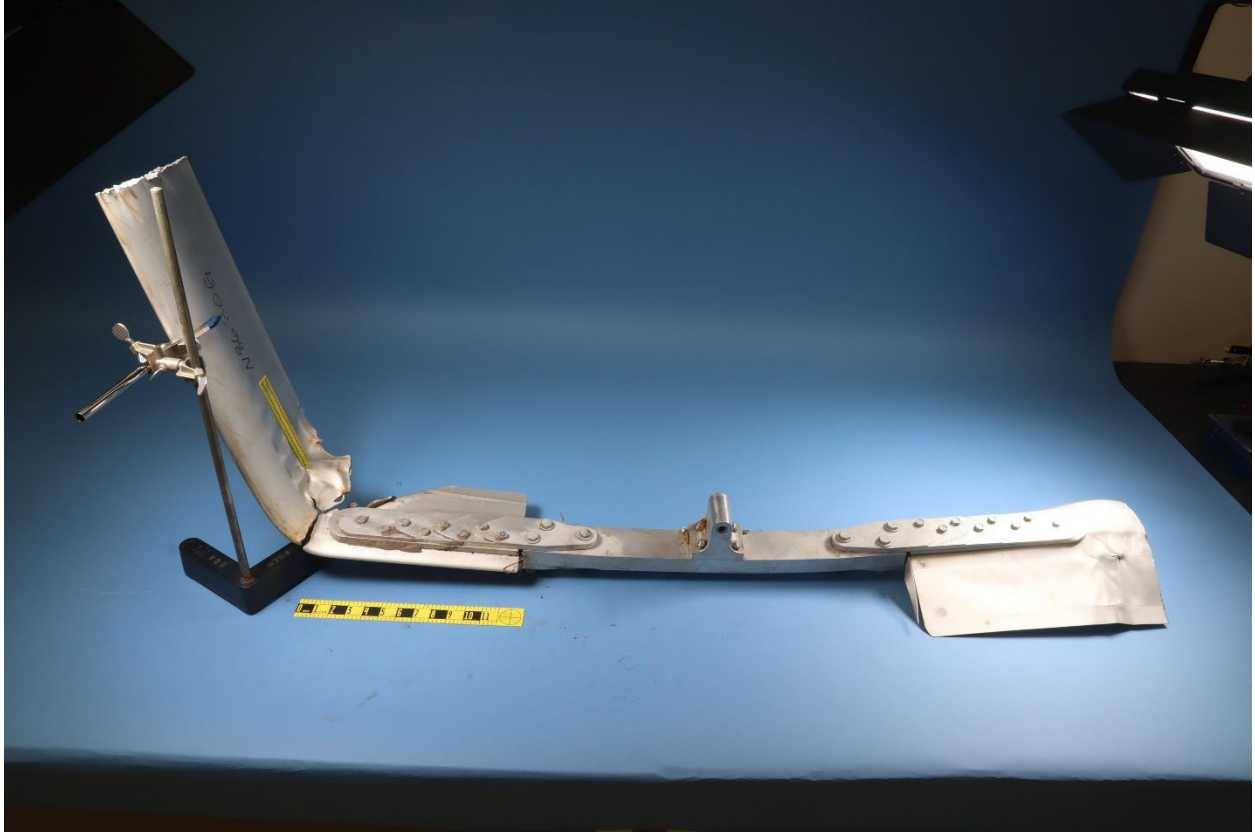
The separated portion of rotor blade was aligned with its corresponding portion of rotor blade still attached to the rotor head (Figure 2). The alignment followed the curvature of the deformed rotor blade across both sides of the fracture (Figure 3). This alignment exhibited that the rotor blade bent in an upward direction more than 45 degrees prior to separation.

**Figure 2.** Alignment of the outboard portion of the rotor blade and the portion of rotor blade attached to the rotor head.

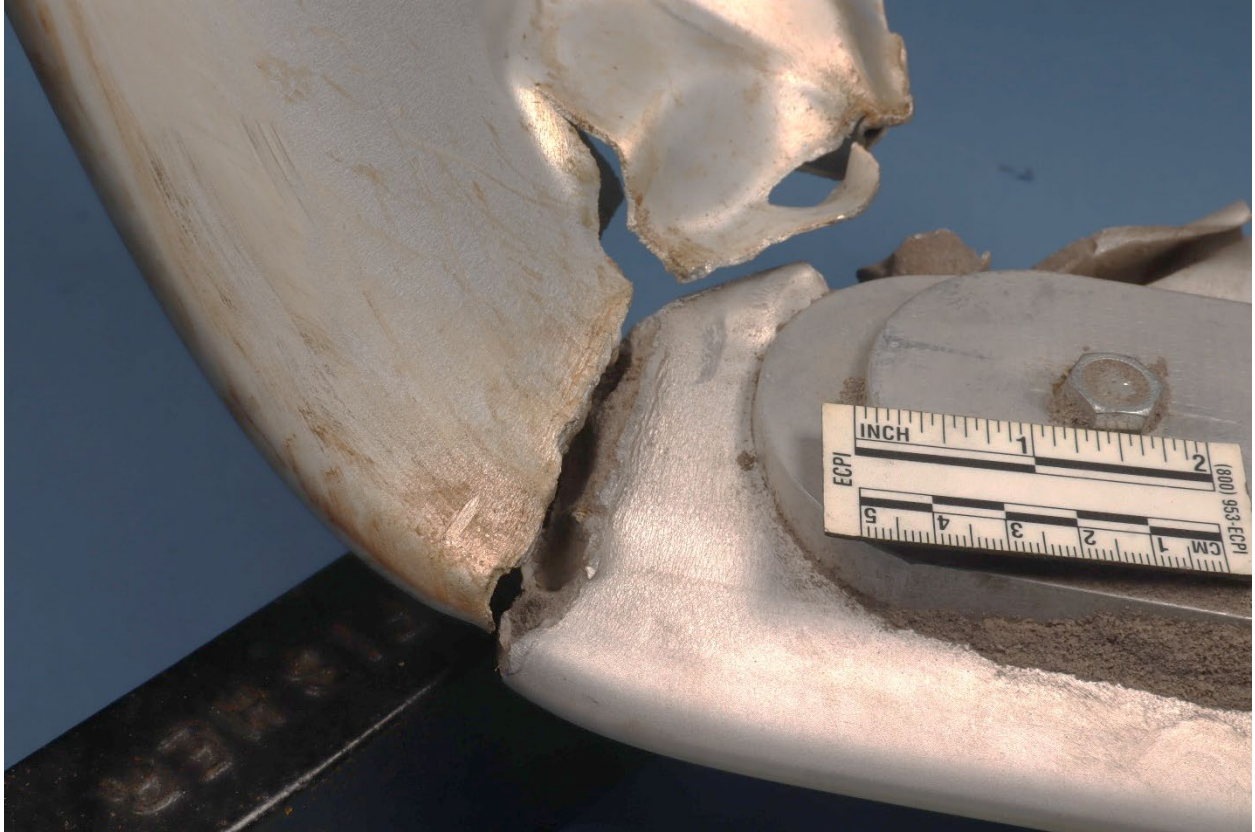
**Figure 3.** Close up of Rotor blade separation point.

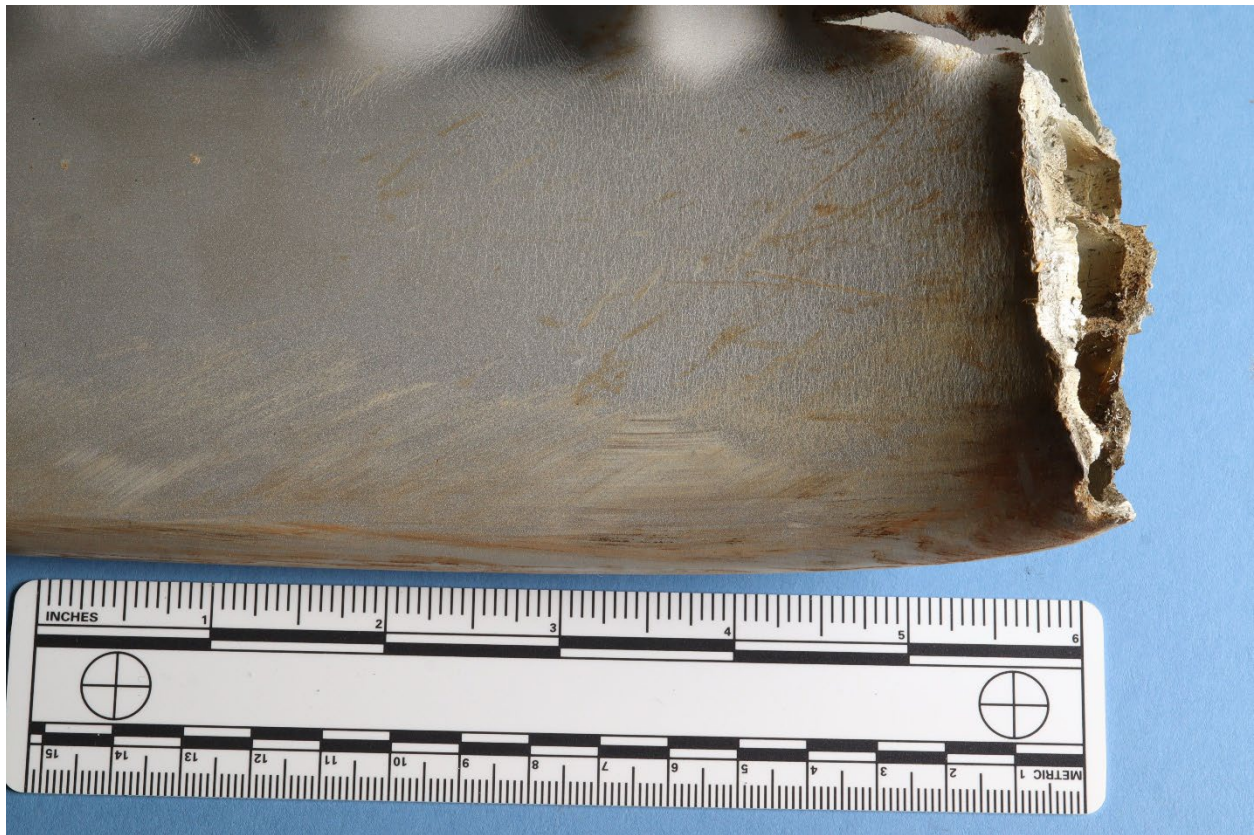
The fracture surface on the separated portion of the rotor blade exhibited slant fractures consistent with overstress. The upper surface of the rotor blade in proximity to the fracture exhibited ridges consistent with deformation caused by compression (Figure 4). The lower surface of the rotor blade in proximity to the fracture exhibited cracking and stretcher strain marks consistent with deformation caused by tension (Figure 5).

**Figure 4.** Outboard portion of rotor blade top surface near fracture.

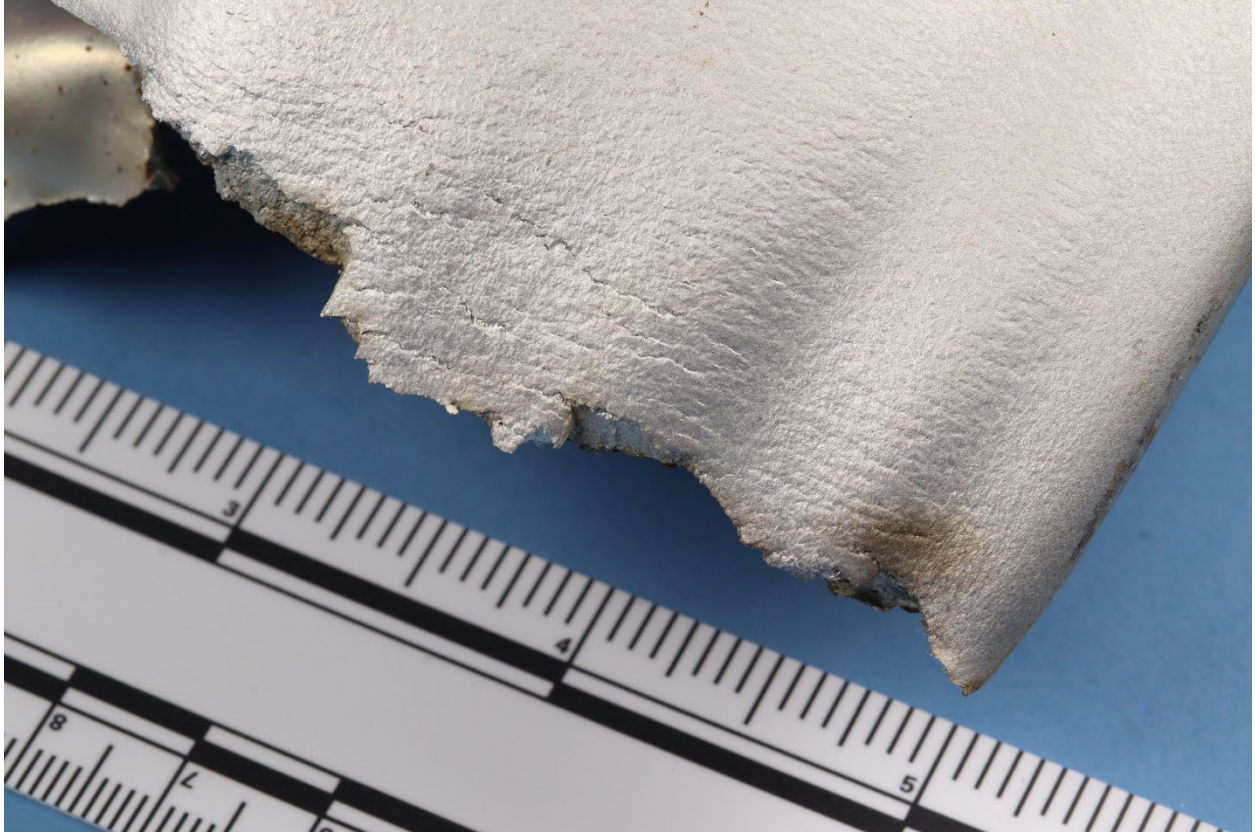
**Figure 5.** Outboard portion of rotor blade bottom surface near fracture.

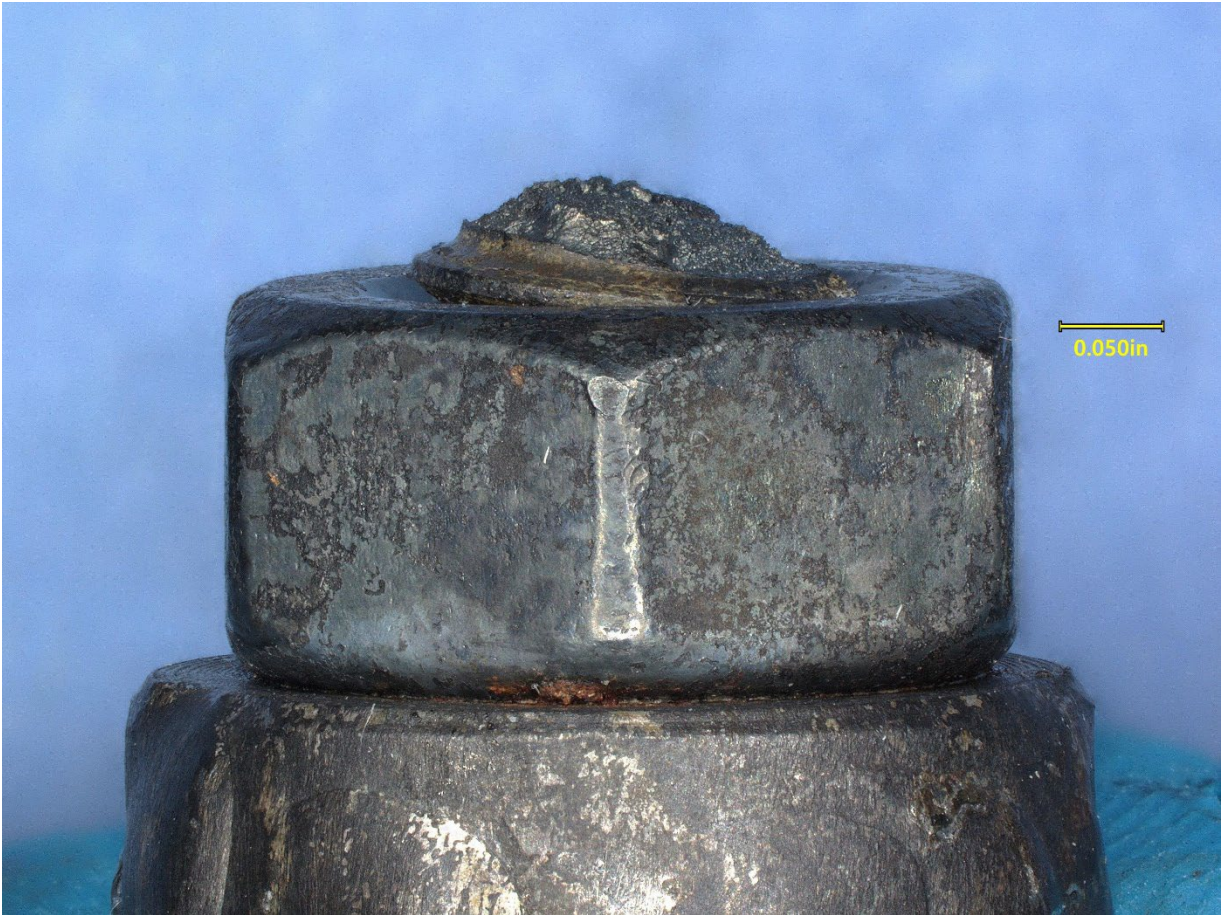
The rudder push pull rod end exhibited a fracture in the threaded shank right above the nut at the end of the rod. The threaded shank exhibited bending deformation and slant fractures consistent with bending overstress (Figures 6, 7).

**Figure 6.** Rudder push pull rod end exhibiting bending of the threaded shank.

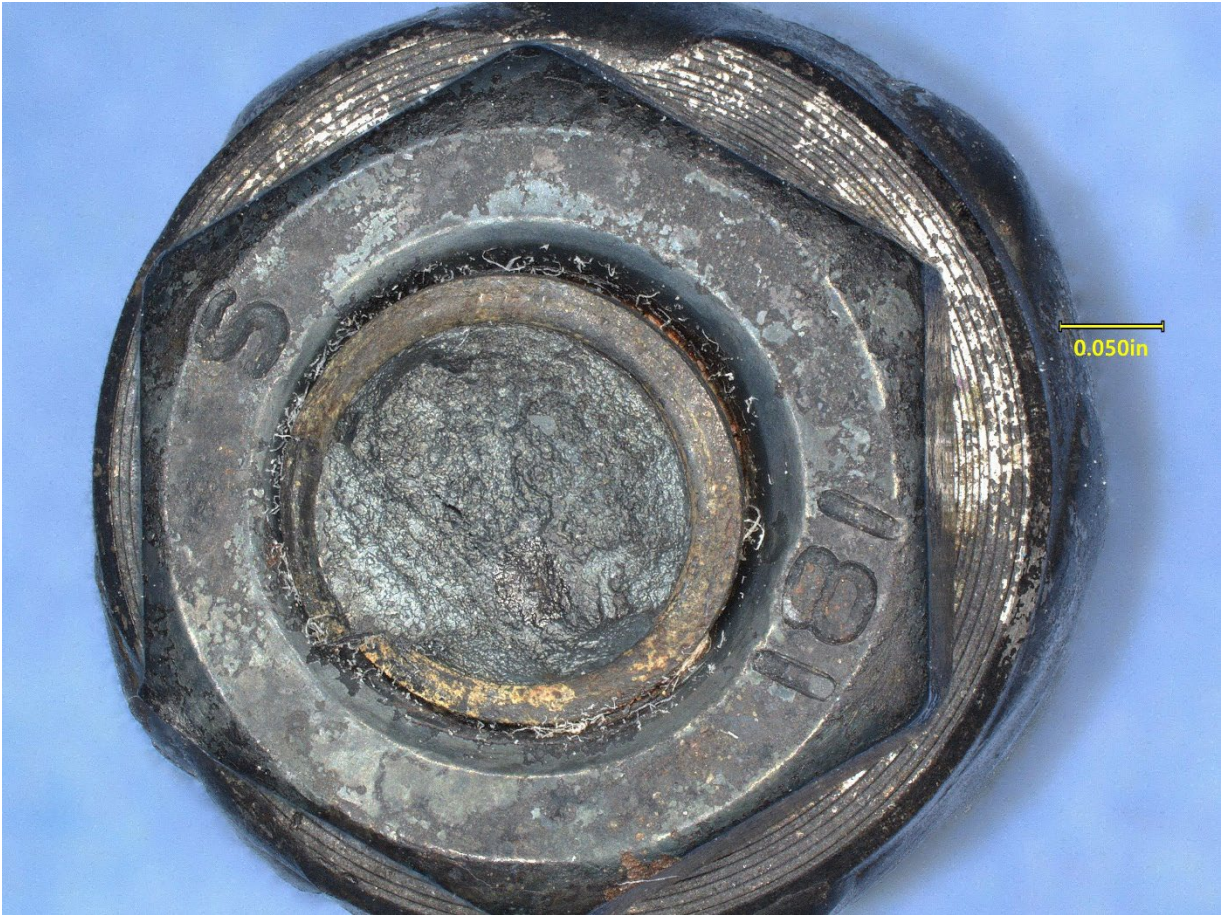
**Figure 7.** Slant fractures on outer periphery of the threaded shank.
