**Hartzell Propeller Air Safety Investigator Exam Report**

**Accident**

NTSB File No.: ERA22FA350  
Accident Date: 8/2/2022  
Location: Near South Haven Regional Airport, MI  
Aircraft: Smith Aerostar 600  
Aircraft S/N: 60-0416-143  
Aircraft Registration: N9784Q  
Total Time: Unknown at time of exam

**Propeller Examination**

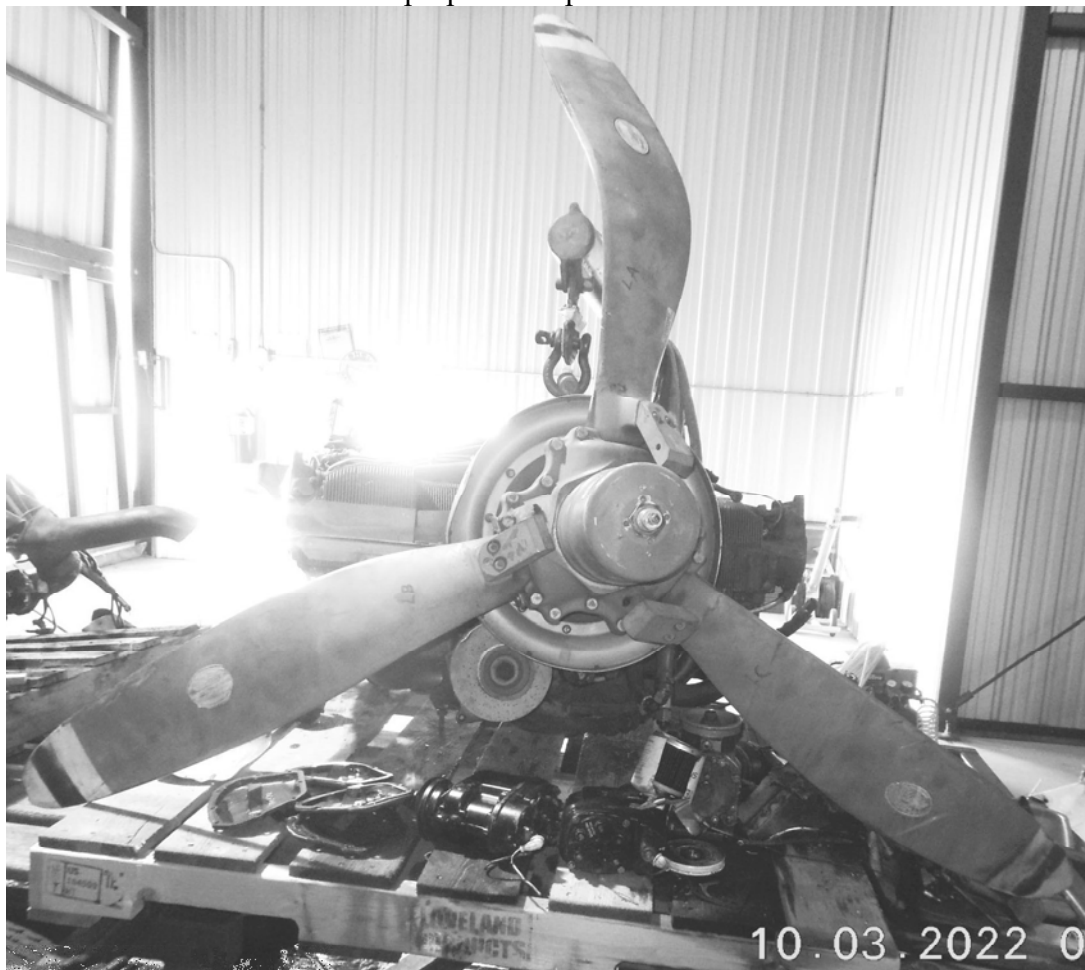
The left propeller remained attached to the engine crankshaft flange with all six studs secure and lockwired. It was presented for examination as shown in Photo #1. All three blades remained secure in the hub with counterweights attached, and there were no visible, external fractures in the hub. All three blades were intact with no remarkable fractures. The cylinder was intact with random, localized scratches.

Photo #1 – Left propeller as-presented for examination

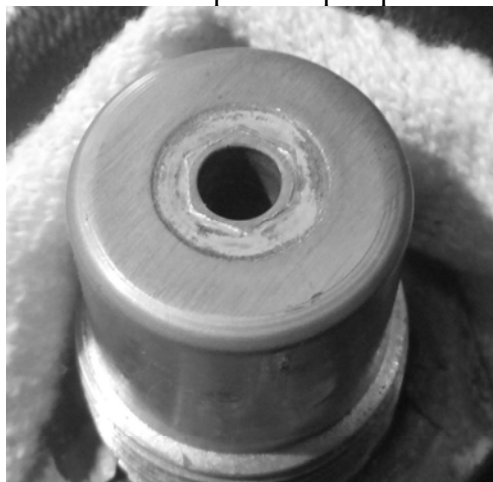
The low pitch stop was removed from the cylinder and it showed impact damage with the cap screw holding the feather and start lock sleeve to the pitch change rod (Photo #2). This impact damage suggests the propeller was at near the low pitch stop at impact.

Photo #2 – Low pitch stop impact mark

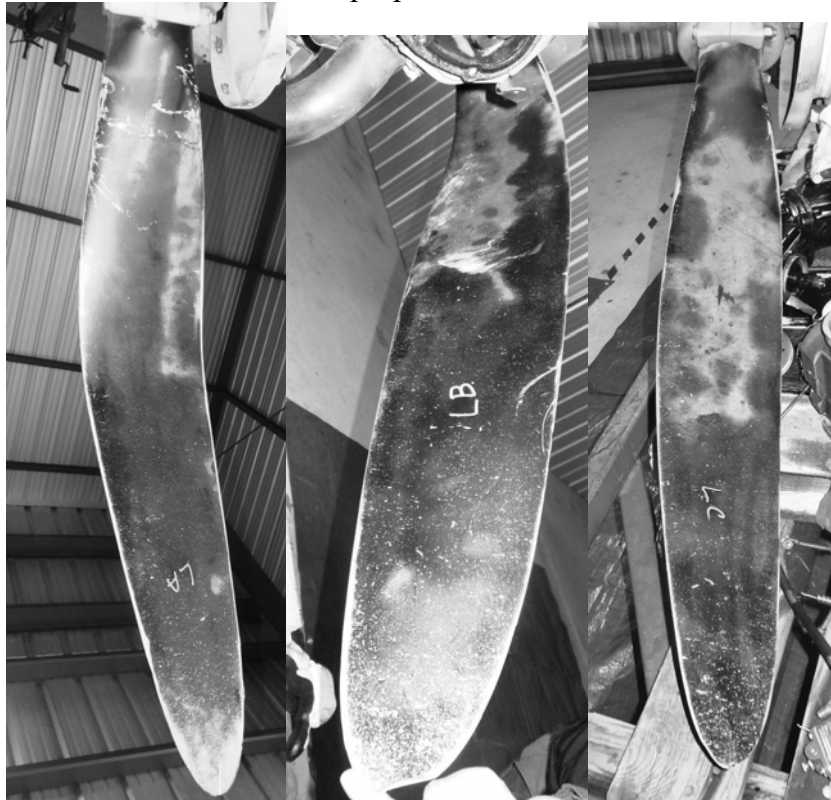
The spinner dome as-presented had been removed prior to this exam and was sitting next to the engine. The spinner dome was crushed and torn. The dome cap was missing, presumed not recovered or in the other aircraft wreckage. The air valve was damaged and there was no aircharge remaining. Blade LA was bent aft with relatively minor chordwise/rotational abrasion on the camber side, no remarkable scoring on the face side. Blade LB was also bent aft with minor chordwise/rotational abrasion on the camber side, no remarkable scoring on the face side. Blade LC was also bent aft with the highest degree of chordwise/rotational abrasion on the camber side, no remarkable scoring on the face side. None of the three blades exhibited any remarkable twisting damage, bending opposite rotation, and there were no remarkable leading edge gouges. See Photos #3 and #4 for relative blade damage)

Photo #3 – Left propeller blades – face side

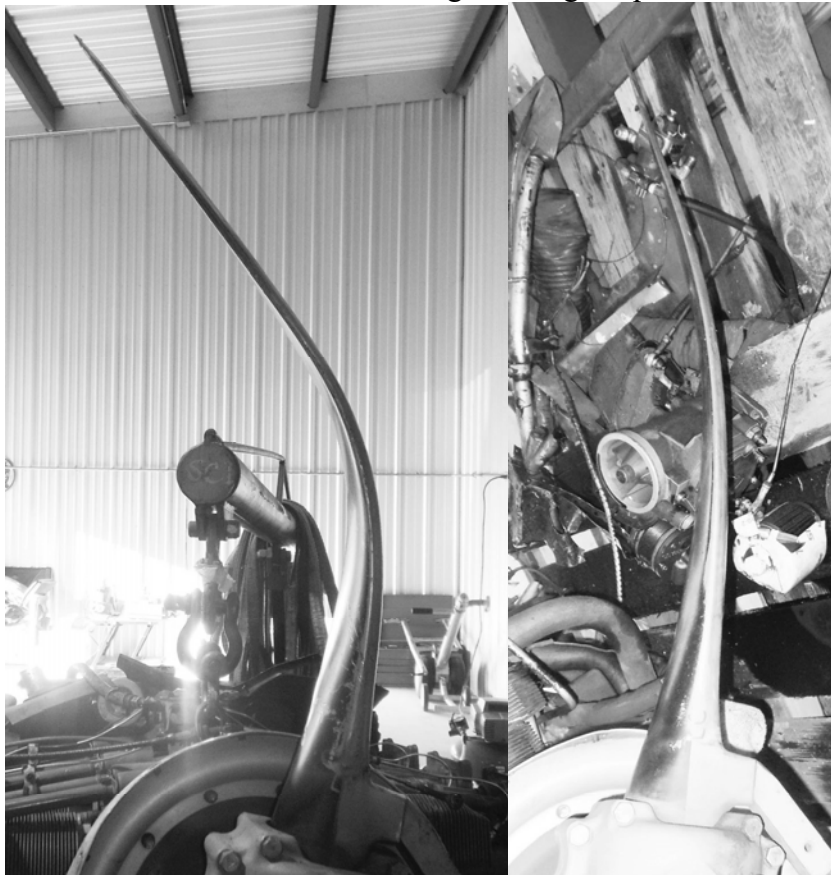
Photo #4 – Blades LA and LC after feathering showing simple aft bends with no twist

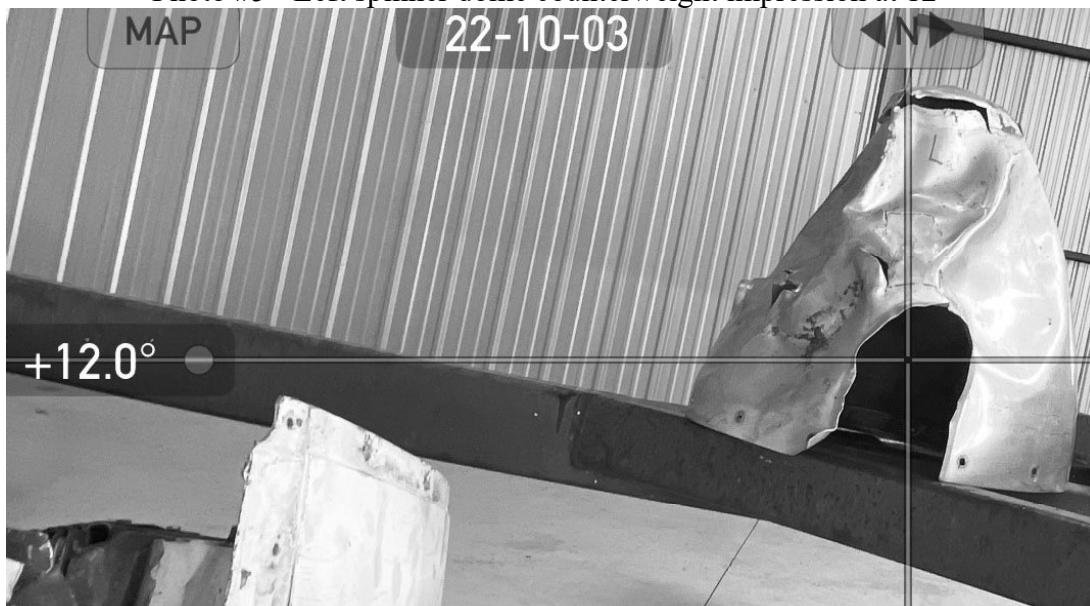
The spinner dome had counterweight impression marks at approximately 12° and 17° (Photos #5 and #6) which are equivalent to blade angles of -1° and 4°, both below the mechanical low pitch stop of the assembly and indicating forceful rotation towards low pitch.

Photo #5 - Left spinner dome counterweight impression at 12°

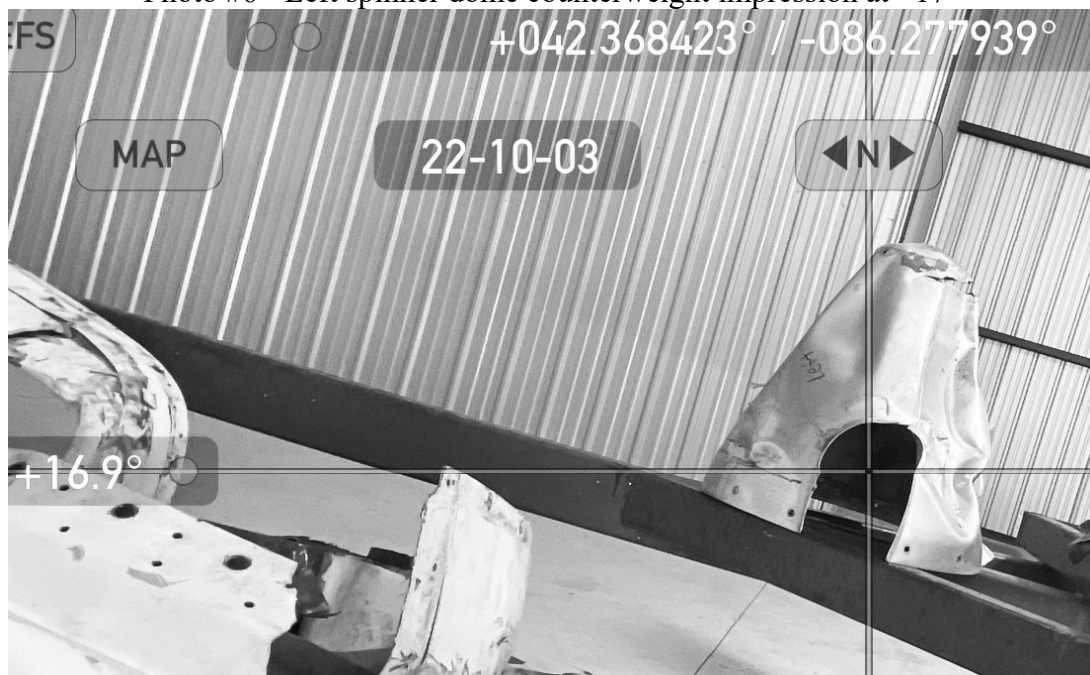
Photo #6 - Left spinner dome counterweight impression at ~17°

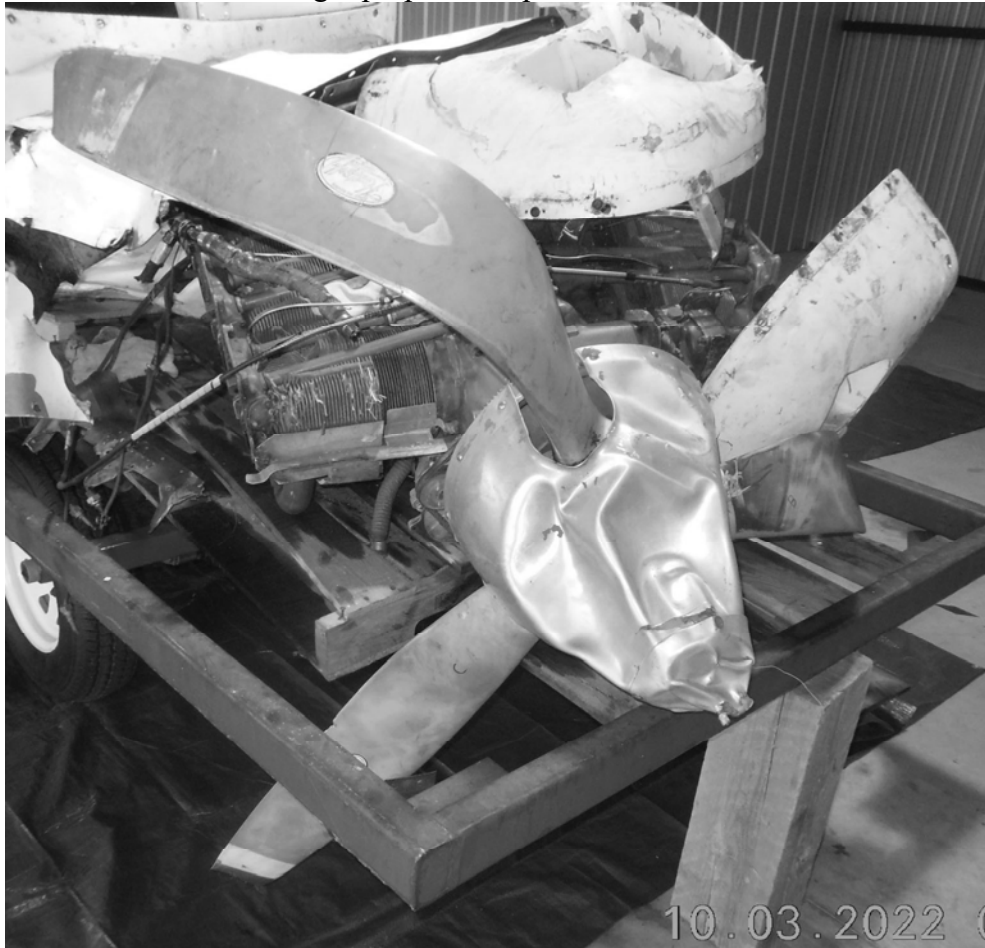
The right propeller remained attached to the engine crankshaft flange with all six studs secure and lockwired. It was presented for examination as shown in Photo #7. The spinner dome and dome cap remained attached but were crushed and torn. The air valve with cap intact punctured through the dome cap. All three blades remained secure in the hub with counterweights attached, and there were no visible, external fractures in the hub. Two blades exhibited tip fractures. The cylinder was intact with random, localized scratches.

Photo #7 – Right propeller as-presented for examination

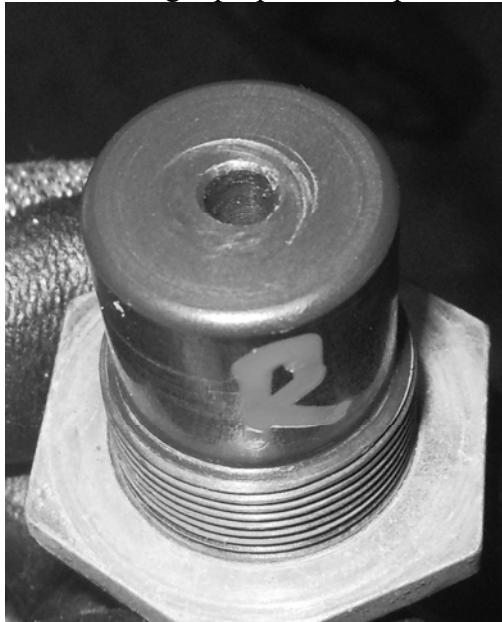
The low pitch stop was removed from the cylinder and it showed impact damage with the cap screw holding the feather and start lock sleeve to the pitch change rod (Photo #8). The impact damage was offset from the centerline. This impact damage suggests the propeller was at near the low pitch stop at impact.

Photo #8 - Right propeller low pitch stop

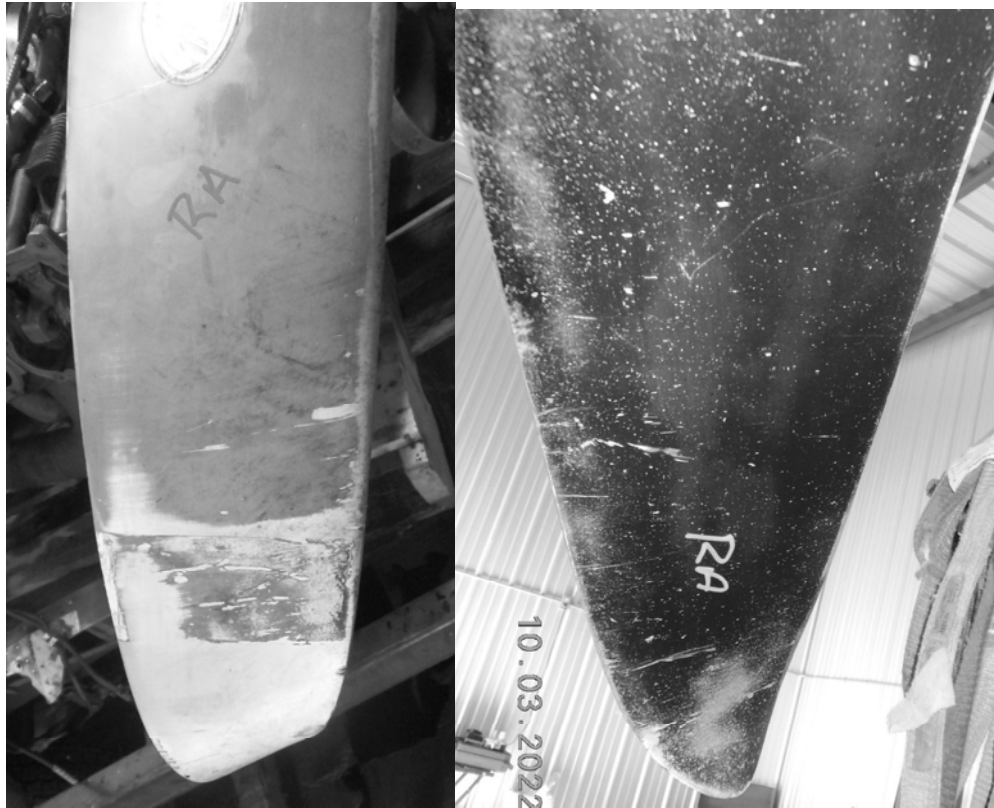
Blade RA was bent aft and twisted towards low pitch, with remarkable chordwise/rotational abrasion on the camber side in the tip region (Photo #9). There was also some chordwise/rotational scoring on the face side. Blade RB was bent forward and twisted toward high pitch with some chordwise/rotational scoring on the camber and face sides (Photo #10). There was a gouge in the leading edge approximately 3" from the tip with material deformation toward low pitch. Approximately 0.5" of the tip was fracture-separated. Blade RB also exhibited remarkable ~45° chordwise scoring and abrasion on the face side in the mid-blade region. Blade RC did not exhibit any remarkable bending or twisting. There was chordwise/rotational abrasion on the camber and face sides (Photo #11). Approximately 2" of the tip was fracture-separated.

Photo # 9 – Blade RA camber and face side

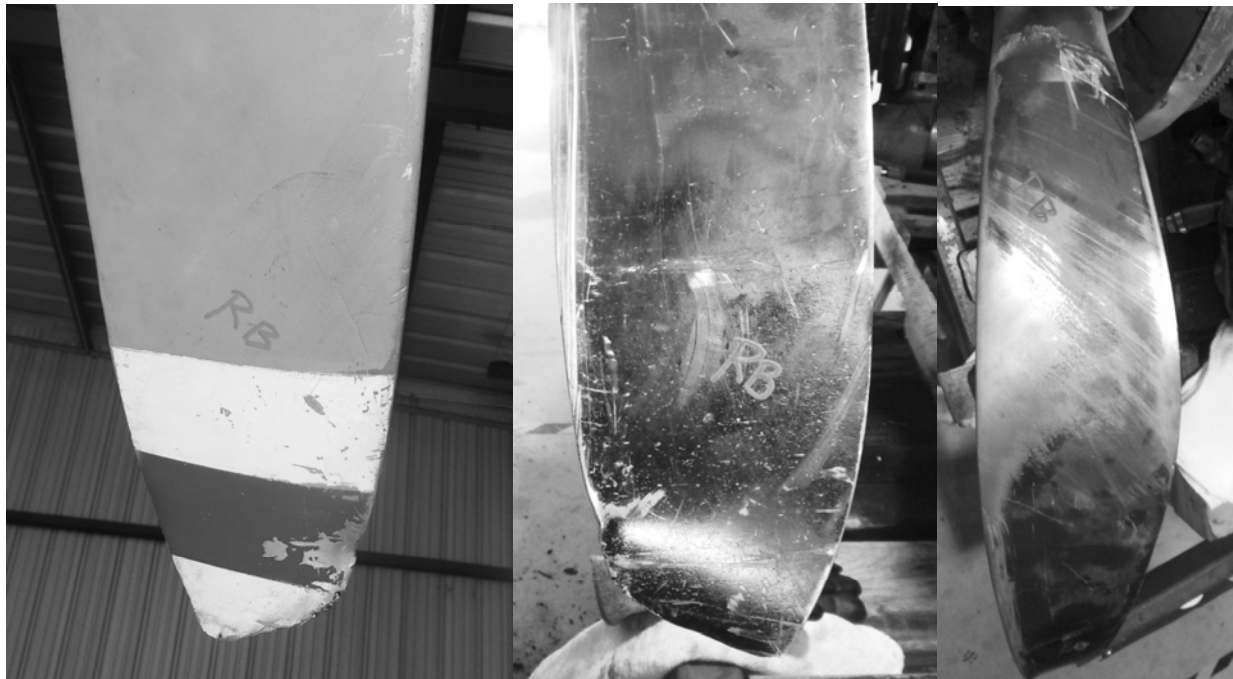
Photo #10 – Blade RB camber and face sides

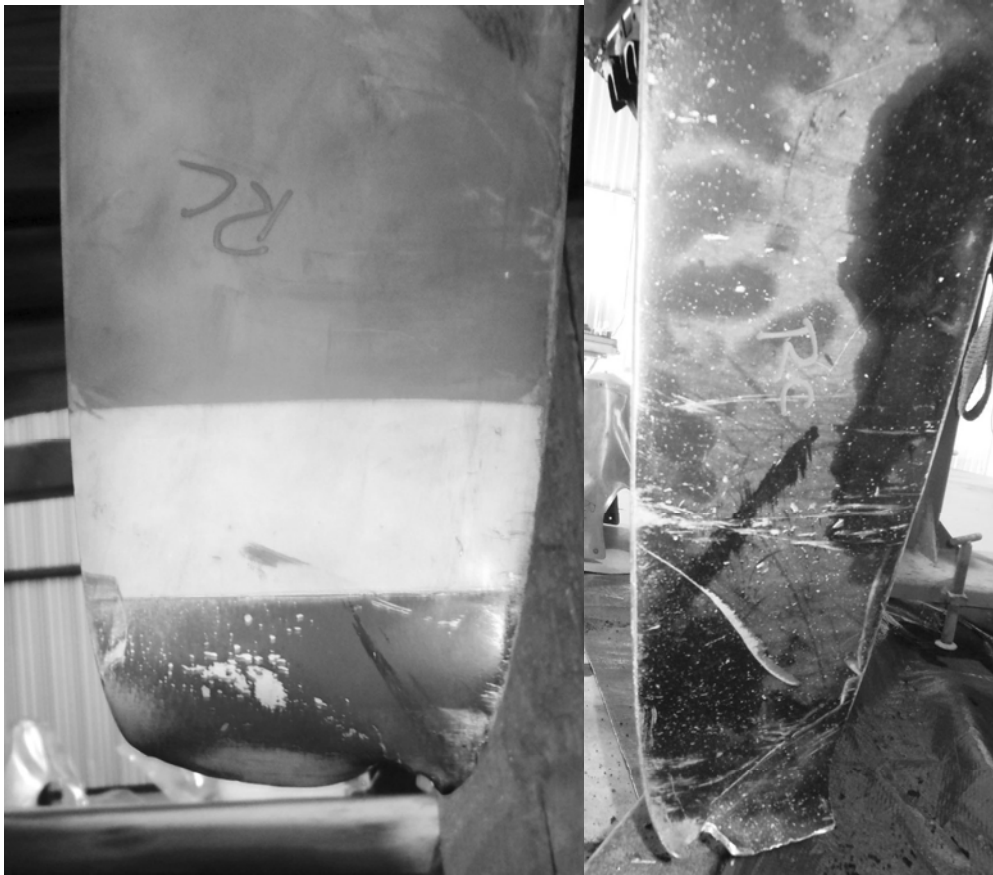
Photo #11 – Blade RC camber and face side near tip

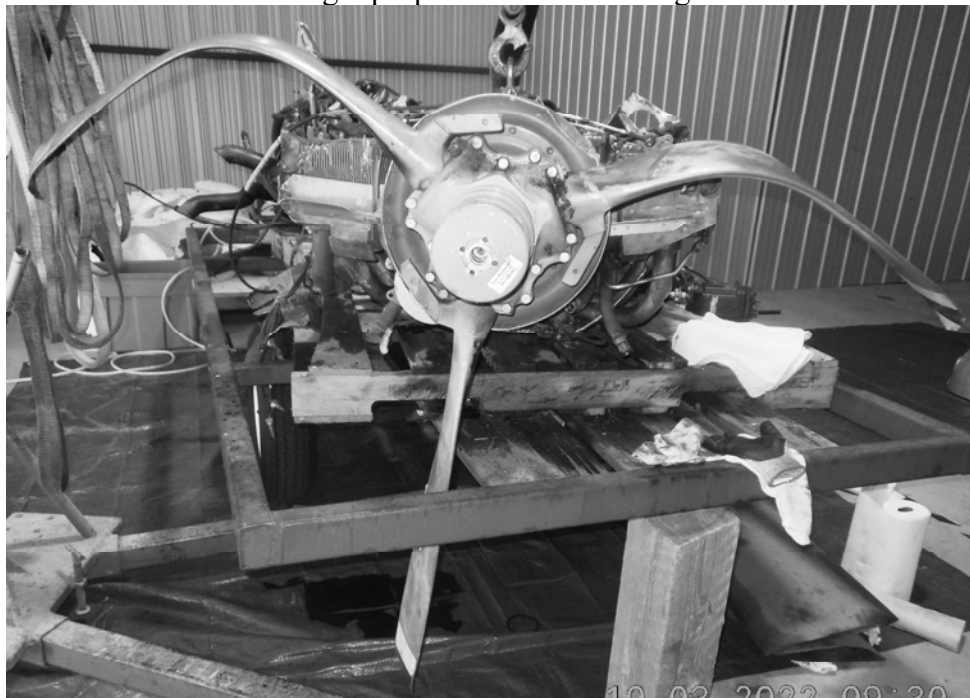
An attempt was made to remove the start lock sleeve and feather stop washer. Although the cap screw unthreaded from the pitch change rod, it could not be removed from the assembly and the propeller would not feather from spring force alone. Rubber mallet strikes on the counterweights were required to move the propeller toward feather. Blades RA and RC moved simultaneously toward feather and RB did not move (Photo #12). The inability to remove the start lock sleeve and the sluggish movement toward feather suggested a bent pitch change rod. Because the governor was not removed from the engine no attempt was made to actuate the propeller with air pressure.

Photo #12 - Right propeller after feathering RA and RC

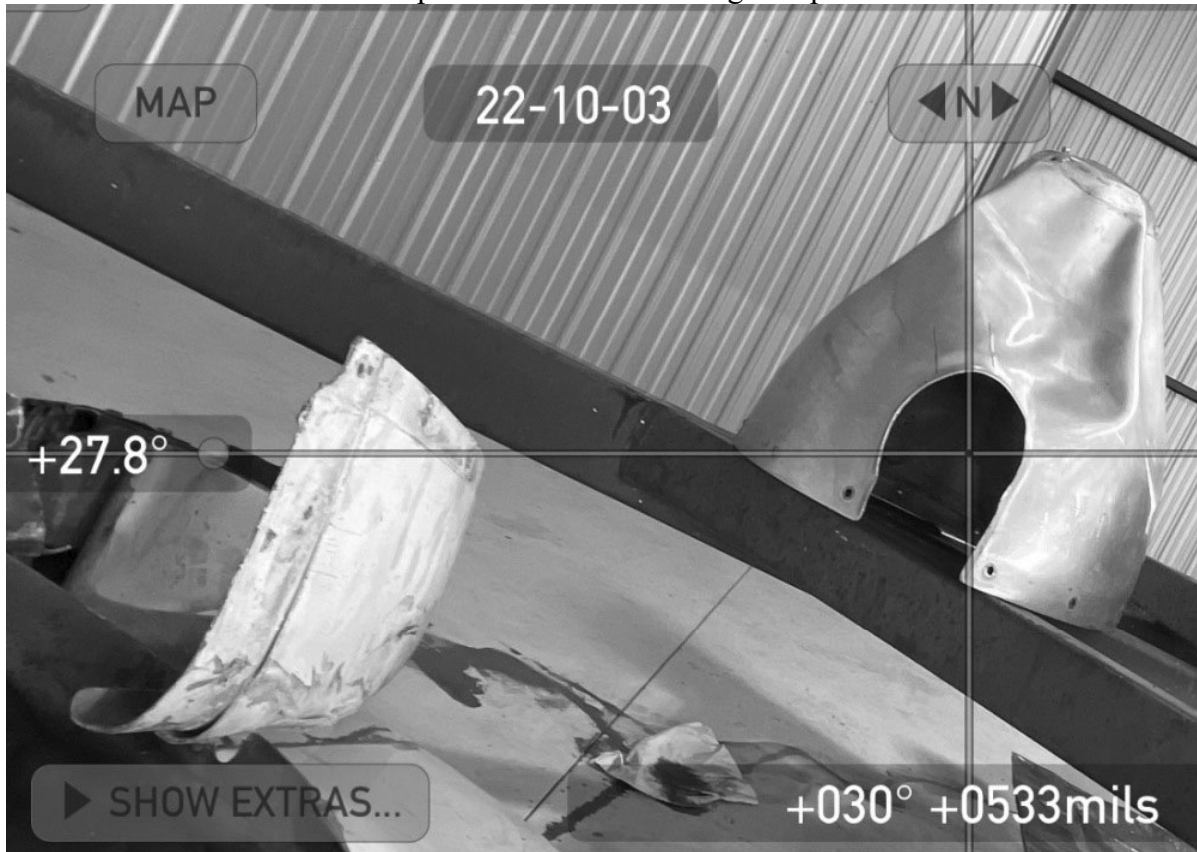
The spinner dome had counterweight impression marks at approximately 28° and 44° (Photos #13 and #14) which are equivalent to blade angles of 15° and 31°. Per Installation Data Sheet No. 875, the mechanical low pitch stop should be set to 14°

Photo #13 - Left spinner dome counterweight impression at ~28°

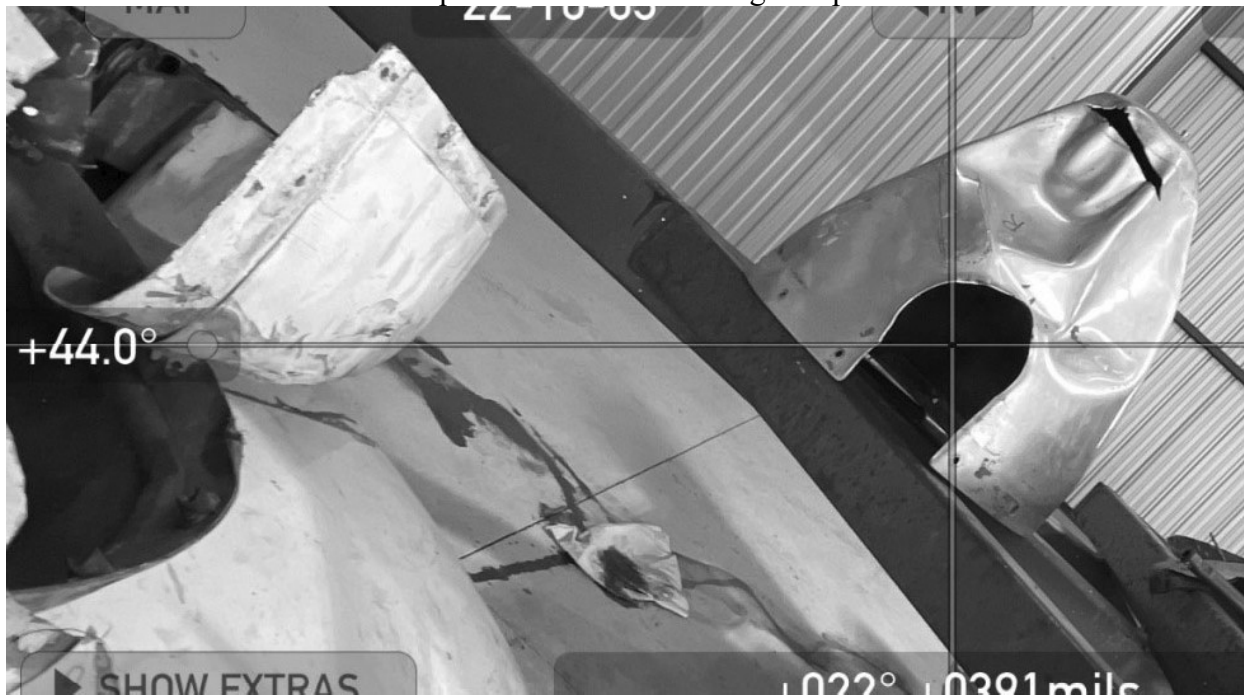
Photo #14 - Left spinner dome counterweight impression at ~44°
