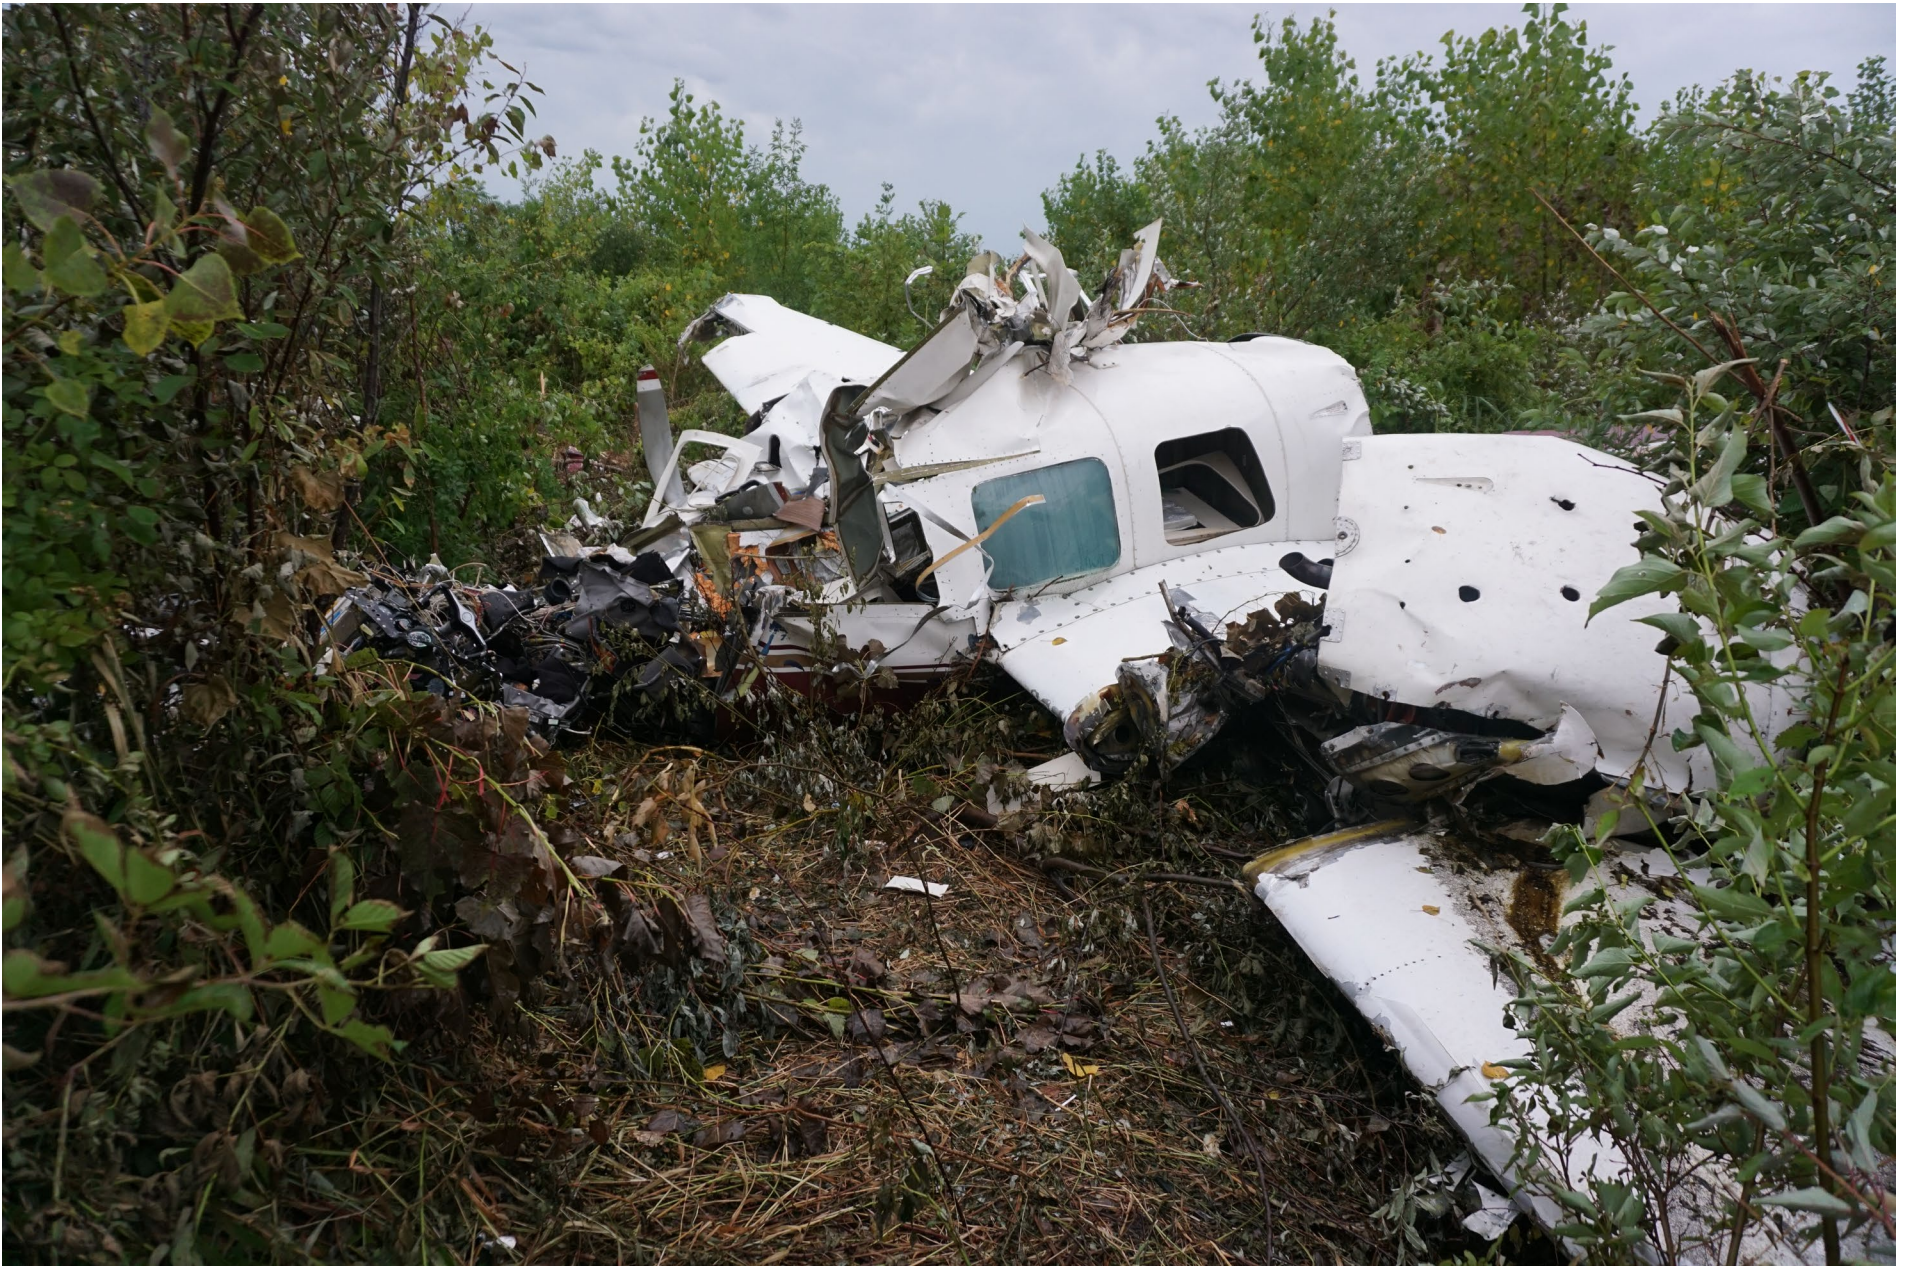
**Photo 1 – View of left side of airplane wreckage at site**

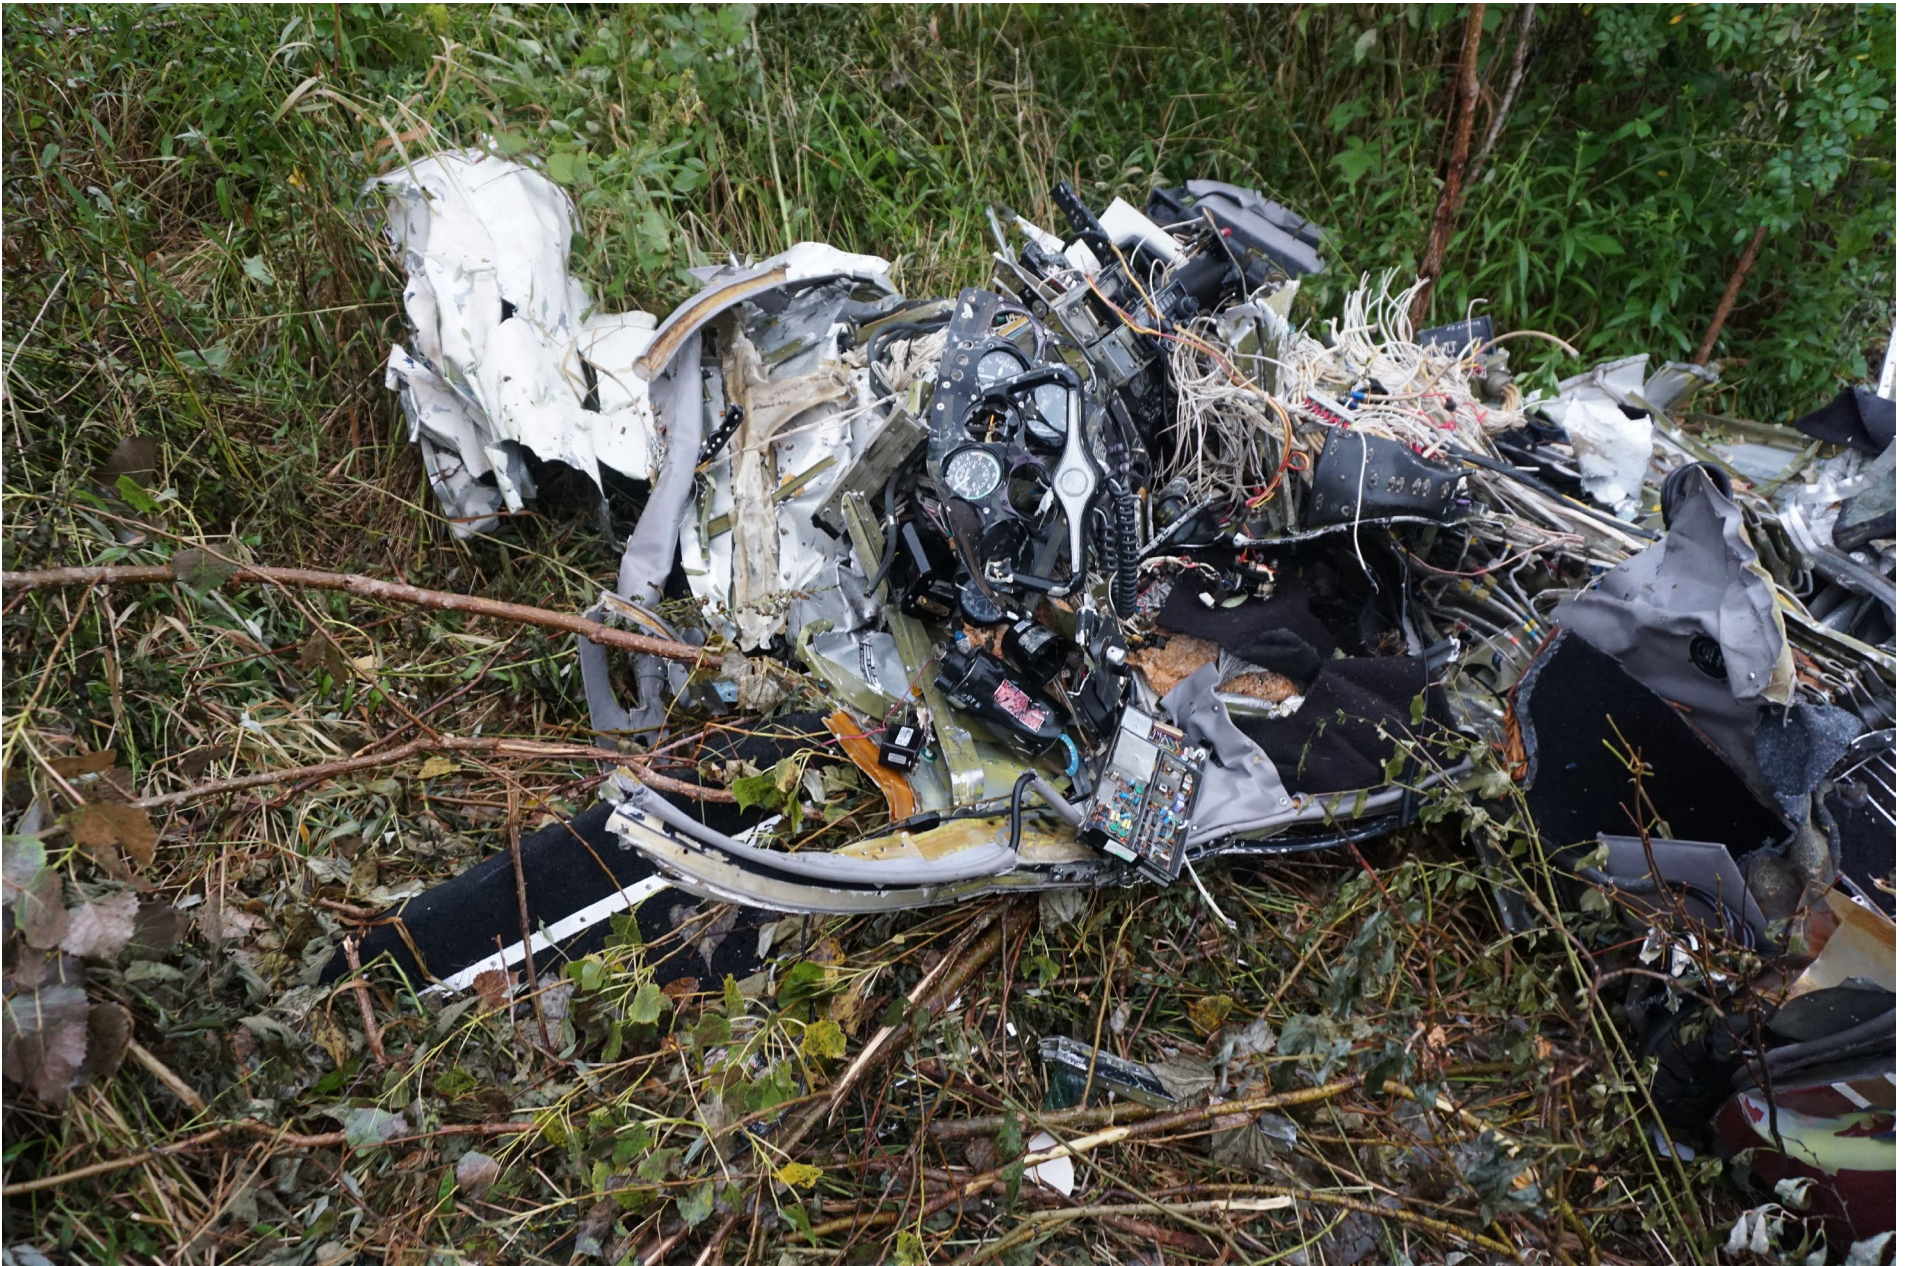
**Photo 2 -View of instrument panel**

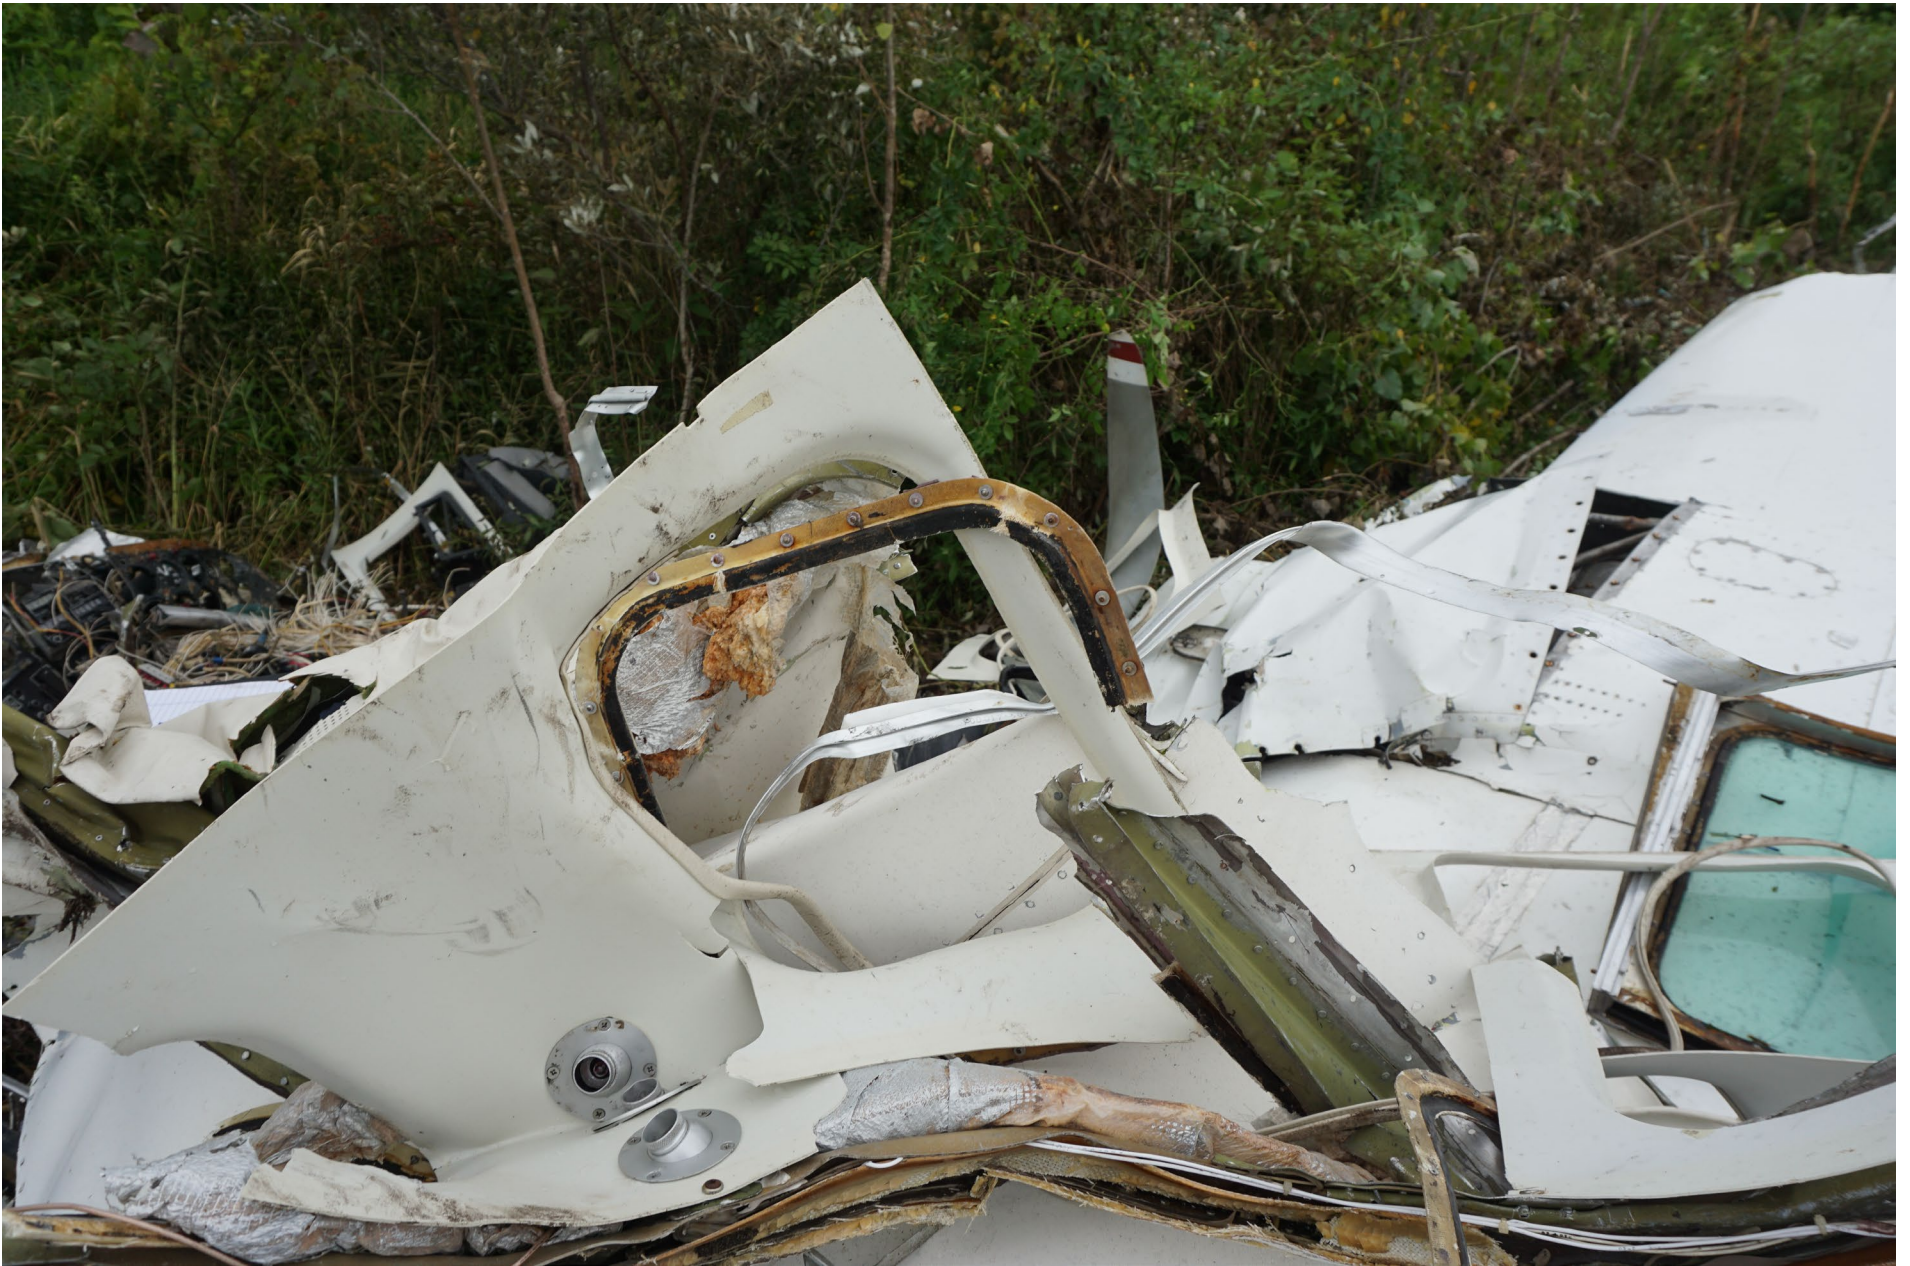
**Photo 3 – View of cabin section of airplane**

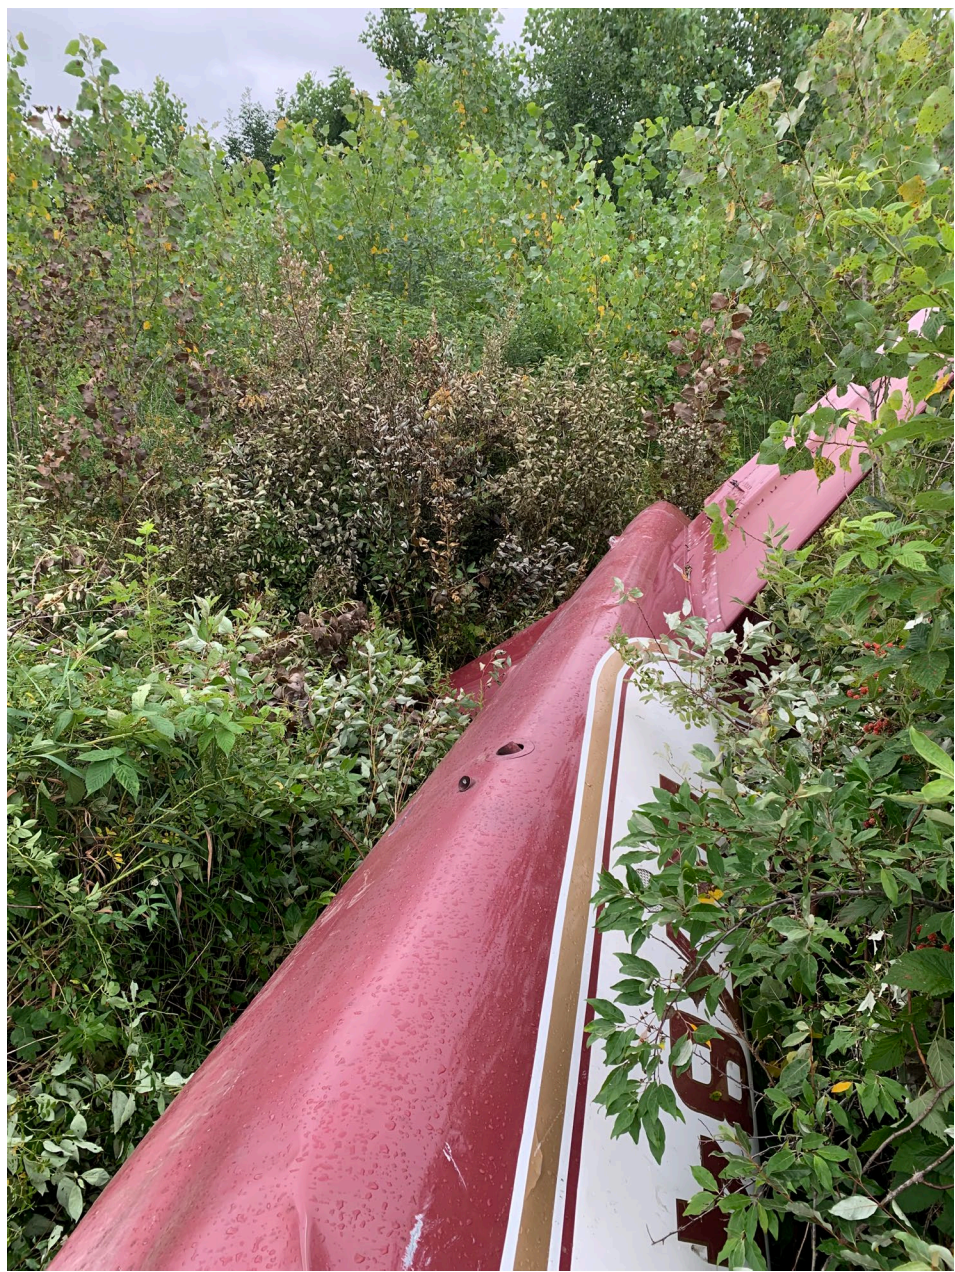
**Photo 4 – View of empennage section in foliage with browning leaves.**

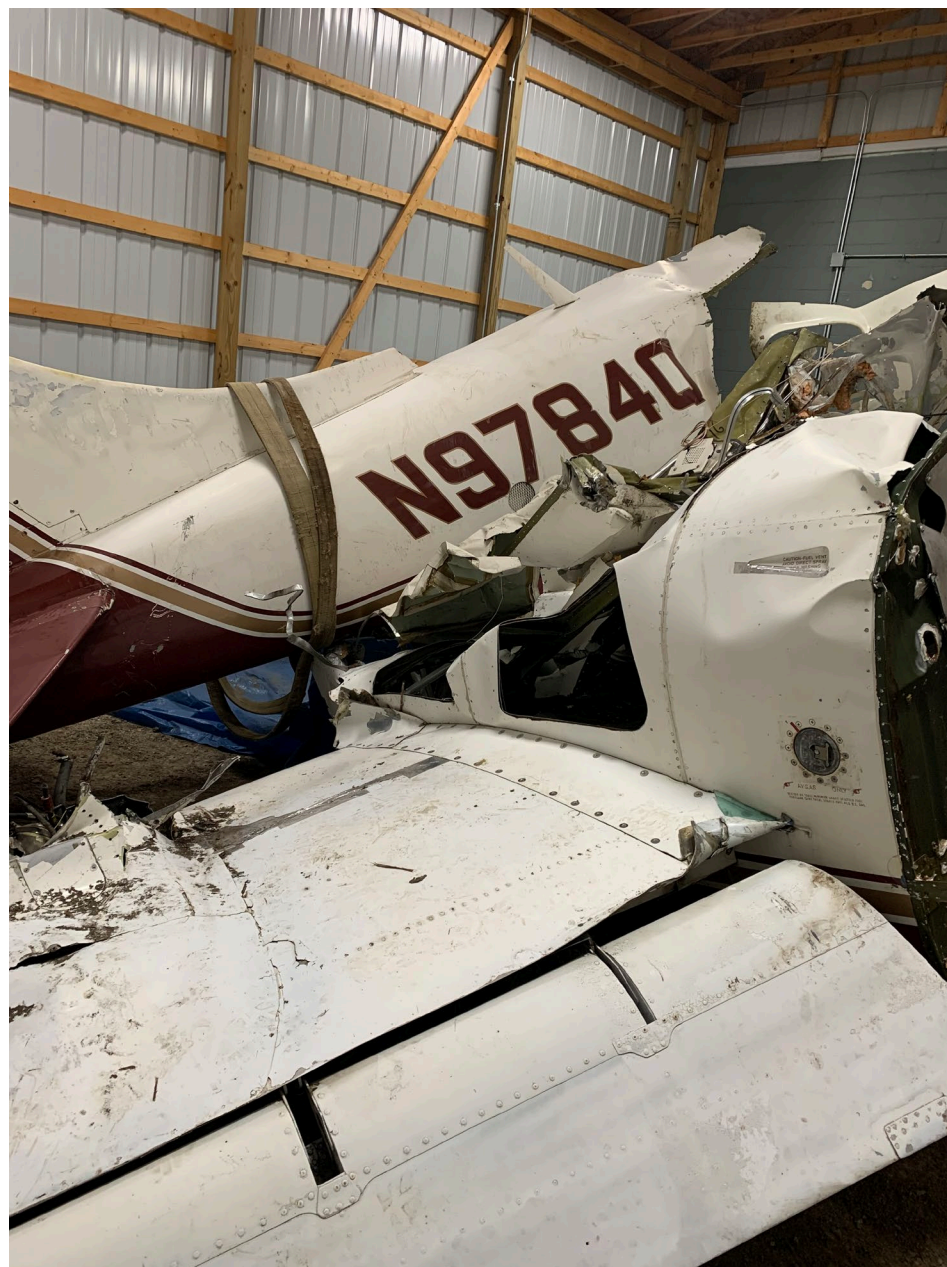
**Photo 5 – View of recovered airplane.**

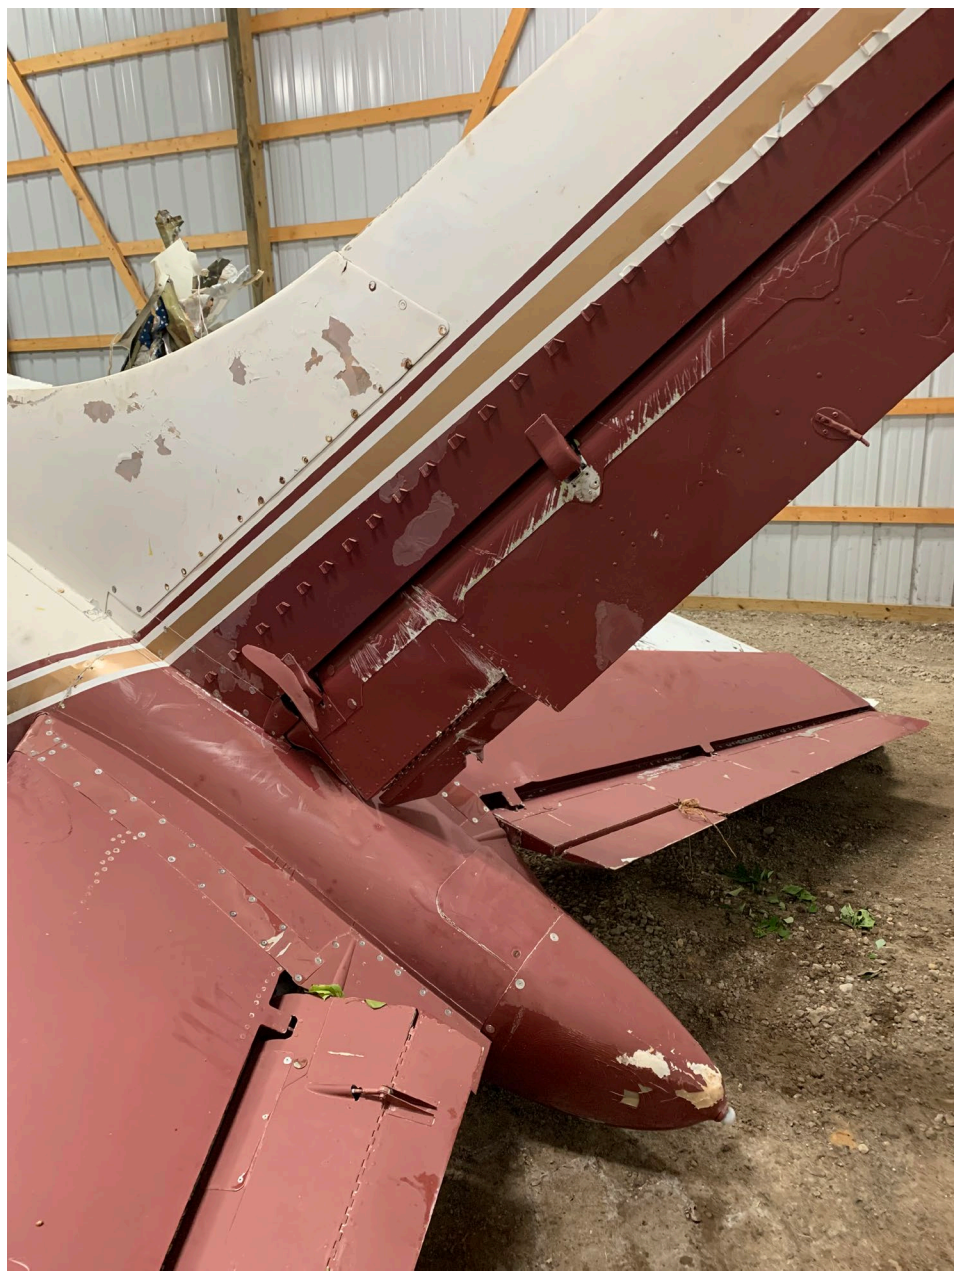
**Photo 6 – View of vertical and horizontal stabilizer**

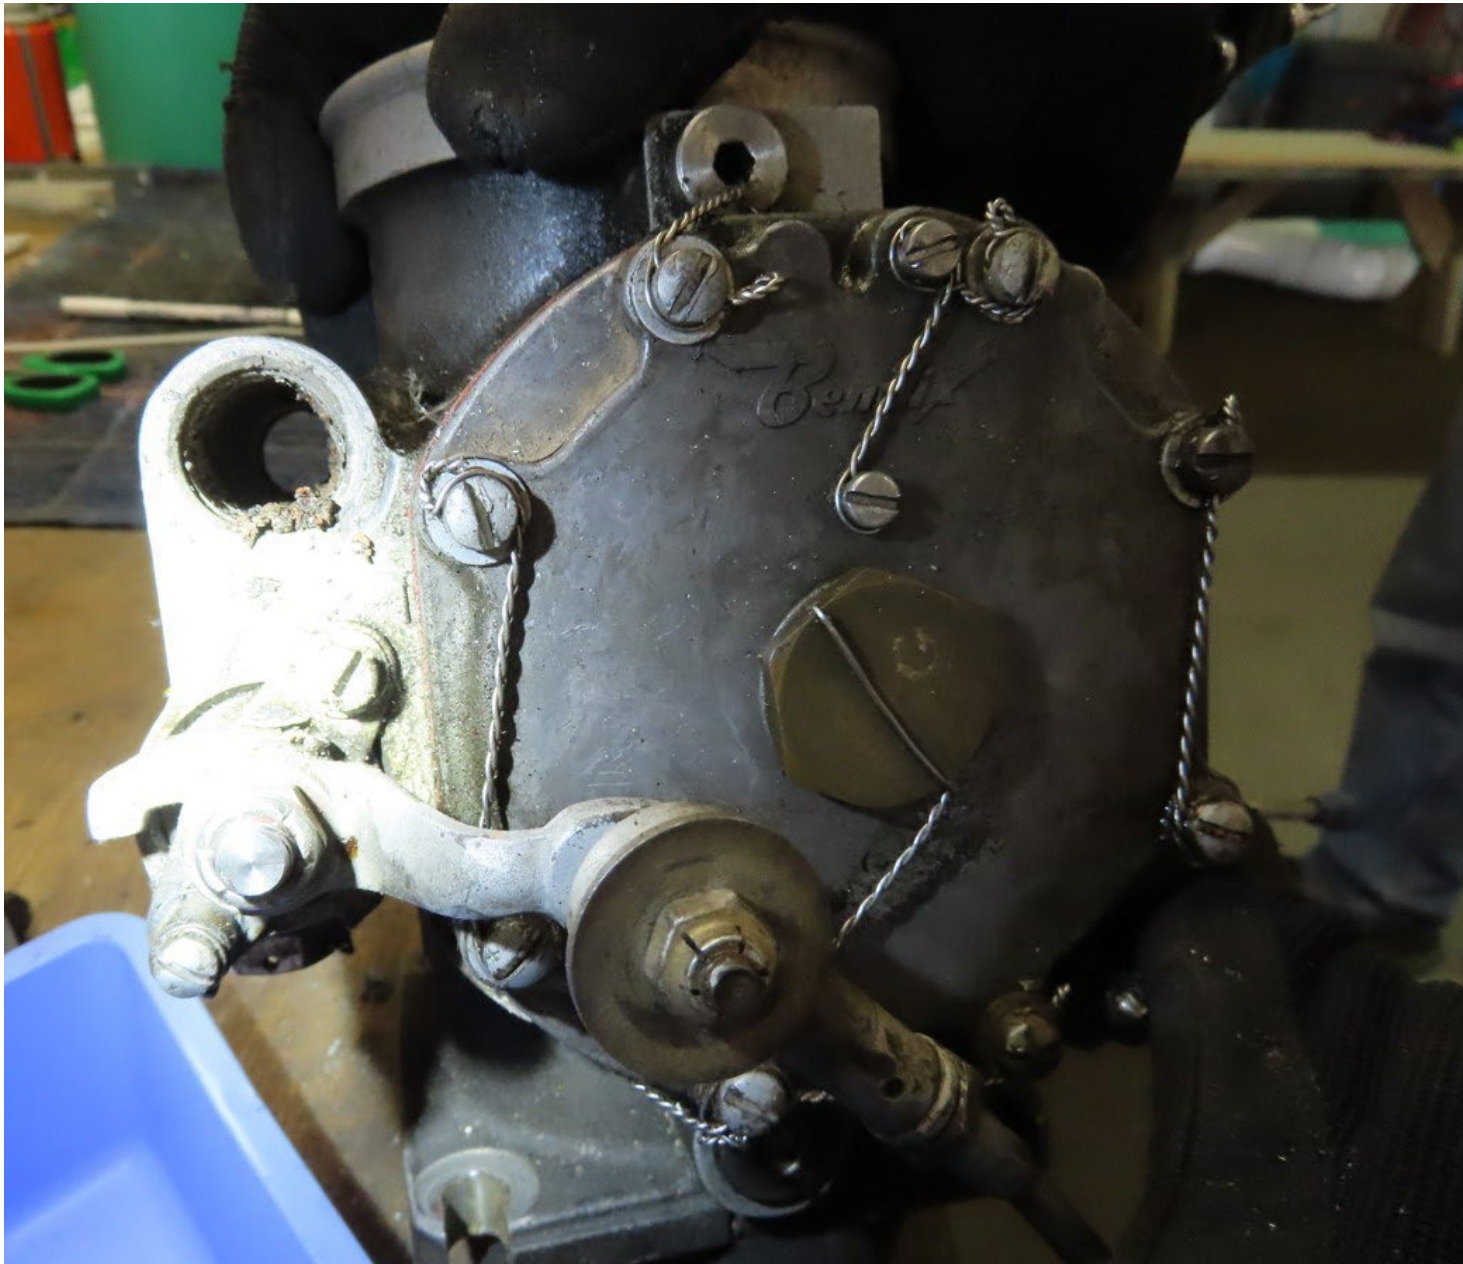
**Photo 7 – View of the inlet side of the left fuel servo.**

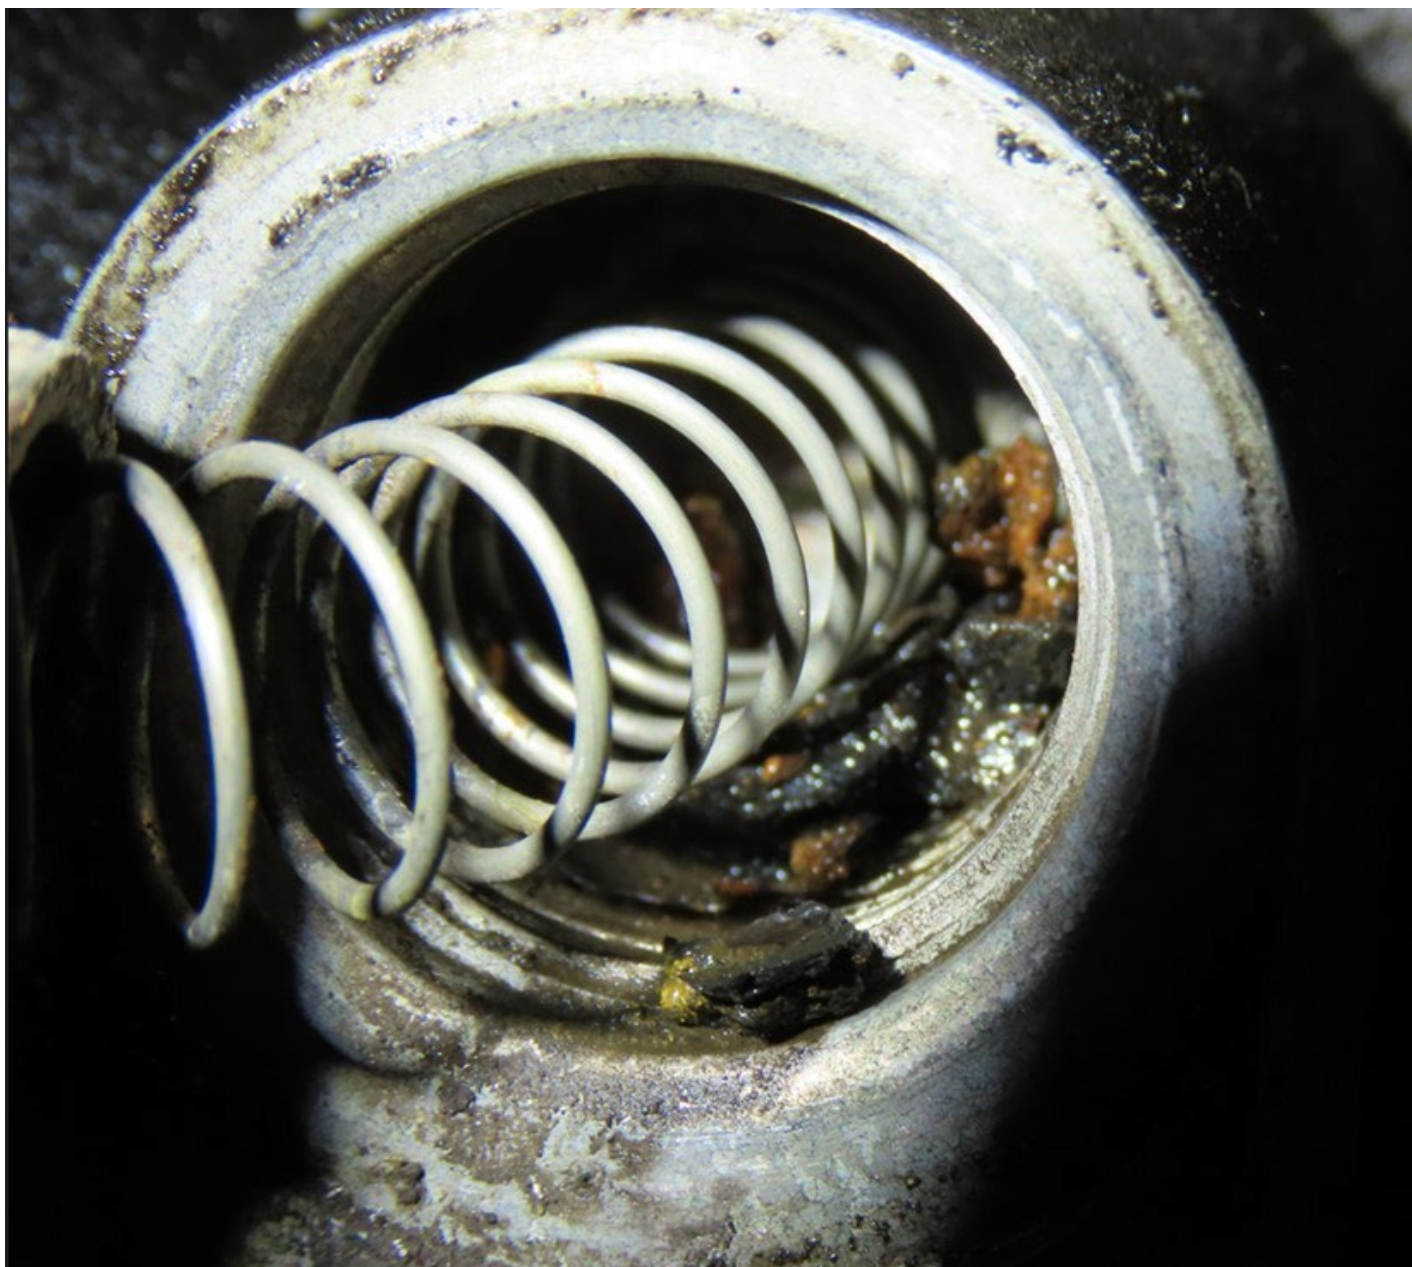
**Photo 8 – Opposite end of left fuel servo screen passageway.**

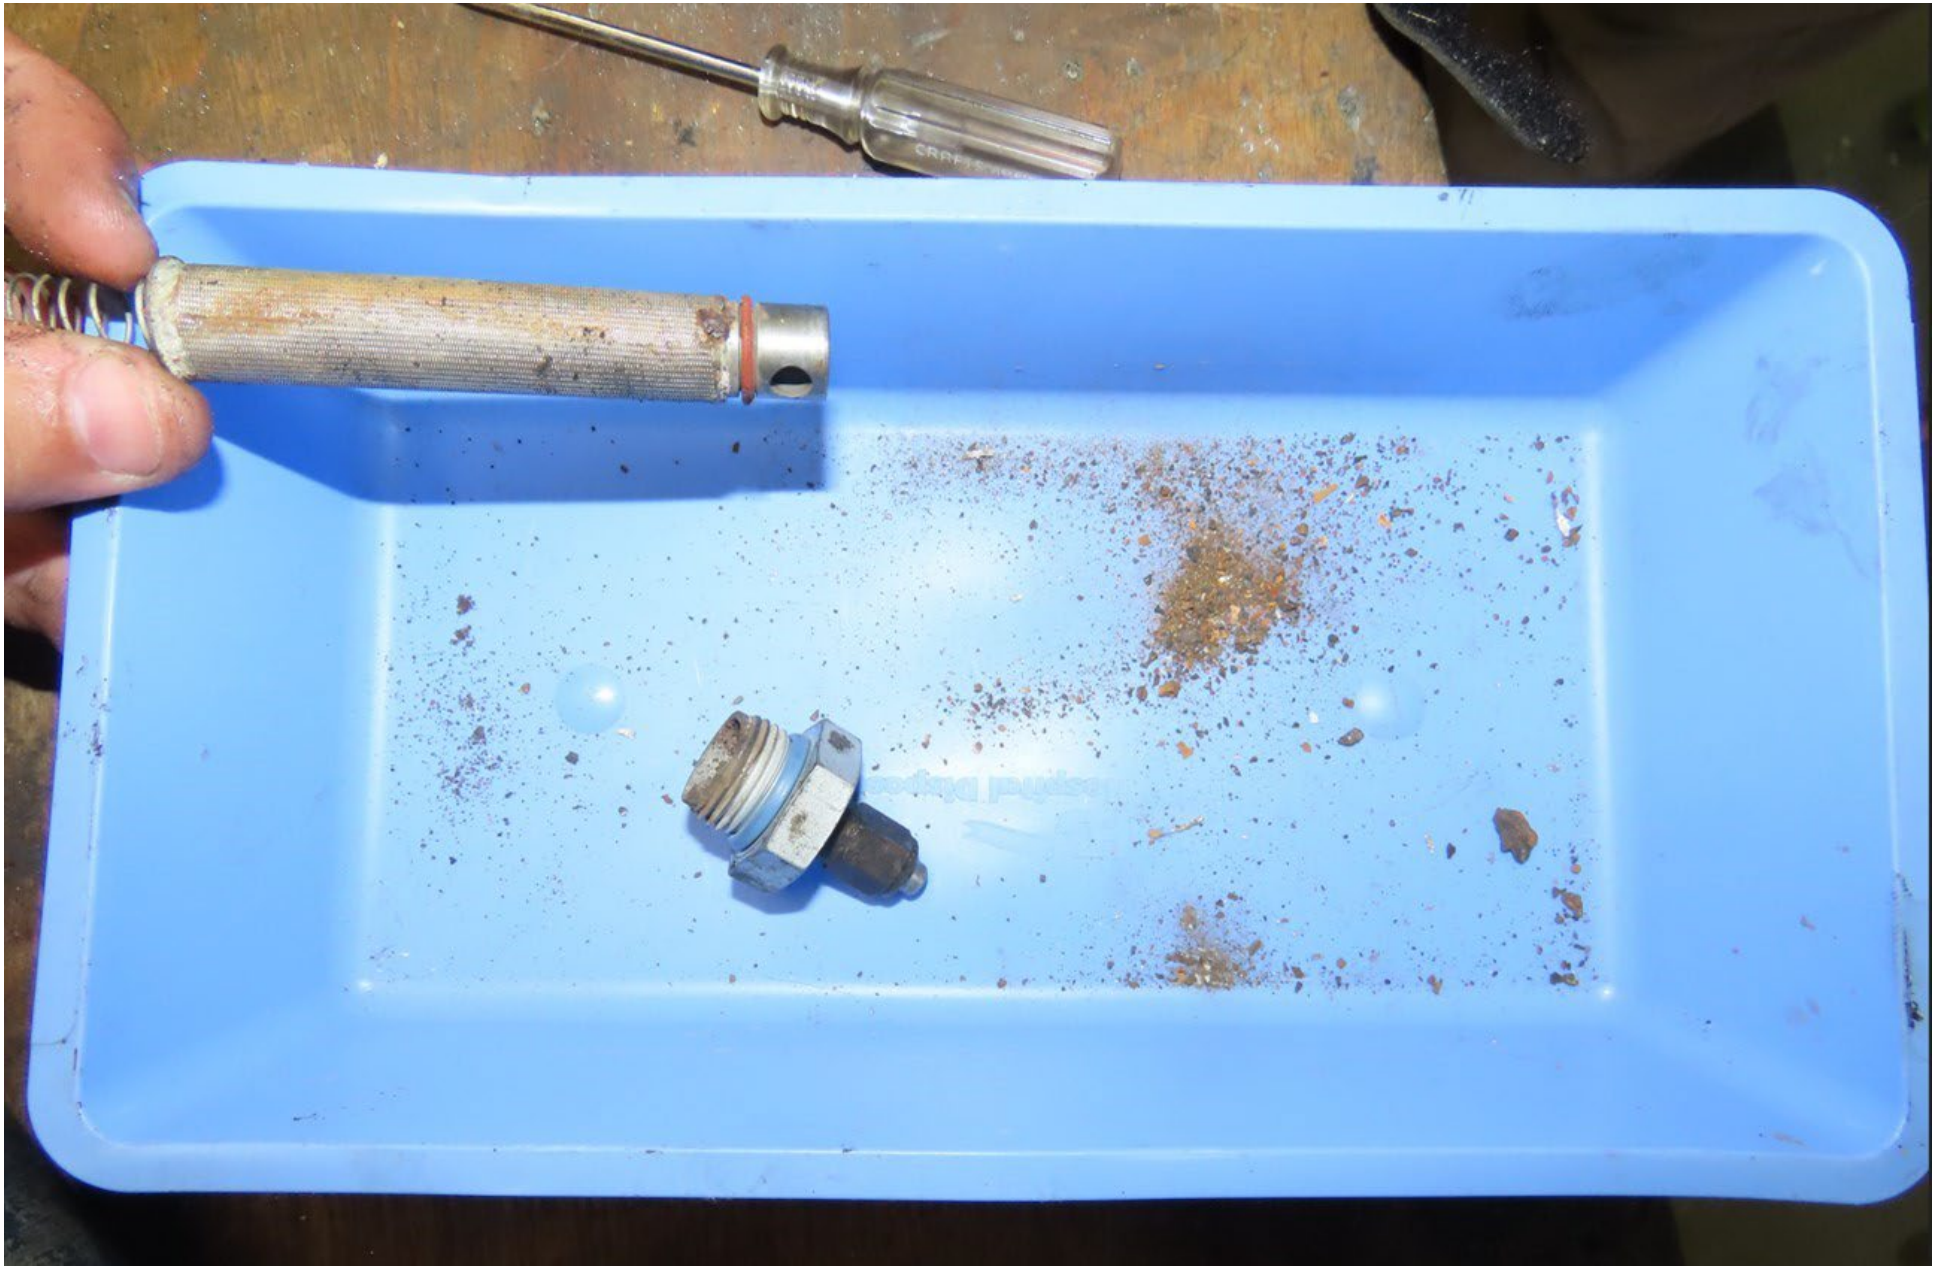
**Photo 9 – View of the fuel servo screen showing contamination.**
