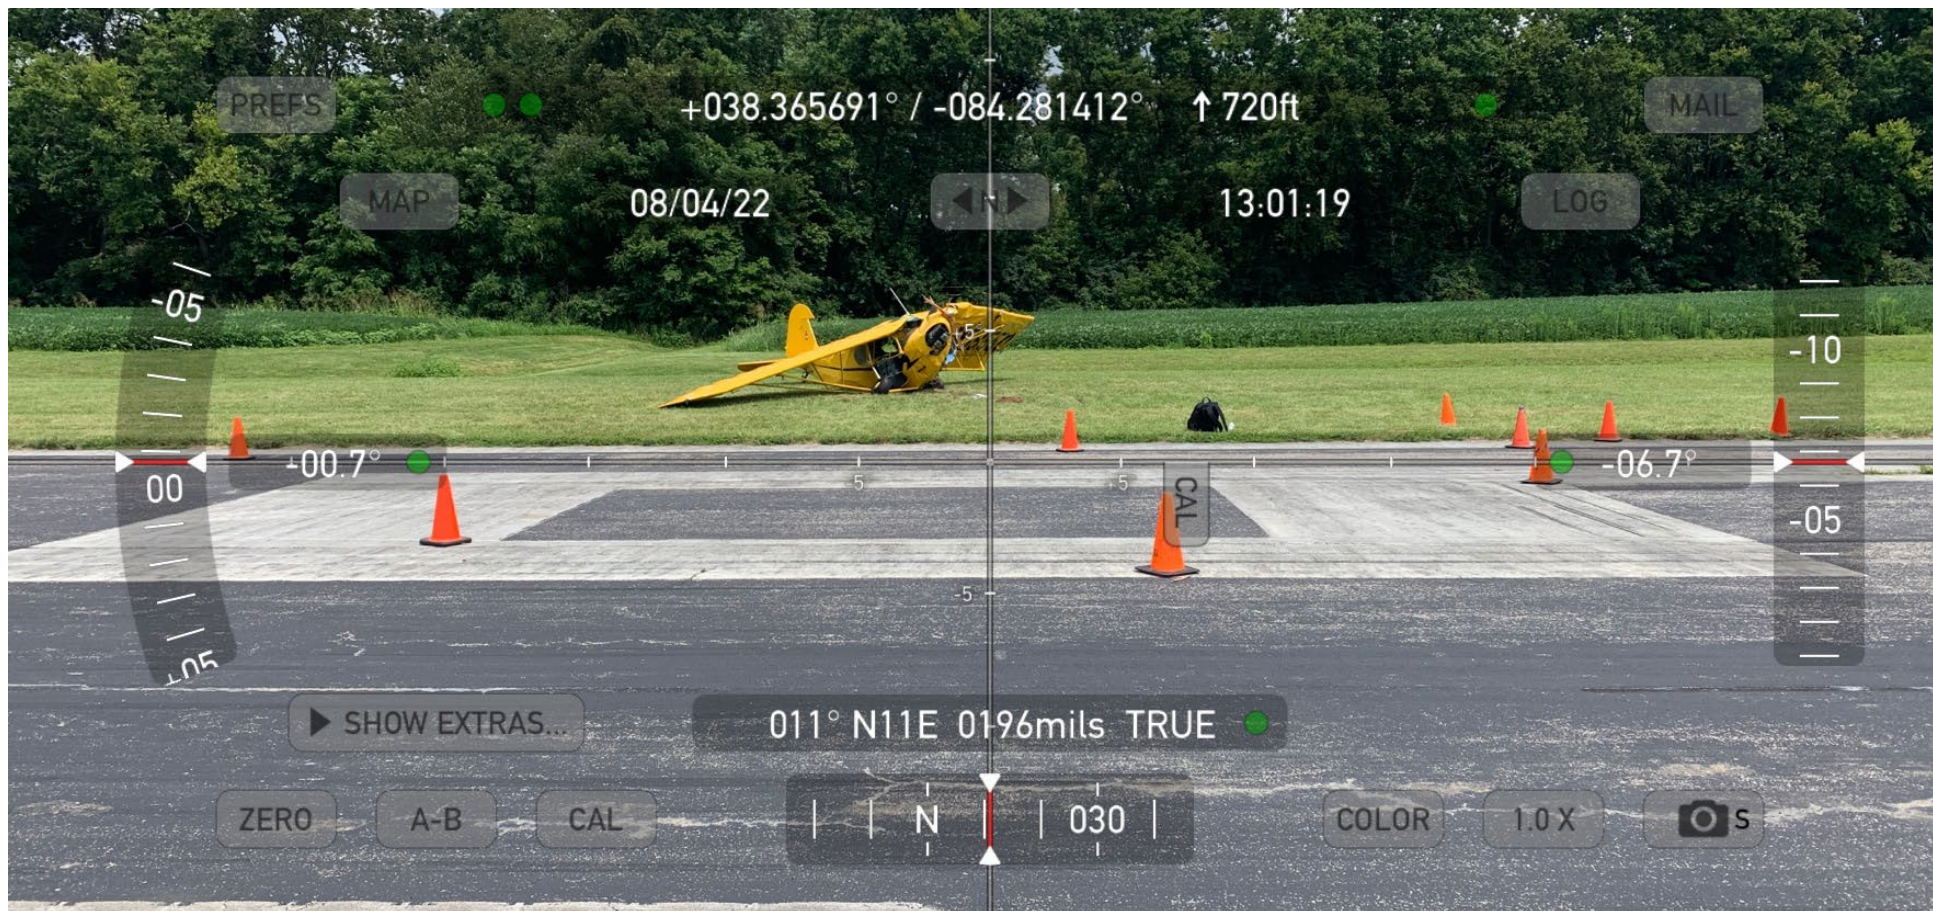
**Photo 1 – Accident site overview. Orange cones mark location of propellor wood**

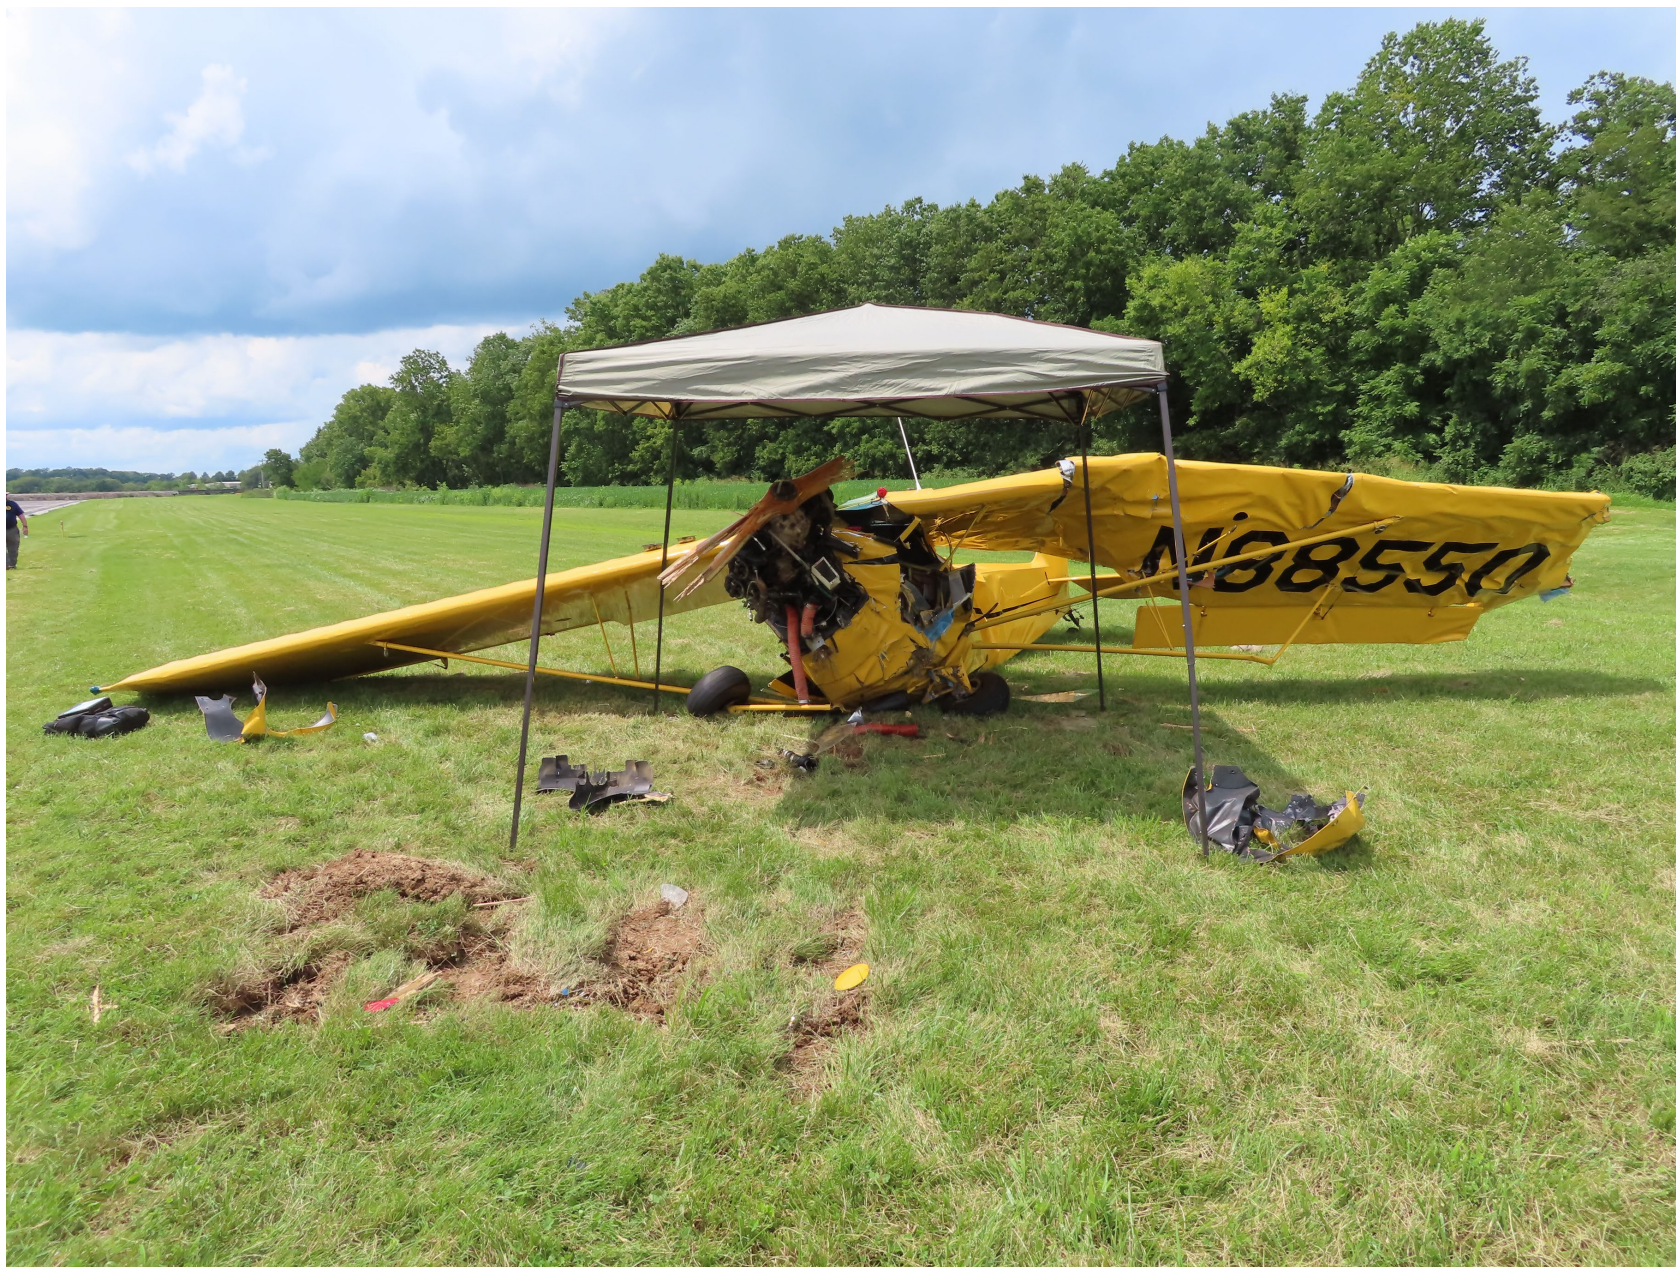
**Photo 2 – Front view of aircraft. Note ground scarring**

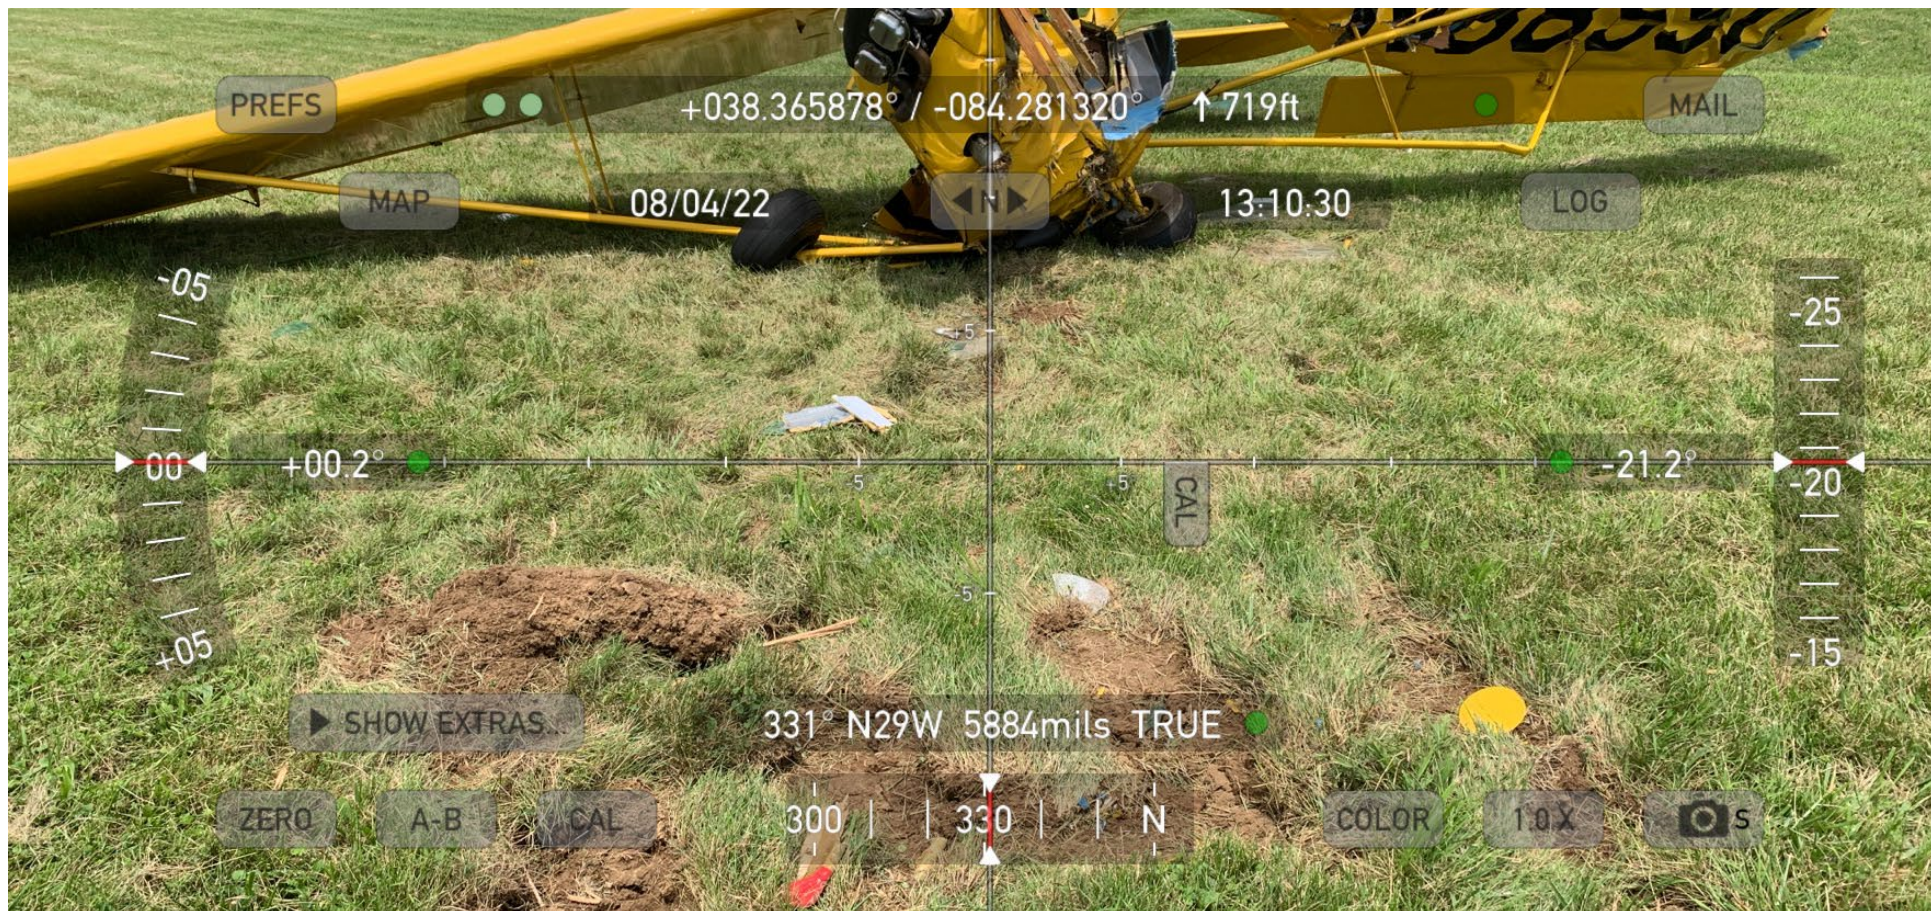
**Photo 3 – Closeup of ground scarring**

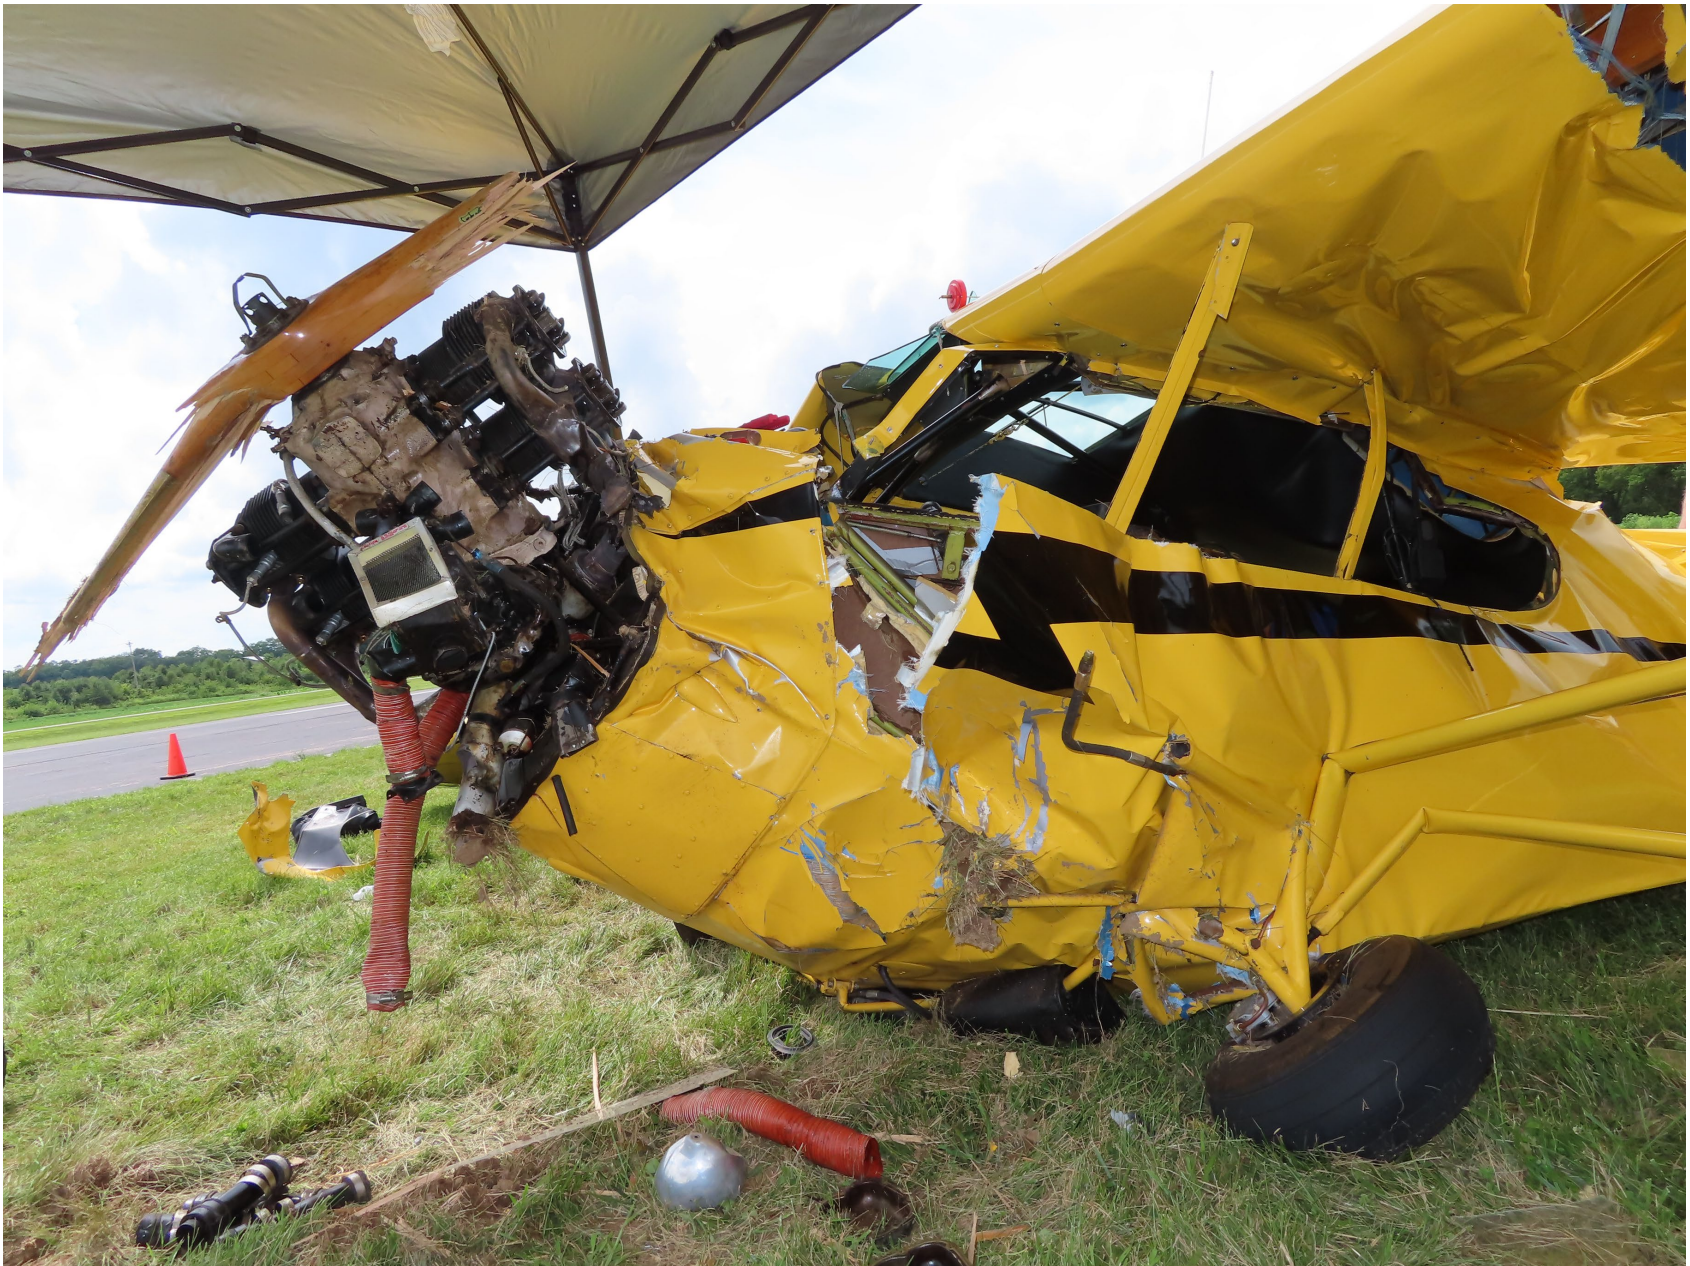
**Photo 4 – Front left side of aircraft**

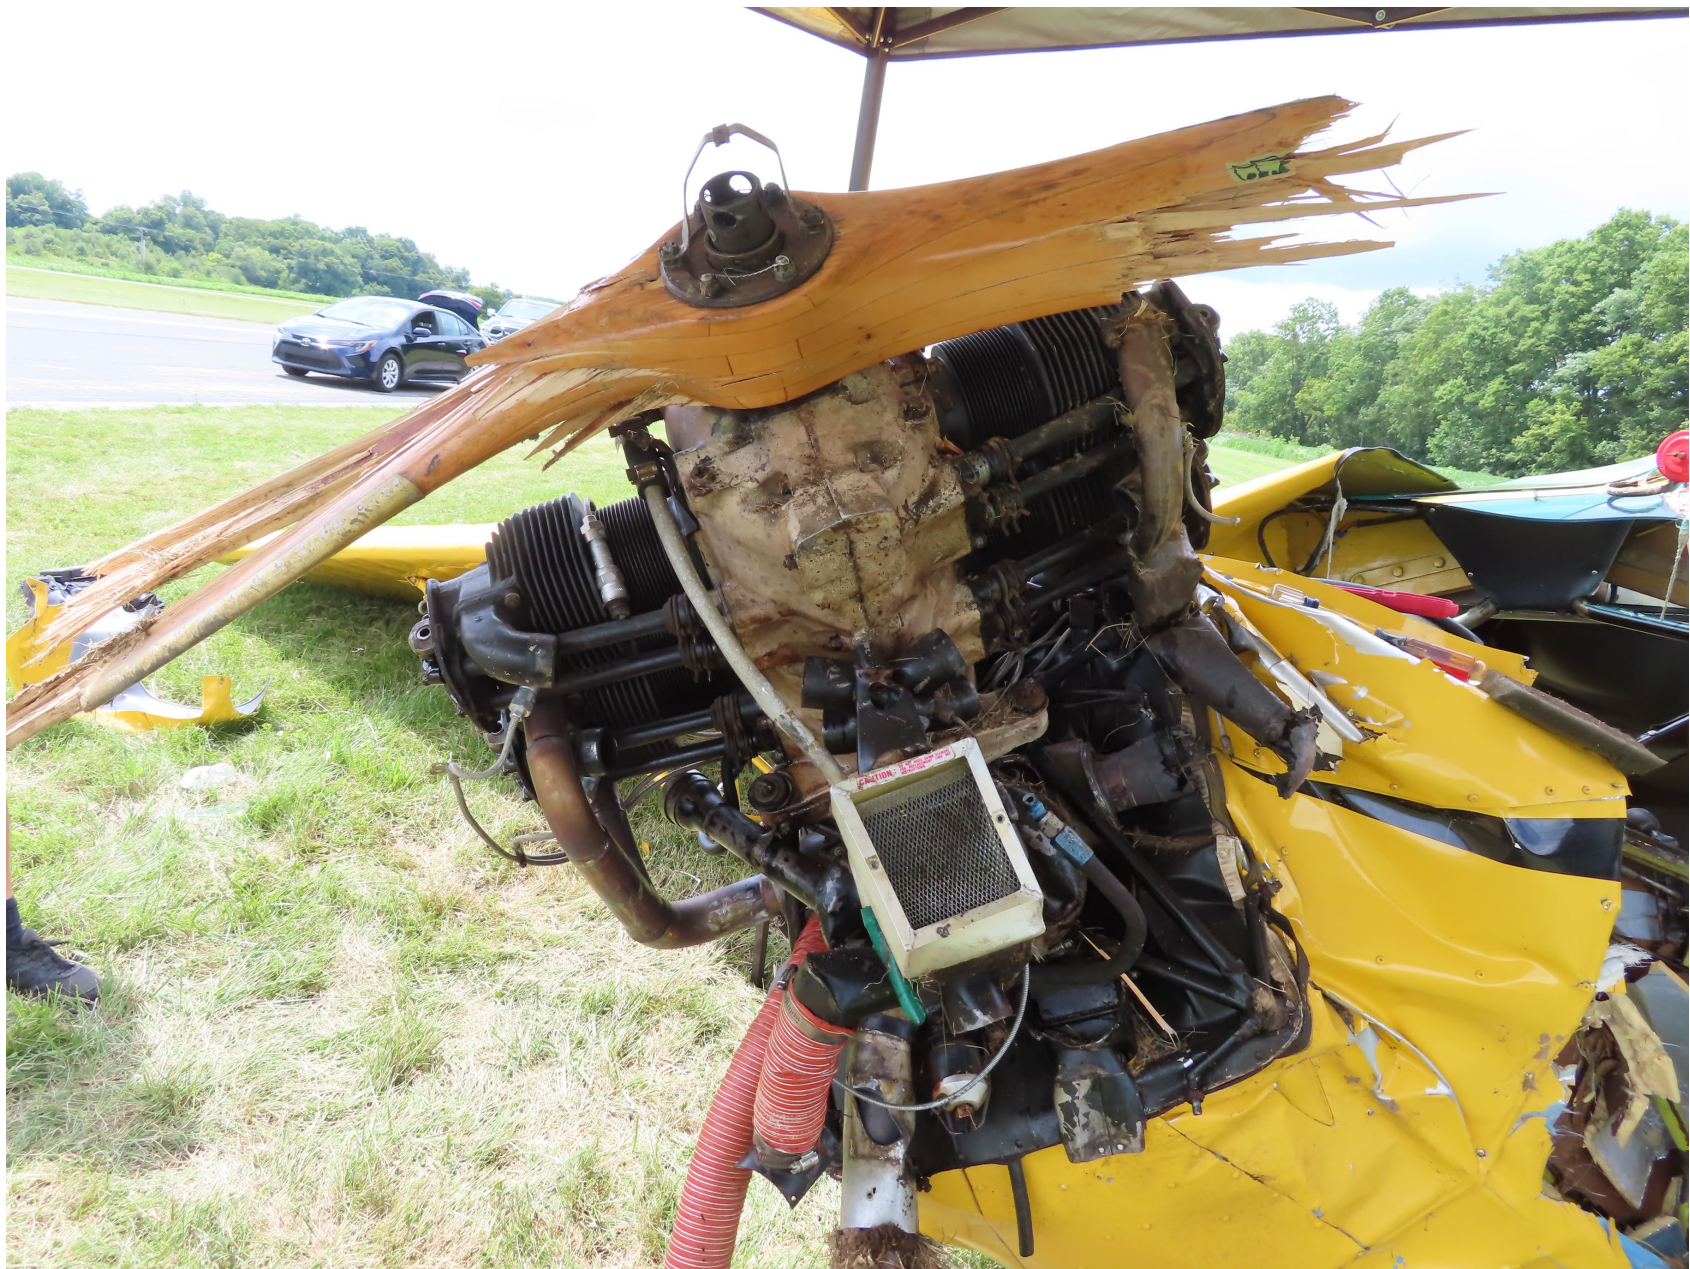
**Photo 5 – Closeup of engine. Note shattered propellor and dirt on engine**

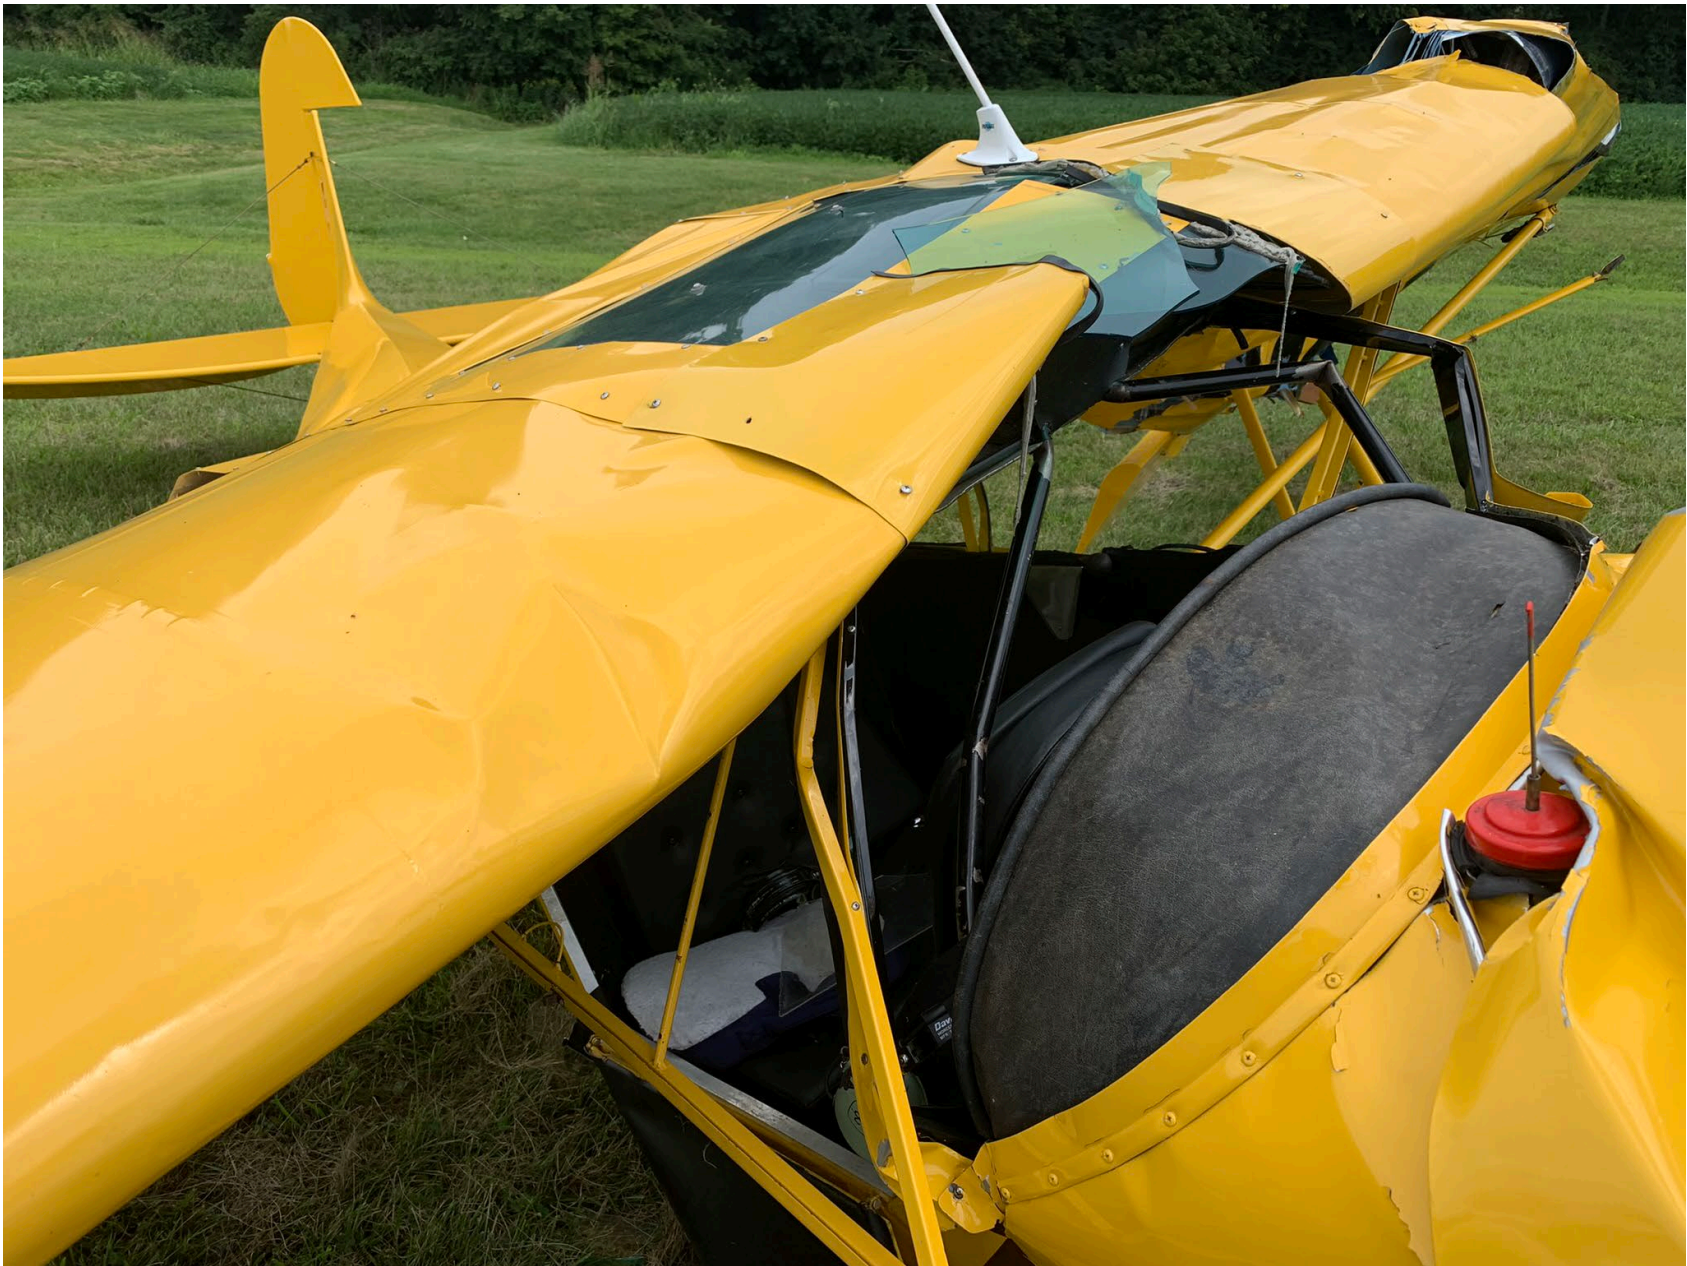
**Photo 6 – Closeup of aircraft cockpit from right side**

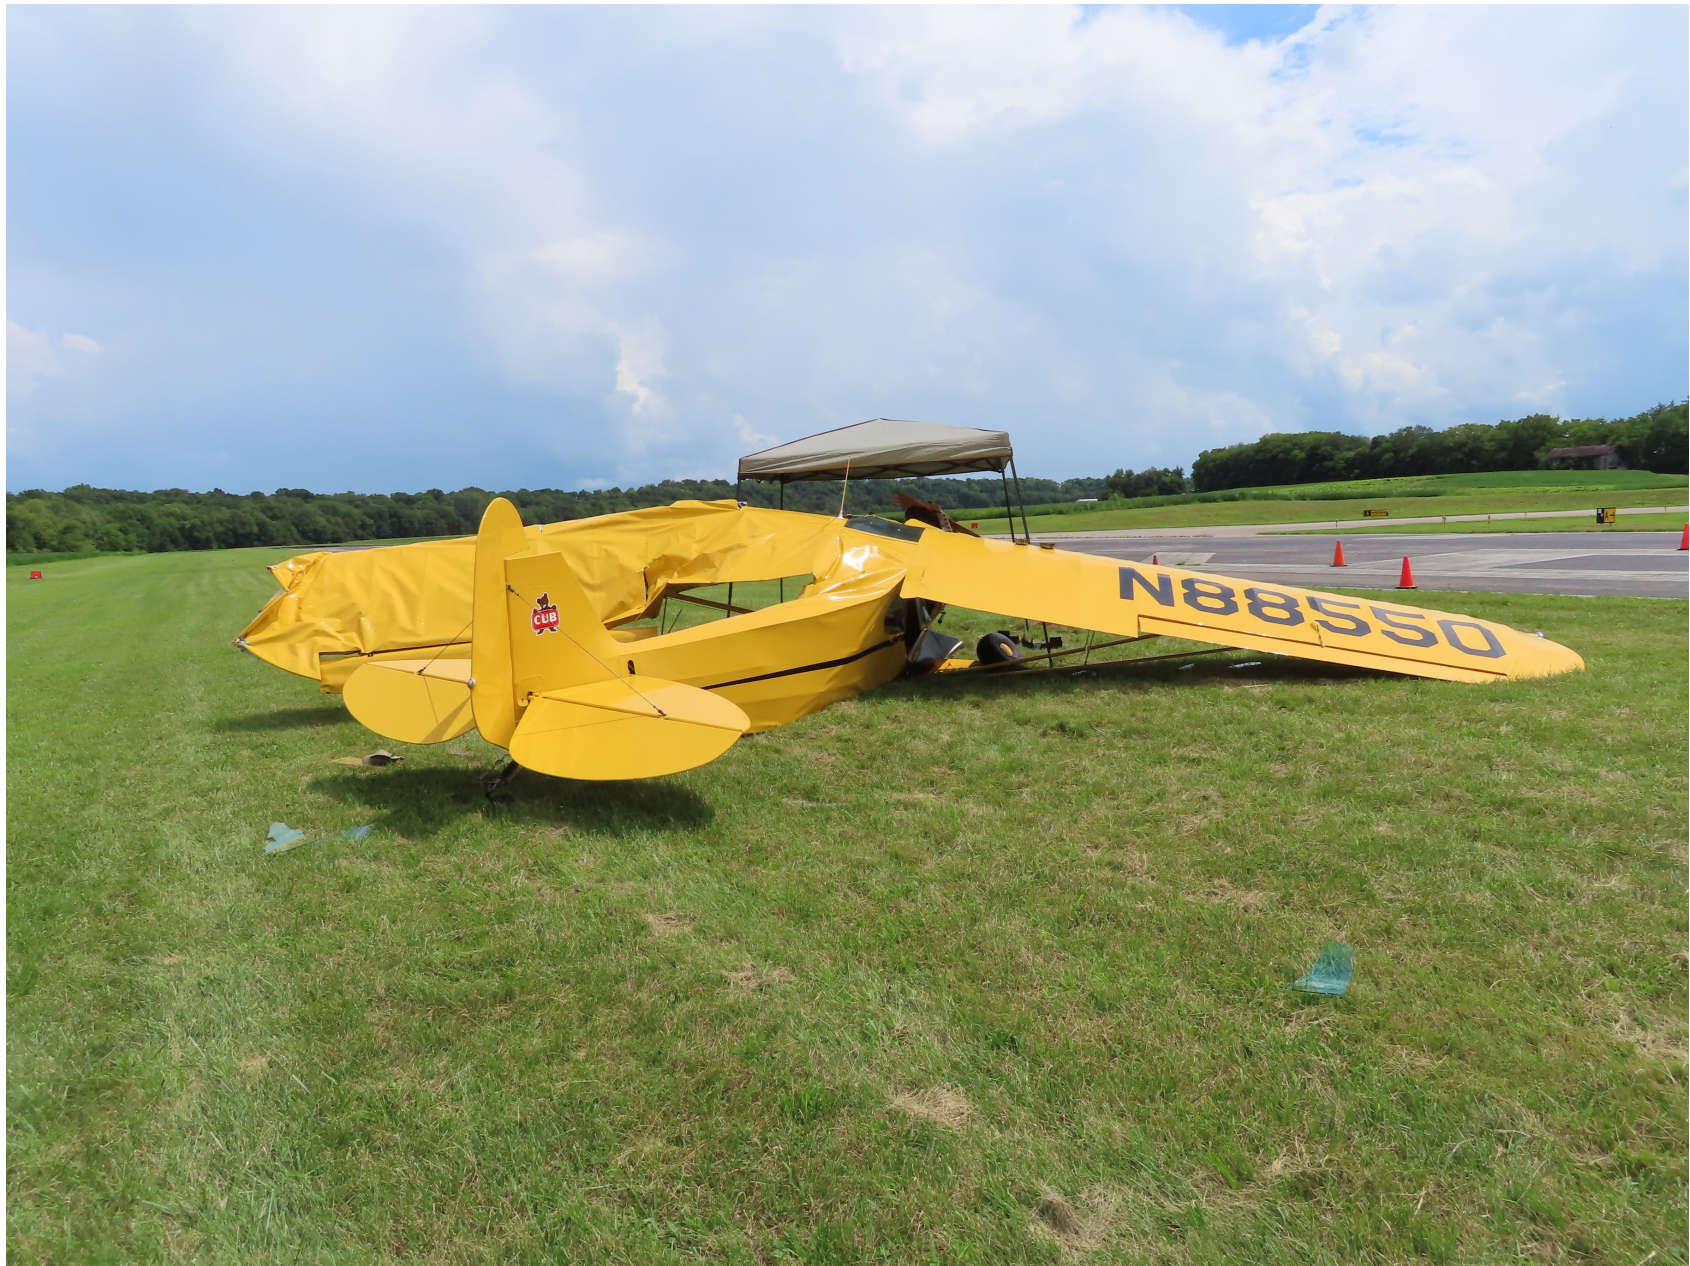
**Photo 7 – Rear view of aircraft. Note damage to left wing**
