**Cynthiana, KY  
Cynthiana-Harrison County Airport  
August 3, 2022  
Piper Cub, J3C-65  
NTSB Accident# ERA22FA354**

**FAA**

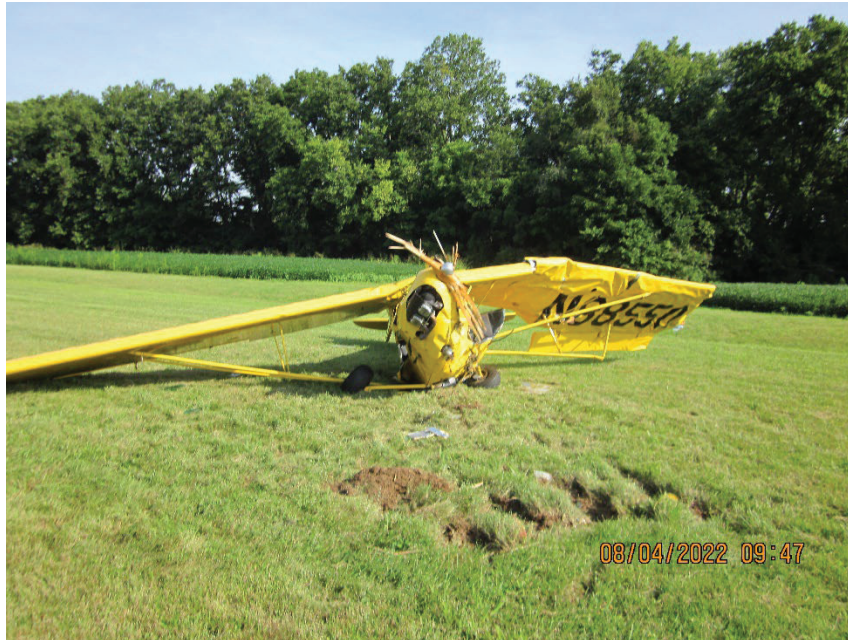
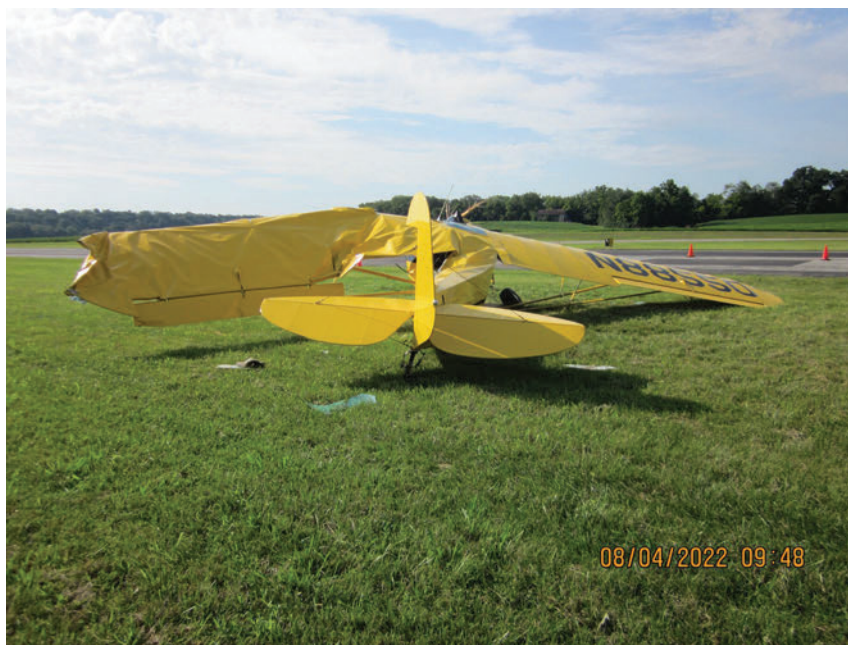
The aircraft came to rest in the grass, about 20 feet to the right of runway 29, with the front of the aircraft pointed at a compass heading of 160 degrees. The wreckage path was compact and all major components of the engine and airframe were accounted for at the scene. There was substantial damage to the left wing, fuselage, cockpit, main landing gear, engine, and propeller.

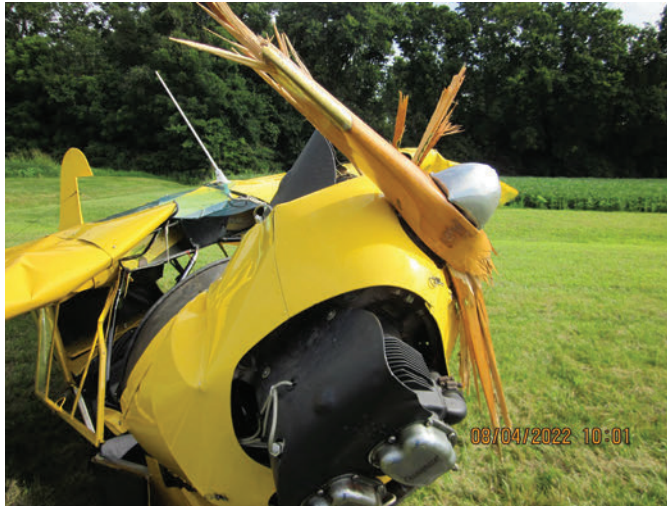
The propeller was destroyed. Both wood blades were splintered, although remained attached to the center hub and crankshaft flange. One blade was shattered down to the spinner and the opposing blade shattered outboard of the erosion strip. There were multiple propeller fragments within a 50-foot radius of the wreckage.

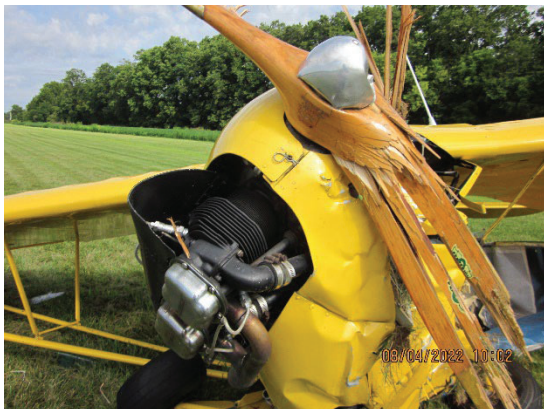
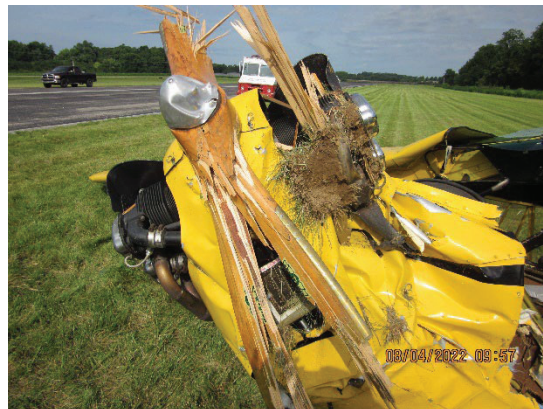
The engine received substantial damage. The entire engine assembly was pushed upwards and twisted to the right. The left bottom side of engine was covered in dirt and wood splinters from the propeller. The engine crankshaft was rotated 720 degrees with no binding noted. Valve train continuity was confirmed and there was thumb compression and suction for all four cylinders. Magnetos were removed and spark confirmed at each post.

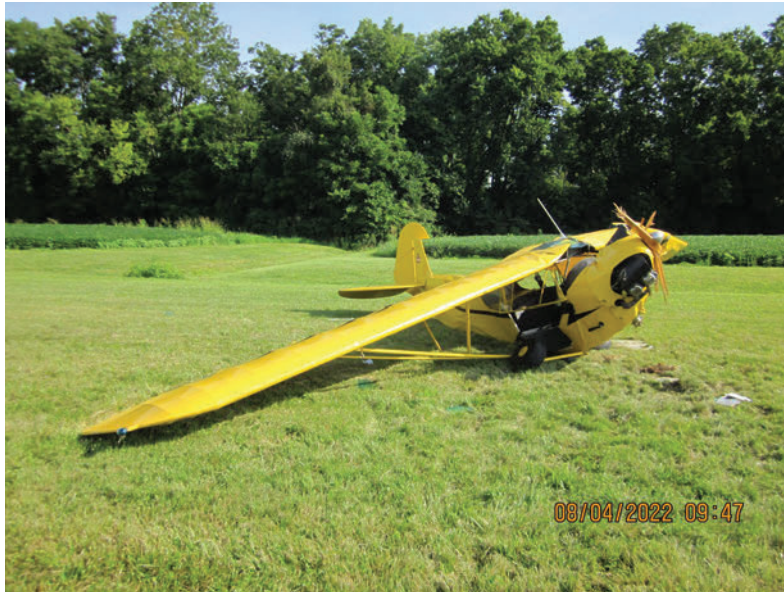
There was minimal damage to the right wing. Right aileron control continuity was confirmed through its respective control cable to the cockpit.

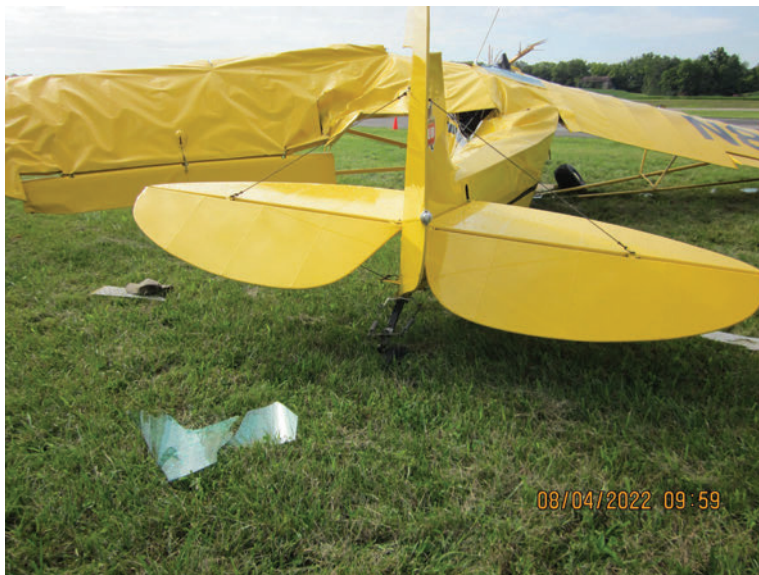
No damage. Control continuity for the elevator, rudder, and trim were confirmed through their respective control cables into the cockpit.

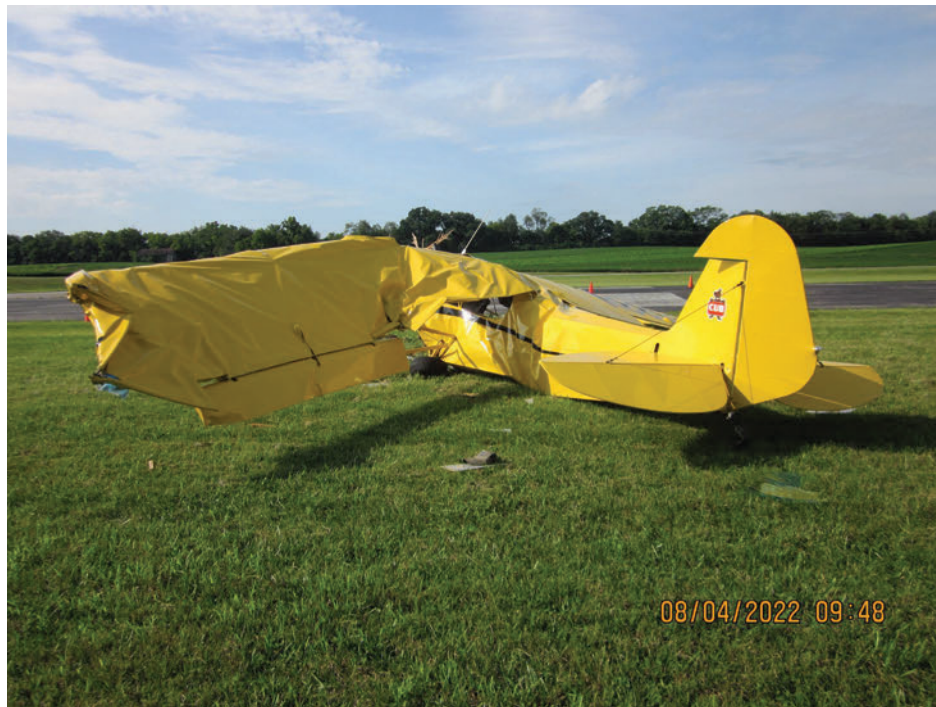
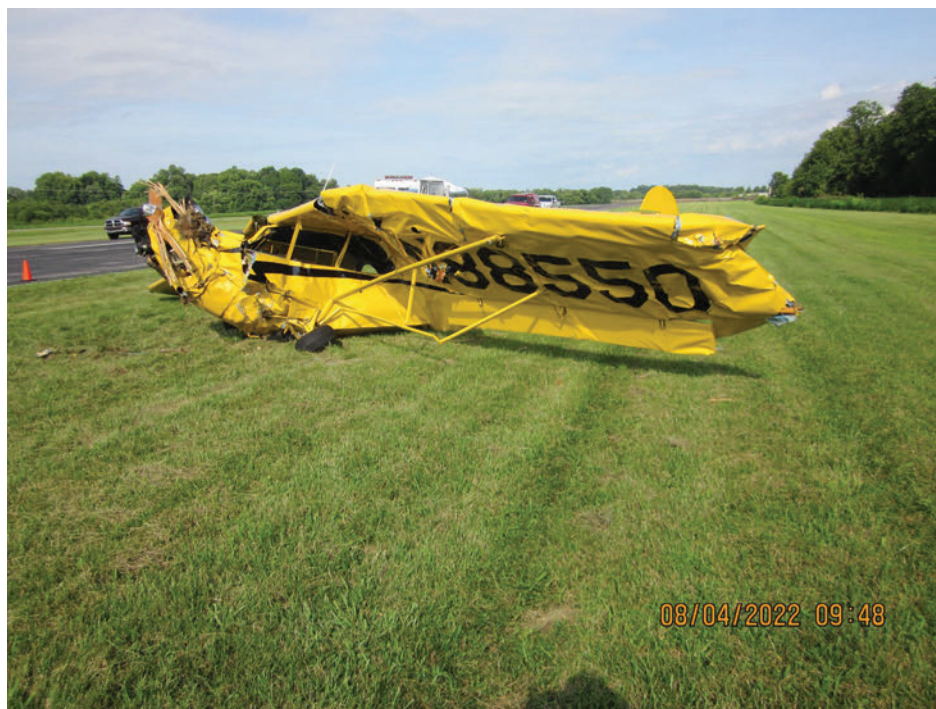
Left wing received substantial damage and was broken aft. Left aileron control continuity was confirmed through its respective control cable to the cockpit.

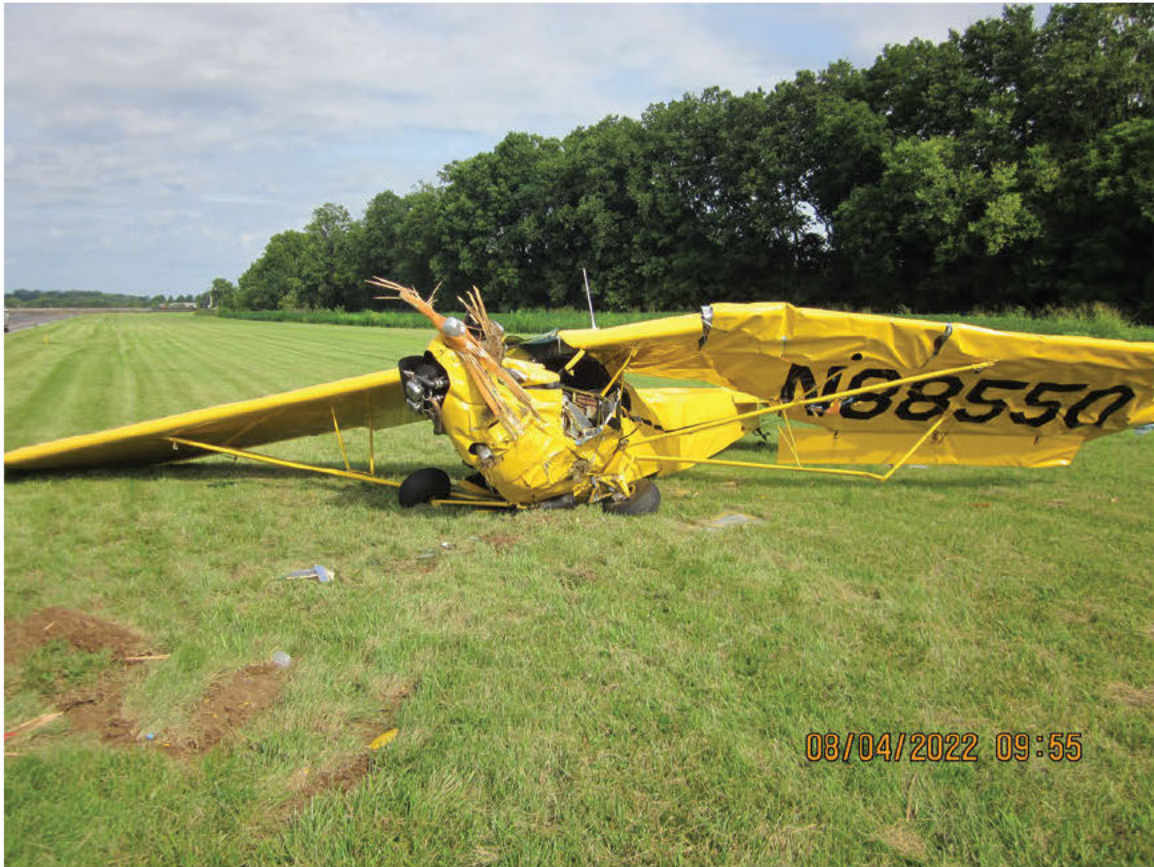
Forward fuselage area and main landing gear received substantial damage.

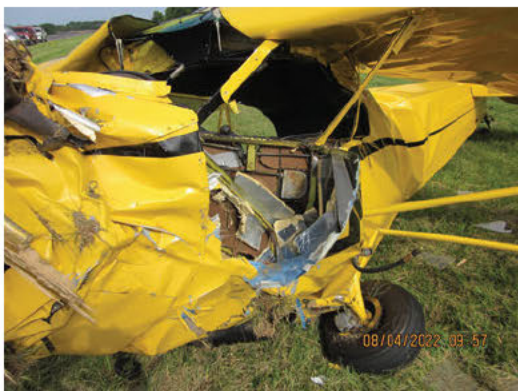
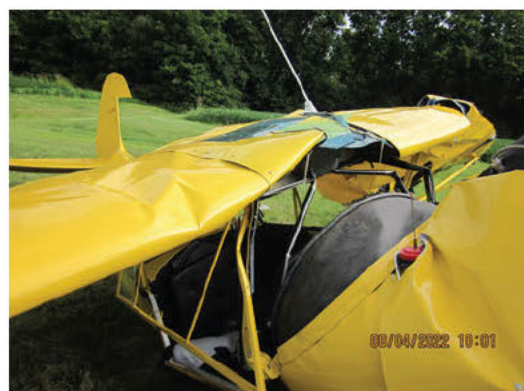
Cockpit received severely compromised. There were no shoulder harnesses installed.
