# National Transportation Safety Board

ERA22FA354

## **NTSB IIC EXAMINATION**

Location: Cynthiana-Harrison County (018)  
Date: August 3, 2022  
Time: 1932(UTC)  
1532 (EDT)  
Airplane: N88550 1946 J3C

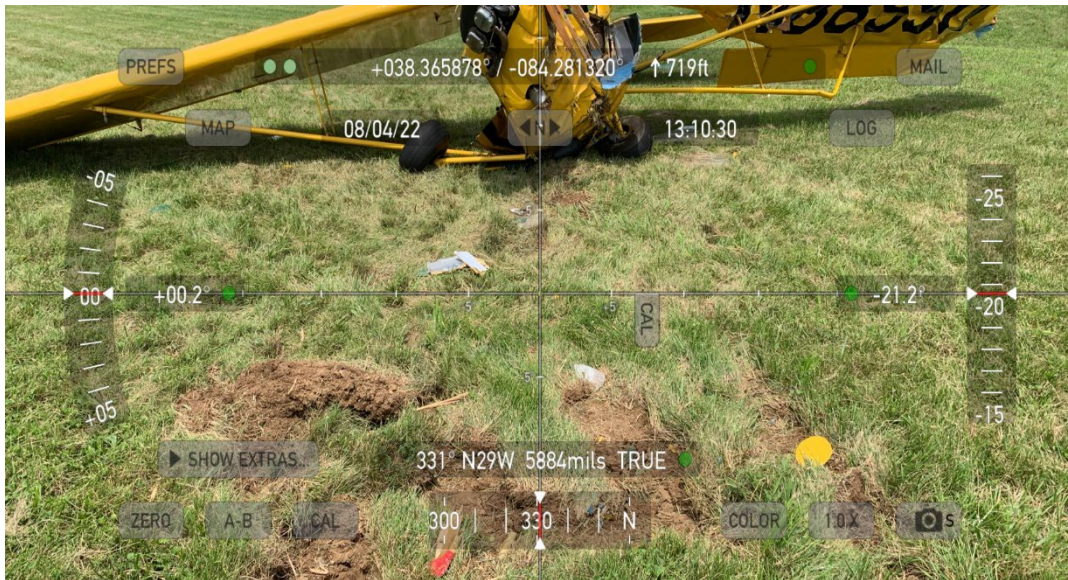
**Figure 1 Accident site with location/ direction details**

The wreckage came to rest in the grass, about 20 ft to right of runway 29 @ . Cynthiana-Harrison County Airport (018) Cynthiana, Kentucky. The wreckage path was compact, oriented on a magnetic heading of 151° from the initial impact point, and all major components of the engine and airframe were accounted for at the scene. (figure 1)

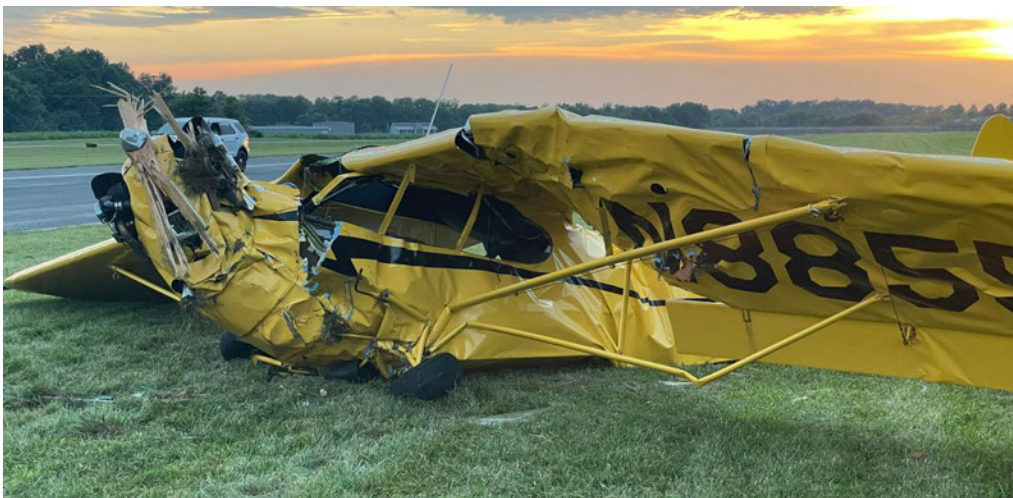
Fuselage buckled and crumpled with severe deformation on the forward left side of the cockpit and engine compartment. The floor of the forward seat was deformed and pushed up into the bottom of the instrument panel displacing the front seat. Holes were cut in the fuselage to gain access to control cables.

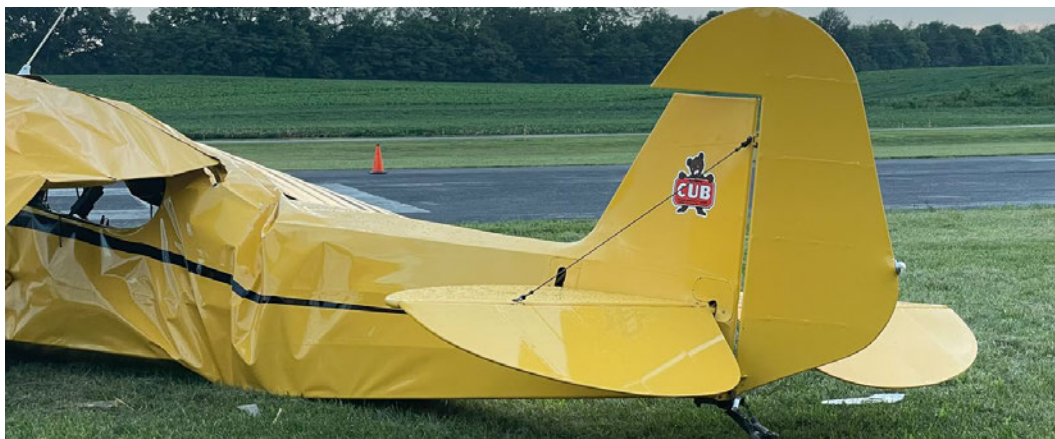
**Figure 2 View of empennage looking forward.**

All tail control surfaces were intact and installed in their respective locations and moved manually with corresponding cable movement. A hole was cut into the fuselage to observe all cables and turnbuckles. No anomalies or other irregularities were discovered. Rudder continuity was established from the rudder-to-rudder pedals. Stabilator continuity was established from the stabilator to the main cabin area. The empennage was relatively intact from about 3 feet forward of the rudder and elevators.

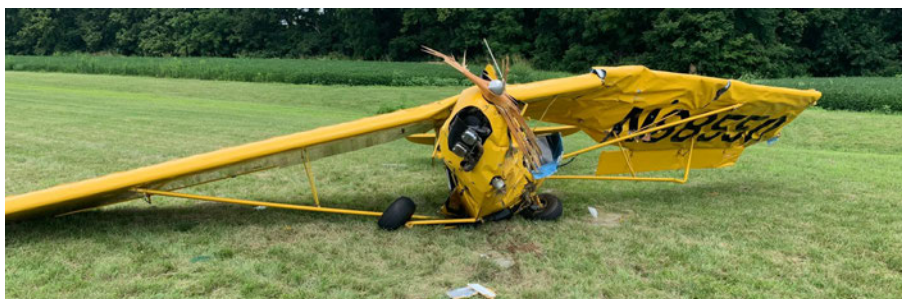
The left wing was broken mid span and severely deformed rearwards. The external wing struts remained attached to their respective locations but were bent and twisted. The aileron remained attached to their respective points and moved manually with corresponding cable movement being observed. The right wing was relatively intact and the external wing struts appeared undamaged. The aileron remained attached and moved manually with corresponding cable movement. All aileron control surfaces had control continuity.

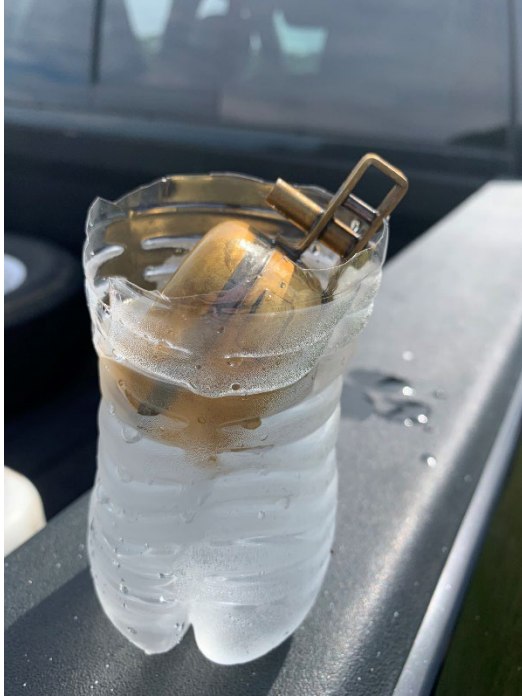
Impact damaged was noted to the fuel tank and about five gallons of gasoline was observed within. The fuel screens were removed and were free of any debris. The fuel inlet line was fractured from the carburetor and the inlet screen was clear of any debris. Partial disassembly of the carburetor revealed no irregularities to the unit or its internal components. A trace amount of blue liquid consistent in color and odor to that of aviation type gasoline was observed within the gascolator bowl. No debris was noted within the gascolator bowl or screen and the fuel was tested for water and none was observed. The brass carburetor float was removed and placed in a container of water to test for floatation/leaks; the float was intact.

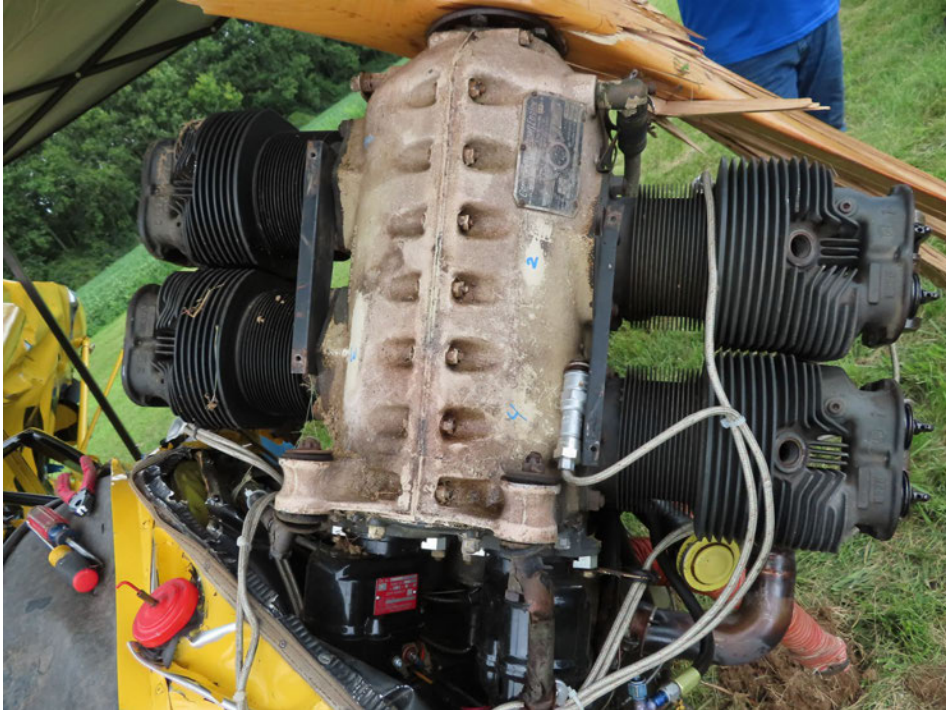
**Figure 3 View of left and right side of engine prior to examination.**

The powerplant is a four-cylinder, air cooled, direct drive, horizontally opposed, carbureted, naturally aspirated engine with a rating of 65HP. The engine was impact damaged, but all cylinders, spark plugs remained intact. There was no evidence of a post-crash fire.

The carburetor remained attached to the intake which was fractured. The throttle control cable remained attached to the carburetor and mid-travel position. The alternate air box was deformed upward, and the induction air filter was clear of obstruction. The alternate air control cable remained attached to its mounts and was noted in the "primary/filtered" air position.

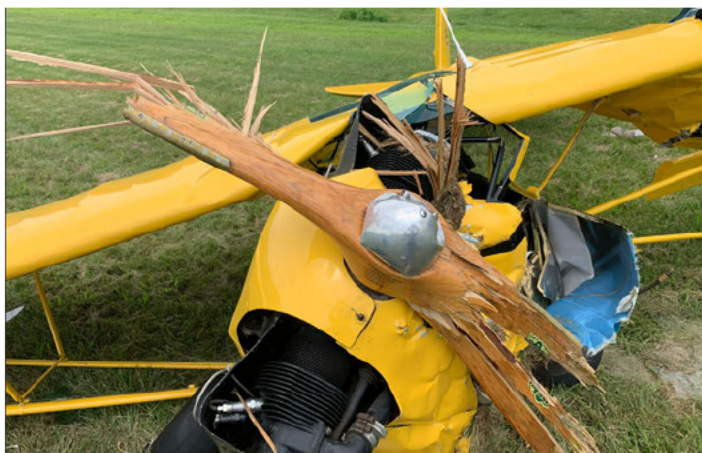
**Figure 4** Propeller damage.

The two-blade wood fixed pitched propeller remained attached to the engine with both blades fractured with their outboard areas separated at the erosion strips. The spinner was separated from its mounts and exhibited some torsional deformation. Pieces of the propeller blade were discovered in a uniform pattern of distribution

around the wreckage up to 40 feet away and there was a 3 inch deep rotational scalp marks in the grass and dirt at the primary impact side.
