# National Transportation Safety Board

ERA22FA376

## **WRECKAGE EXAMINATION SUMMARY**

Location: Glendora, Mississippi  
Date: August 19, 2022  
Time: 1005 CDT  
Airplane: N602PB, Air Tractor AT-602

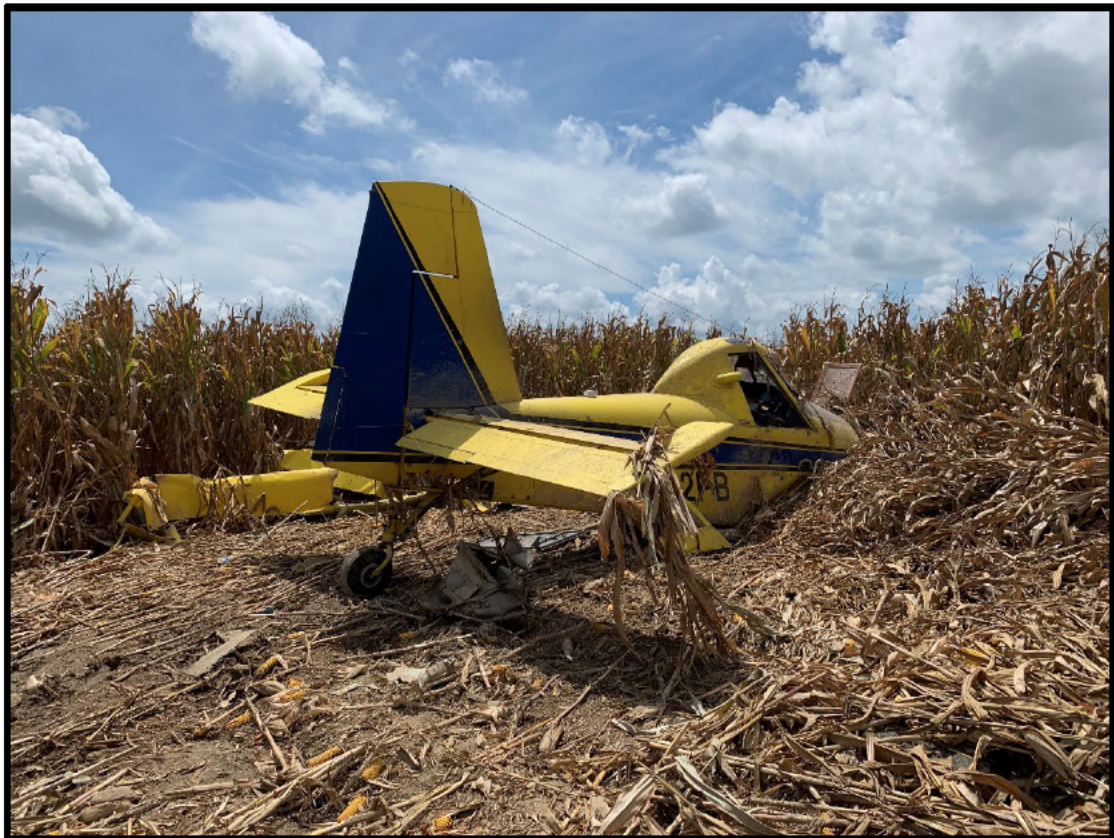
The airplane came to rest in a cornfield, at an elevation of 140 ft, upright, on a 230° heading. All major components of the airplane were located in the vicinity of the main wreckage. The airplane struck multiple rows of corn in a left-wing low position prior to impacting the ground. The first vegetation strike was about 155 ft from the main wreckage. There was an odor of fuel at the accident site.

**Figure 2. Main Accident Site**

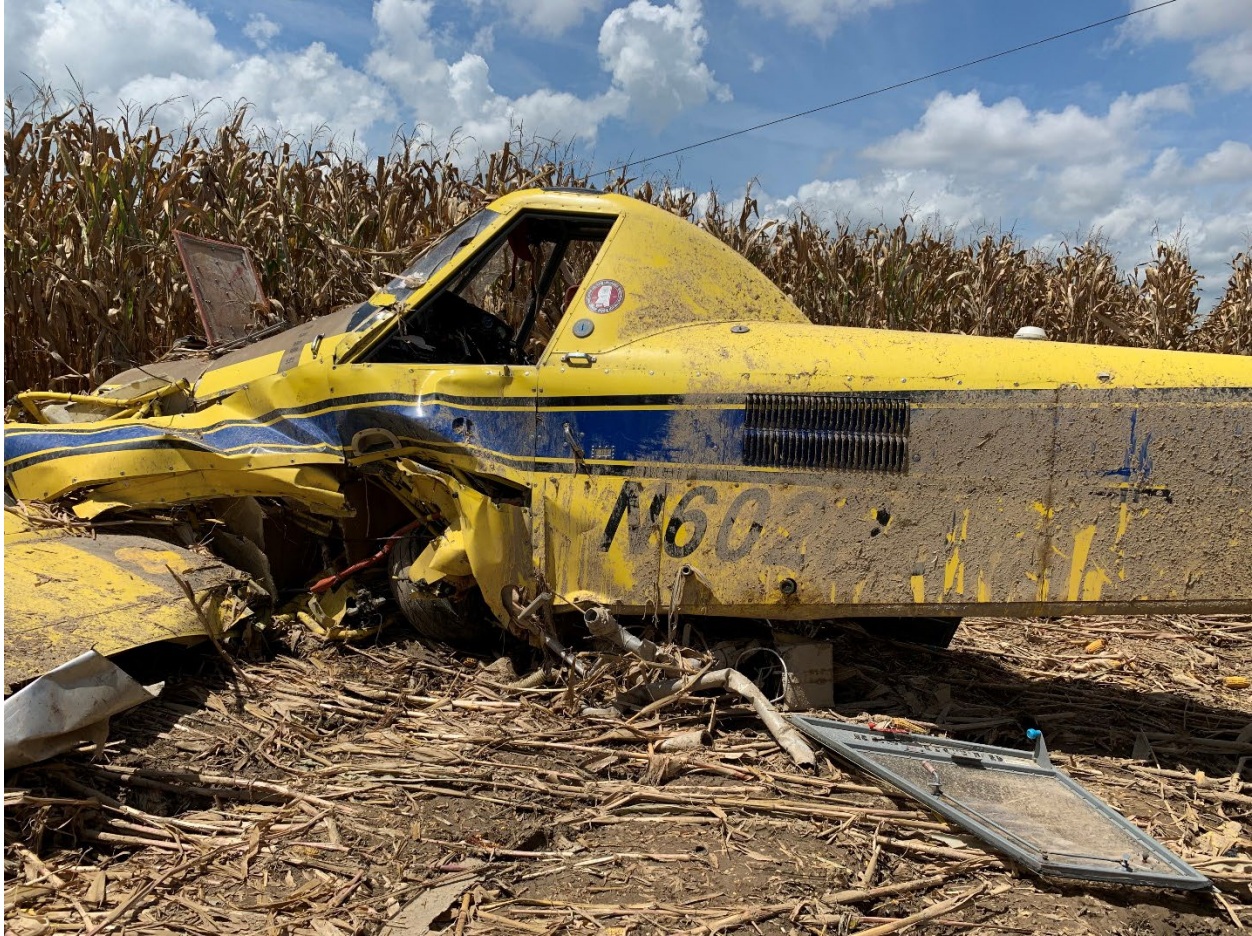
The fuselage remained intact and the engine remained partially impact separated from the airframe. The cockpit remained intact and the windscreen was cracked. The right window of the windscreen was impact separated and cracked. The doors remained on the airframe but were removed by first responders.

**Figure 3. View of fuselage.**

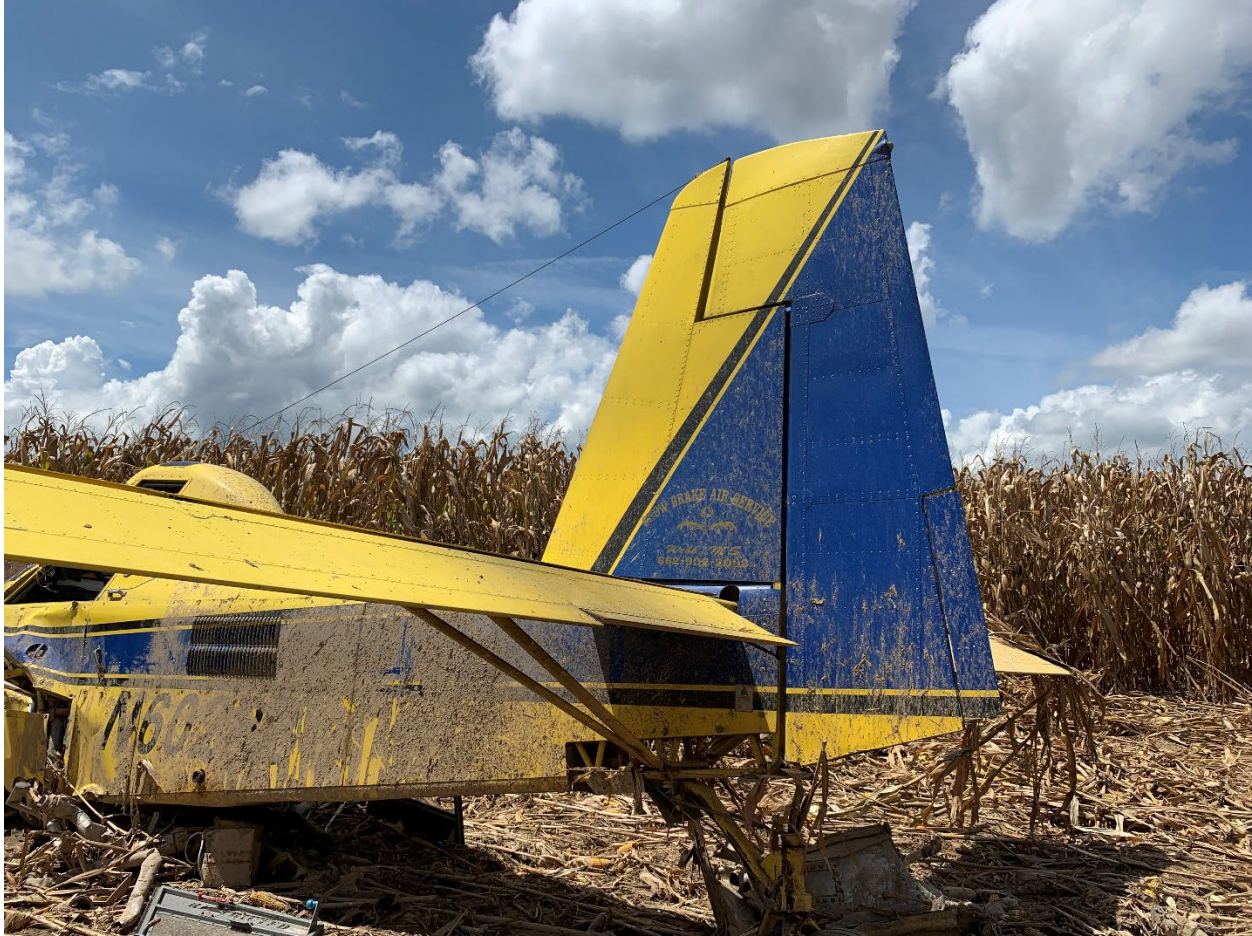
The empennage remained attached to the fuselage and was not damaged. The leading edge of the left horizontal stabilizer was dented and remained attached to the empennage. The right horizontal stabilizer was bent aft and wrinkled about 1 ft from the empennage attach point. The left and right elevators remained attached to the empennage and the trim tabs remained attached to the elevators. The left elevator trim tab was in the trailing edge up position and the right trim tab was in the trailing edge down position. The elevators could be moved freely by hand. The vertical stabilizer remained attached to the empennage and the leading edge was undamaged. The rudder and rudder trim tab remained attached to the vertical stabilizer and were undamaged. The tailwheel remained attached to the empennage.

**Figure 4. View of left side of empennage.**

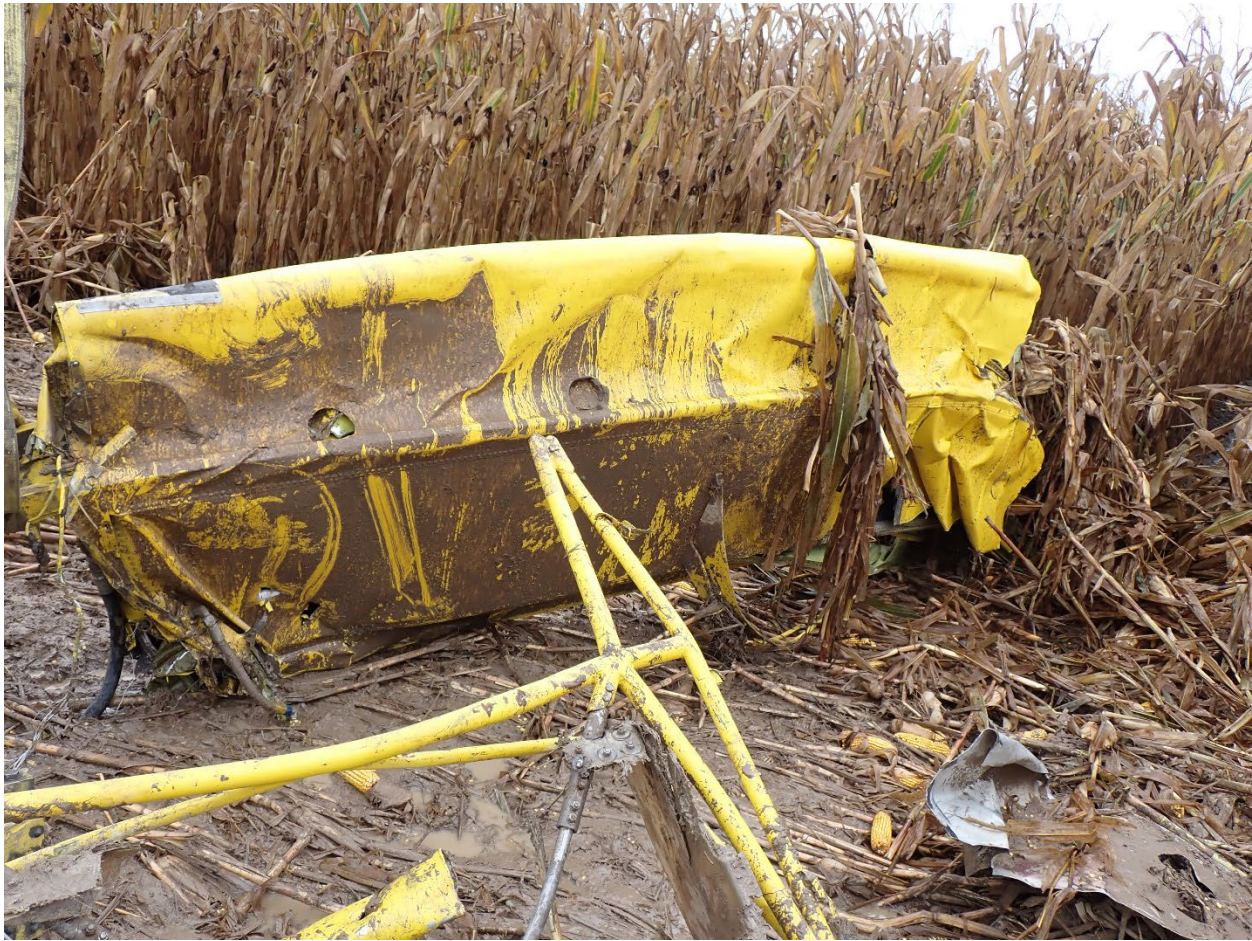
The right wing remained attached to the fuselage and was bent aft. The right flap was impact separated from the inboard attach point but remained attached to the wing through the outboard attach point. The right aileron balance weight remained attached to the right wing. The right aileron remained attached to the right wing and the outboard section was impact damaged. The right fuel cap remained seated and in place.

**Figure 5. View of right wing.**

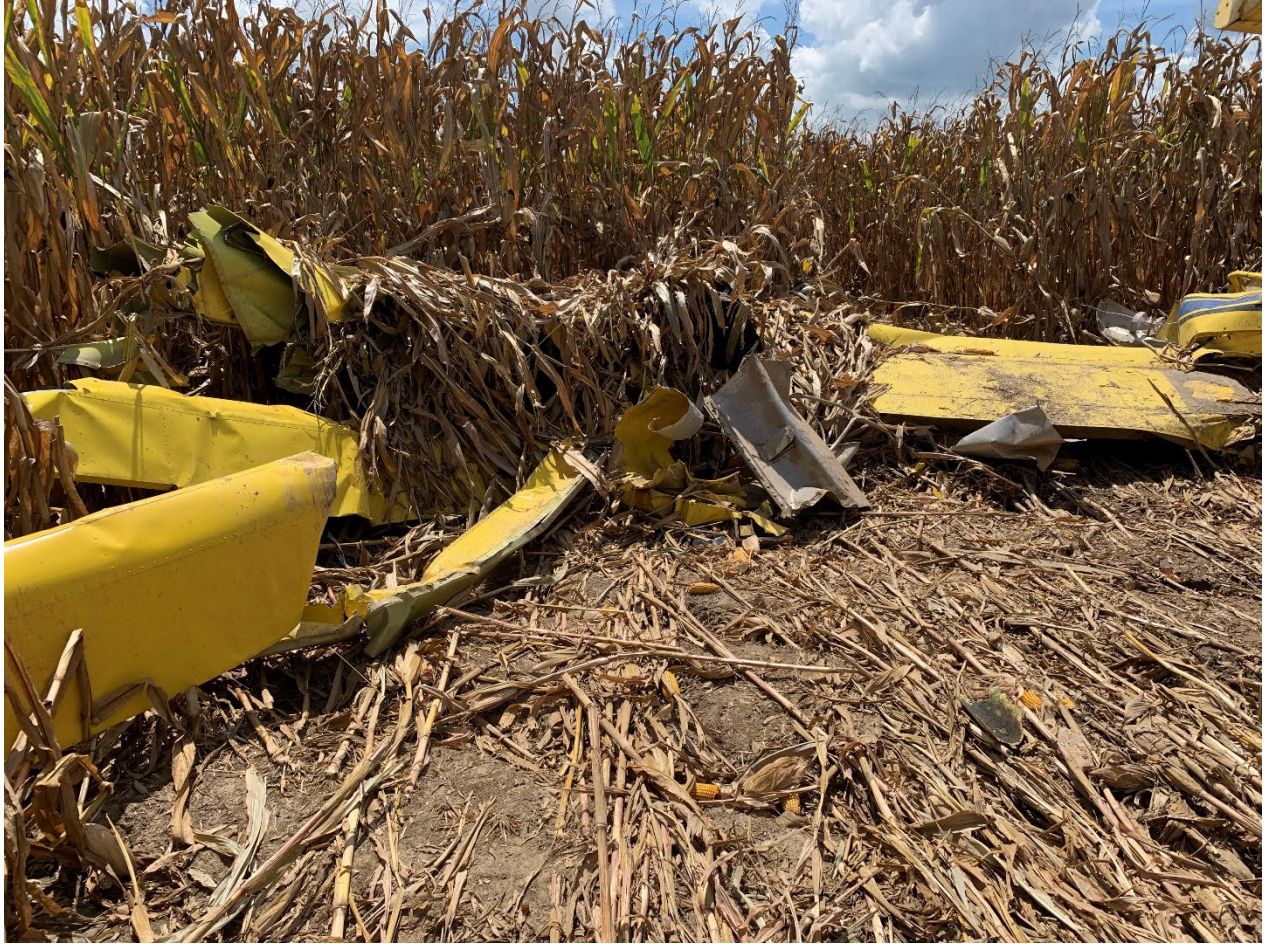
The left-wing tip was impact separated and the red lens light were located about 140 ft from the main wreckage. The inboard section of the left wing remained attached to the fuselage. The outboard 20 ft of the left wing was impact damaged and bent aft. The flap was impact separated and located along the debris path. The inboard section of the left flap was impact separated from the flap and located near the left wing. The outboard section of the aileron was impact separated and damaged. The left aileron balance weight was impact separated and located next to the left wing. The left fuel cap remained seated and in place. Flight control continuity was confirmed from the ailerons to the flight controls in the cockpit through multiple overload breaks.

**Figure 6. View of left wing.**

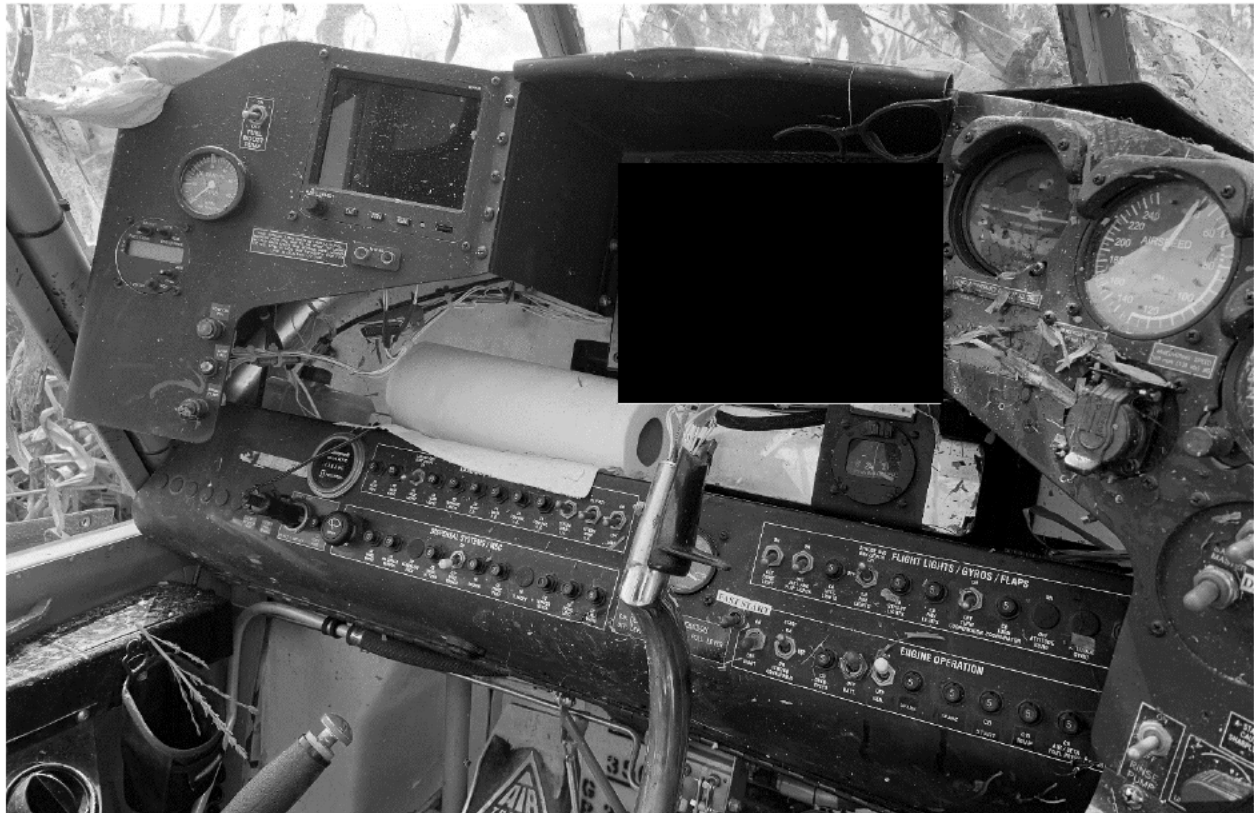
**Figure 7. View of instrument panel.**

The power lever was in the full forward position. The propeller lever was in the full forward position. The mixture level was in the flight idle position.

The low oil pressure warning light was removed from the panel, examined, and the filament was not stretched. The low fuel warning light was removed from the panel, examined, and the filament was not stretched.

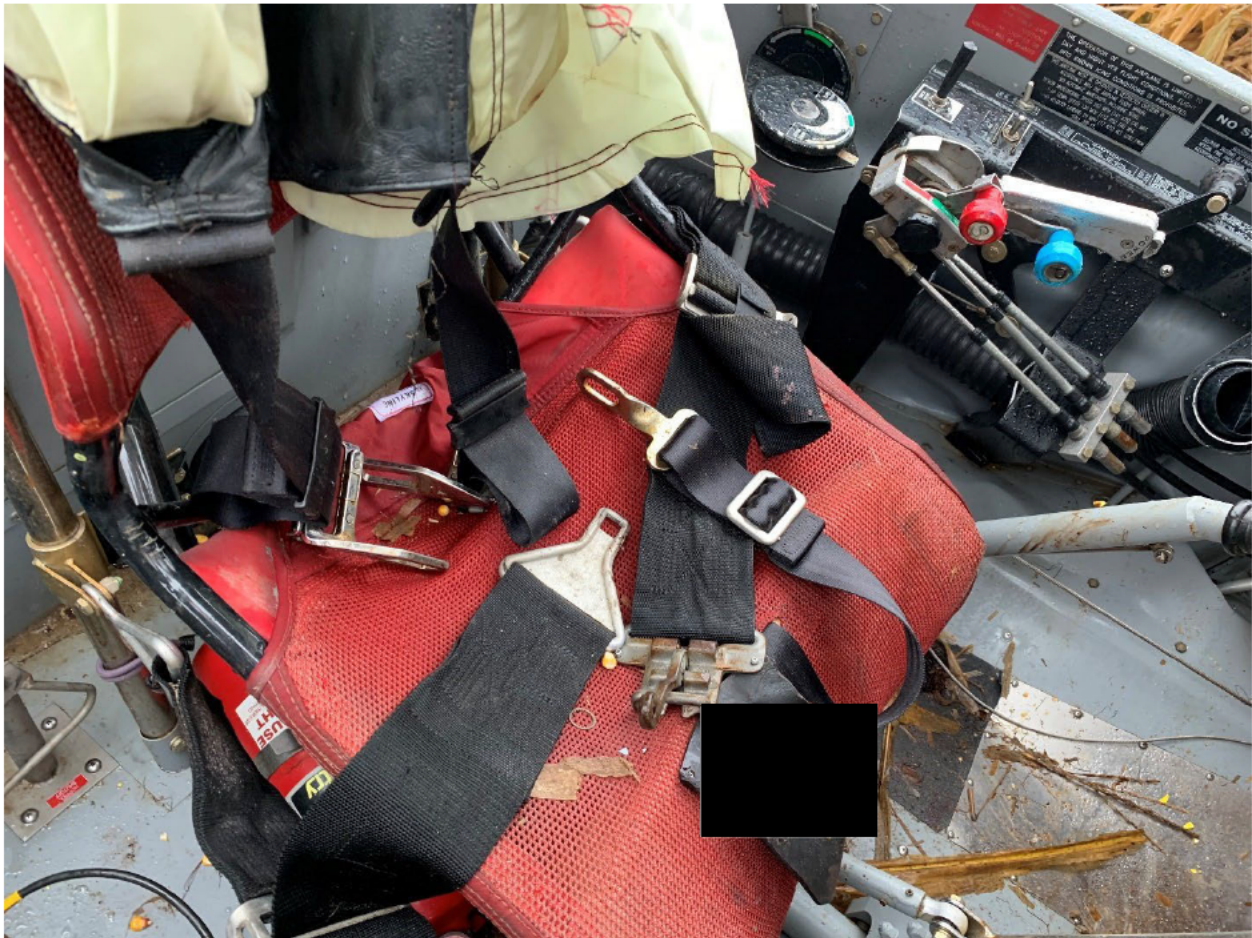
Restraint - the airplane was equipped with a 5-point harness. The seatbelt remained secure to the seat and the webbing was examined and slight stretching was noted. The shoulder harness was an inflatable restraint. The airbag was deployed on both sides and there were no tears or rips in the airbags. The seat rails exhibited a slight bend forward where they seat attached to the rails. The seat was deformed in a downward direction and sloped forward. First responders unbuckled the pilot and removed him from the left side of the airplane.

**Figure 8. View of all seatbelt attach points.**

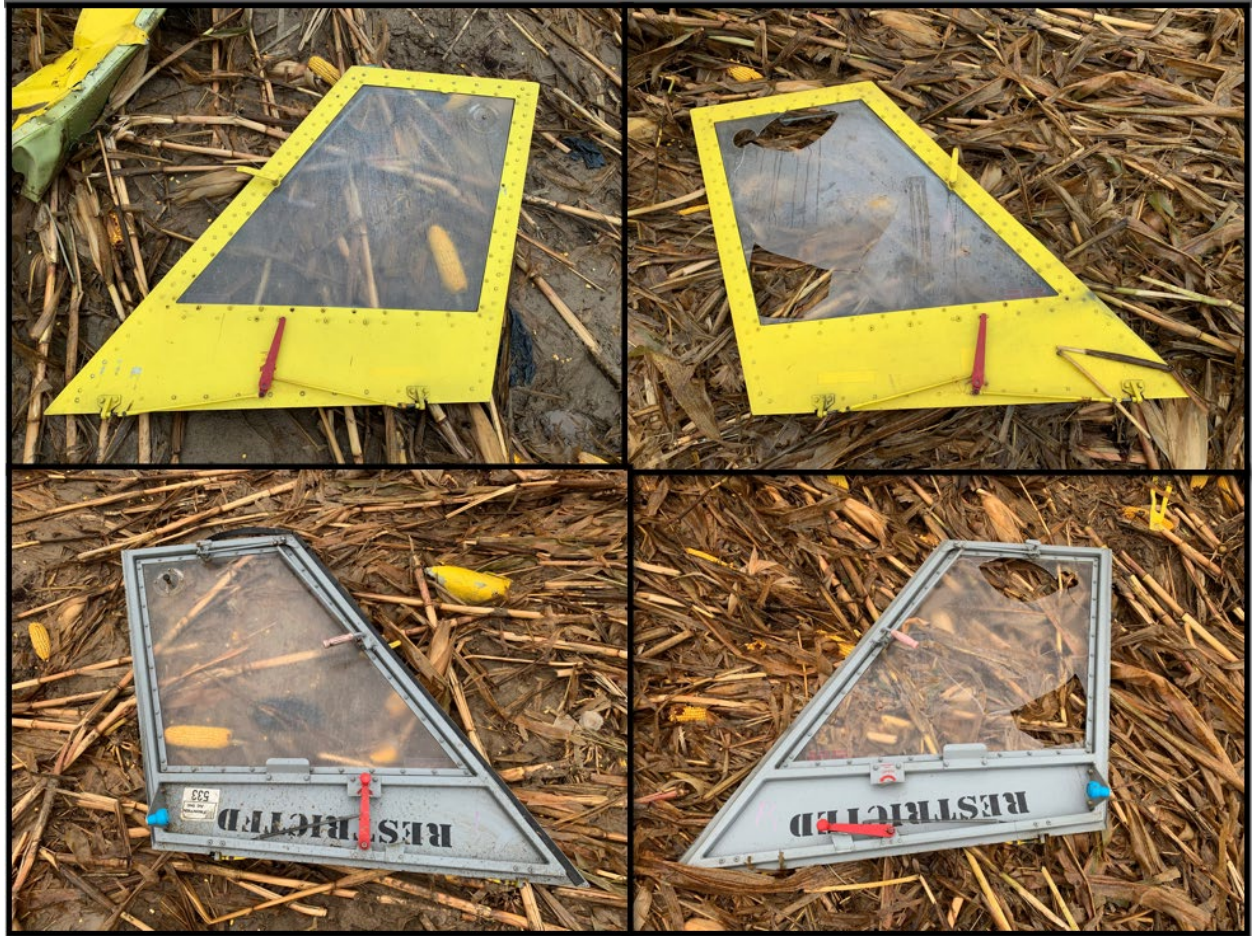
Egress - the airplane doors were not jammed. They were operated by regular means by first responders when they arrived at the accident location.

**Figure 9. View of cockpit doors.**

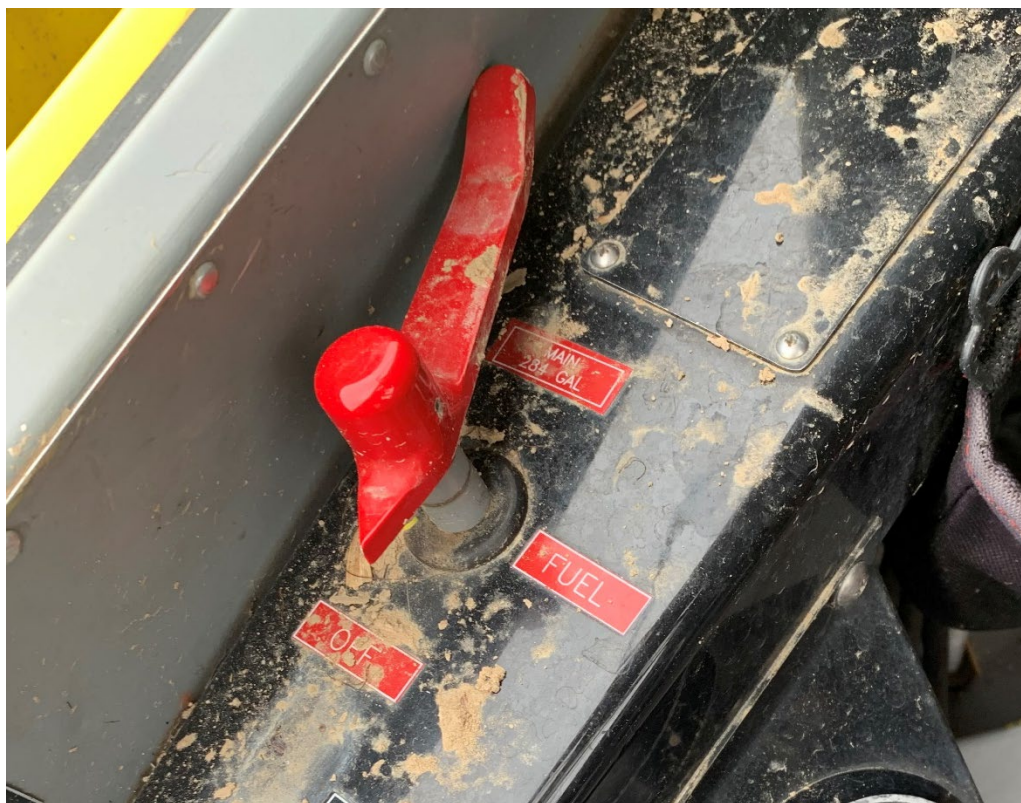
The fuel selector was in the OFF position; however, it was confirmed that first responders moved it to the OFF position. When the accident first happened, the fuel selector was in the ON position. The fuel valve was in the ON position. There was no fuel in the line from the boost pump to the engine.

**Figure 11. View of fuel selector as found.**

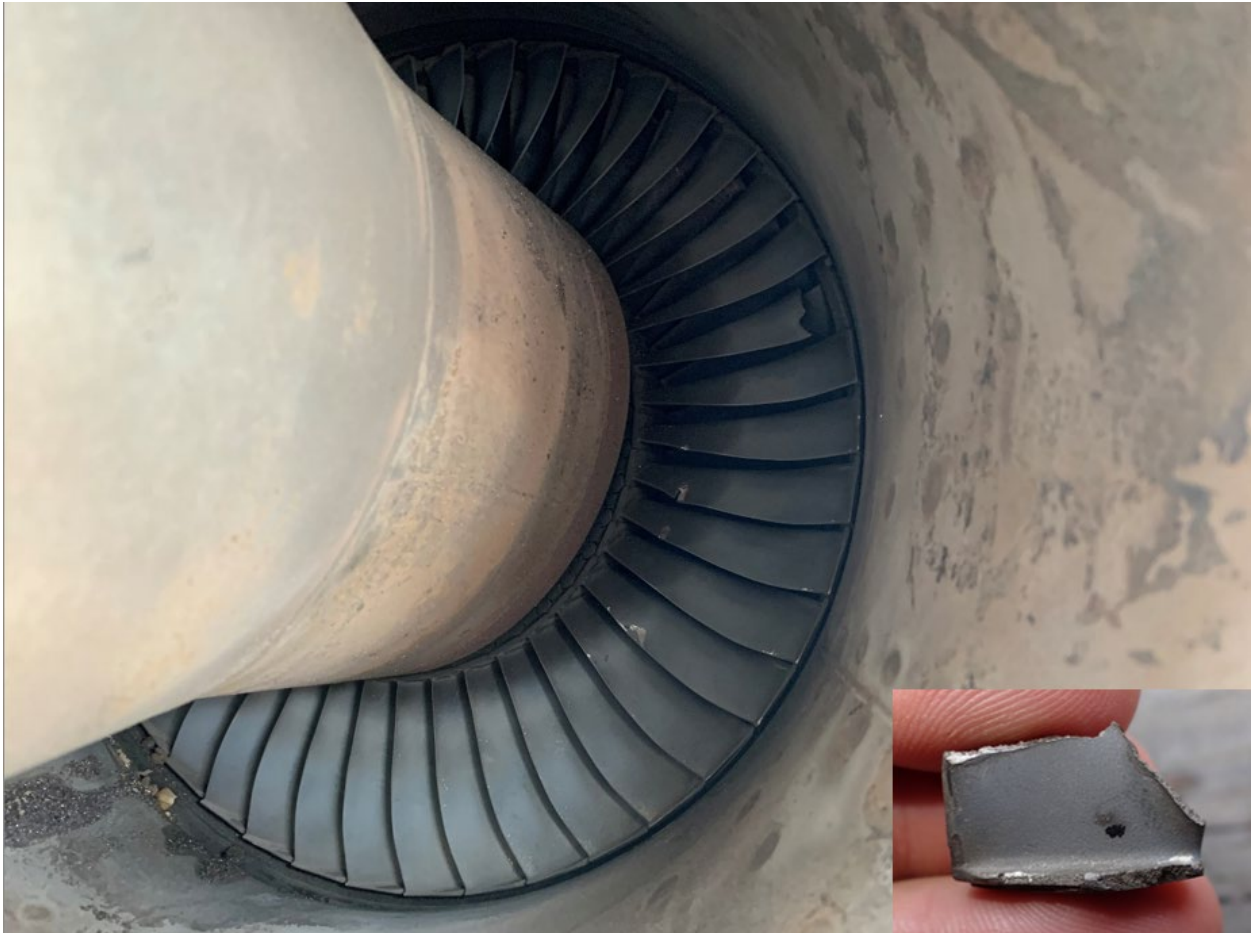
The engine remained attached to the airframe engine mounts. The front reduction gearbox was impact separated and remained attached to the propeller. Remnants of the front reduction gearbox flange remained attached to the power section of the engine. Multiple gear teeth on the reduction gearbox exhibited rotational scoring. The exhaust stacks were removed to facilitate examination. The 2<sup>nd</sup> stage power turbine remained intact and one of the blade tips was impact separated and located at the accident site in the vicinity of the engine. Multiple turbine blades exhibited trailing edge damage. Rotational scoring was noted on the power turbine

section case. Furthermore, the sections of the exhaust duct exhibited torsional/compression damage.

**Figure 14. View of power turbine disk. Note broken blade & piece found outside the engine.**

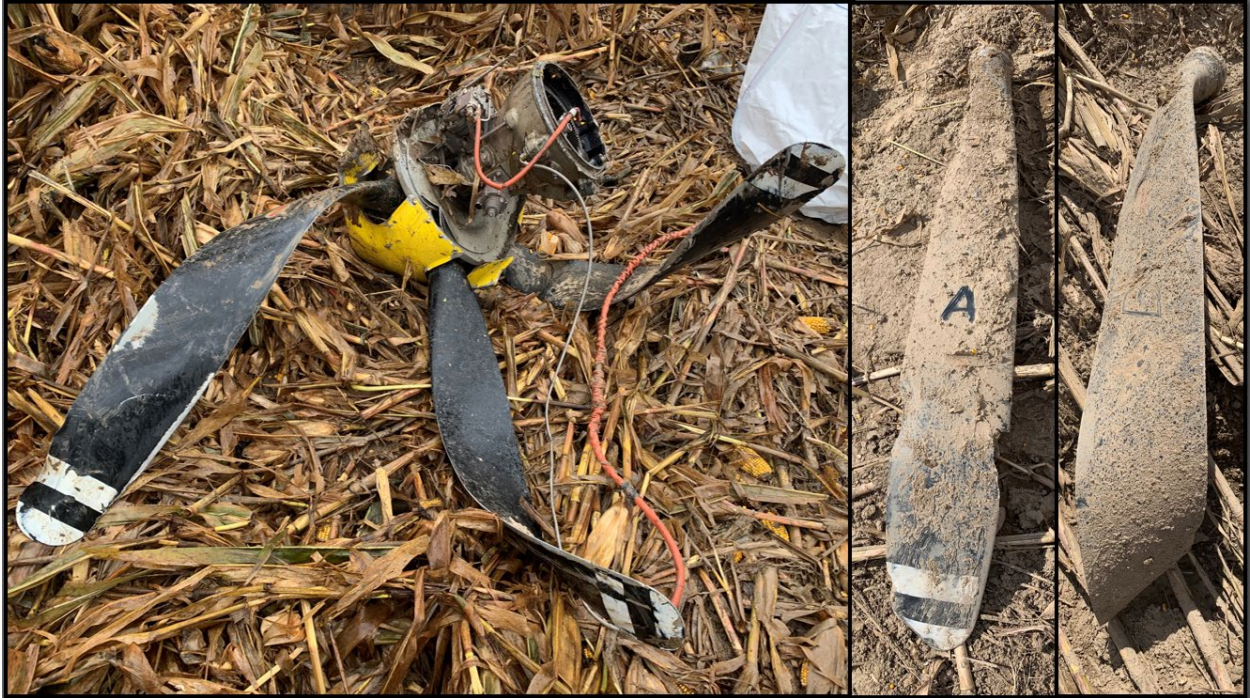
The airplane was equipped with a 5-blade Hartzell controllable pitch propeller. The propeller and reduction gearbox were impact separated from the airplane. Two of the 5 propeller blades were impact separated from the hub and located along the debris path. The other 3 propeller blades remained attached to the hub. Multiple blades were bent the opposite direction of travel and exhibited chordwise scratching. Furthermore, blade A exhibited leading edge gouging.

**Figure 15. View of propeller blades.**
