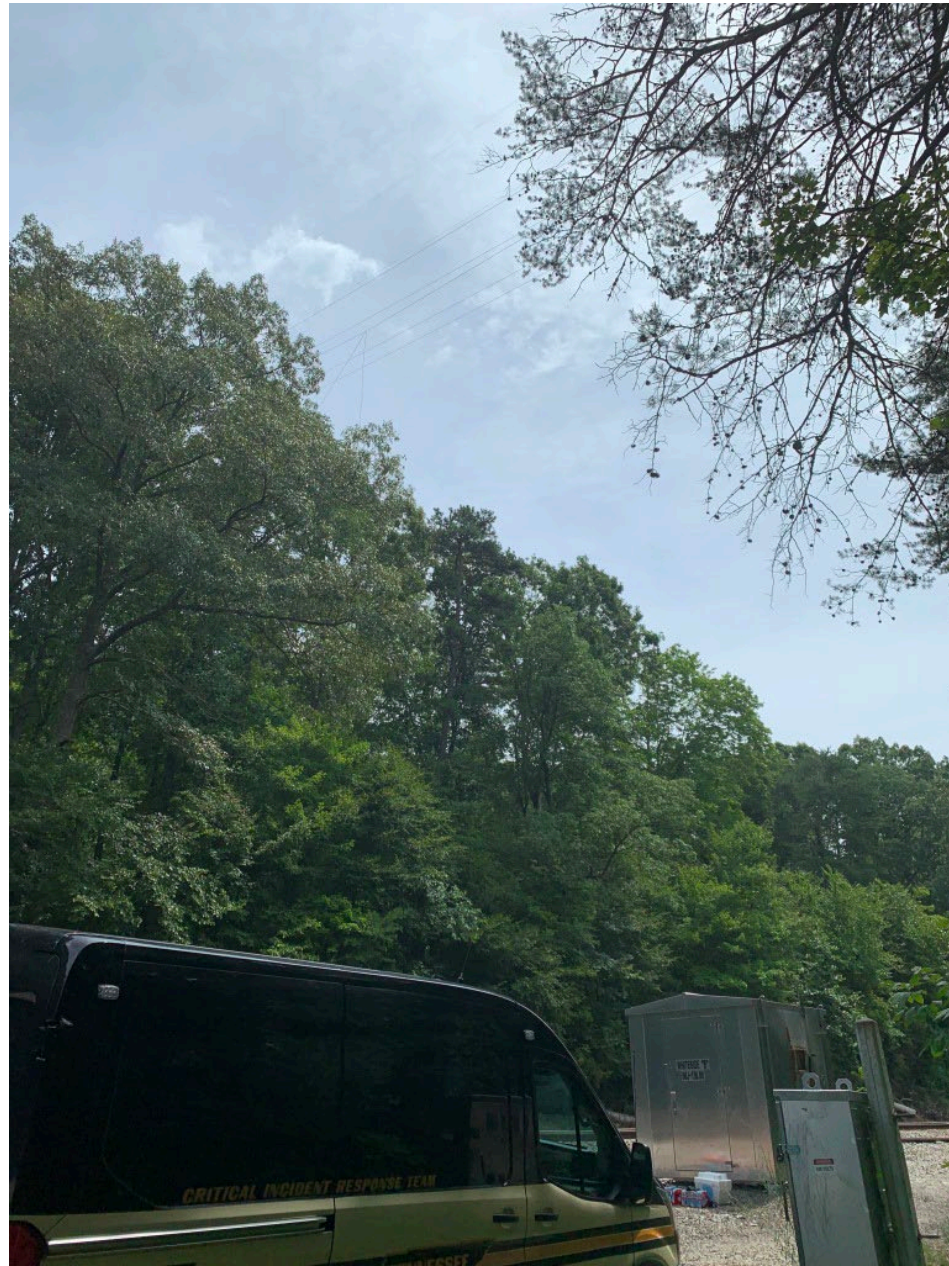
**Photo 1 – Fractured Powerline**

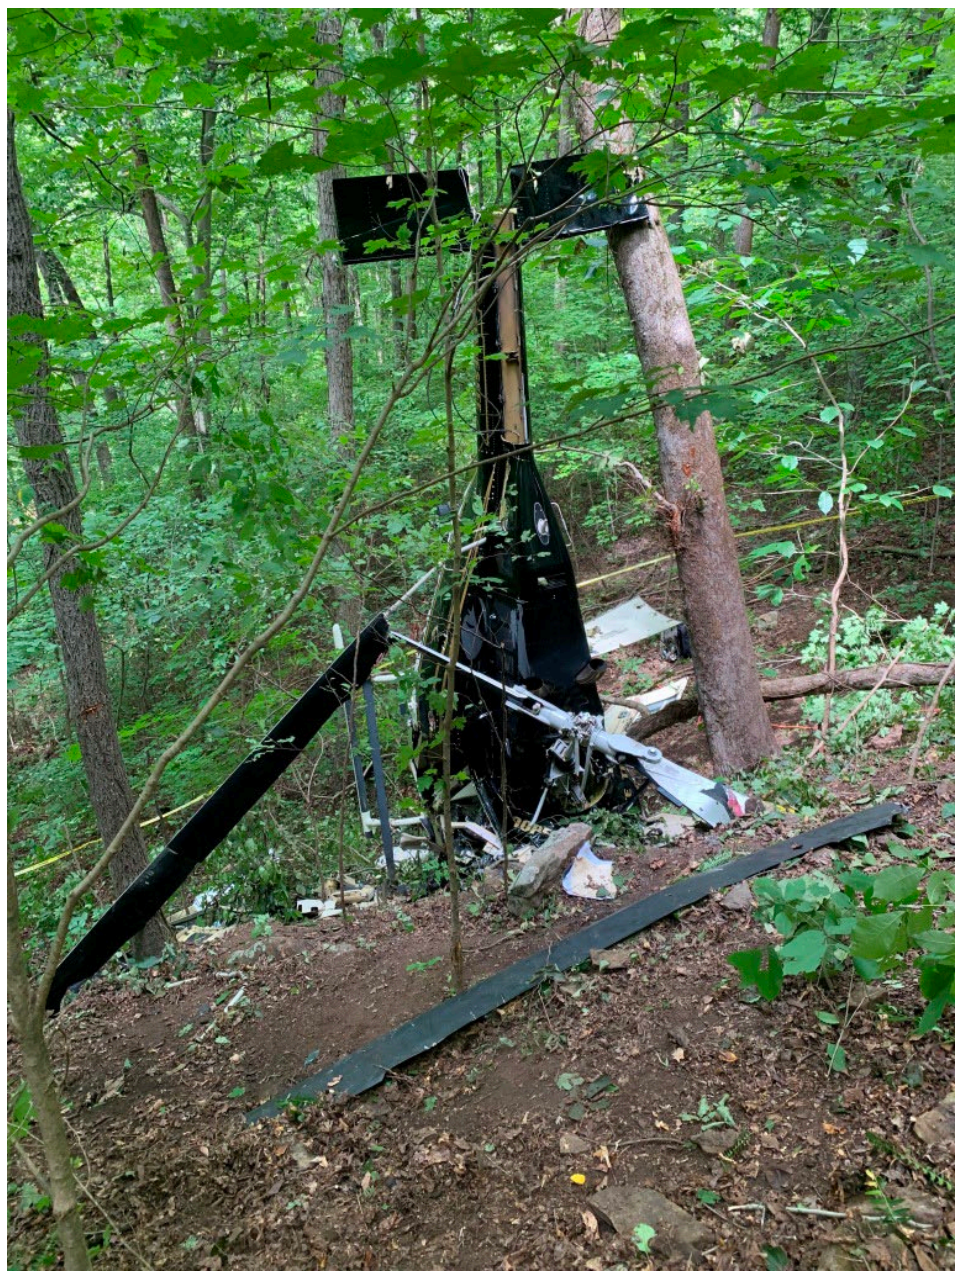
**Photo 2 – Top of Helicopter at Accident Site Looking Down Hill**

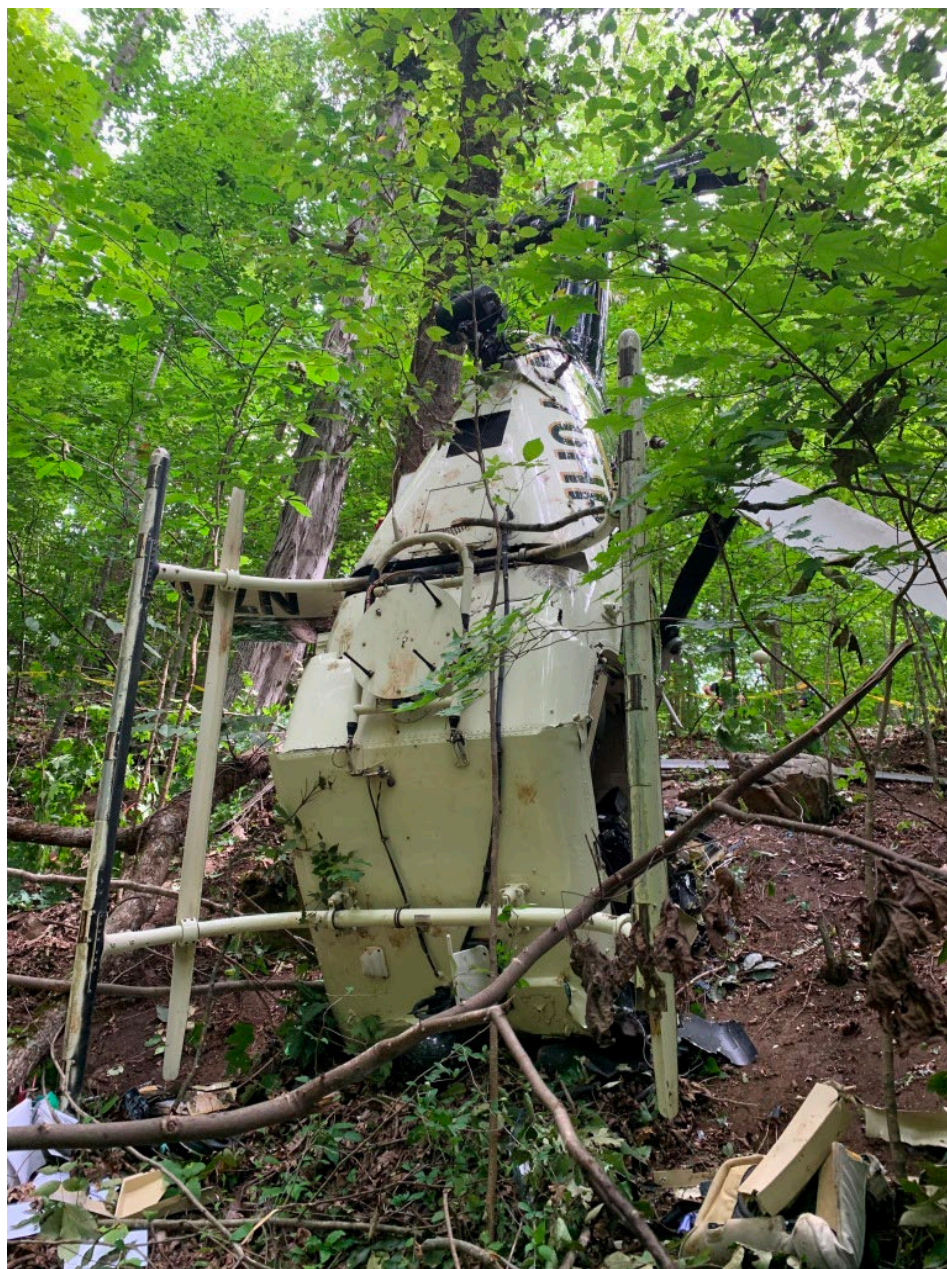
**Photo 3 – Bottom Side of Helicopter Looking Up Hill**

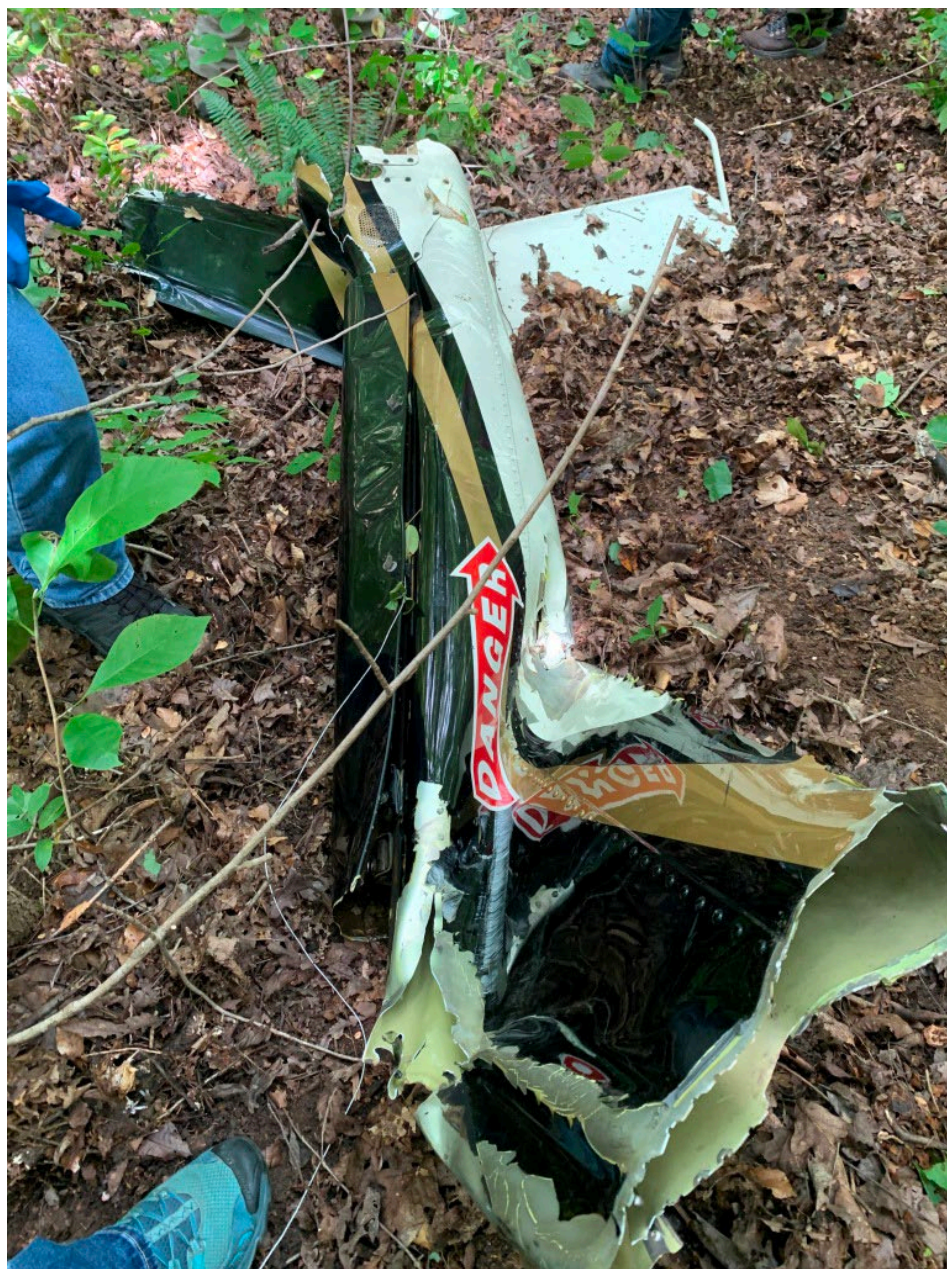
**Photo 4 – Fractured Section of Tail Boom**

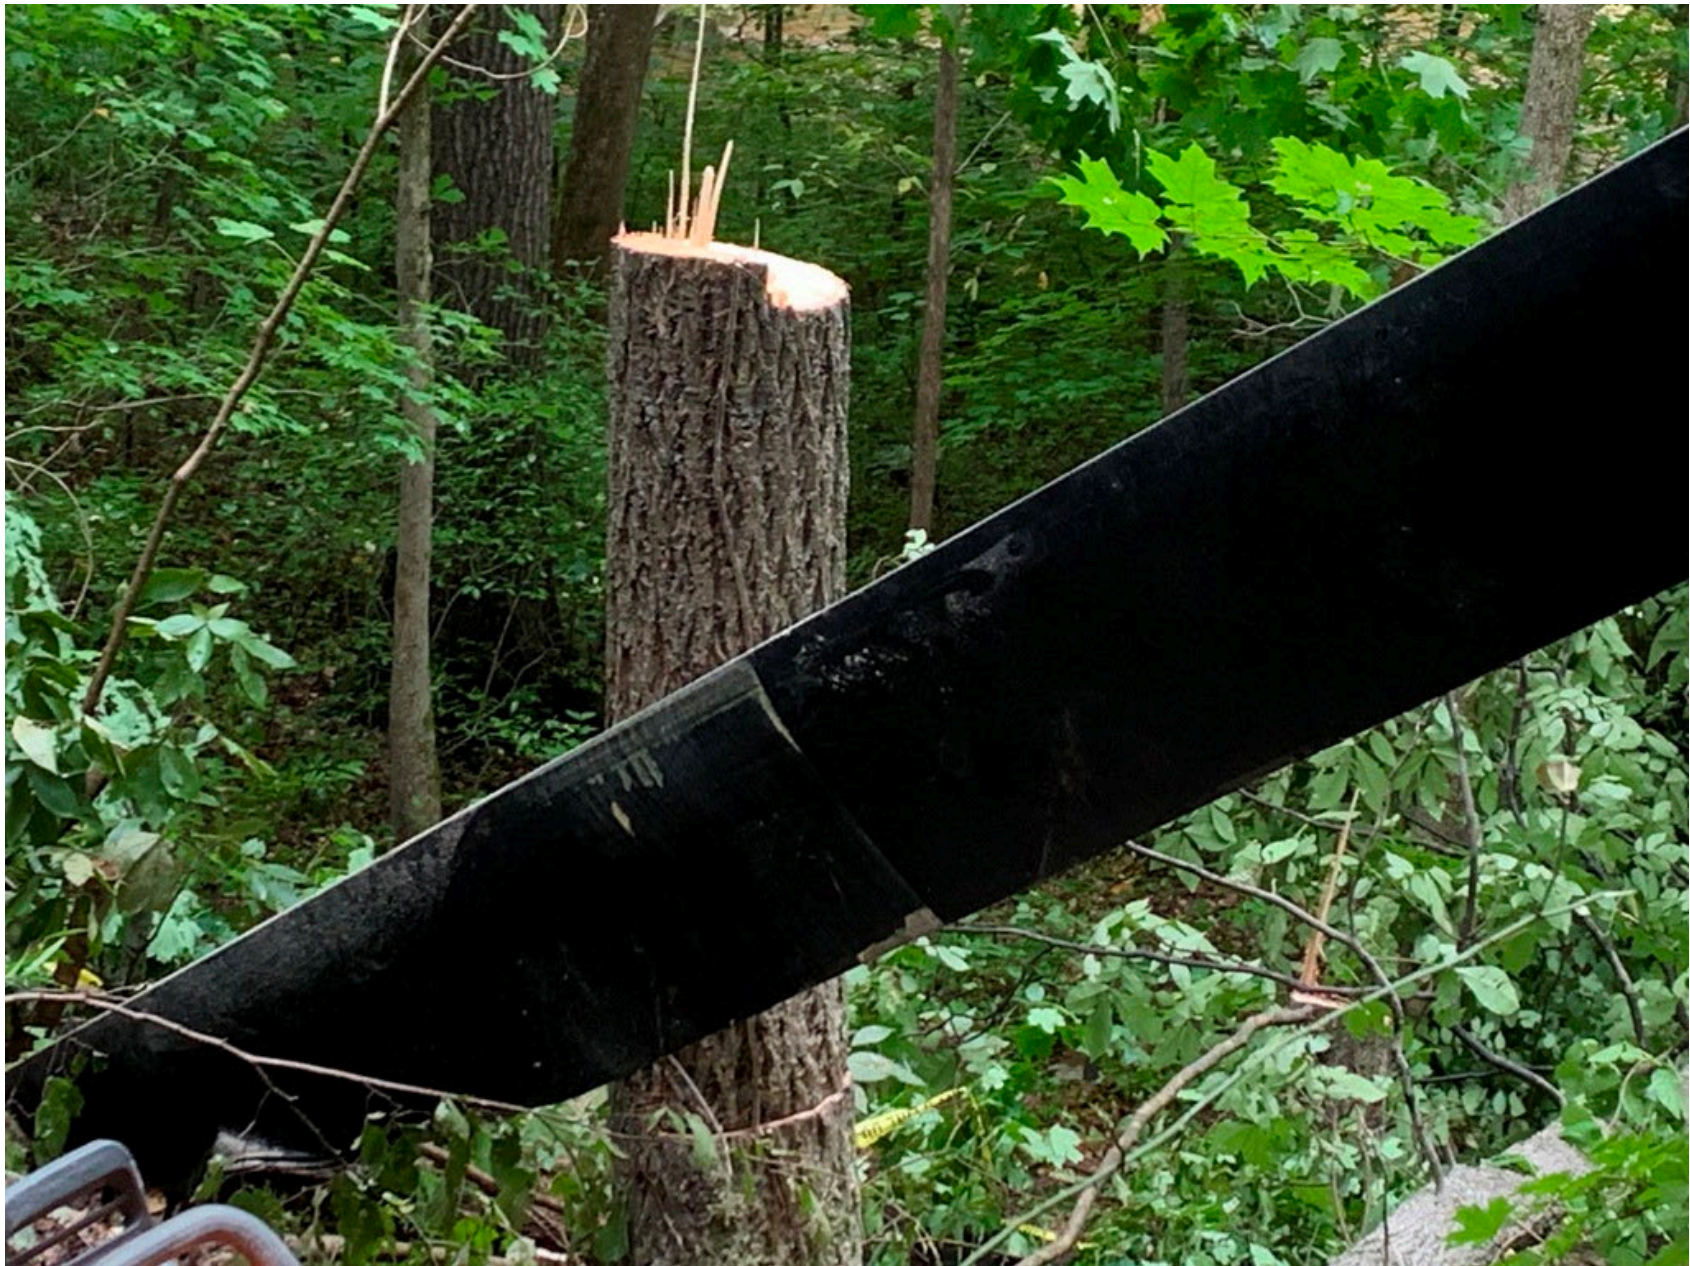
**Photo 5 – Impact Striation Marks on White Main Rotor Blade**

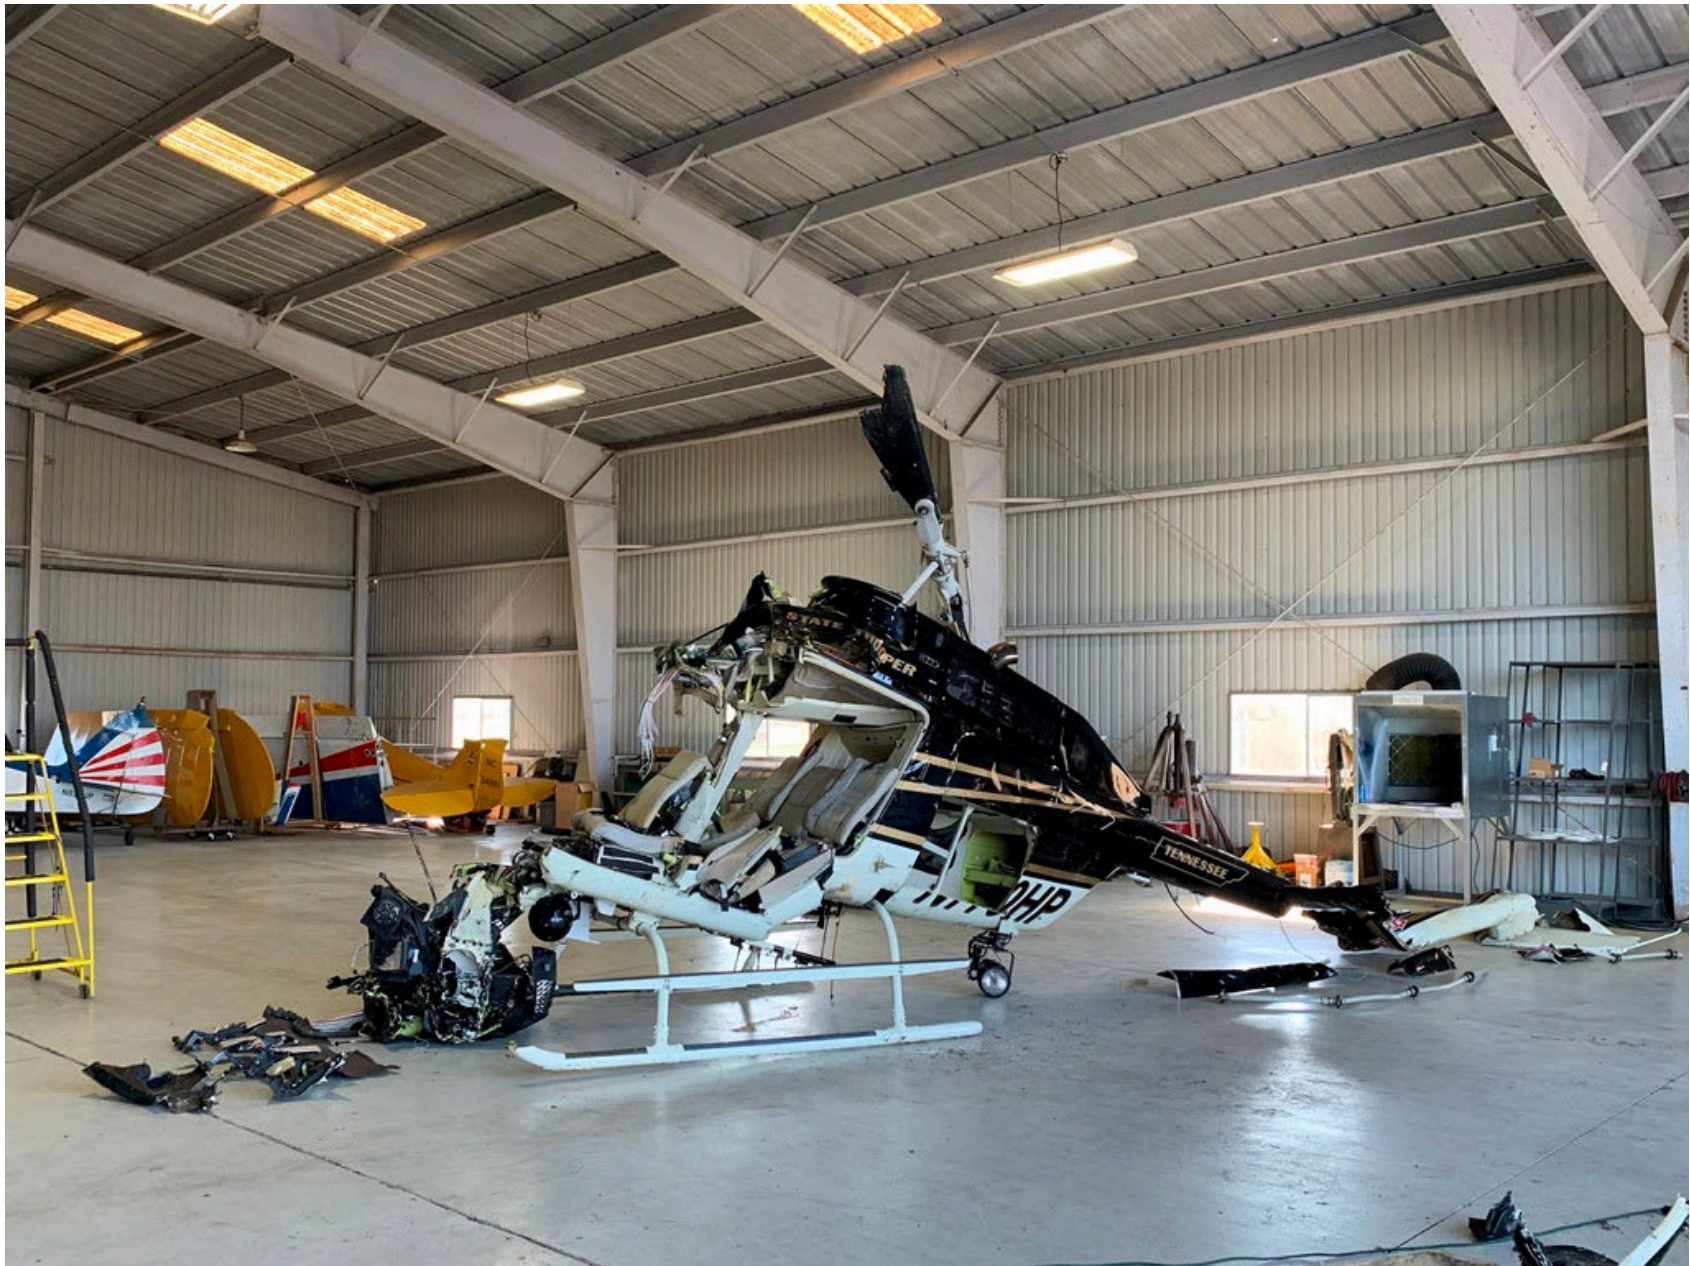
**Photo 6 – Left Side View of Helicopter at Salvage Yard**

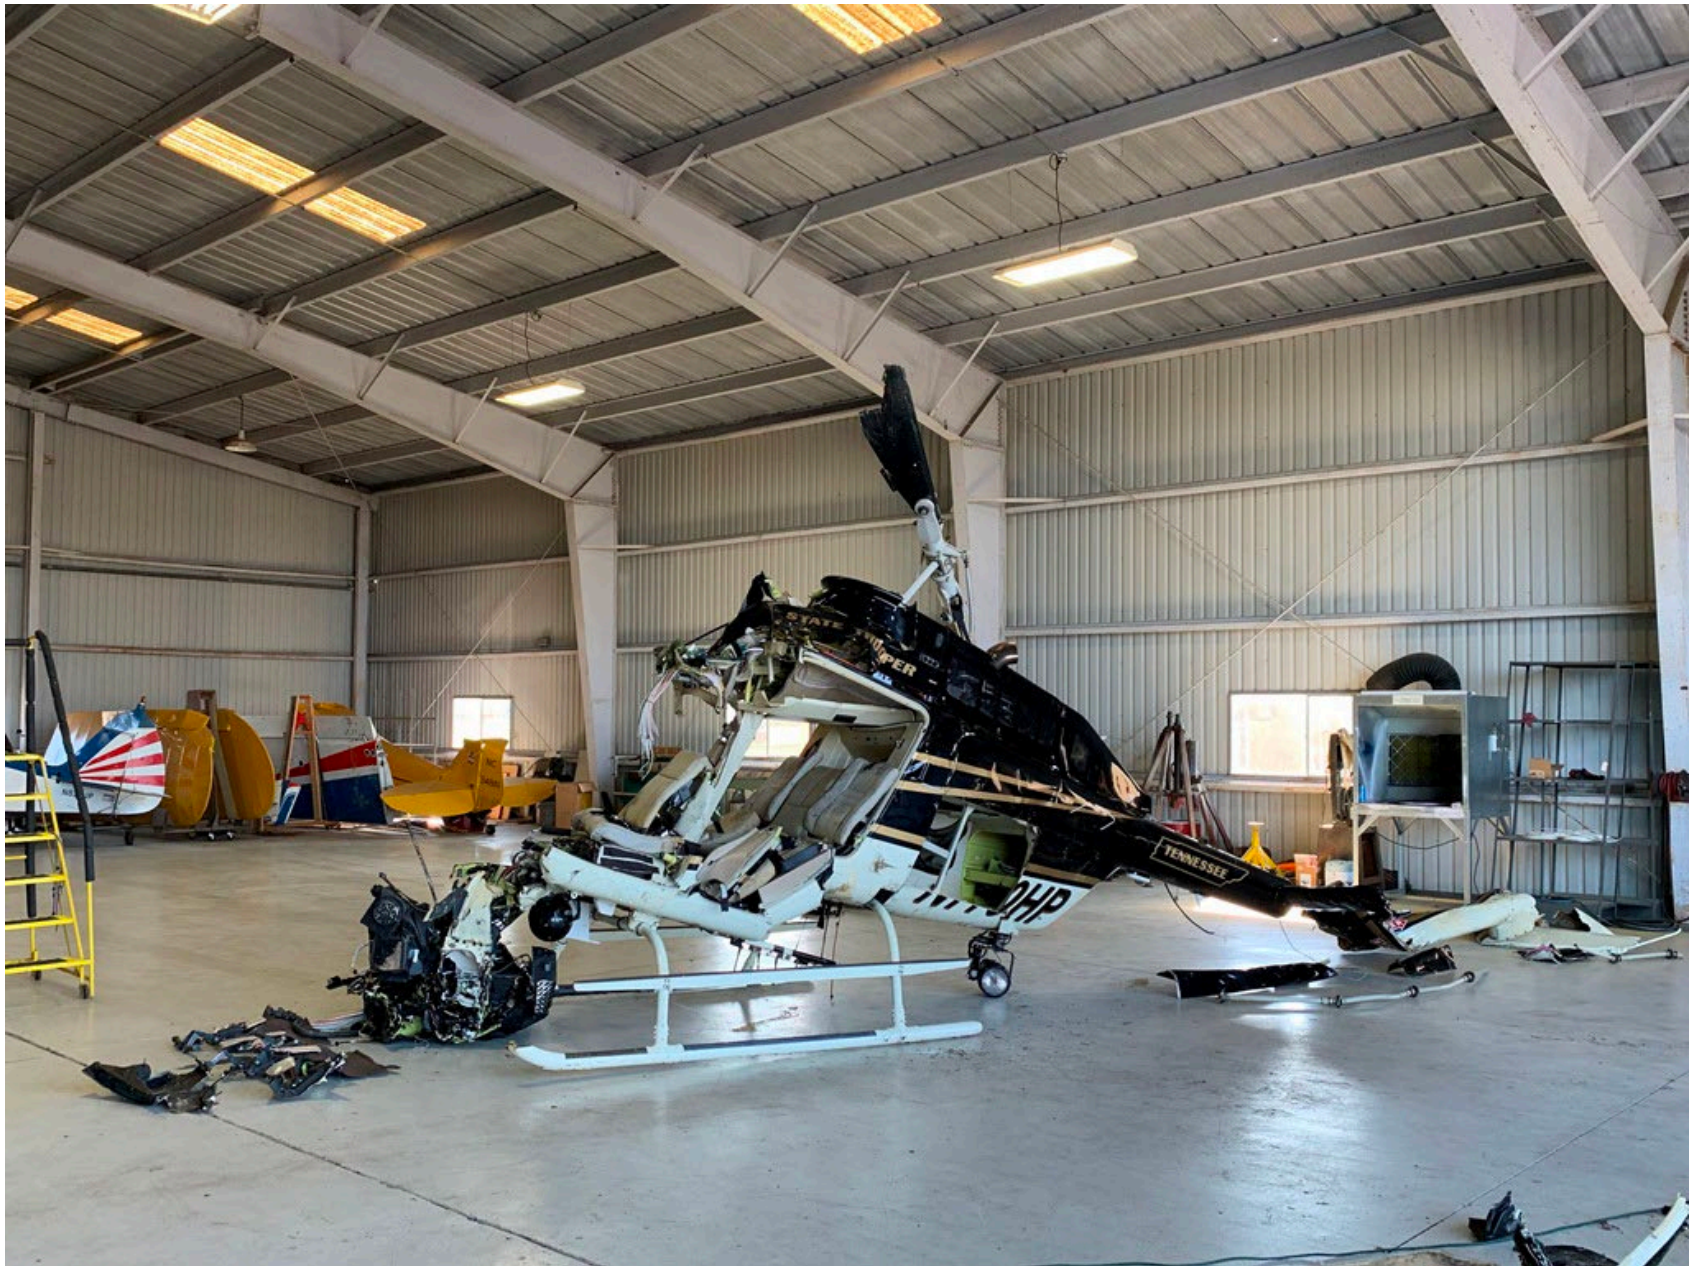
**Photo 7 – Left Side View of Helicopter at Salvage Yard**

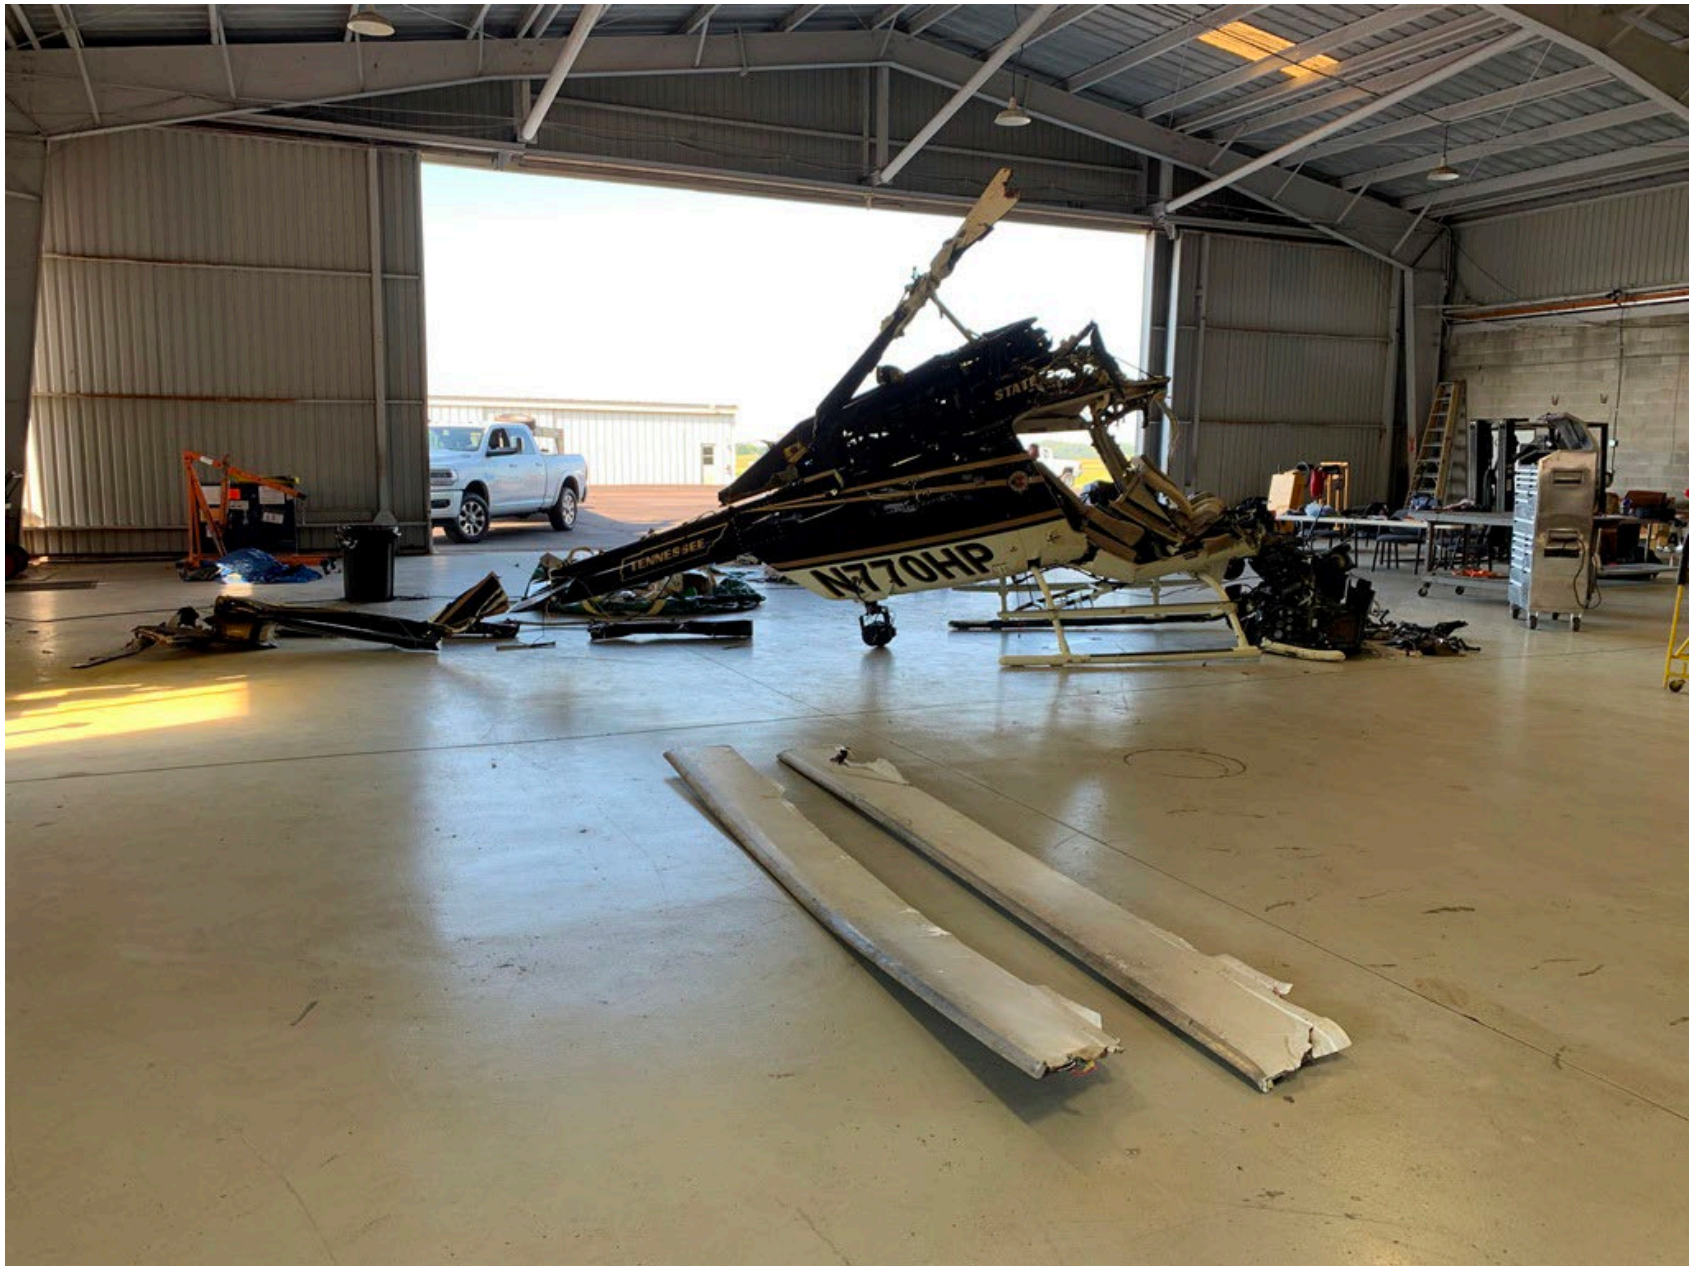
**Photo 8 – Right Side View of Helicopter at Salvage Yard**

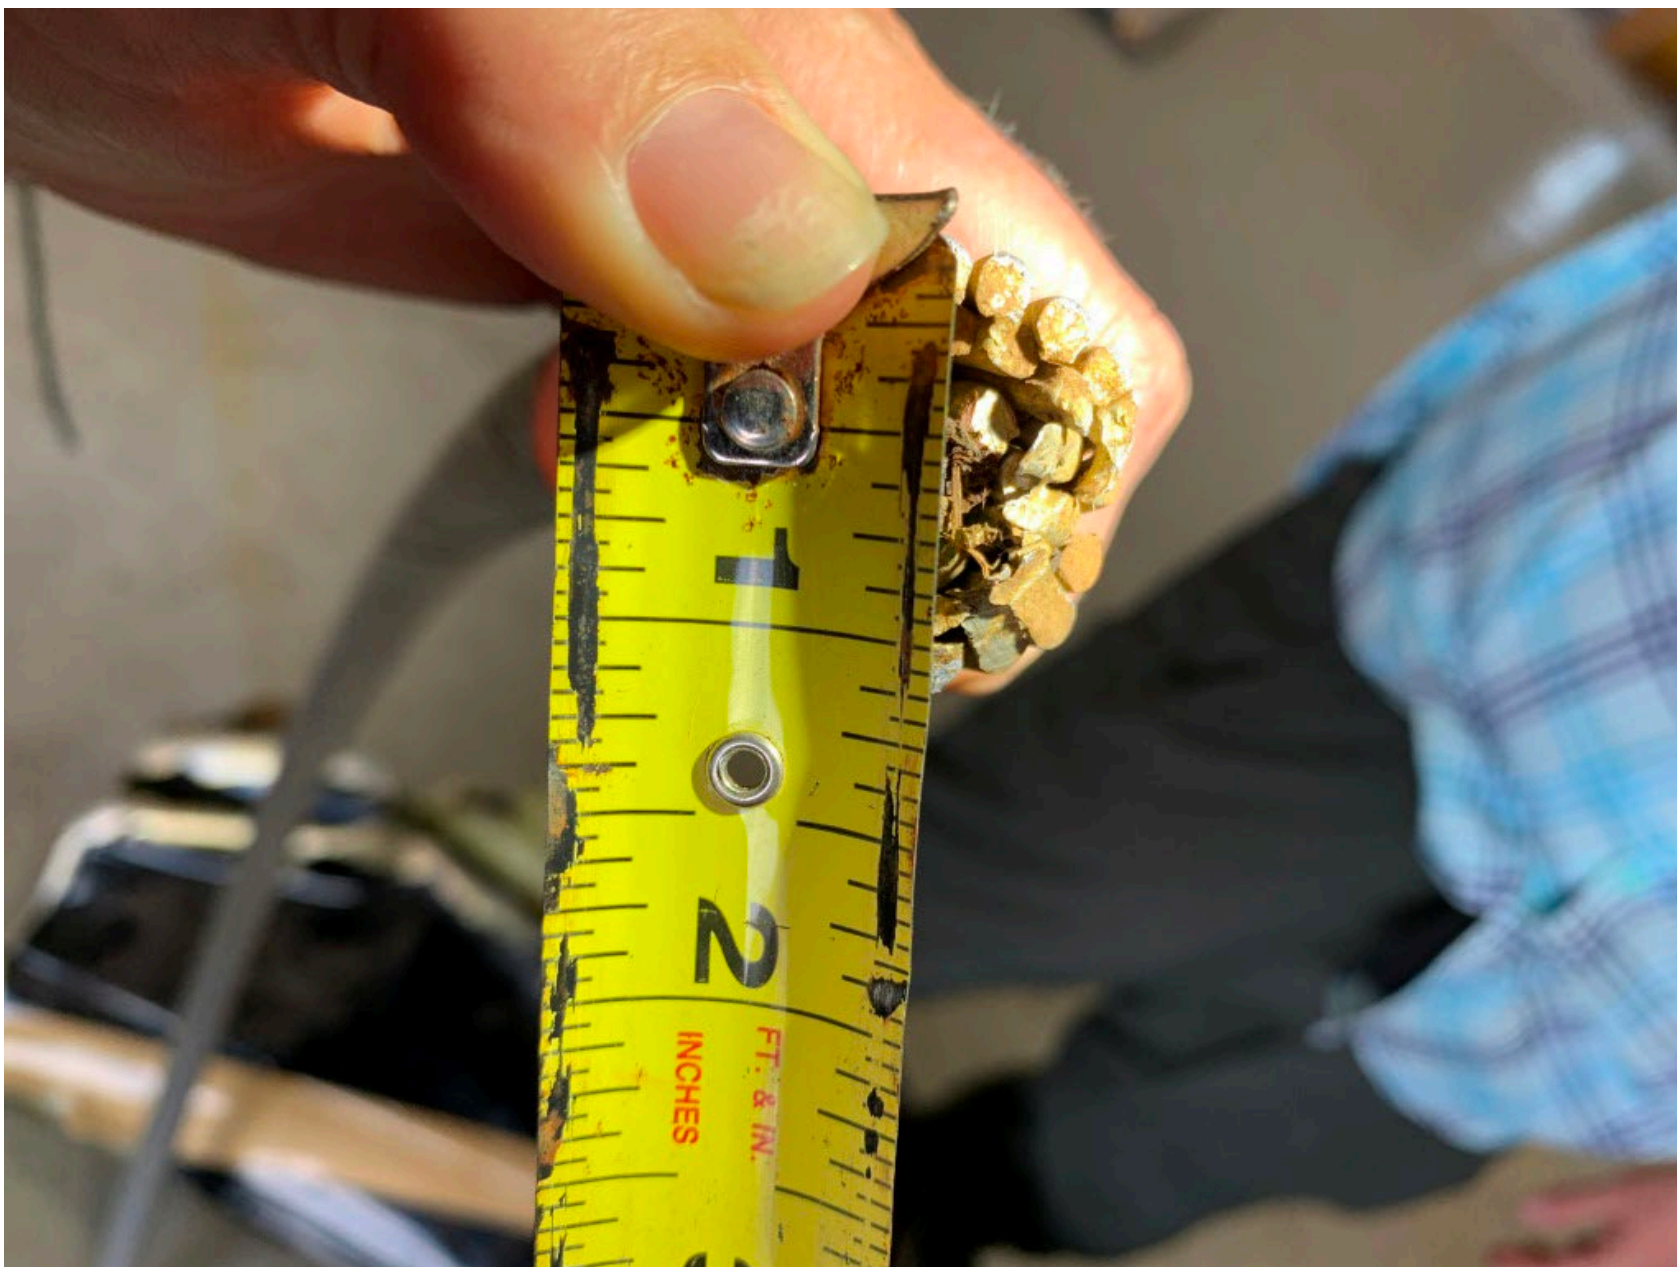
**Photo 9 – Exemplar Section of Powerline Cable**

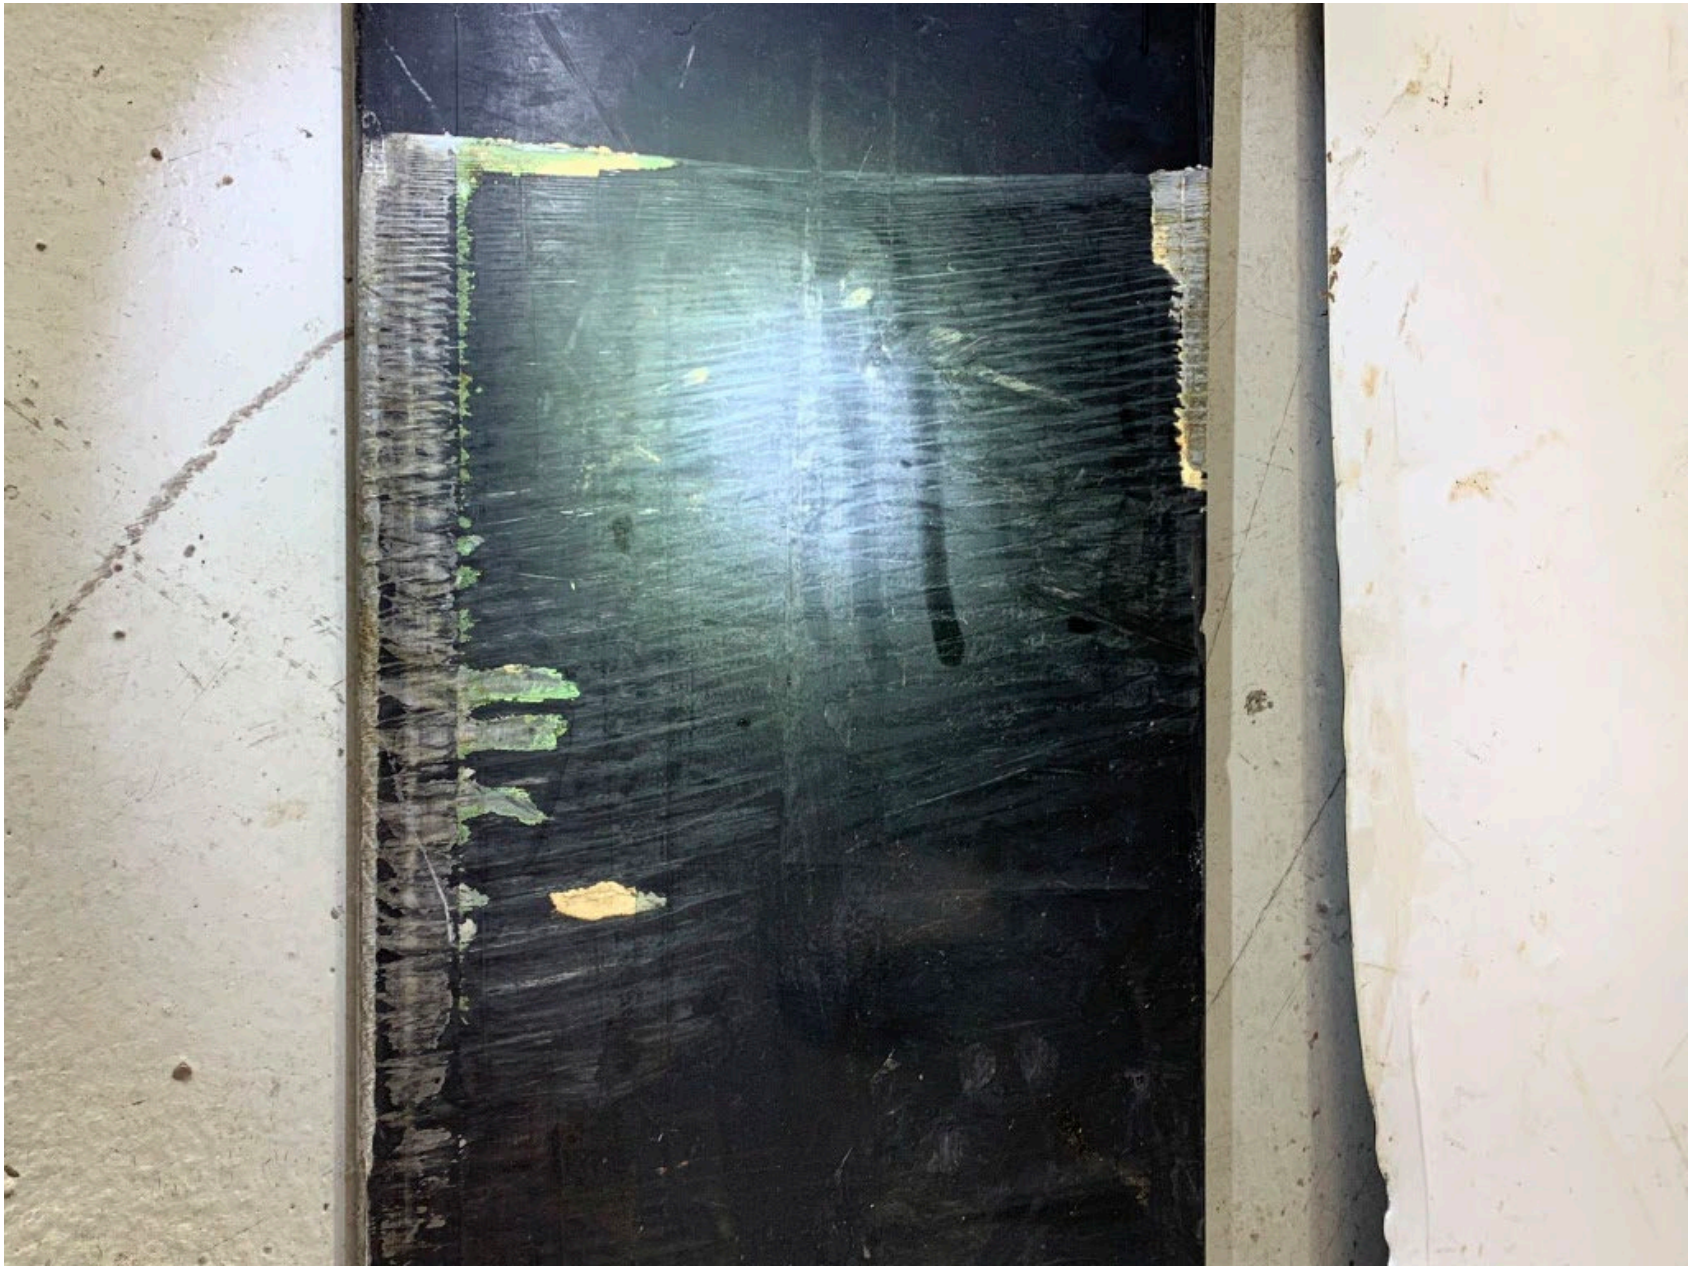
**Photo 10 – Impact Marks/Striations to Bottom of White Main Rotor Blade**

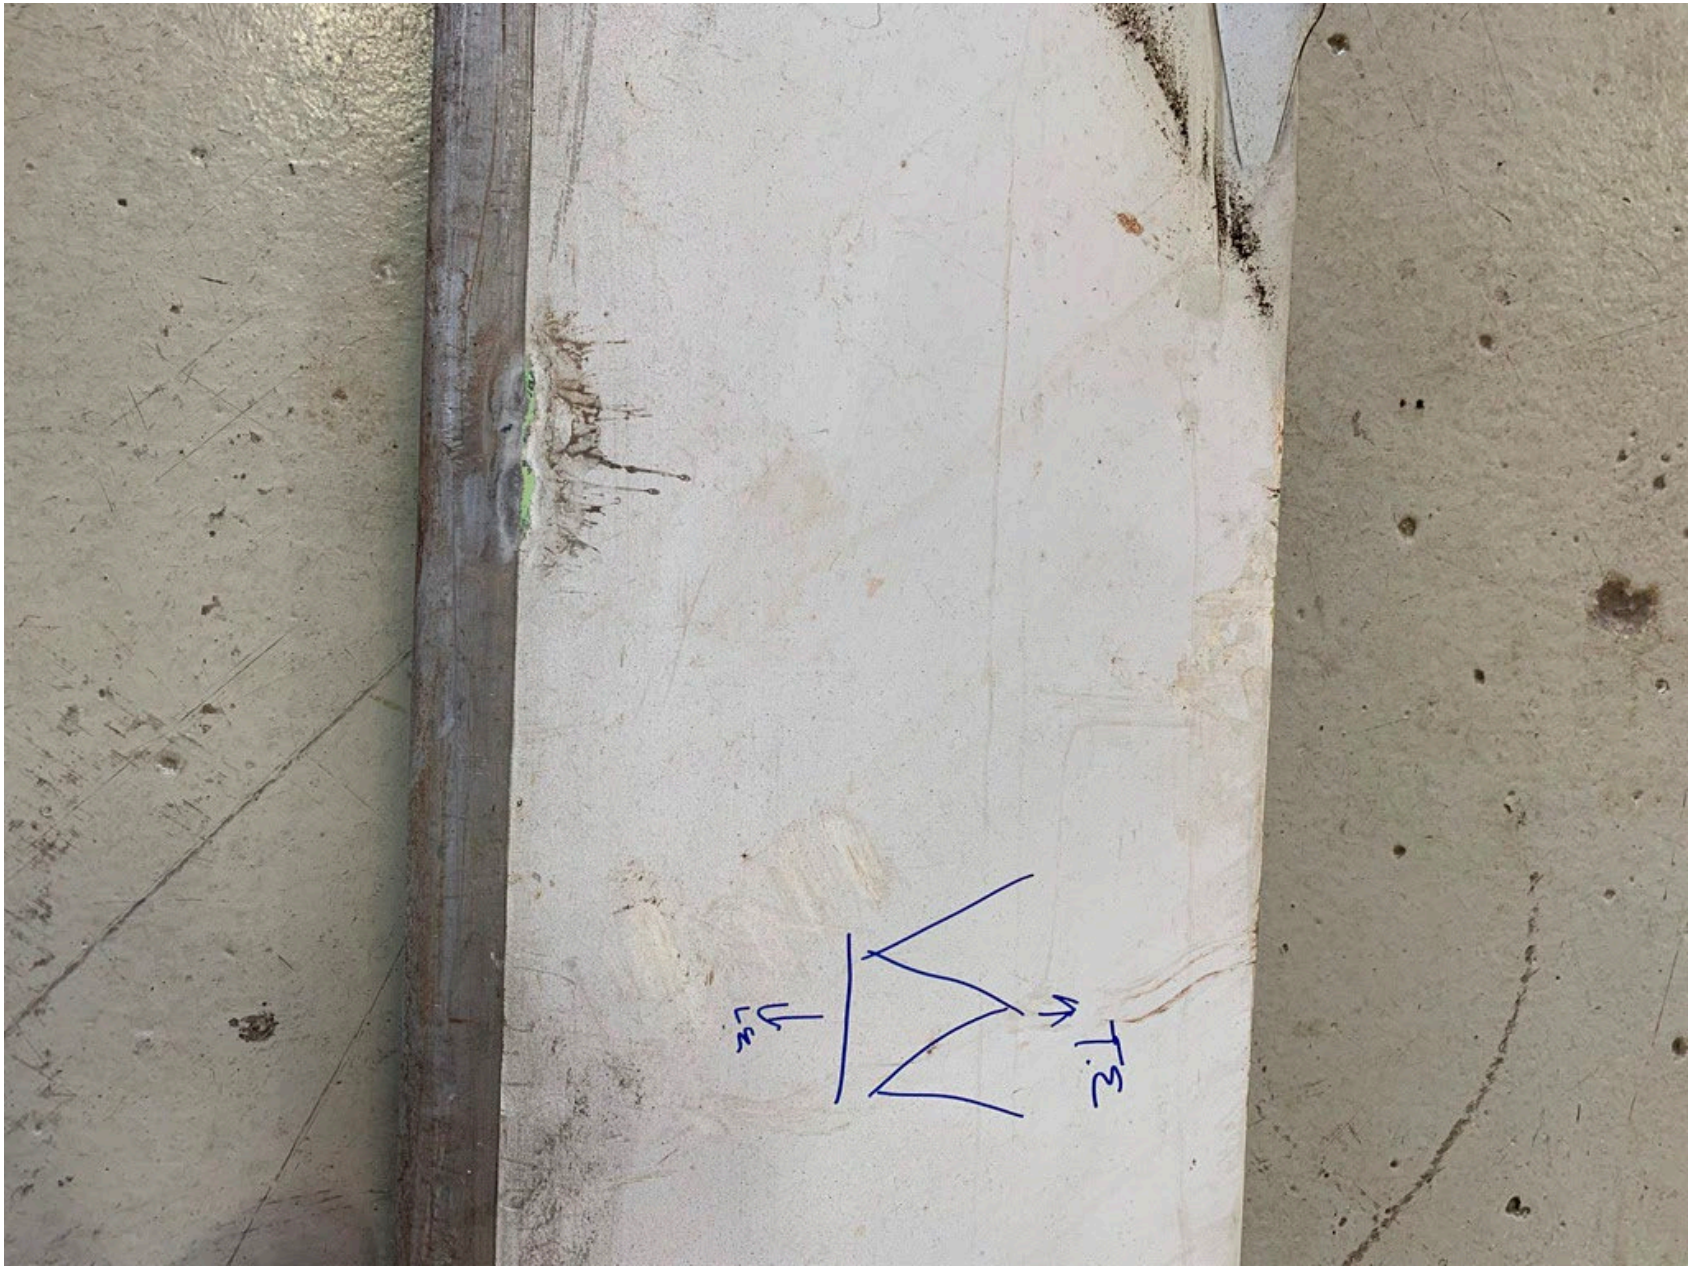
**Photo 11 – Impact Marks/Striations/Arcing to Top of White Main Rotor Blade**

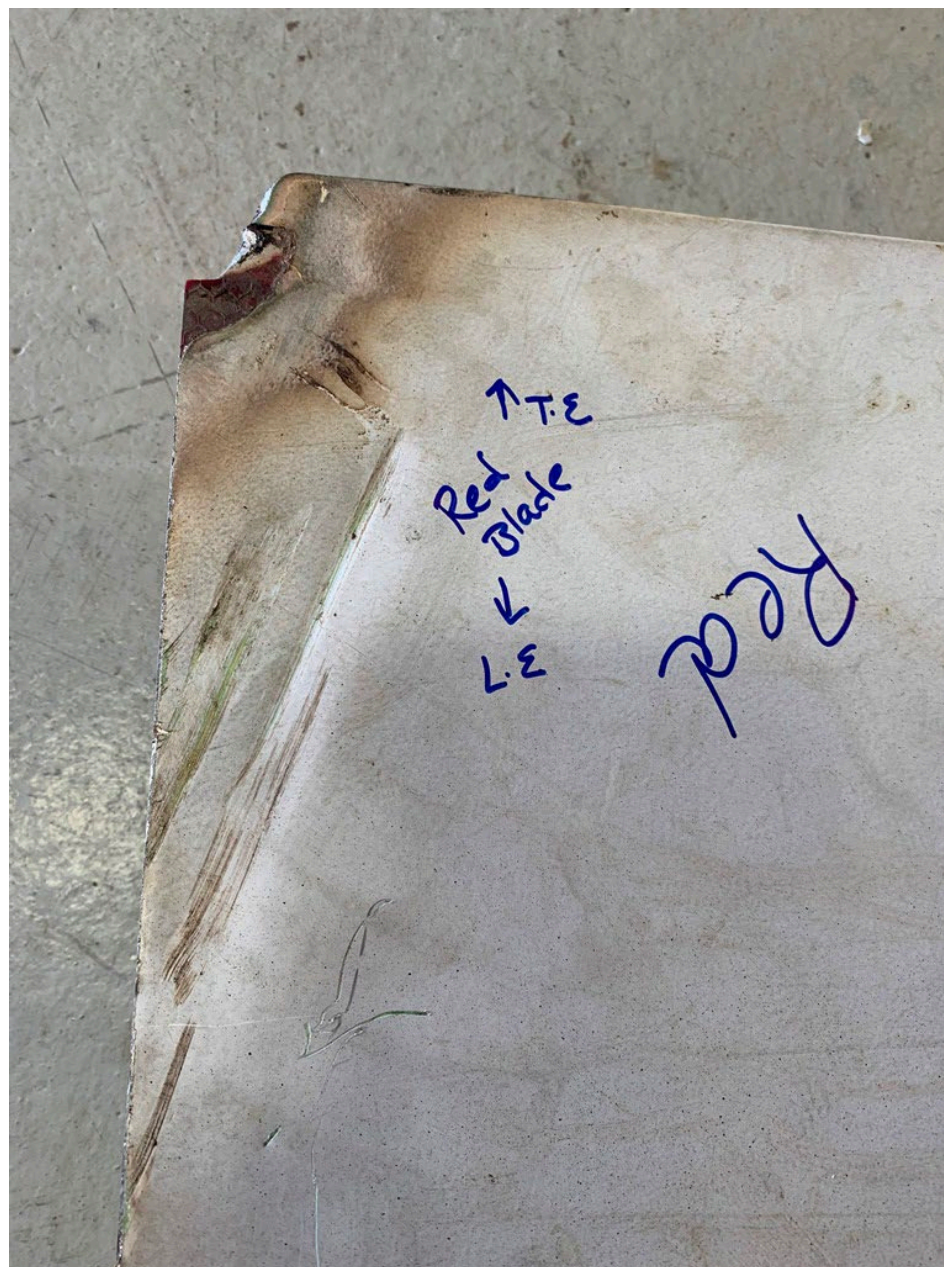
**Photo 12 – Arcing to the Trailing Edge Tip of the Red Main Rotor Blade**
