**From:** [REDACTED]  
**To:** [REDACTED]  
**Subject:** ERA22FA384 - Osteen, FL - Lab exam results  
**Date:** Friday, September 23, 2022 9:41:49 AM  
**Attachments:** [2209Image80483.jpg](#)  
[2209Image80485.JPG](#)  
[2209Image80487.JPG](#)  
[image001.png](#)

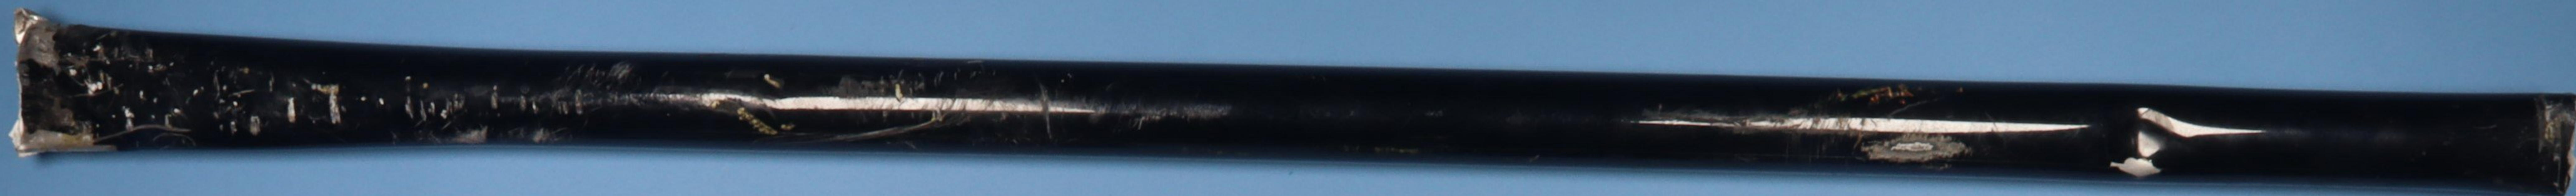
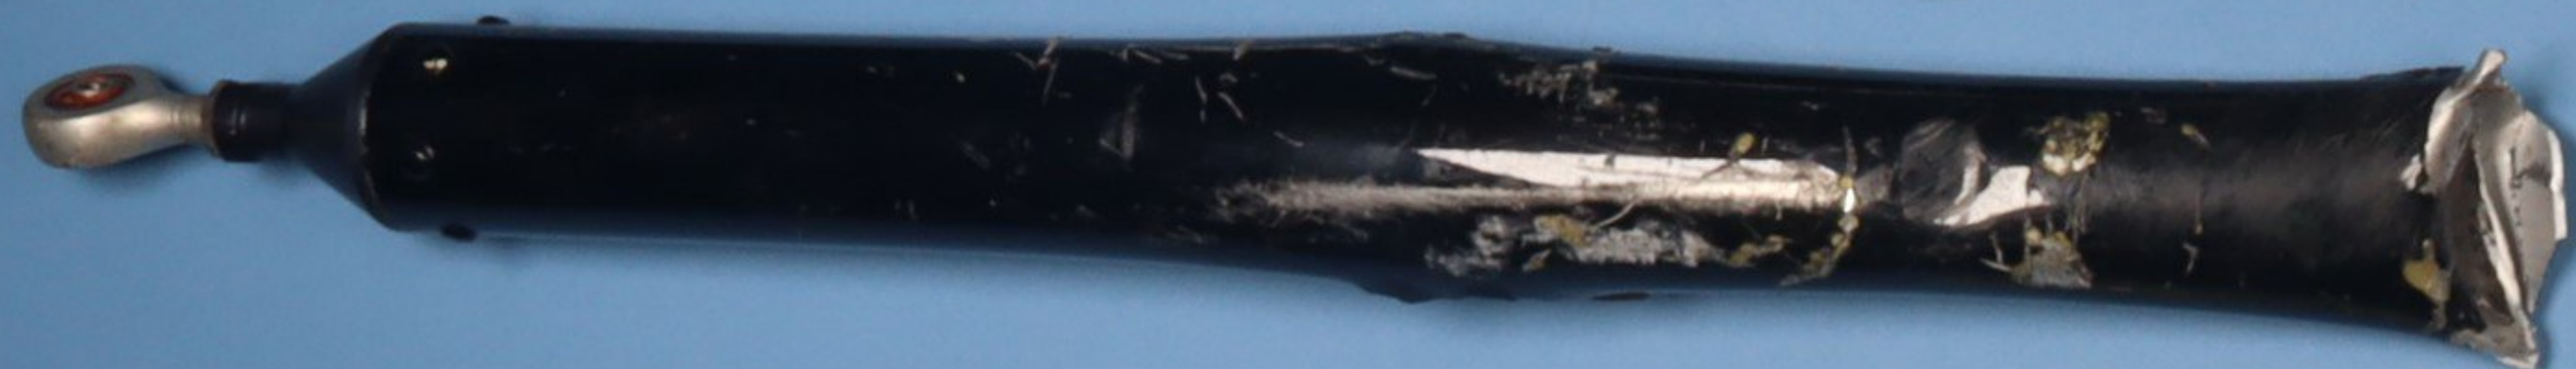
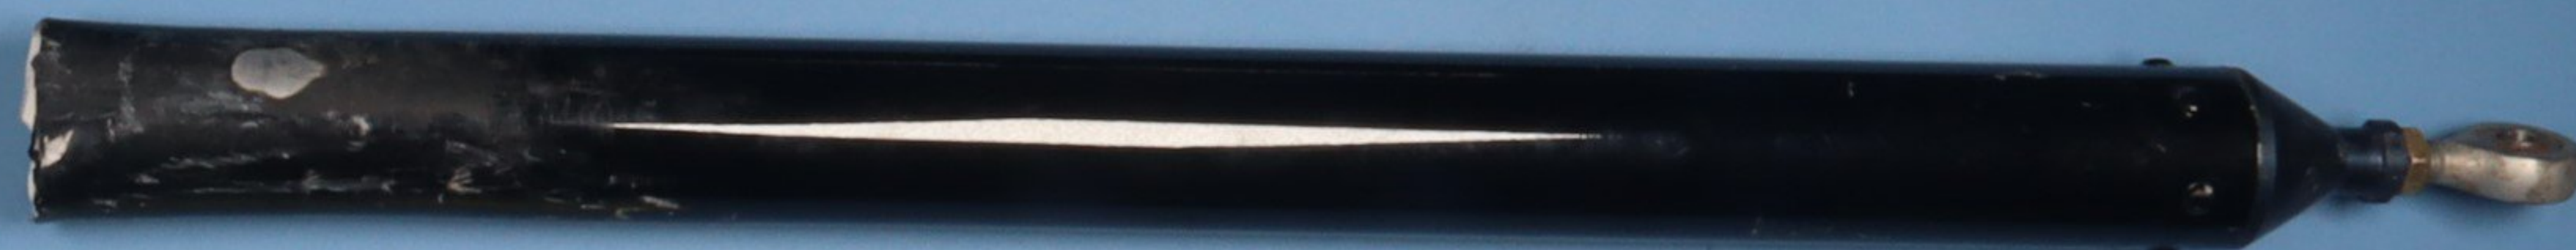
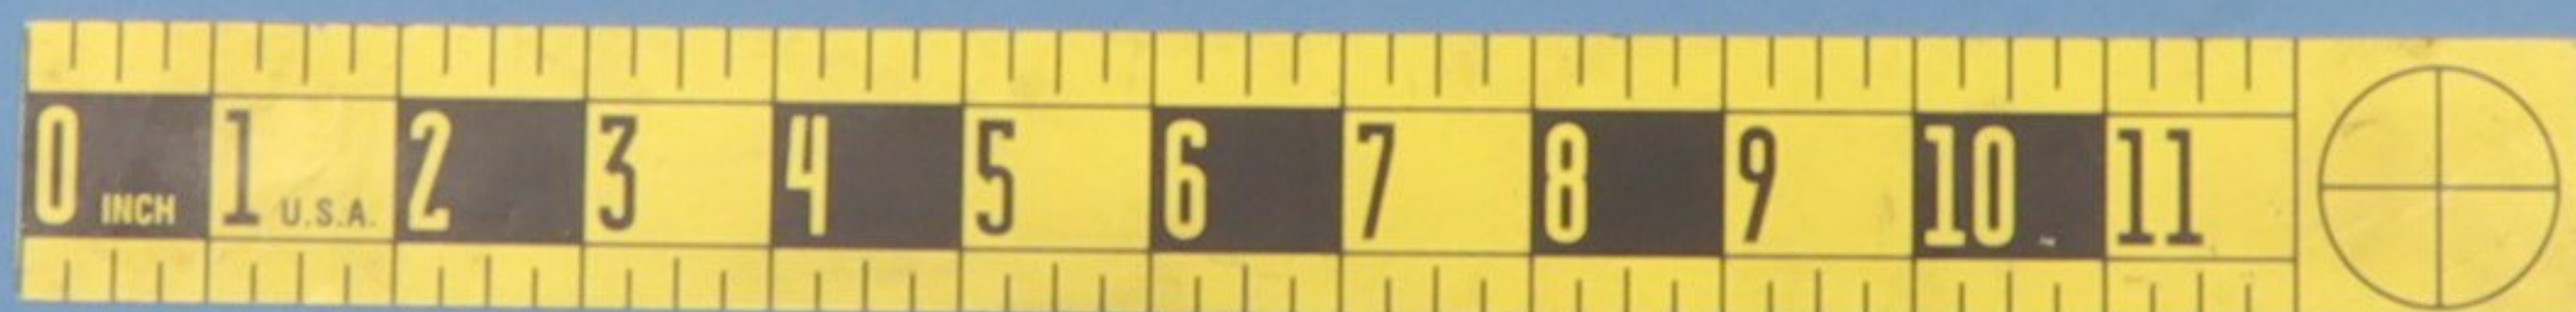
The elevator control tube from the subject investigation (see attached photos) was examined visually and under an optical stereomicroscope. The control tube was fractured at two locations. Both fractures were associated with contact damage adjacent to the fracture location. The fractures occurred on slant angles and had matte gray features consistent with ductile overstress fracture. No evidence of preexisting damage was observed.
