## **NATIONAL TRANSPORTATION SAFETY BOARD**

# **EXAMINATION SUMMARY**

**ERA22FA384**

Location: Osteen, Florida  
Date: August 24, 2022  
Time: 1639 EDT  
Airplane: MXR Technologies MX2, N263MX

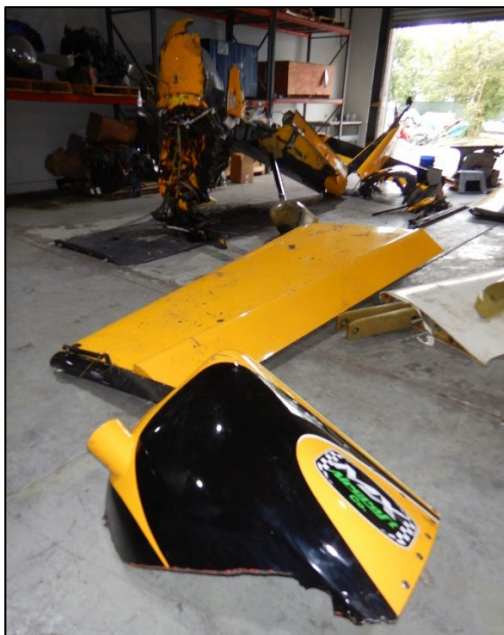
*Photo 1 - Wreckage from front before layout and examination*

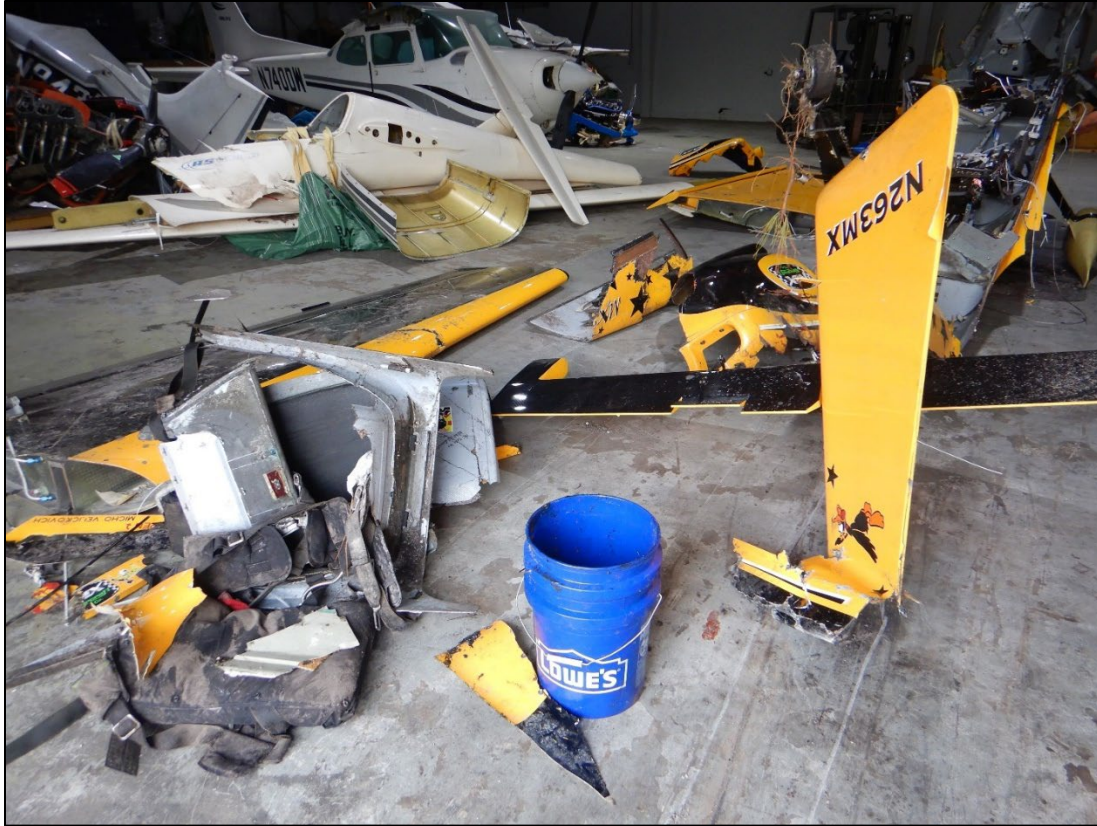
*Photo 2 - Wreckage from rear before layout and examination*

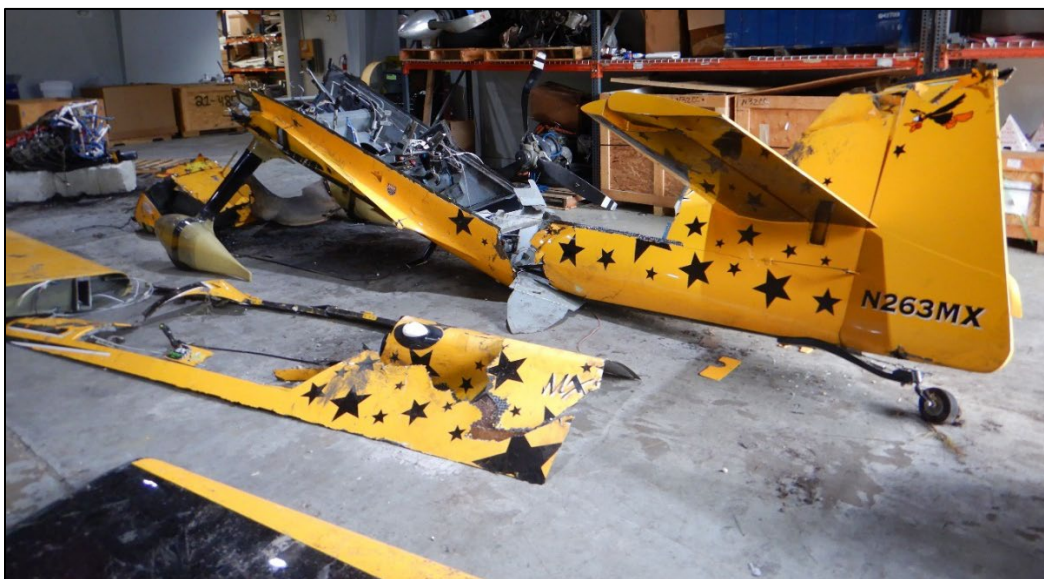
The lower fuselage structure was intact to the just aft of the rear pilot seat and bulkhead, and the canopy frame and other pieces of the canopy were fractured along the bond line to the lower

*Photo 3- Fuselage, empennage and fractured canopy structure*

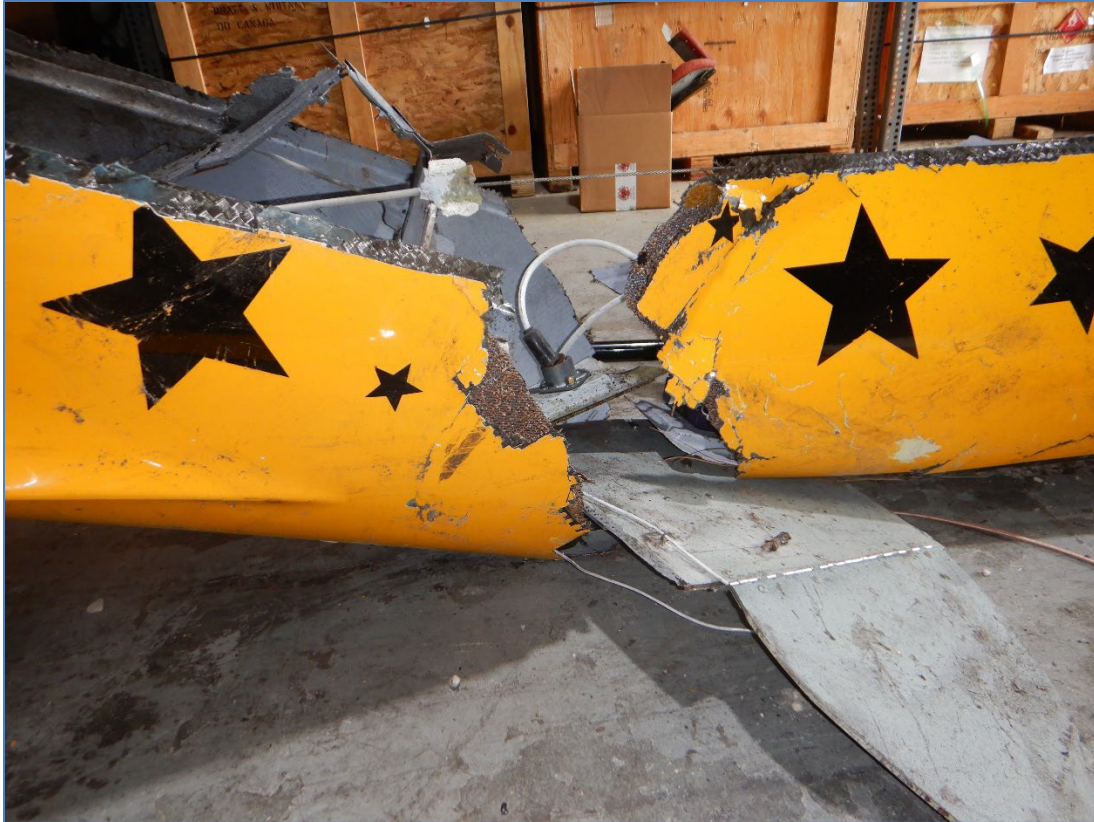
The empennage was intact although fractured along the bond line of its upper and lower surfaces and separated from the fuselage aft of the rear bulkhead. The elevators remained attached to the horizontal stabilizer and the rudder remained attached to the vertical stabilizer at the bottom attachment point. The top front section of the vertical stabilizer was missing forward of the top rudder attachment point.

*Photo 4 - Fuselage fracture aft of rear bulkhead*

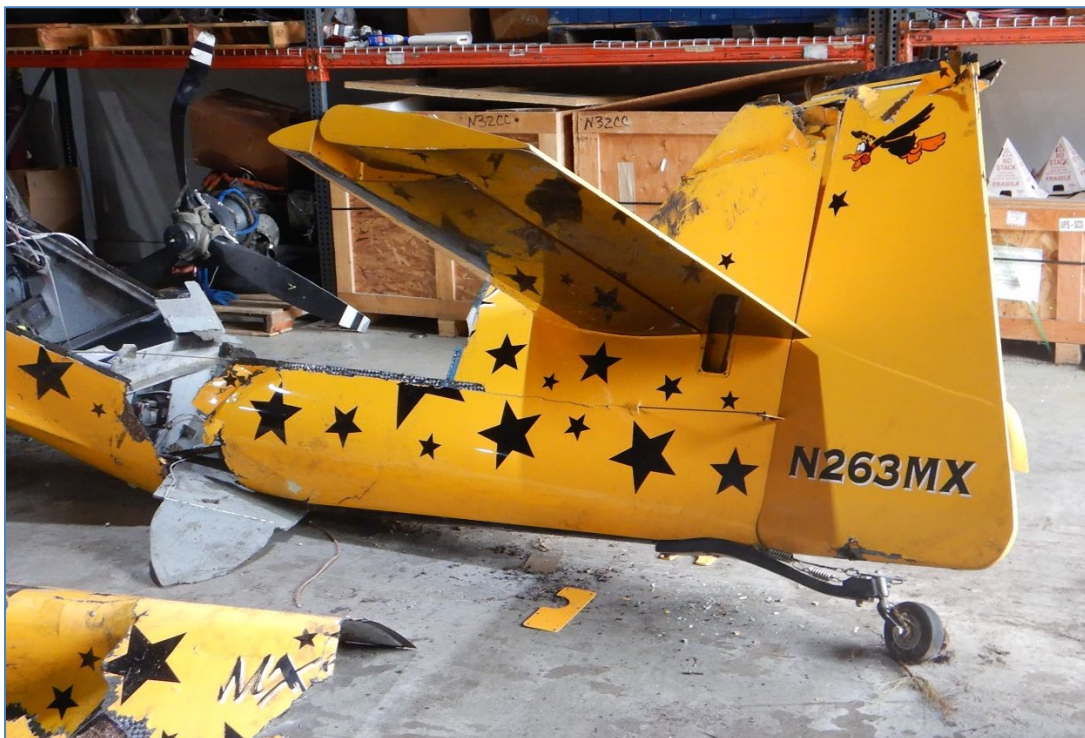
*Photo 5- Empennage*

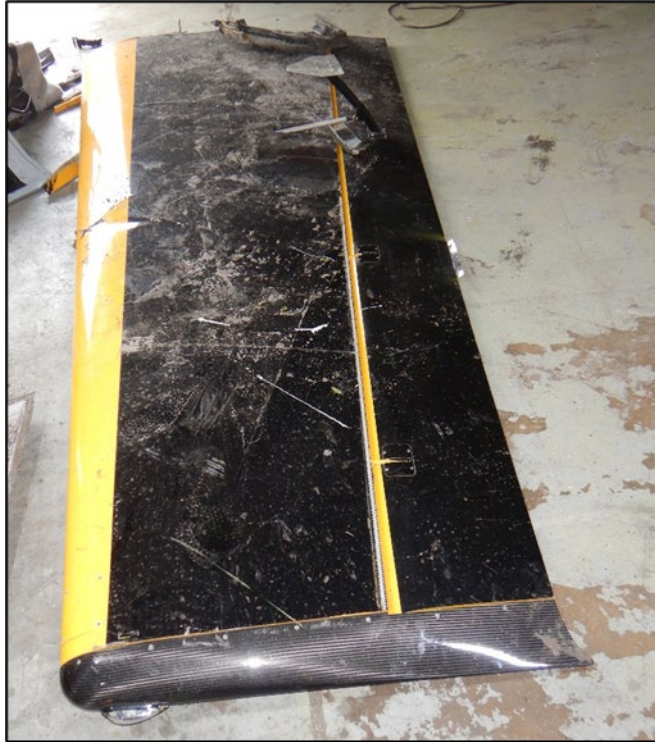
The left wing with aileron and aileron spade blade intact displayed no fractures or leading edge damage. The right wing with aileron and aileron spade blade intact displayed a tear-fracture mid-span with deformation to the second most outboard aileron attachment point. Recovery personnel stated that they cut through all rods, hoses, and spars when they removed the wings for recovery and that a total of 10-15 gallons of fuel drained from the wings (in total). About 1/2 gallon of fuel drained from the right wing fuel line when the wing was turned upright during the examination.

*Photo 6 - Inverted right wing with aileron spade blade*

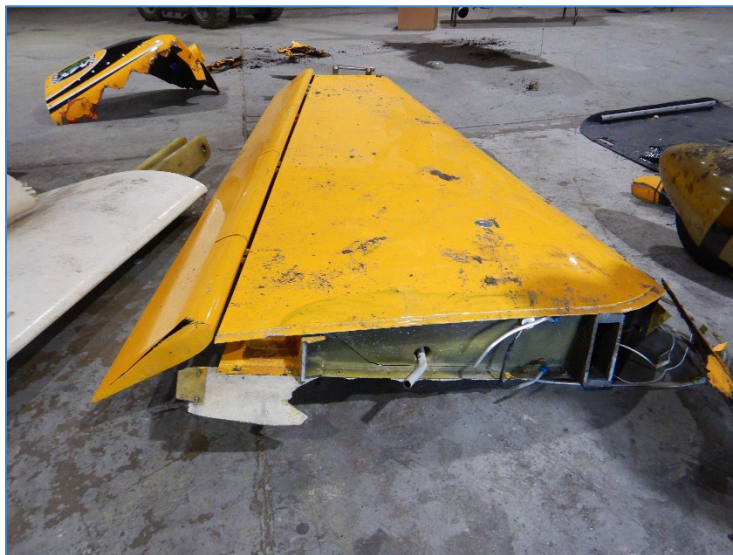
*Photo 7 - Left Wing*

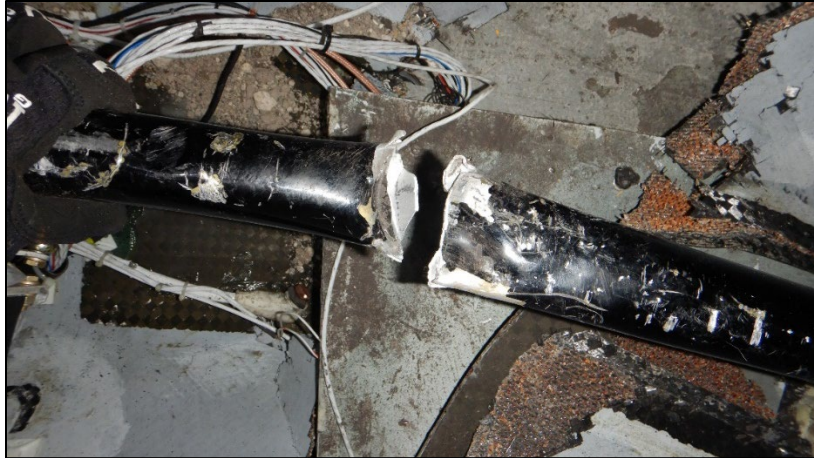
Elevator control continuity was confirmed from the cockpit control column to just aft of the lower bulkhead behind the rear pilot seat, where there was a bend fracture 17 1/2 inches aft of the elevator torque tube end fitting. Recovery personnel stated that this torque tube was very bent but still intact until they attempted to load the fuselage onto the trailer for recovery. There was a 40-inch span of torque tube leading to a second fracture about 20.5 inches forward of the aft bell crank. This fracture corresponded to where the torque tube was positioned at the aft bulkhead opening with the elevator control surface in the full upward position. The torque tube passed through the bulkhead opening 16 inches forward of the aft bell crank with the elevator control surface in the full down position. Examination of the aft fracture surface revealed deformation of

*Photo 8 - Close-up photo of forward elevator torque tube fracture*

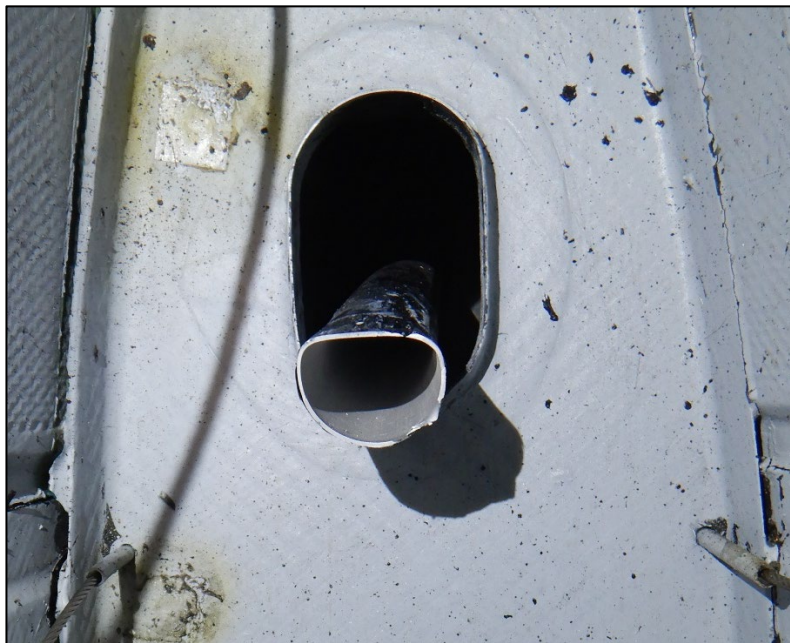
*Photo 9 - Photo of aft elevator torque tube fracture at rear bulkhead*

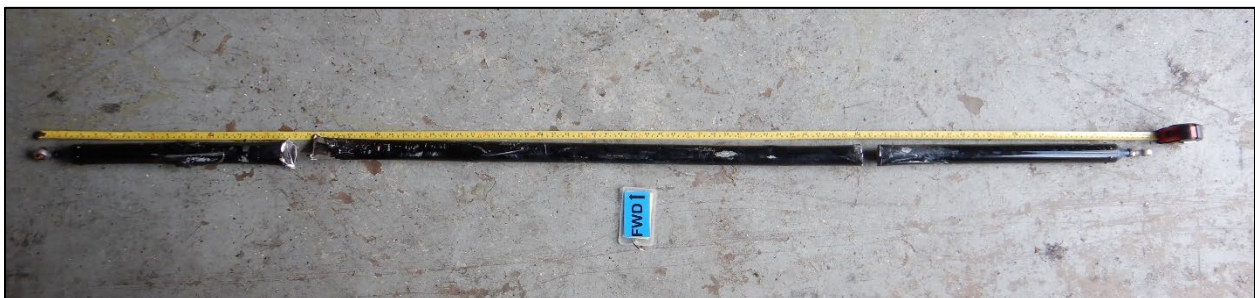
the torque tube and paint transfer 5-6 inches aft of the fracture. Examination of the center span of the fractured torque tube revealed a “dent” with chipped paint about 7 inches forward of the aft fracture, and abrasion damage about 3 inches farther forward. All three sections of the fractured elevator torque tube were sent to the NTSB Materials Lab for more detailed examination.

*Photo 10 - Elevator control tube with fractures after removal*

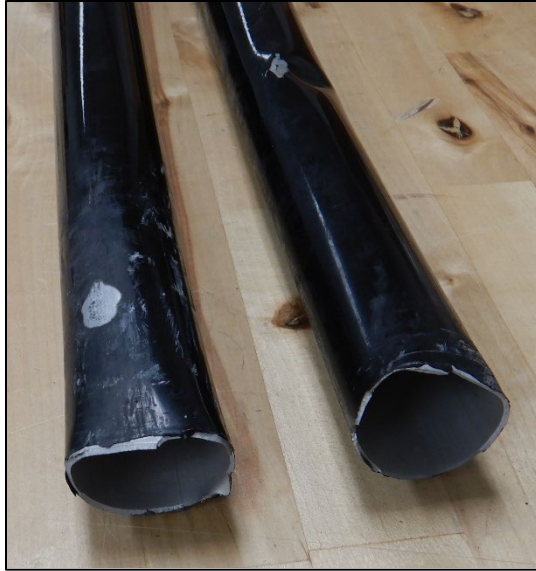
*Photo 11 - Aft fracture surfaces of elevator torque tube and abrasion damage*

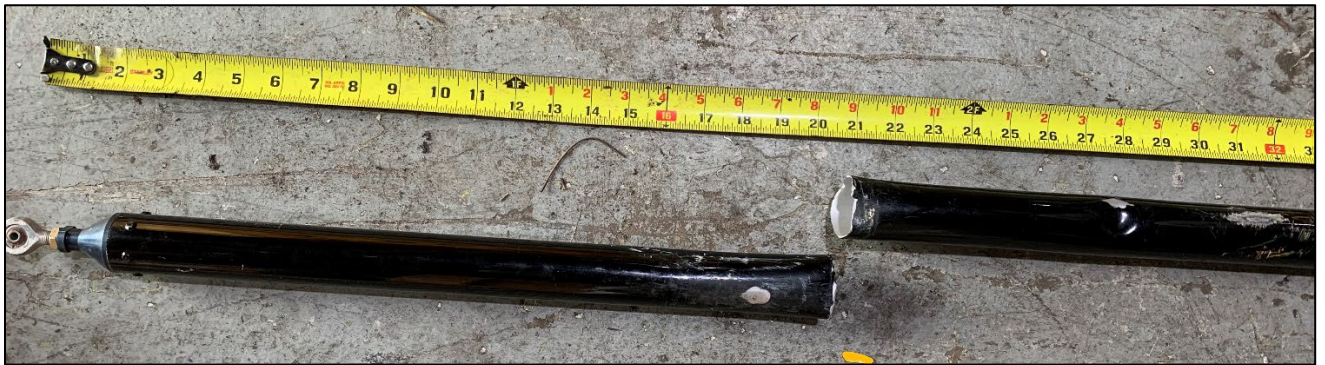
*Photo 12 - View of aft elevator torque tube fracture and abrasion*

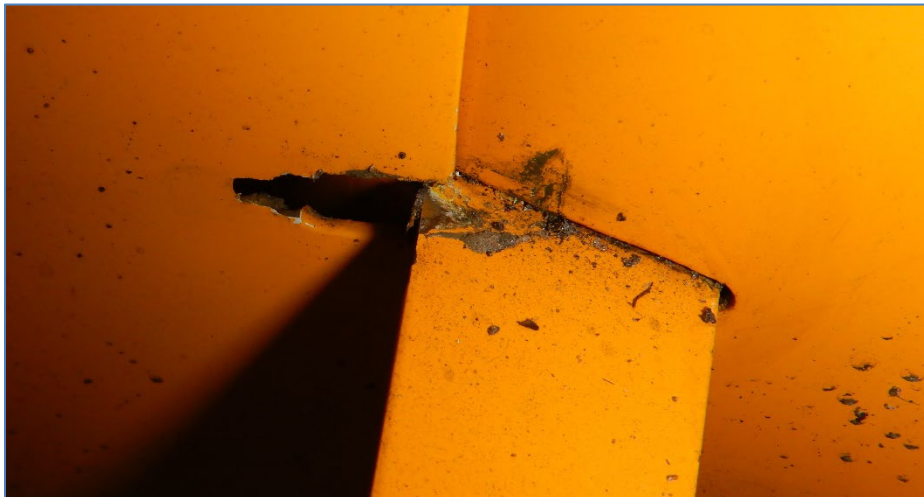
Left rudder continuity was confirmed from the cockpit rudder controls to the control surface. Right rudder continuity was confirmed from the cockpit to the control surface thru a cut made for recovery. Examination of the tailcone revealed damage to the left empennage where the rudder control cable exited the empennage to attach to the rudder control horn. Examination of the rudder control horns revealed chipped paint and deformation on the left rudder control horn and chipped paint on the right rudder control horn resulting from empennage contact. The rudder cables had detached from their interior empennage attachment points.

*Photo 13 - Close-up view of left rudder horn and empennage damage*

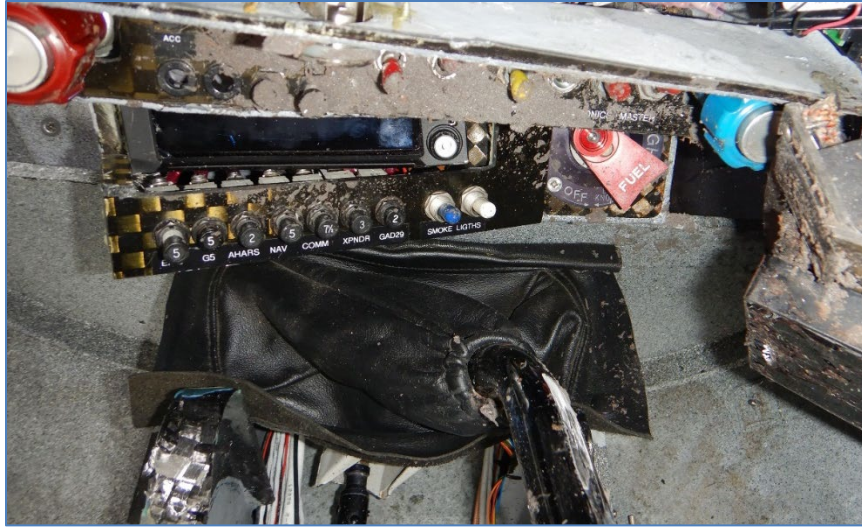
The propeller and mixture control knobs were fully forward. The cockpit throttle control lever was detached and observed.

*Photo 14 - Cockpit controls*

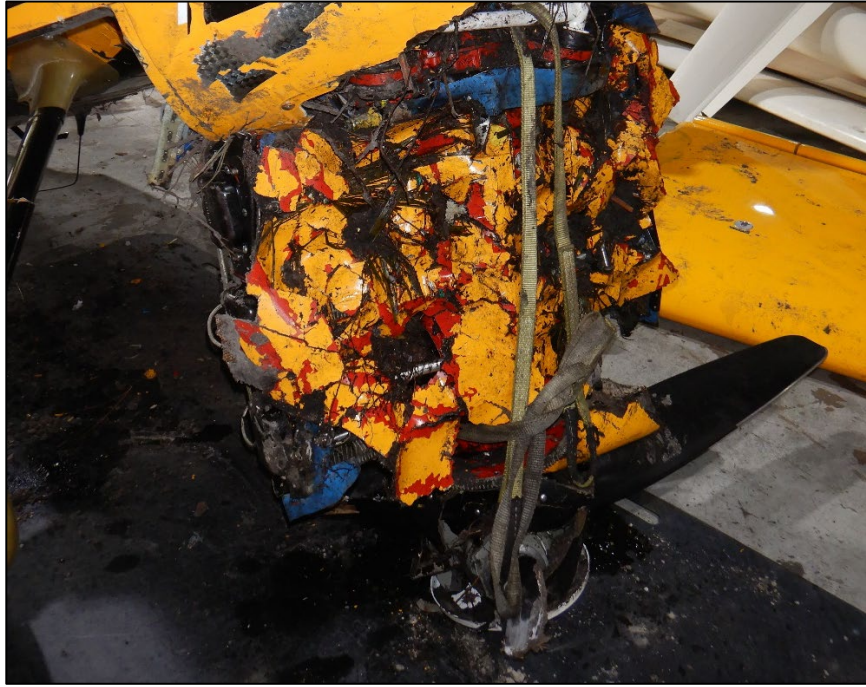
The nose section was suspended from a lift and separated from the fuselage. The firewall was removed from the engine tubular mount. The engine was partially disassembled to facilitate the examination. The fuel flow divider, injector lines, pushrod tubes and upper ignition leads were impact damaged. Crankshaft continuity was confirmed from the front to the rear of the engine. When the propeller was rotated, thumb compression and suction was achieved on cylinder Nos 1, 2, 3, 4, and 6. The damaged pushrod tubes and pushrods were removed from cylinder No 5, the crankshaft was turned, and compression and suction was achieved. Borescope examination of the cylinders revealed no anomalies. All piston domes exhibited normal combustion deposits and all intake and exhaust valves were intact and appeared to be in good condition with normal combustion signatures.

*Photo 15 - Engine before examination*

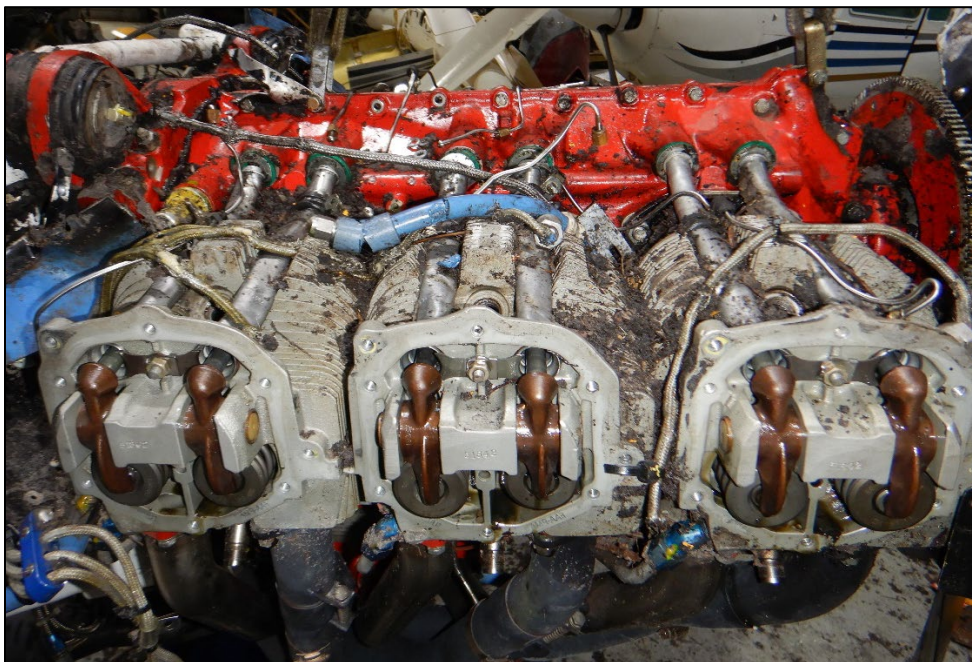
*Photo 16 - Cylinder Nos 5, 3 and 1 with rocker covers removed*

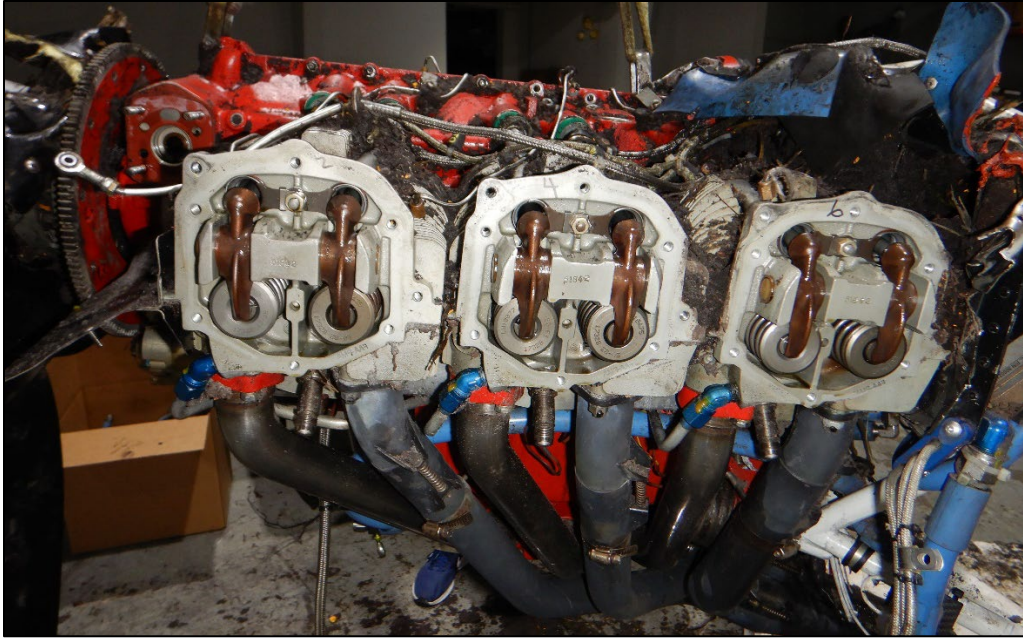
*Photo 17 - Cylinder Nos 2, 4 and 6 with rocker covers removed*

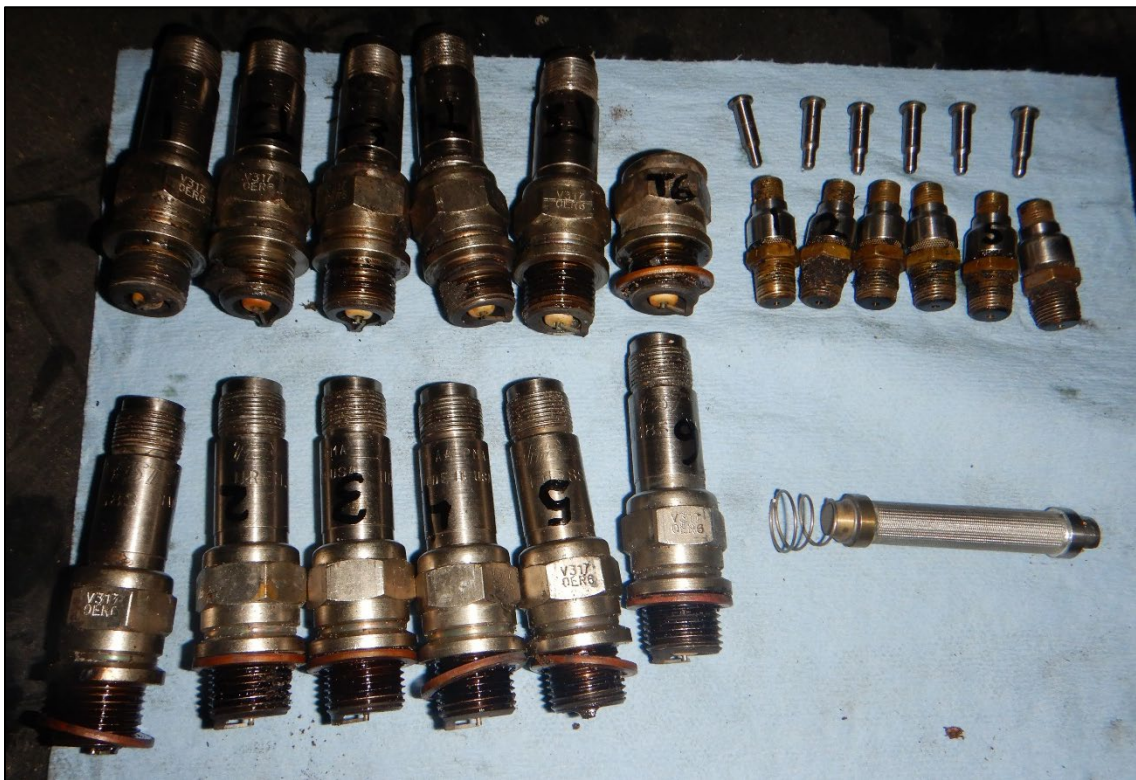
Examination of the fuel injector servo revealed that the servo remained attached to the engine with no external damage noted. The throttle control cable remained attached to the servo throttle arm, and the arm was positioned near the full throttle stop. The mixture control cable remained attached to the servo mixture control arm and was positioned near the full rich stop. The servo was partially disassembled and no damage to the rubber diaphragms or other internal components noted. The servo fuel inlet screen was unobstructed. The fuel flow divider was crushed against the top of the engine with one injector line separated from the flow divider. The flow divider was partially disassembled and no damage to the rubber diaphragm noted. Oily fuel was observed in the flow divider. The 2-piece fuel injector nozzles were unobstructed. The engine driven fuel pump remained attached to the engine and no damage was noted. The pump produced air at the outlet port when actuated by hand. The pump was partially disassembled and no damage to the rubber diaphragms or internal check valves noted. Liquid with an odor consistent with aviation gasoline was observed in the fuel hoses forward of the firewall and in the engine driven fuel pump, fuel injector servo and the fuel flow divider. The aircraft fuel strainer remained attached to the forward surface of the firewall. It was not disassembled.

Both magnetos remained attached to the engine and no external damage was noted. Both magnetos produced spark from all ignition towers when the magnetos were rotated using an electric drill. The spark plug electrodes exhibited dark gray coloration and nearly new condition when compared to Champion Aviation Check-A-Plug Card AV-27. The Nos 4 and 6 top spark plugs were impact damaged. The No 3 top and the Nos 1, 3, and 5 bottom spark plugs were oil soaked. The ignition harness exhibited substantial impact damage and was not tested. The starter remained attached to the engine with no damage noted. The alternator was impact separated from the engine with no external damage noted.

*Photo 18 - Spark plugs, fuel servo inlet screen and fuel injector nozzles*
