**NATIONAL TRANSPORTATION SAFETY BOARD**  
Office of Aviation Safety

**Engine Examination**

**A. ACCIDENT      ERA22FA386**

Location:            French Lick, IN  
Date:                August 27, 2022  
Time:                2104 Eastern Daylight Time (EDT)  
Operator/Pilot:    Robert Charles Flick  
Aircraft:           Beechcraft B-35  
Engine:            Continental, E-185 sn 26791-D-4-8-R  
Registration:      N8741A

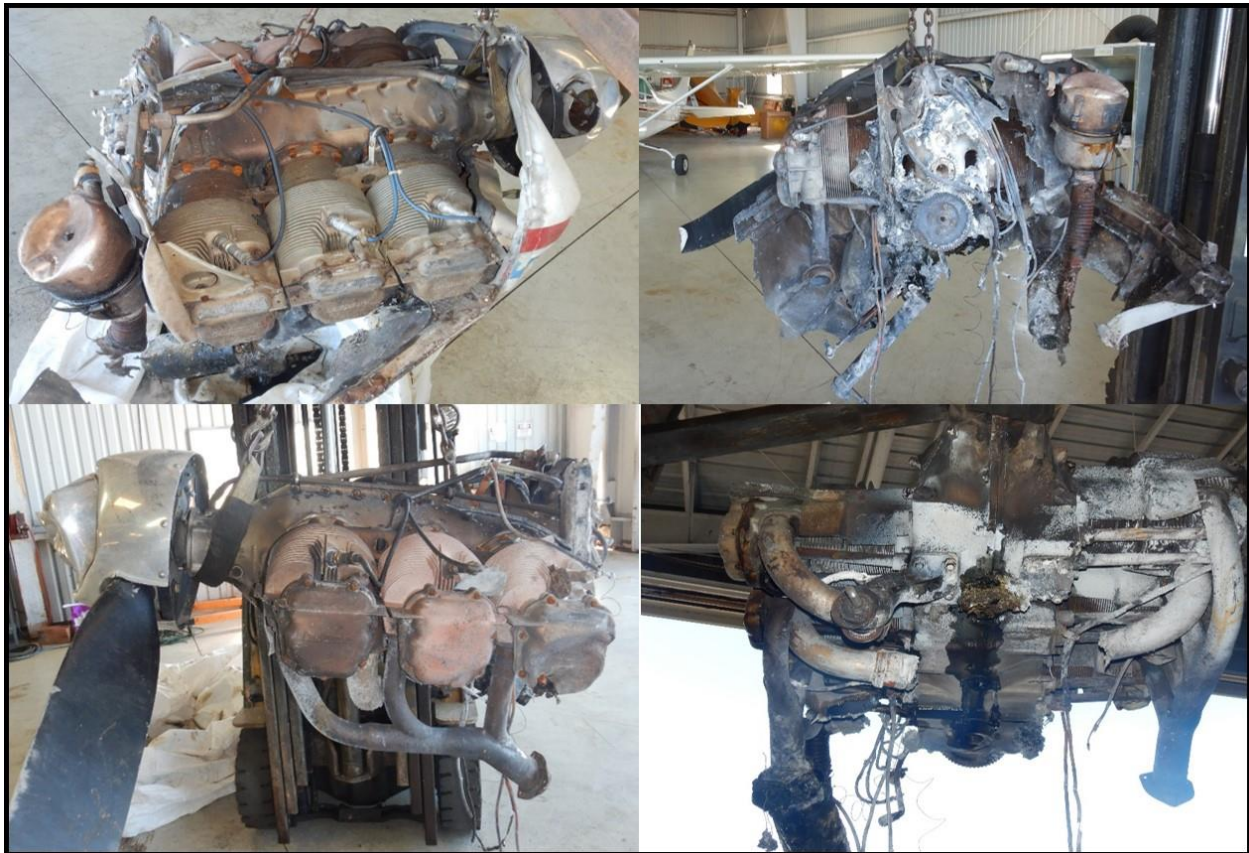
*Photograph 1 – Accident airplane engine at recovery facility.*

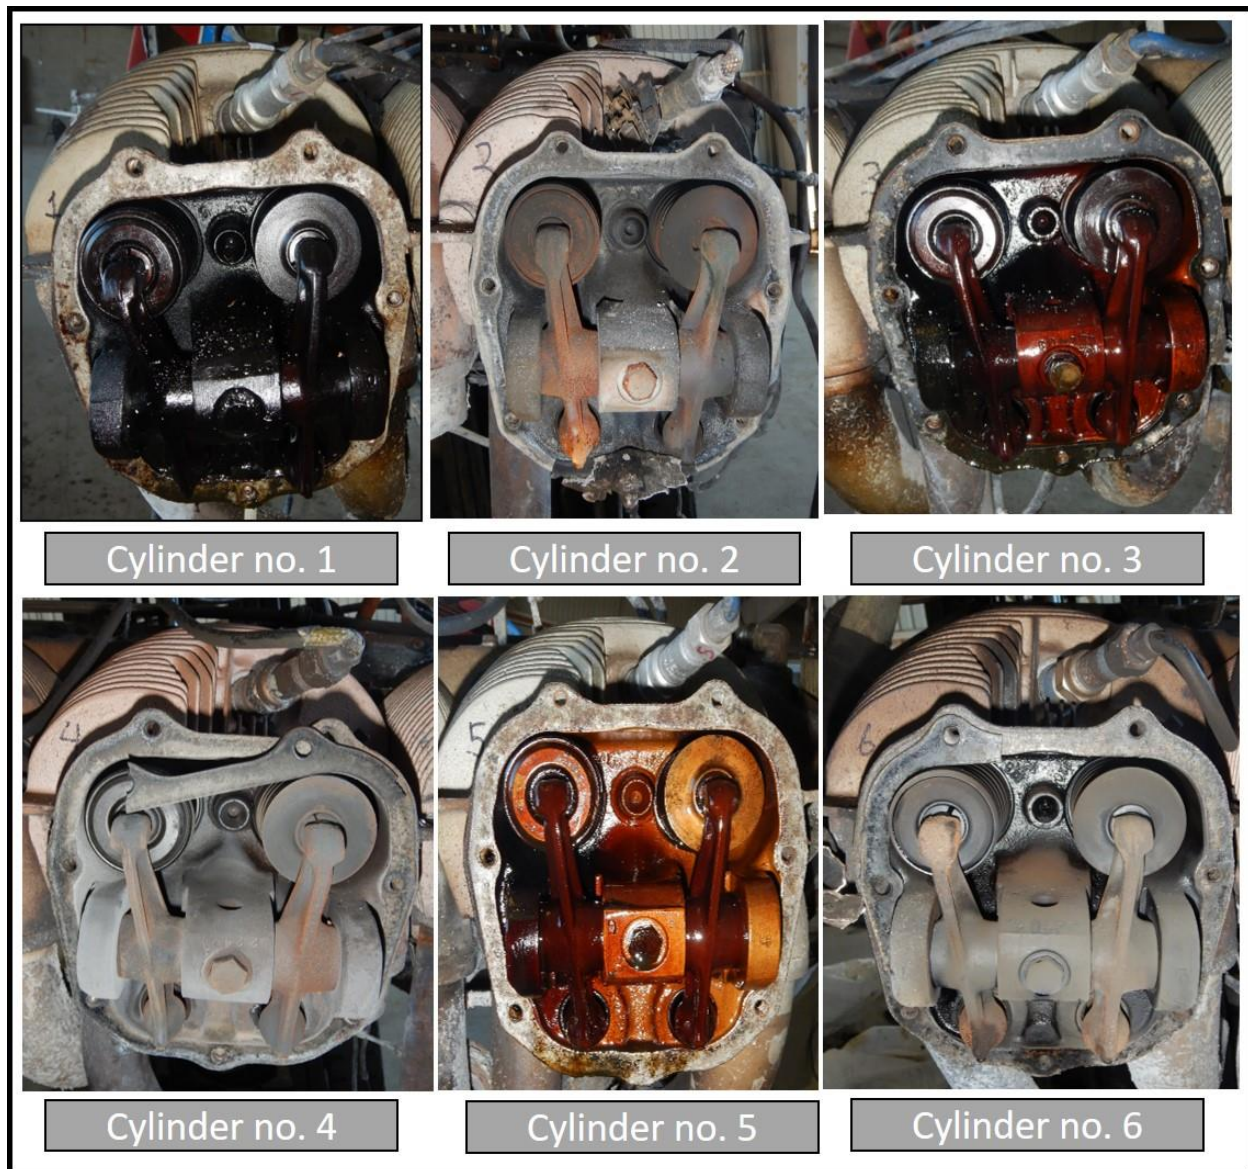
The rocker covers were removed exposing the cylinder valves stems, springs and rocker arms.

*Photograph 2 –Cylinders*

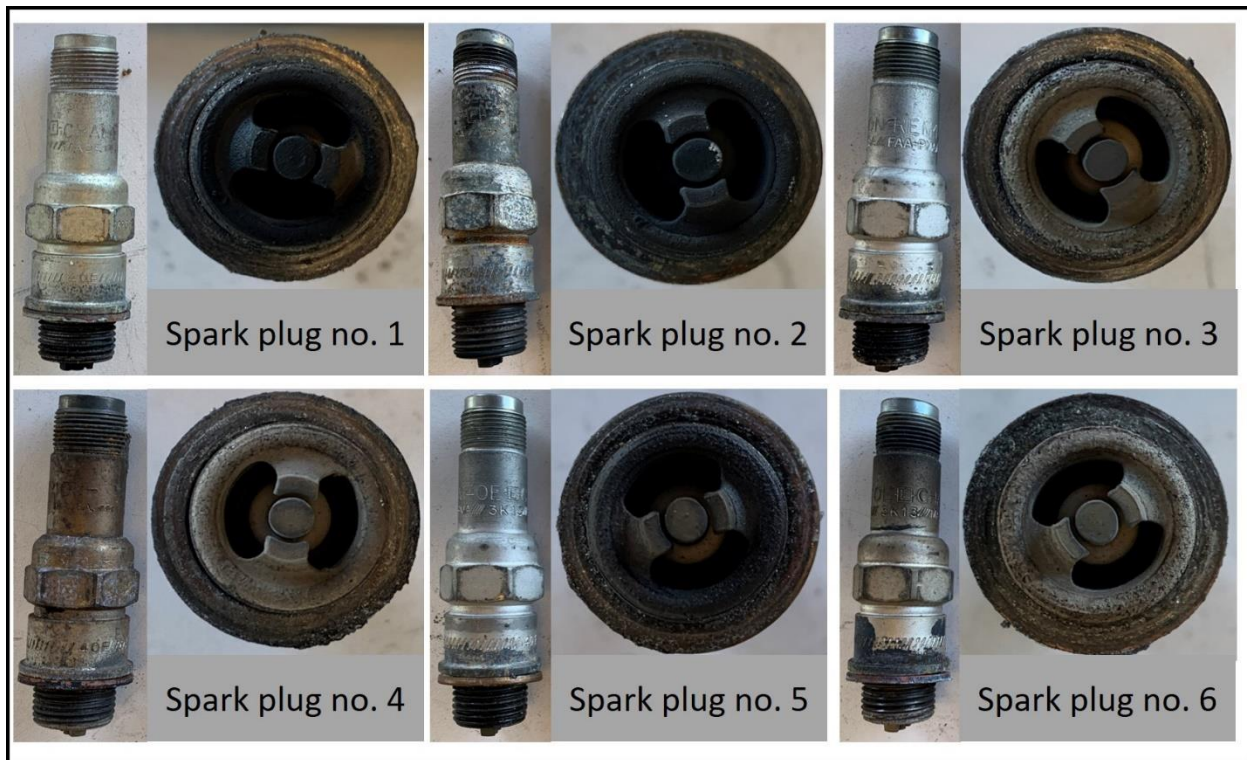
The top spark plugs were removed from each cylinder head for examination. The spark plugs were Champion REM 40 E.

*Photograph 3 –Champion REM 40 E top spark plugs removed from the accident engine.*

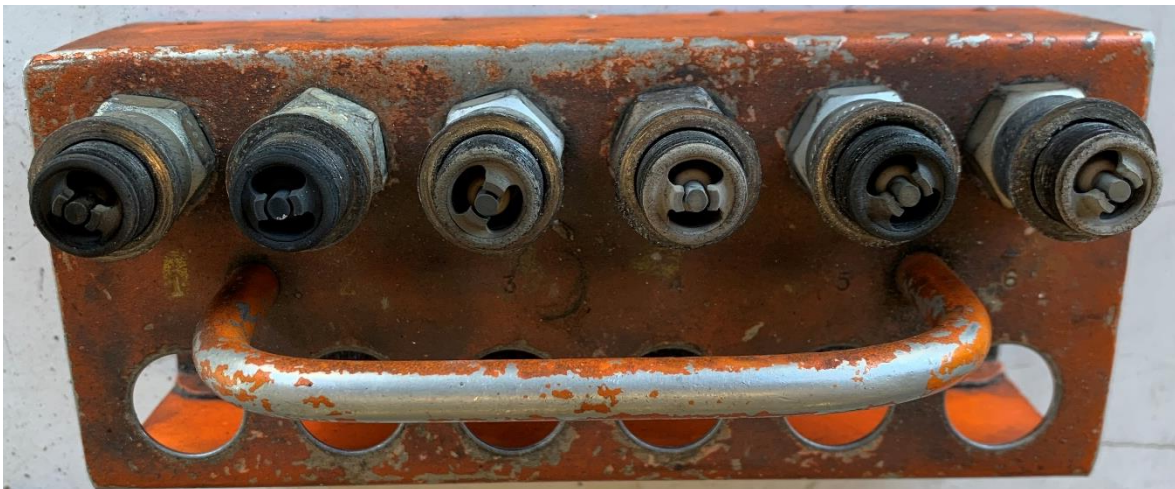
*Photograph 4 –Champion REM 40 E top spark plugs removed from the accident engine.*

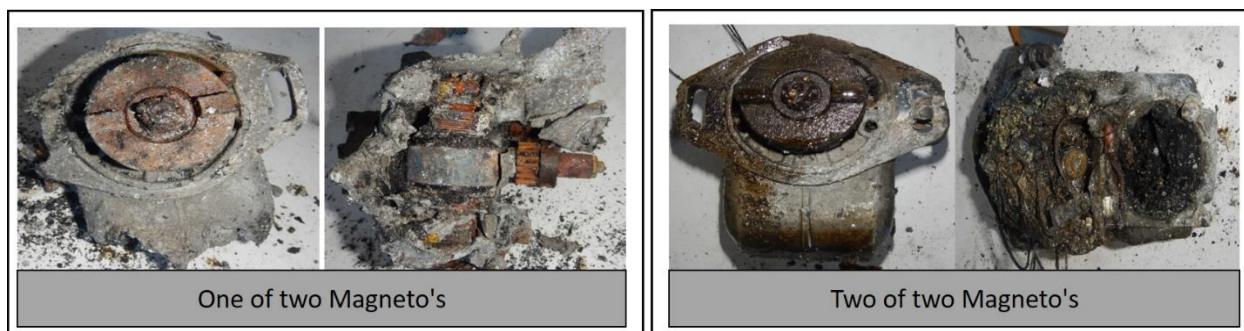
Both magneto's were located near the engine at the accident site but could not be identified, as right or left. Both show signs of thermal damage and could not be operationally tested

*Photograph 5 –Magneto's*

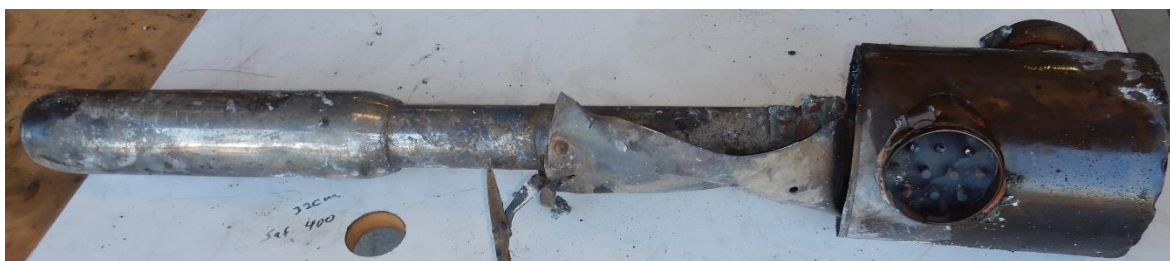
*Photograph 6 –Engine left heat exchanger and tailpipe*

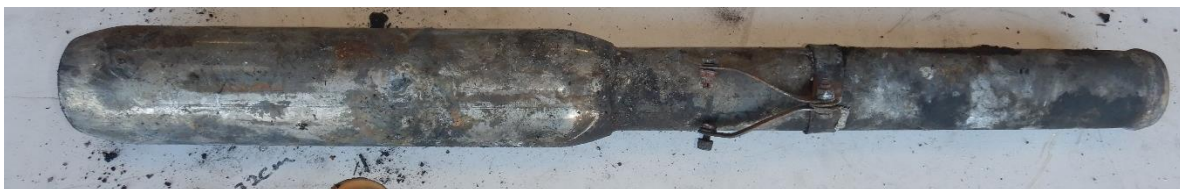
*Photograph 7 –Engine right tailpipe*

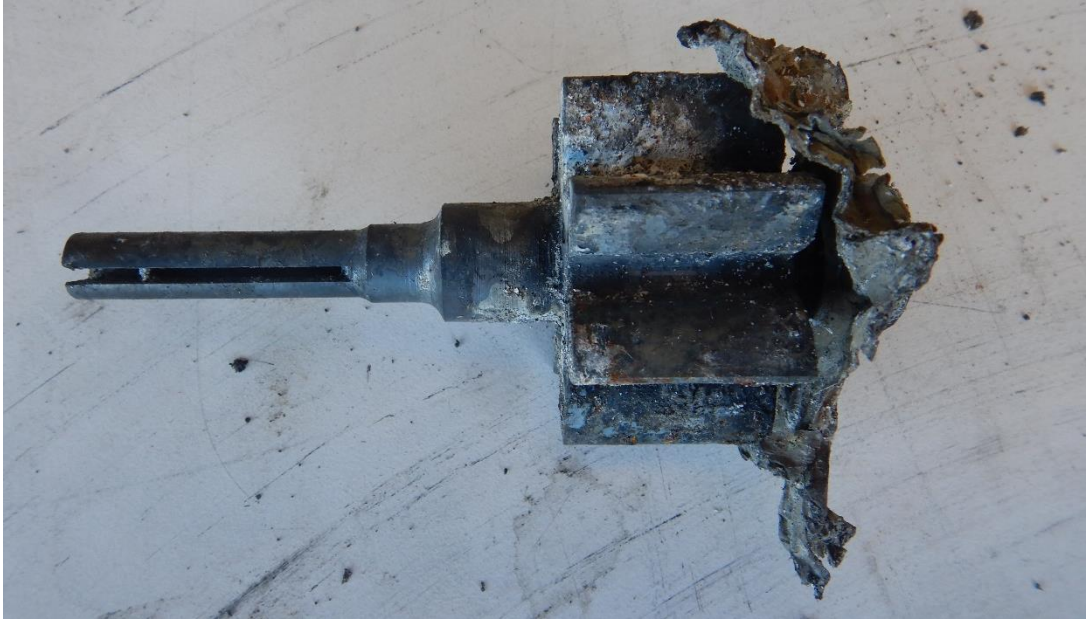
*Photograph 8 –Oil pump gear*

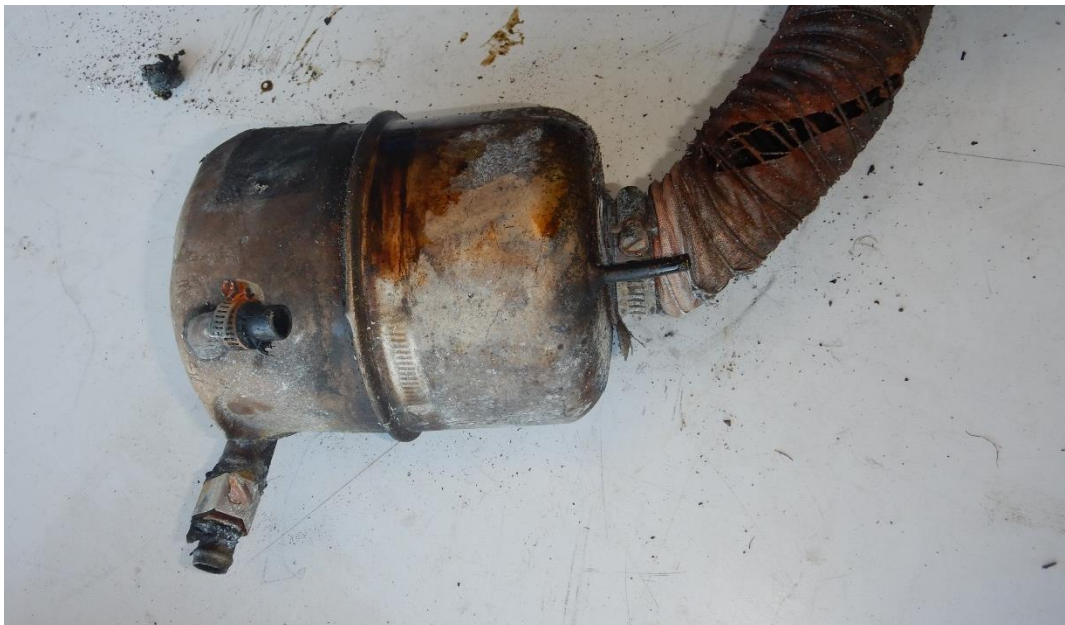
*Photograph 9 –Air-oil separator*

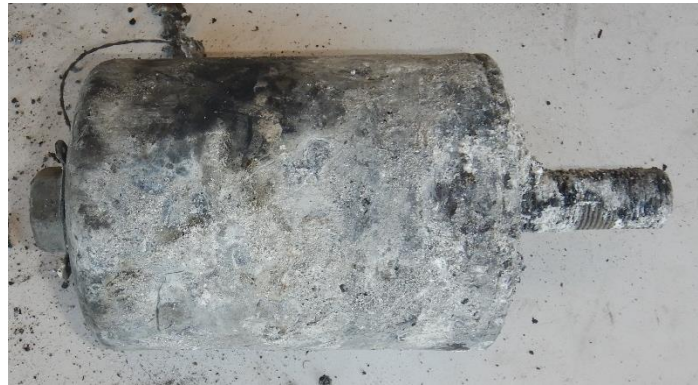
*Photograph 10 –Oil filter*

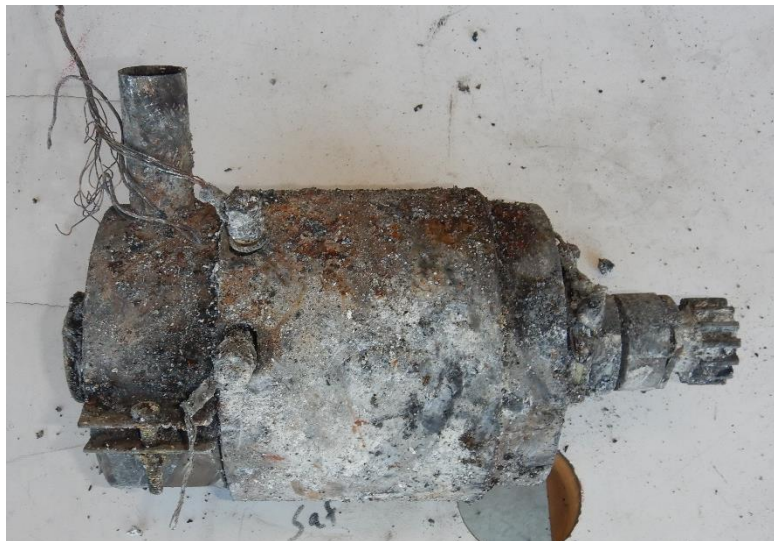
*Photograph 11 –Generator*

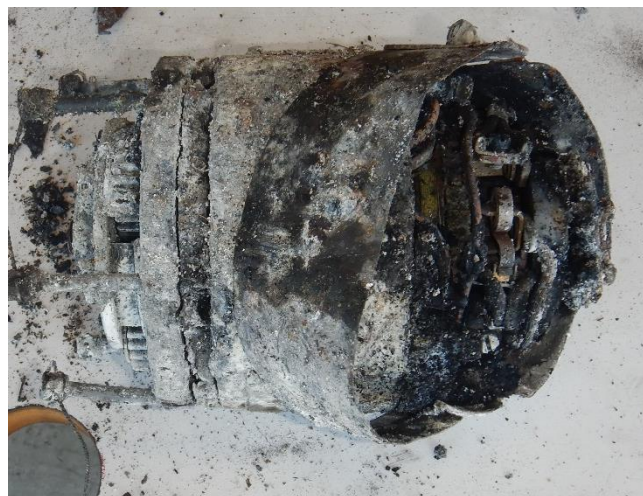
*Photograph 12 –Starter*
