# National Transportation Safety Board

ERA22FA387

## **WRECKAGE EXAMINATION SUMMARY**

Location: Emily, Minnesota  
Date: August 28, 2022  
Time: 1734 CDT  
2234 coordinated universal time (UTC)  
Airplane: N505DB, Sea & Sky, Inc., Krucker Cygnet Weight-Shift Control Aircraft

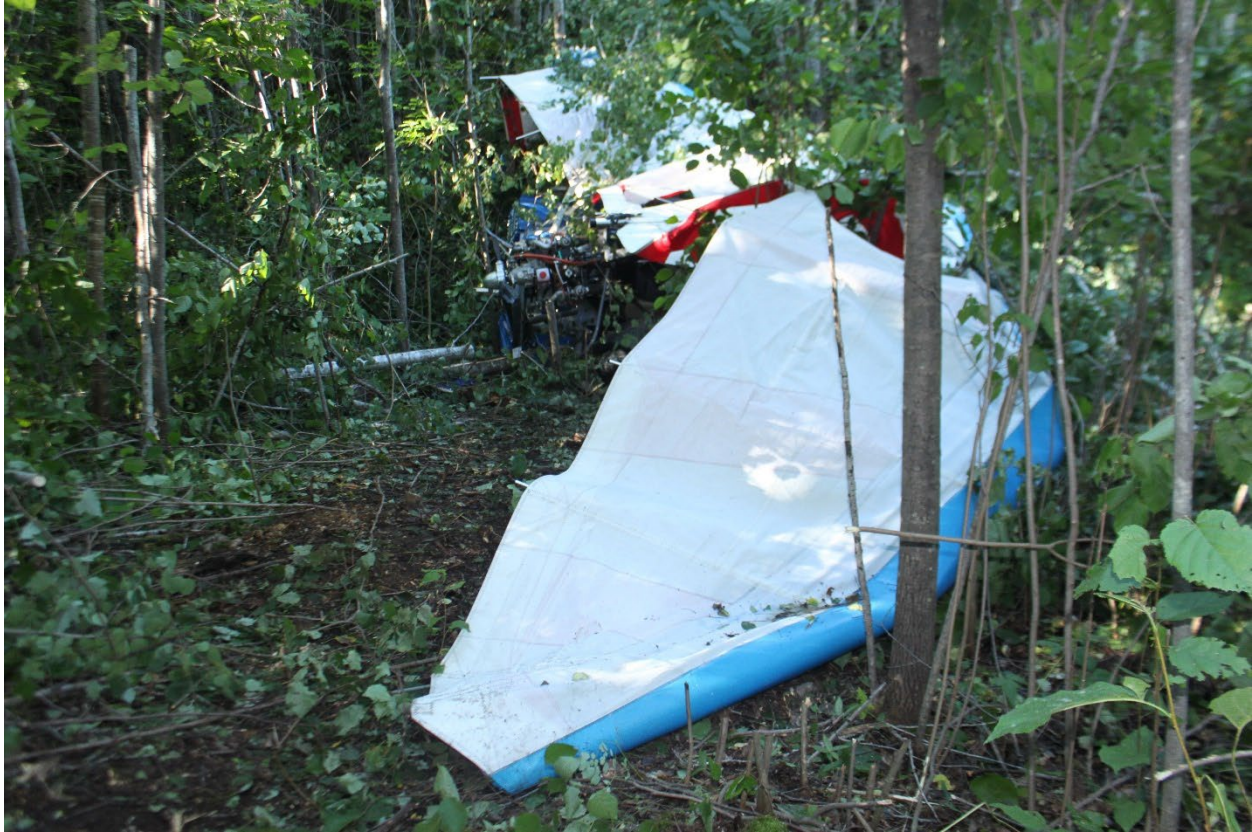
The WSC aircraft crashed in a densely wooded area coming to rest upright on a magnetic heading of about 270°, listing about 45° to the right at 46.770733° north and -94.01418° west (Figure 2). The wreckage remained secured by law enforcement until NTSB arrival and completion of the on-scene investigation.

**Figure 2: Right Side View of the Wreckage at the Accident Site.**

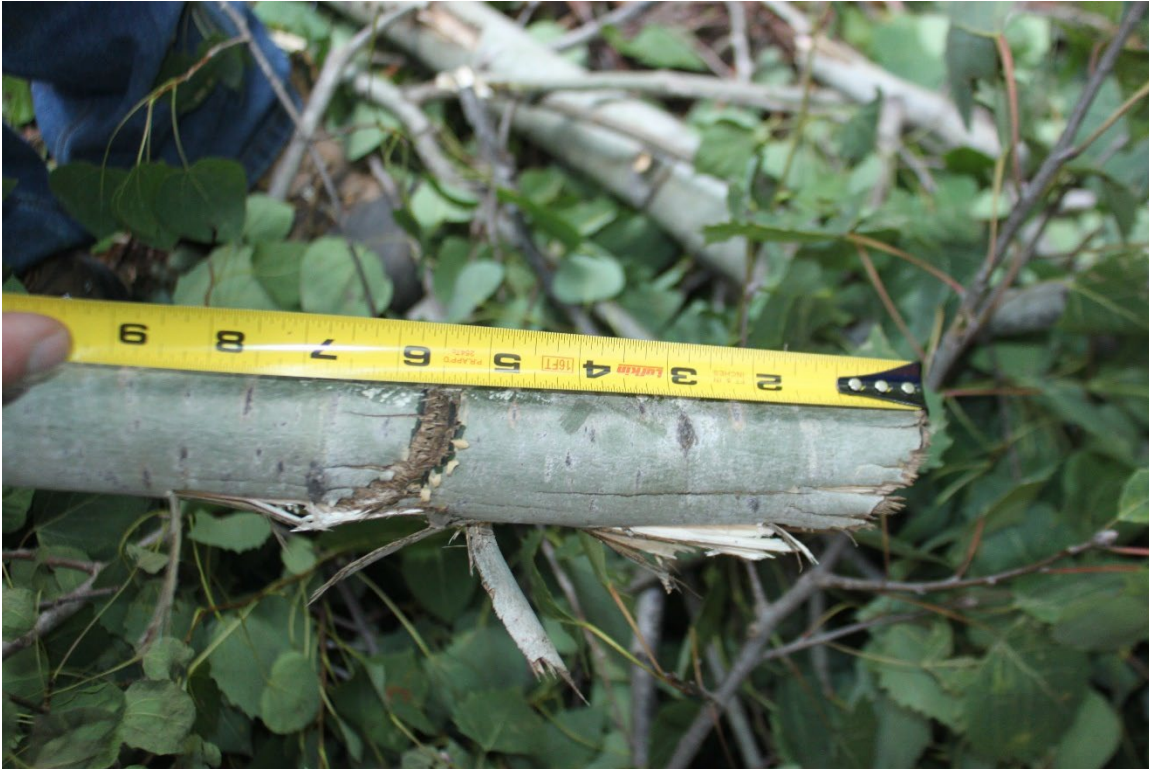
Further examination of the accident site area which contained small diameter trees revealed no evidence of a shallow descent. Rather, the damage to trees was consistent with a steep descent. There was no evidence of bird remains found at the wreckage site or among the wreckage, and there also was no pre or postimpact fire. A slight smell of fuel was noted at the accident site<sup>1</sup>. The following tree trunks were noted to have the following damage consistent with propeller blade contact:

- 1.625 inches diameter tree trunk with 2 parallel cuts at 45° angle. 1 cut was completely through the trunk and the second cut about 5.375 inches later was thru about 1/2 the diameter (Figure 3).
- 2 inches diameter tree trunk has 1 cut at 45° angle completely thru.
- 2.25 inches diameter tree trunk has 1 cut diagonal measuring 14 inches long thru the diameter.
- 2.5 inches diameter tree trunk with 1 cut at 45° angle completely thru.

**Figure 3: View of the 1.625 inches diameter tree trunk with parallel slash marks and black color consistent with propeller blade contact.**

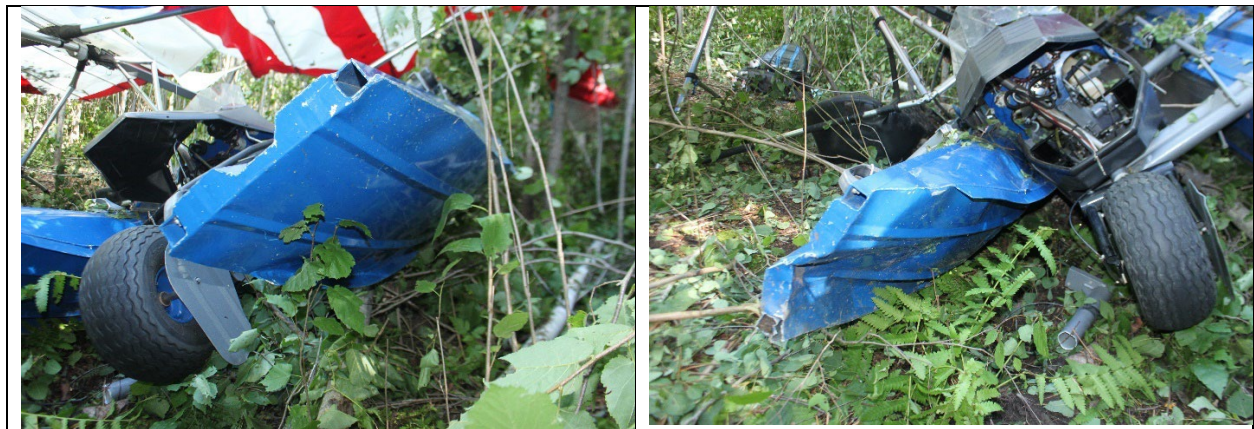
Examination of the left and right floats revealed the right exhibited more extensive damage on the front portion than the left (Figure 4).

**Figure 4: Views of the Front Portions of Both Floats.**

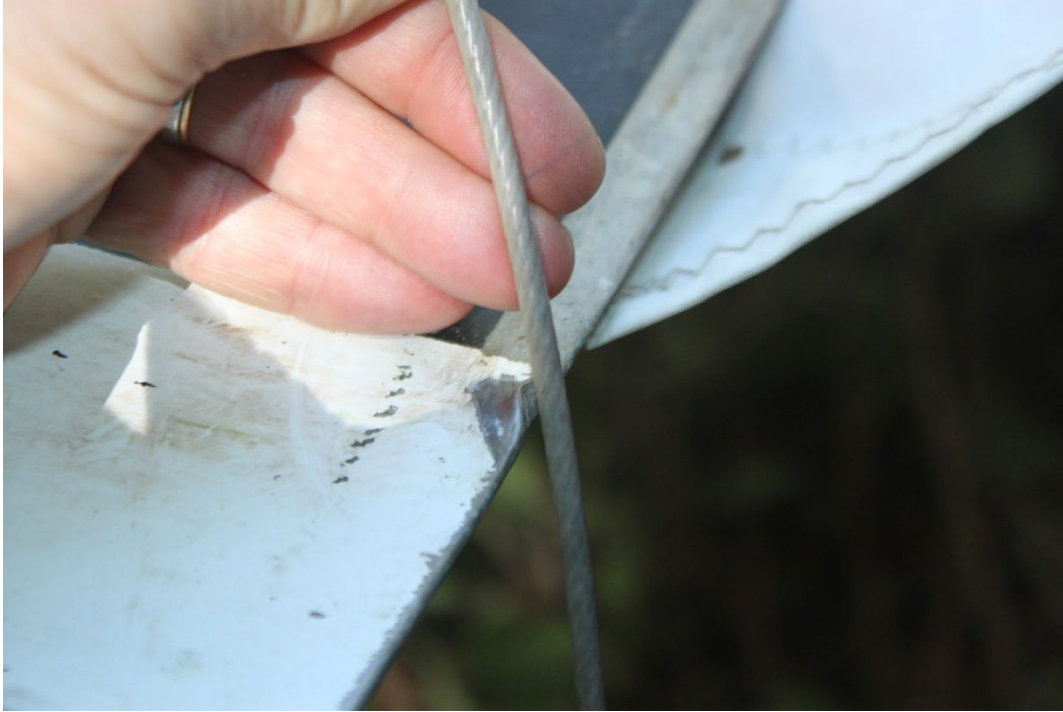
Examination of the right portion of the wing revealed the leading-edge tube was overload fractured 11 ft 3 inches from the center point of the wing. The flying wire or control cable from the right lower control bar attach point to the center forward attach was fractured 32 inches from the wing leading edge tube and 43 inches from the control bar; the cable measured about 5/32's inch in diameter. The remaining sections of cables remained attached at both ends. Examination of the fractured cable ends revealed several strands exhibited permanent bending deformation with fractures at a 45° angle (slant fracture) consistent with overstress. The cable damage was consistent with contact by one propeller blade (Figure 5).

**Figure 5: View Showing the Flying Wire or Control Cable from the right lower control bar attach point to the center forward attach in Proximity to the Damage on One Propeller Blade Leading Edge.**

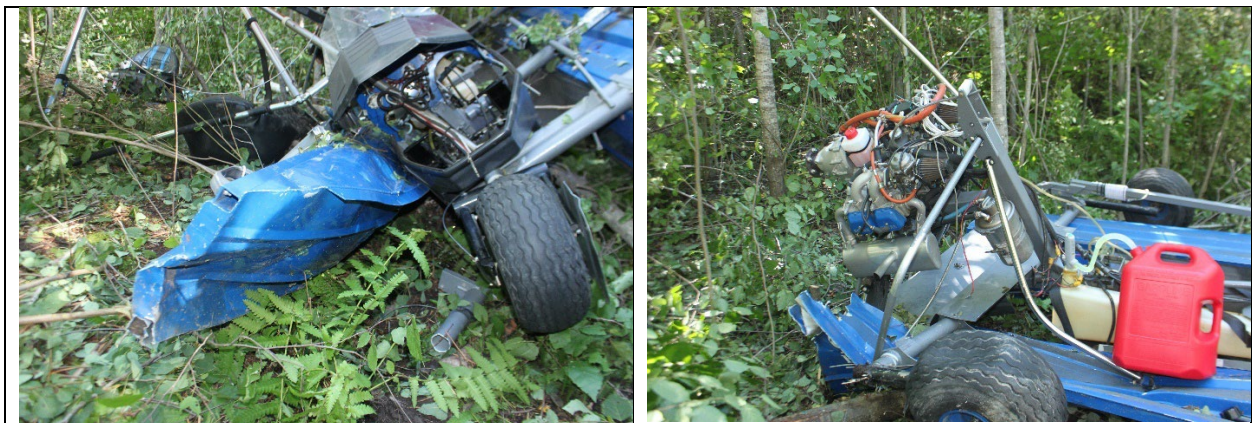
The front and rear wheels were in the retracted or water landing position (Figure 6).

**Figure 6: View of the Front and Both Rear Wheels.**

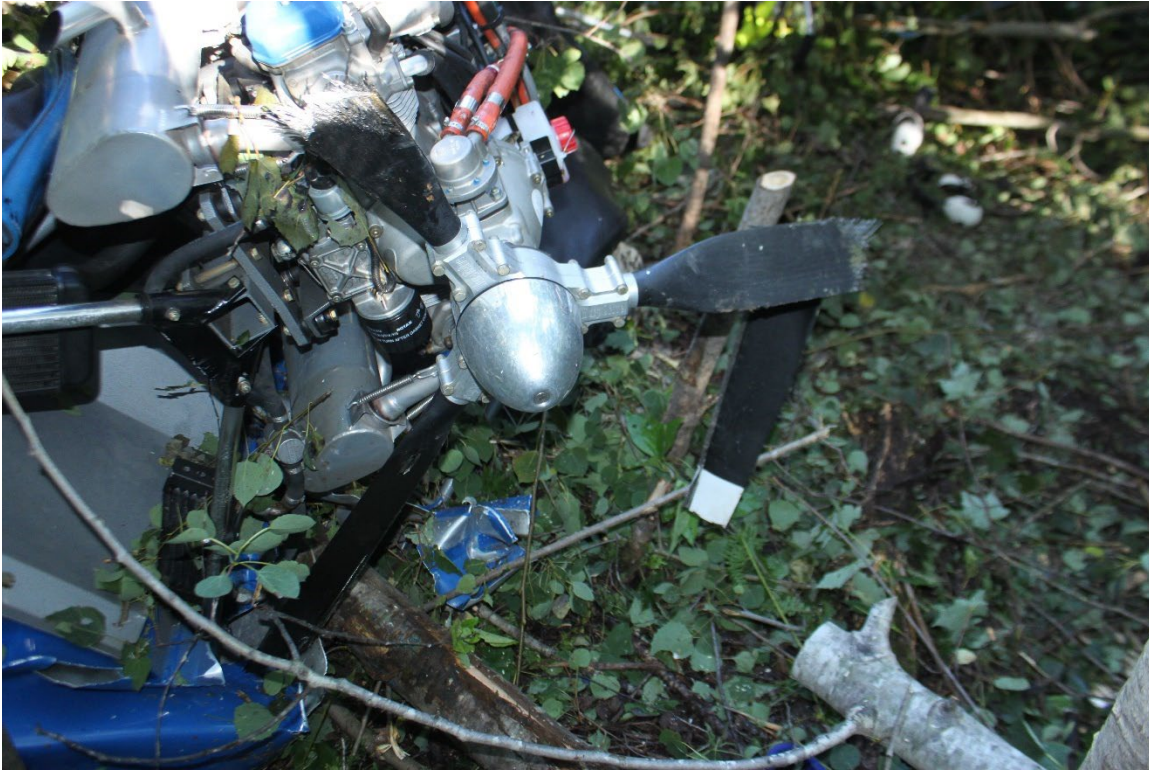
Examination of the Rotax 912UL engine, serial number 4409896<sup>2</sup> revealed it remained attached to the structure at all 4 attach points but the fore/aft longitudinal structural member that provided support for the engine was overload fractured near a weld for the 45° brace for the vertical post; thus, the engine was canted slightly to the right (Figure 7). Following removal of the propeller, rotation of the propeller shaft from the reduction gearbox through 360° revealed crankshaft, camshaft and valve train continuity to all cylinders and to the rear of the engine. Thumb suction and compression was noted in all cylinders. Both carburetors remained attached to the engine and both air filters remained attached to both carburetors. No fuel leakage was noted at either carburetor. The flex coupling of the left carburetor was cracked about 90° circumference at the outboard mounting bolt. Both cables remained attached to both carburetors. The Nos. 1/3 and 2/4 carburetor slides both were 3/4 closed<sup>3</sup>. About 1 ounce of automotive fuel without water contamination was found in the #2/4 carburetor<sup>4</sup> and #1/3 carburetor. Slight specs were noted in the #1/3 carburetor bowl. All ignition leads remained attached to all spark plugs, which were all installed in each cylinder. Examination of the left and right exhaust outlets revealed both exhibited black sooty deposits. The throttle control from the hand/foot controls were continuous from each control to both carburetors. The oil level in the oil tank was at the full level.

**Figure 7: View of the Engine and Propeller Assemblies.**

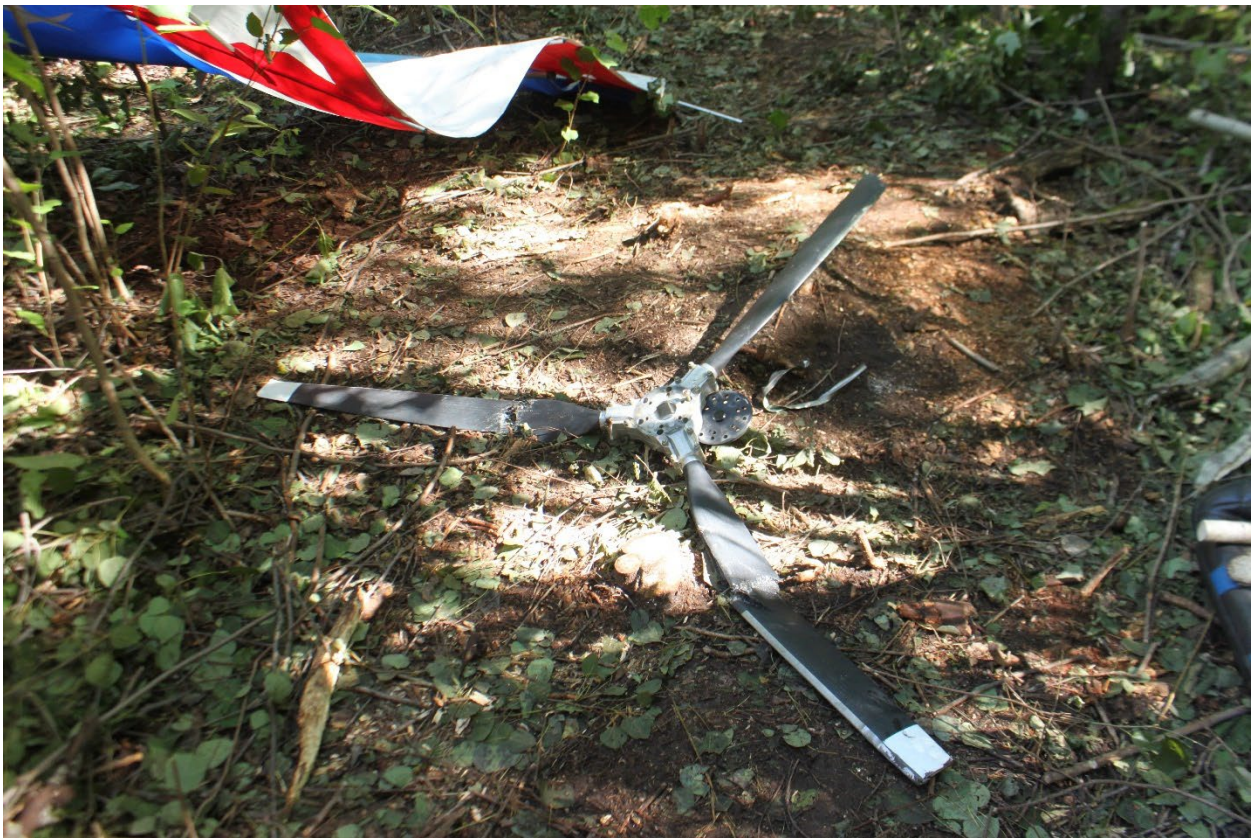
Examination of the Warp Drive composite propeller, model 68L-NX-HPL3, serial number N20745<sup>5</sup> which remained attached to the engine revealed all blades remained secured in the hub. One blade (marked 3<sup>6</sup>) that was missing 4 inches of the tip was resting against the float. The separated section of propeller blade was not located, but the associated nickel leading edge with manufactured ends on both ends was found among the main wreckage. The second blade (marked 2) was full span but partially fractured 12 inches from the outboard end of the hub. The final blade was fractured about 8 inches from the outboard end of the propeller hub (Figure 8). The separated blade piece which was located at the accident site was inspected and exhibited a semi-circular gouge on the leading edge of the blade about 3 inches inboard from the tip. Blue paint transfer was noted on the cambered side of the separated blade piece from the tip to the area of the semi-circular gouge. Close examination of the gouge on the leading edge revealed it measured about 8/32 inch in diameter and parallel striations were noted in the gouge. The gouge was consistent with being made by the right wing cable that went from the control bar to the center forward attach point of the wing.

**Figure 8: View of the Reconstructed Propeller.**
