# National Transportation Safety Board

ERA22FA387

## **ONBOARD IMAGE RECORDER**

Location: Emily, Minnesota  
Date: August 28, 2022  
Time: About 17:34 central daylight time (CDT)  
Airplane: Sea and Sky Krucker Cygnet, private, N505DB

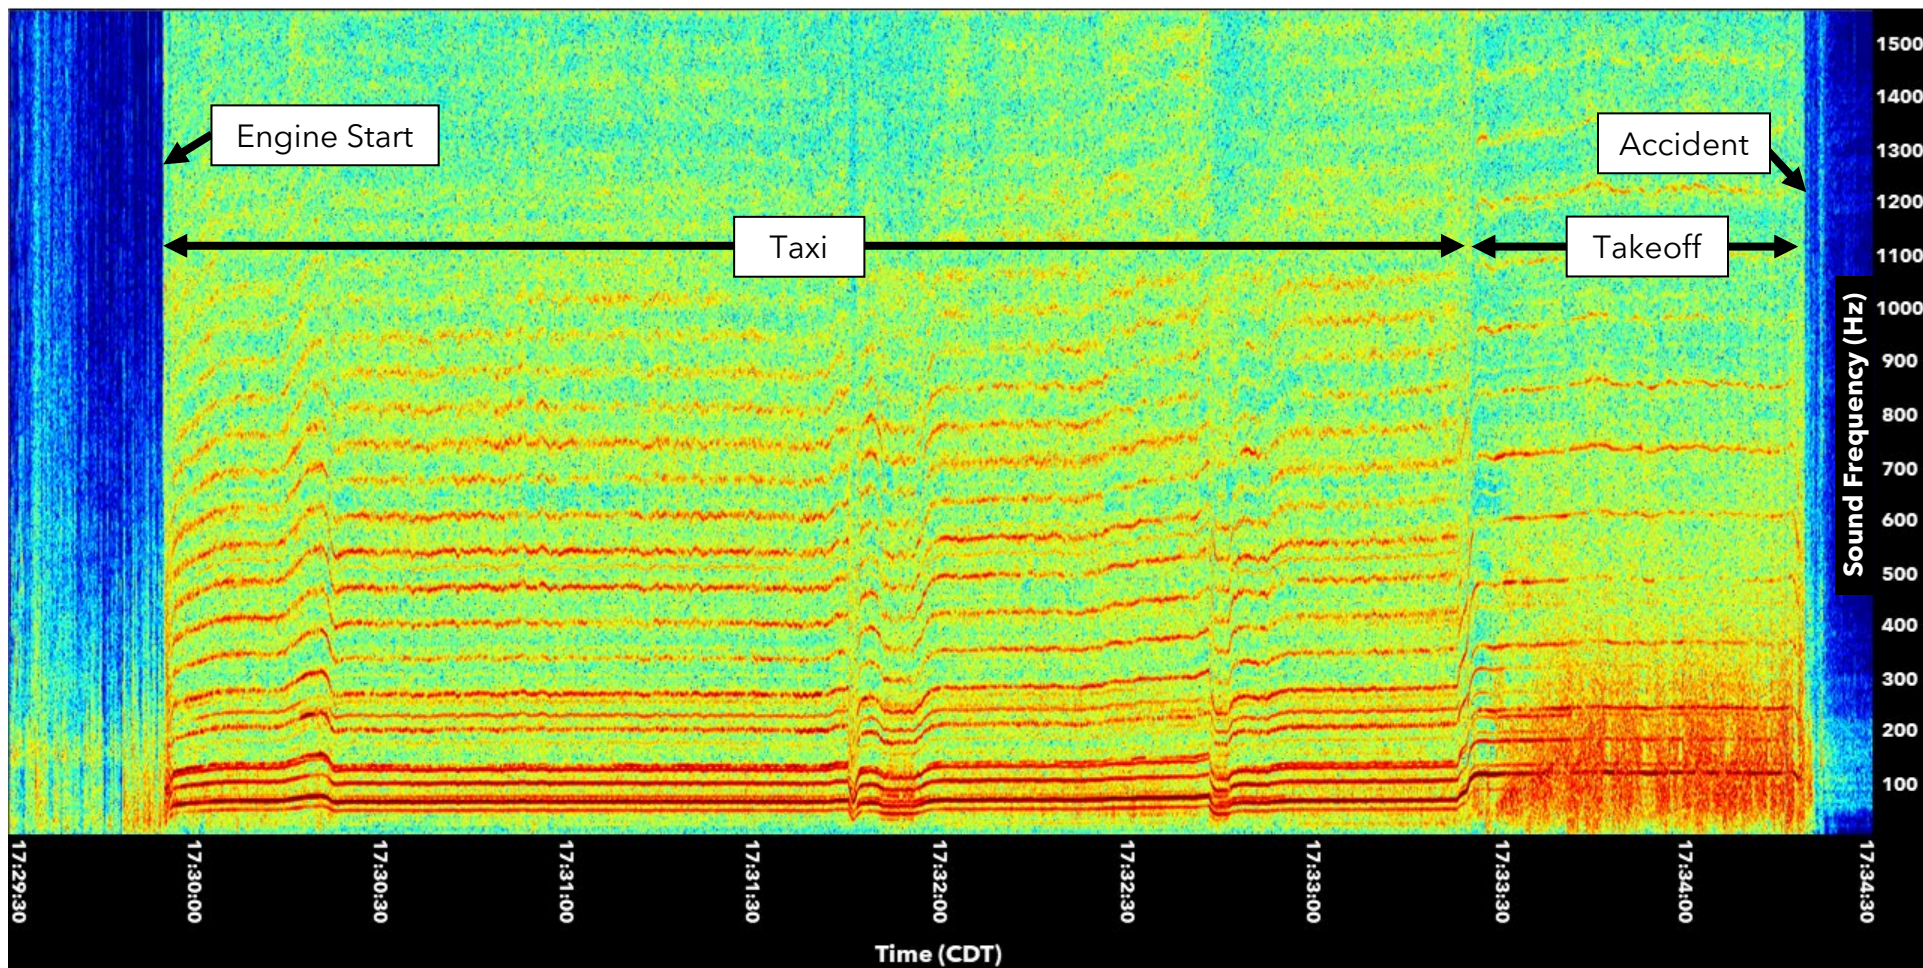
A three-dimensional spectrogram was generated, as shown in Figure 1, from the audio extracted from the video file from 17:29:30 to 17:34:30. The x-axis represents time in CDT and the y-axis represents sound frequency in Hertz (Hz). The color represents sound intensity, with blue being the lowest intensity sound and red being the highest intensity.

The calculated engine RPM during the accident flight's takeoff roll and through the airplane's impact with trees appeared to be consistent with the engine operating at or near its published maximum continuous power setting.

**Figure 1.** 3D spectrogram of audio - 17:29:30 to 17:34:30 CDT.

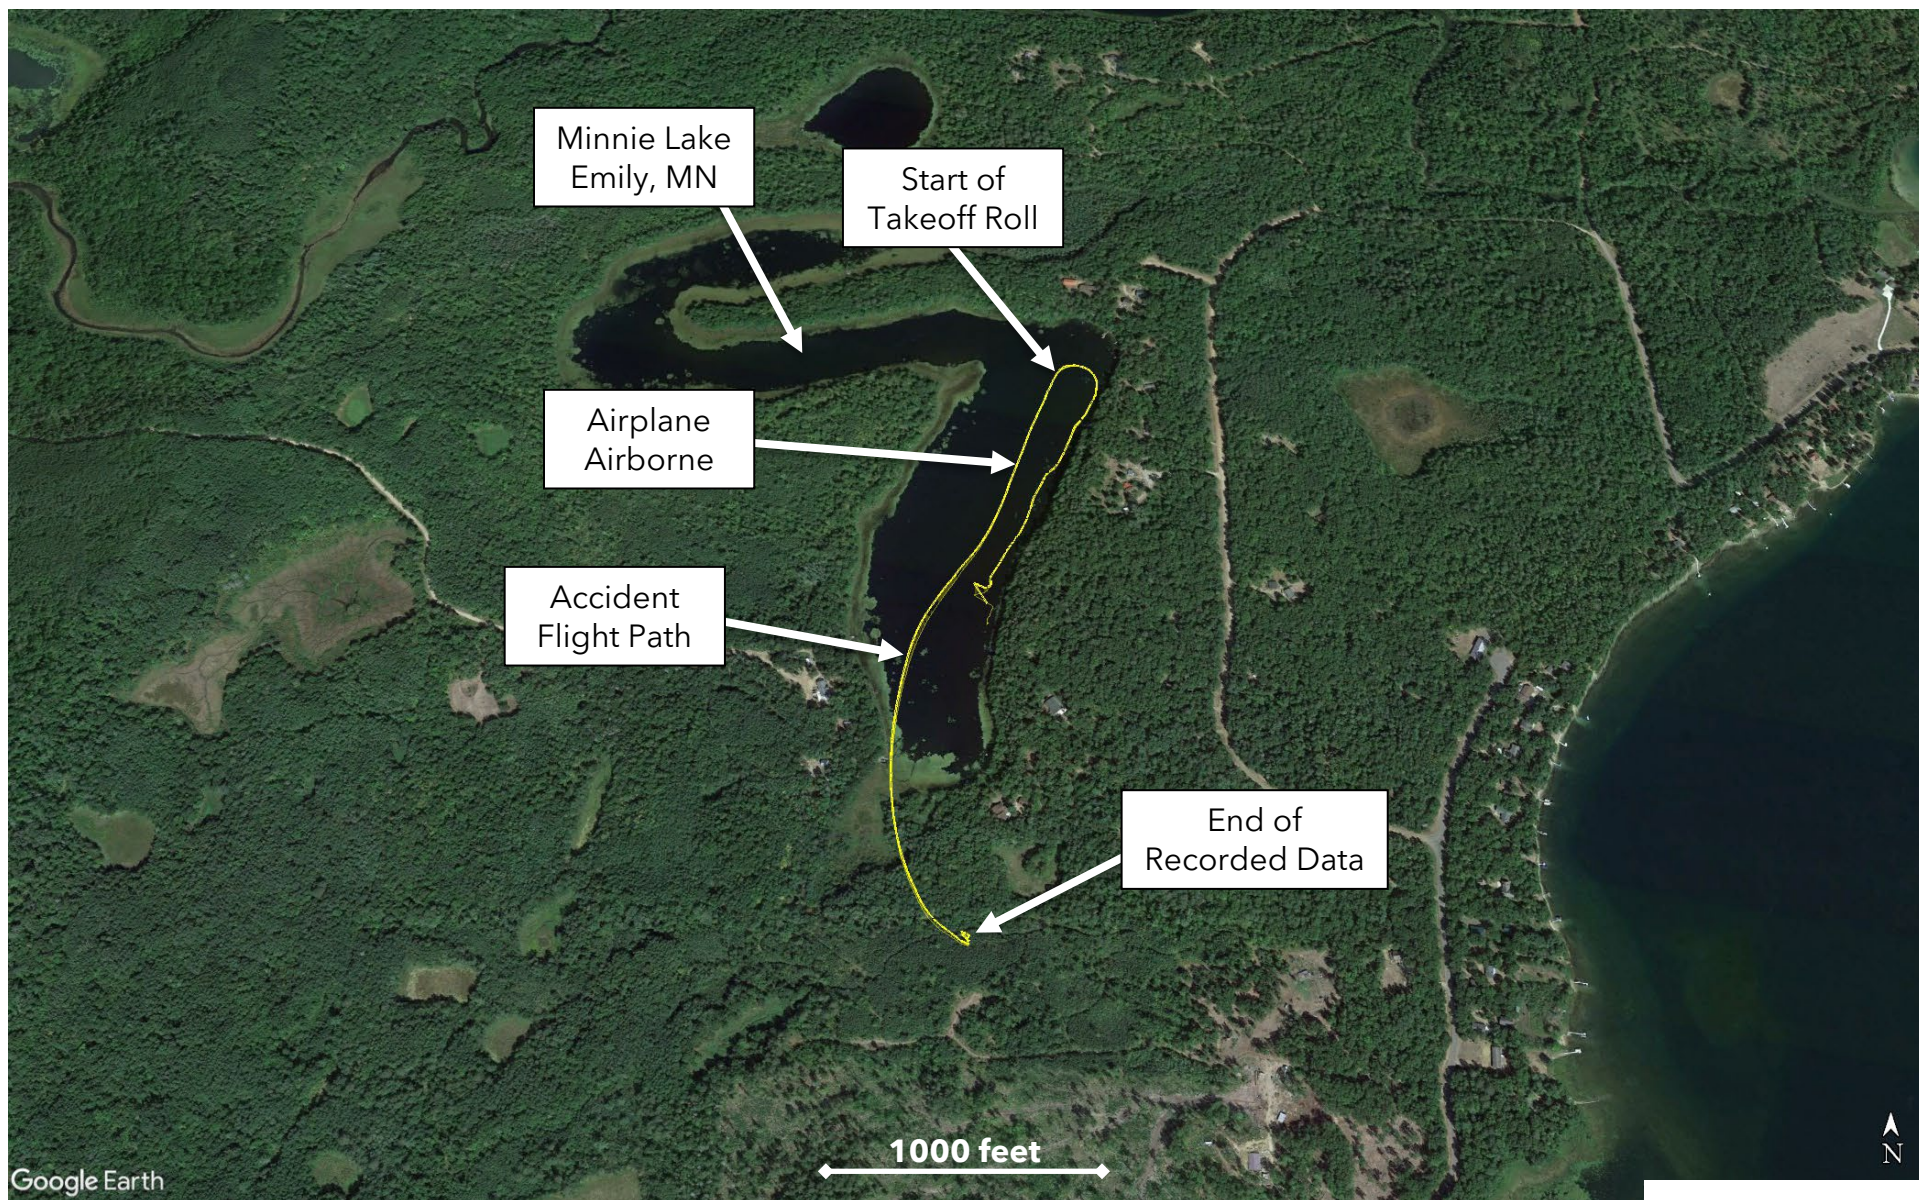
The GoPro HERO7 video contained embedded GPS data including latitude, longitude, and GPS altitude. Figure 2 is a Google Earth overlay of the embedded GPS data extracted from the accident flight video. The weather and lighting conditions shown in the Google Earth overlay are not necessarily representative of the conditions at the time of the accident.

**Figure 2.** Overview of GPS data recovered from GoPro HERO7 for the accident flight.
