# National Transportation Safety Board

ERA22FA391

## **WRECKAGE EXAMINATION**

Aircraft: Aeronca 7AC

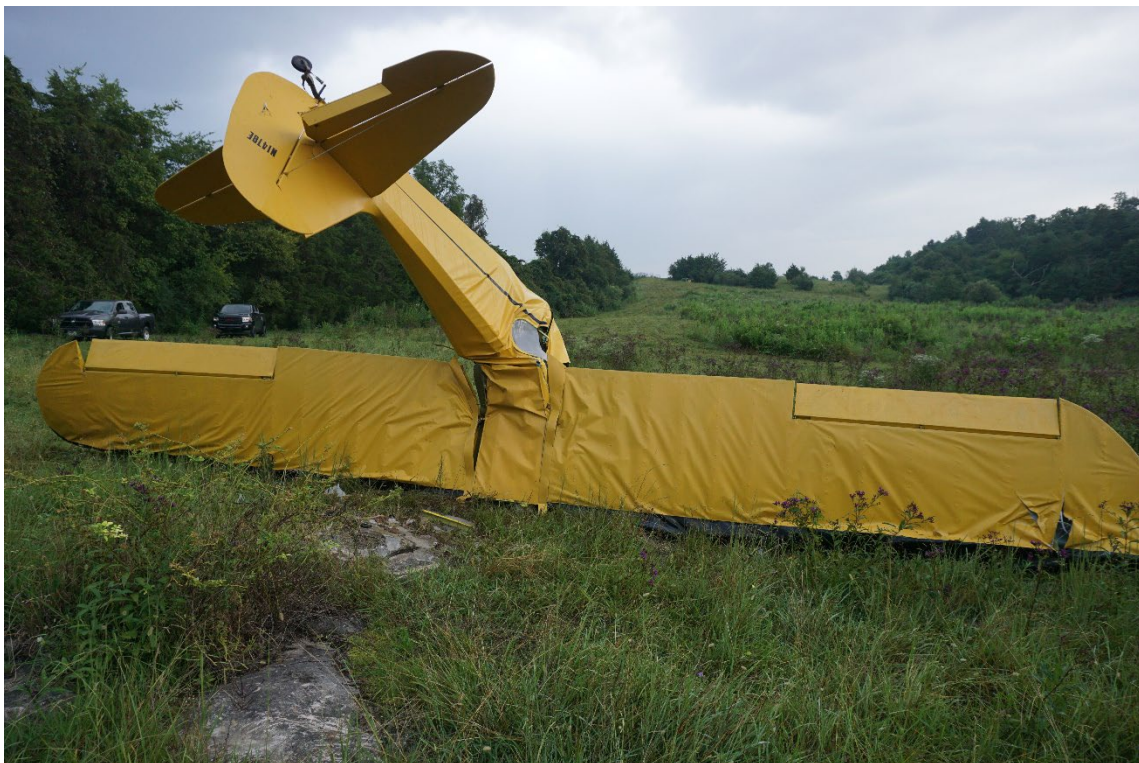
Figure 1 - Wreckage Diagram

The airplane came to rest nose down in a field adjacent the airport runway. It was orientated on a magnetic heading of 23°. All primary flight control surfaces remained attached to the airplane. The nose of the airplane was crushed aft to the cockpit. All structural components of the airframe, engine, and propeller were accounted for at the accident site. A main wreckage came to rest nose down and suspended upright.
