# National Transportation Safety Board

ERA22FA405

## WRECKAGE EXAMINATION SUMMARY

Location: Hartwell, Georgia  
Date: September 10, 2022  
Time: 1237 EDT  
Airplane: Beech BE55, N3670D

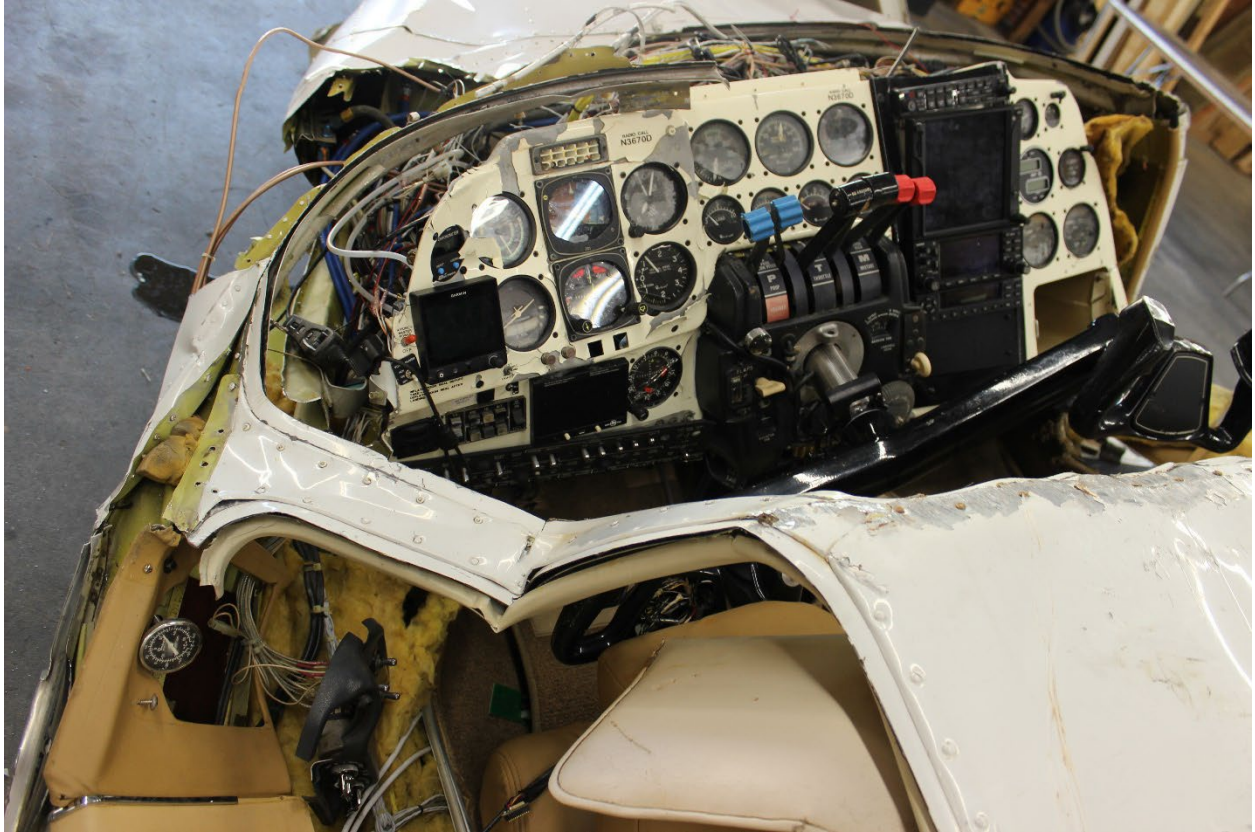
The instrument panel was intact. The tach indicated 3693.0 hrs. The left ignition switch was in the RIGHT position. The right ignition switch was in the LEFT position. The left fuel selector handle was in the LEFT position. The right fuel tank selector handle was out of position, pointed to the upper right. The throttle, mixtures, and propeller controls were mid-position. Flight control cable continuity was established from the flight controls in the cockpit to the flight control surfaces through multiple cuts made by recovery personnel.

The heading aid was on 174°. A Garmin G5 and King KFC 200 autopilot was installed, the autopilot select push switch labeled HDG/GPS was in the HDG position.

Figure 1 View of the instrument panel.

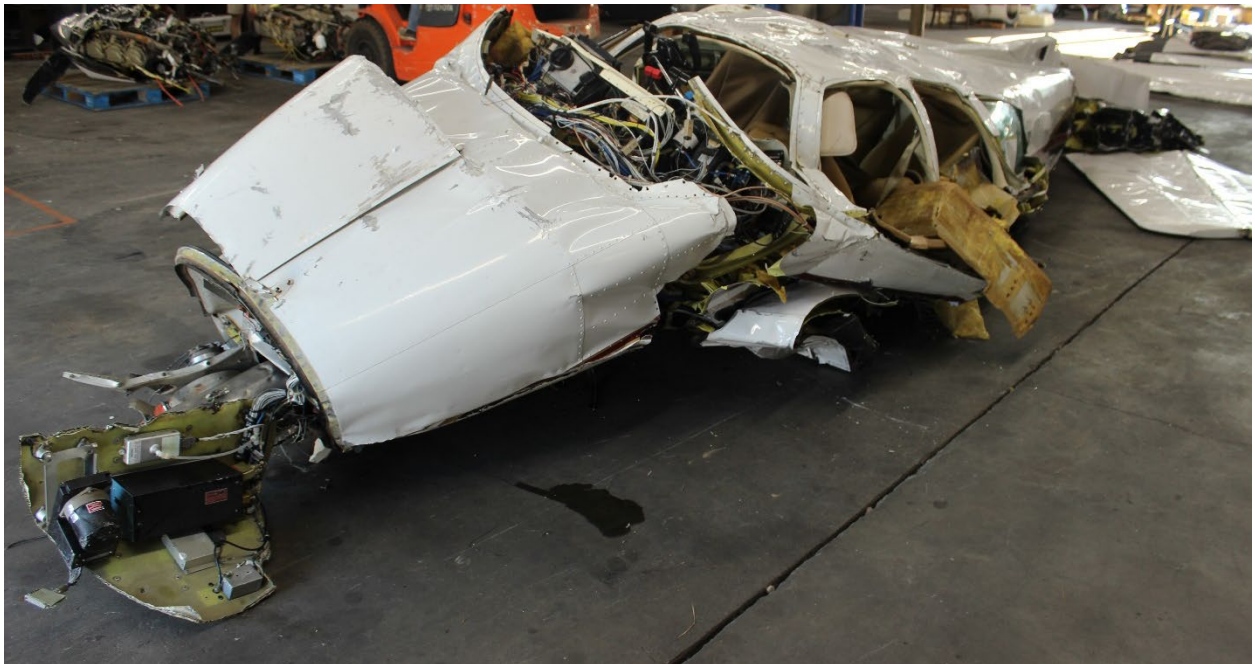
The main fuselage was intact and had upward crushing on the bottom of the fuselage. The seats remained attached to the airframe at all attach points.

Figure 2. View of Fuselage.

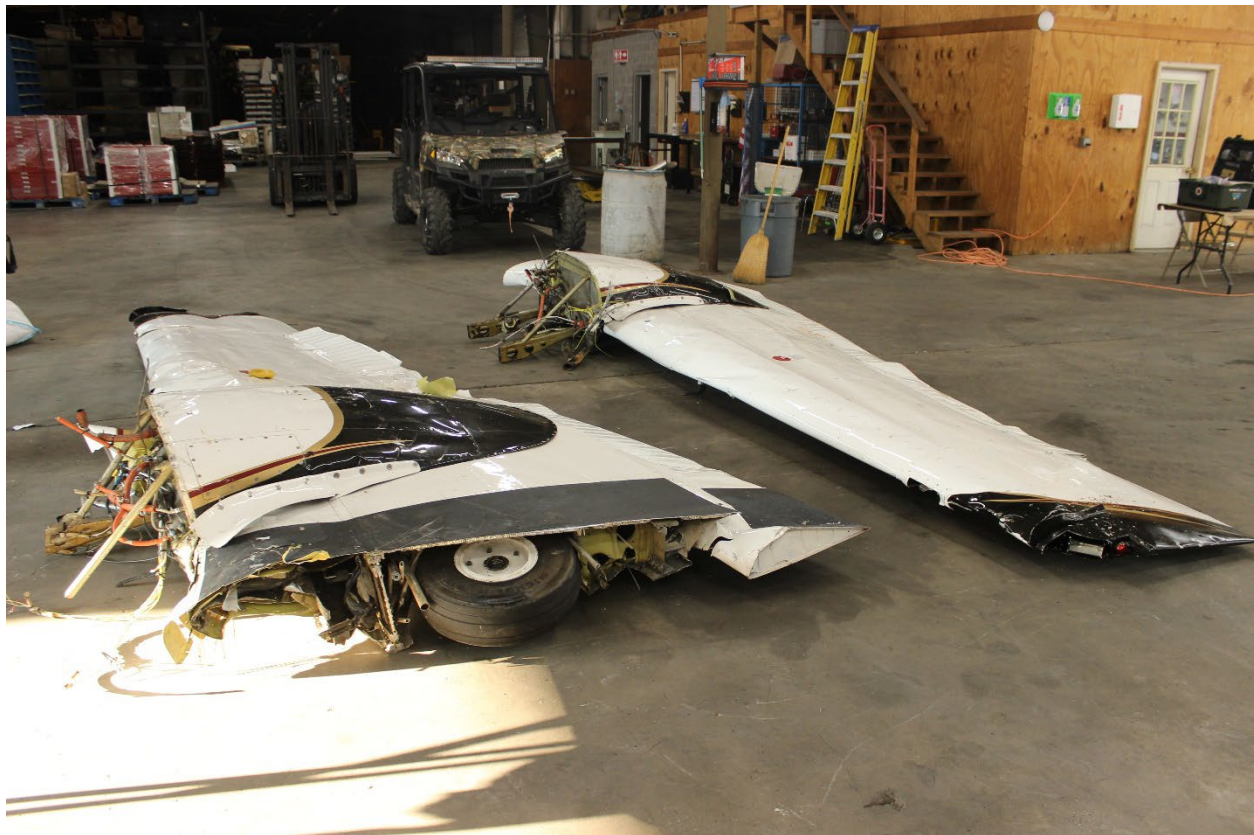
The right and left wing was separated to facilitate recovery. The bottom of the wings had upward impact crushing, there was no crushing present on the leading edges. The right and left flap actuators were both in the retracted position, and the handle was in the UP position.

Figure 3 View of the left and right wings.

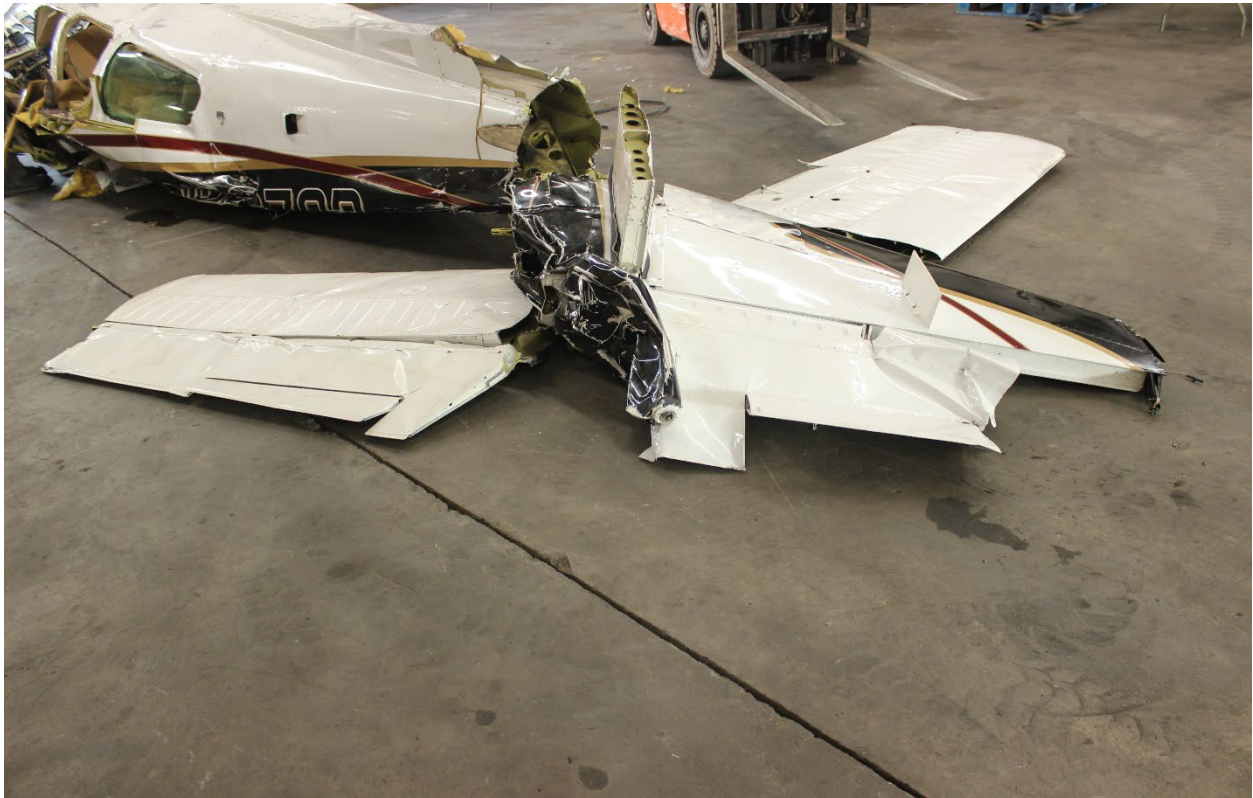
The empennage was cut from the fuselage to facilitate recovery. The elevator remained attached to the horizontal stabilizer. The elevator trim was between neutral and nose down. The vertical stabilizer remained attached to the empennage and the rudder remained attached to the vertical stabilizer.

Figure 4. View of Empennage

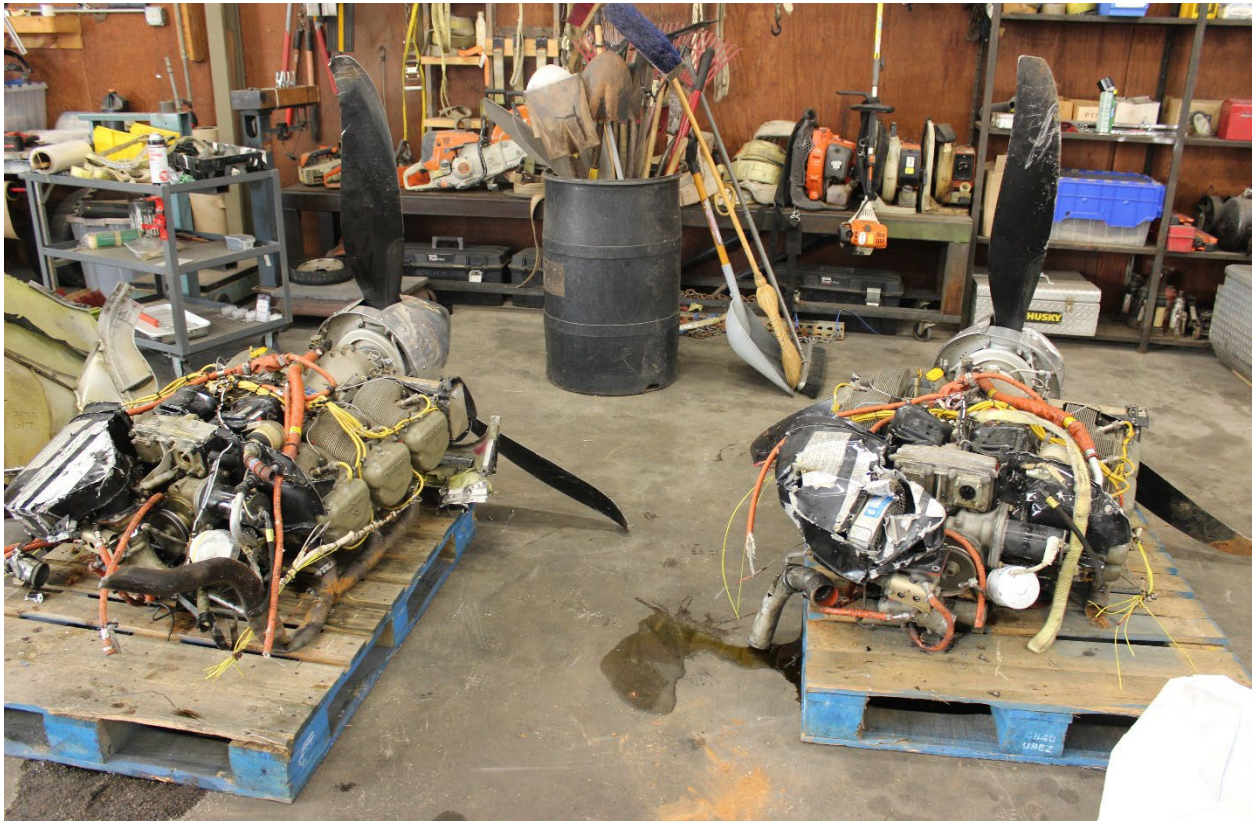
The engines were partially separated from the airframe from impact, they were removed to facilitate recovery. The top spark plugs were removed and compression and suction were observed on all cylinders. Crankshaft and valvetrain continuity were confirmed by rotating the propeller by hand.

Figure 5. Top View of Engine

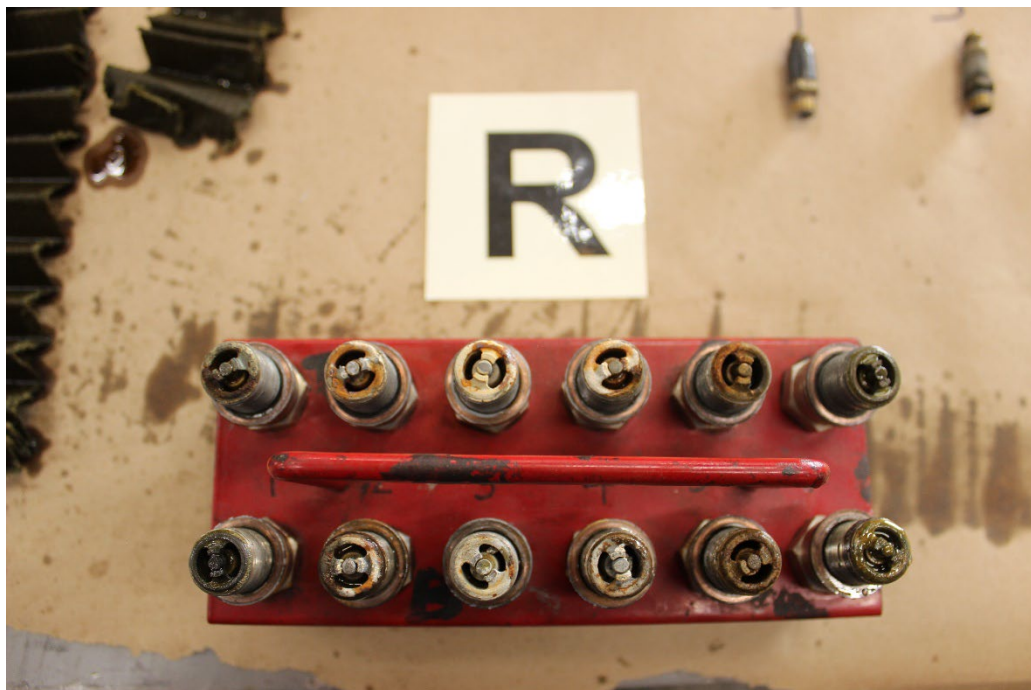
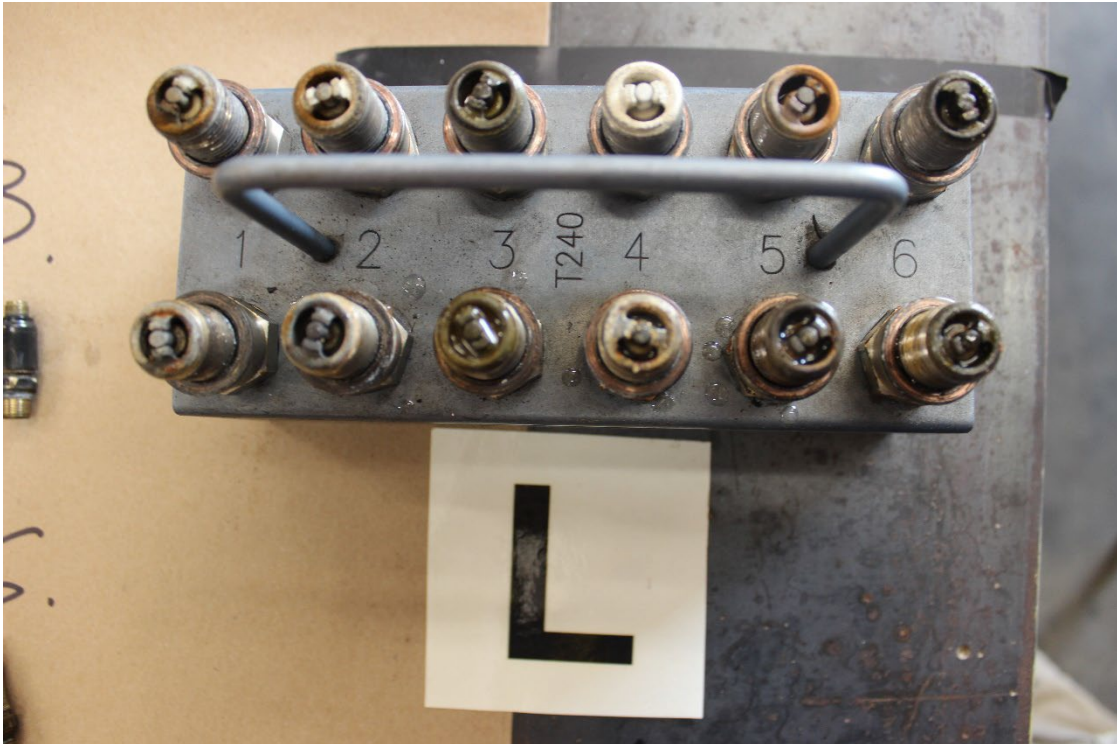
Figure 6. View of the spark plugs from the right engine.

Figure 7. View of the left spark plugs.

All spark plugs were removed and were light grey in color and in normal condition when compared to the Champion Check-A-Plug Chart.

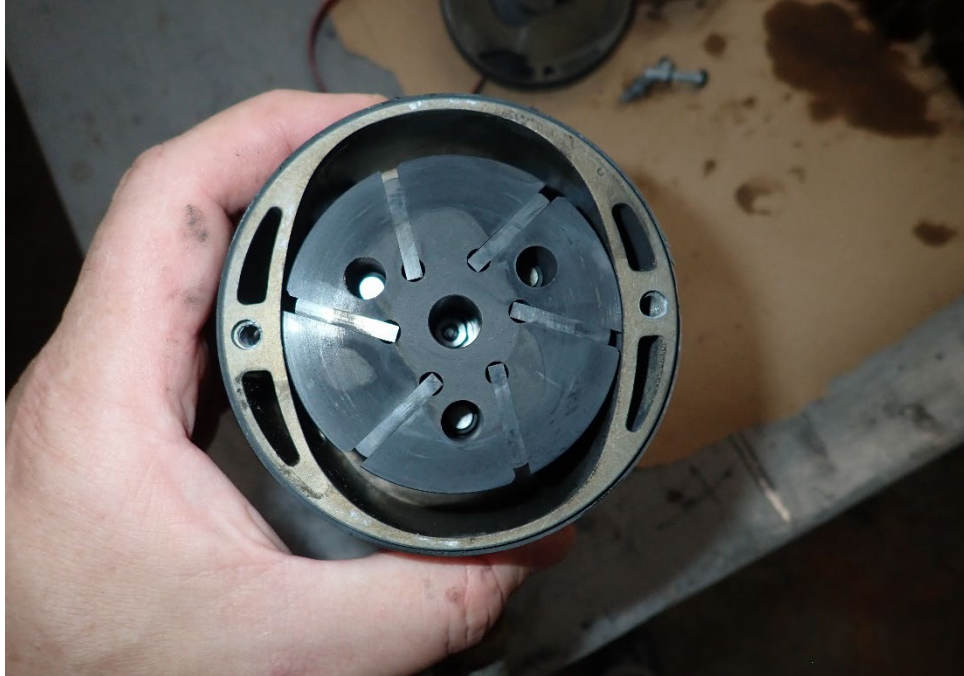
The left and right engine-driven vacuum pumps were intact and expelled air when rotated, and the carbon vanes were intact.

Figure 8. View of the vacuum pump.

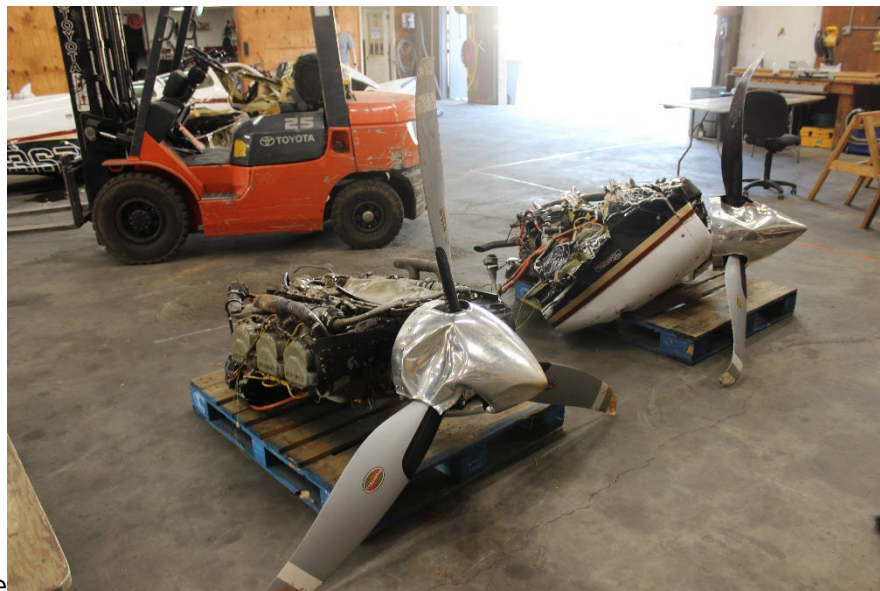
Both three-bladed propellers remained attached to the hub. The right propeller blades sustained minor damage to the tips. Blade A on the right propeller had trailing edge scrapping from recovery. The left propeller blades sustained minor damage. Blade A was bent forward, from damage sustained during recovery. The propellers were rotated through 360° of motion.

Figure 9. View of the right and left propellers attached to their respective engines.
