**Wreckage Examination  
NTSB Accident Number  
ERA22FA418**

| Date: | September 14, 2022 |
| Aircraft: | Piper PA-32-300 |
| Registration | N2104J |

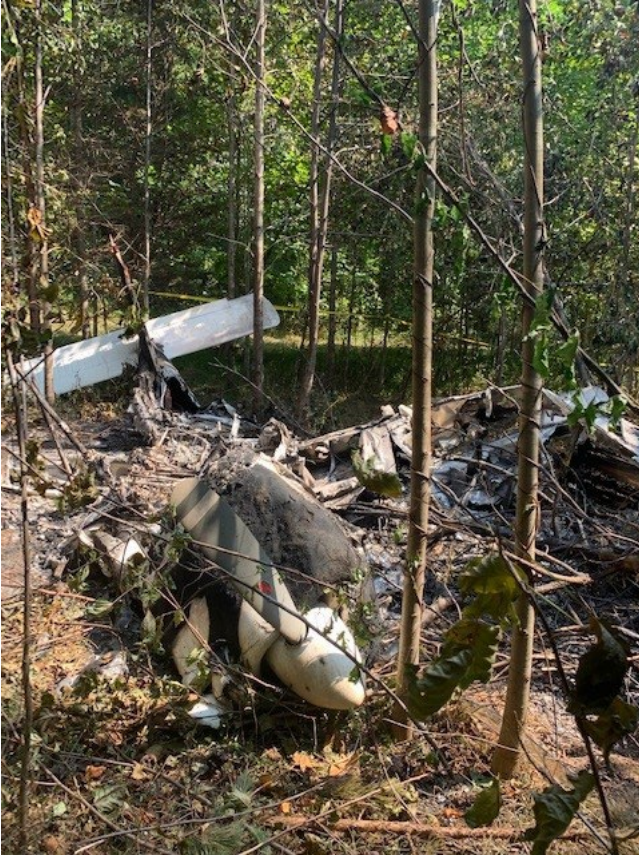
An approximate 100-ft debris path was observed, extending on a 60° magnetic course, consisting of severed trees at a downward angle of approximately 45°. The wreckage came to rest upright, oriented on a magnetic heading of 240°. The cockpit and cabin were consumed by fire. The fuel selector valve exhibited thermal damage and was positioned to the left main fuel tank. The fuel strainer bowl was thermally damaged, and the fuel strainer screen was destroyed. Flight control cable continuity was continuous from the cockpit to each of the respective control surfaces except for a separation in each of the rudder cables consistent with impact forces. The propeller remained attached to the crankshaft propeller flange. Both propeller blades remained in the hub. One blade appeared straight and undamaged. The other blade was bent aft about 90°. The spinner was crushed on one side.

The left wing was located on the left side of the fuselage and appeared to be displaced slightly forward. The main spar was bent and twisted consistent with impacting trees. The majority of the wing was consumed. The flap and aileron remained attached to the wing and were impact and thermally damaged. The right wing was located on the right side of the fuselage and appeared to be displaced slightly aft. The majority of the wing was also consumed by fire. The flap and aileron remained attached to the wing and were impact and thermally damaged. The empennage remained intact. The leading edge of the vertical stabilizer exhibited thermal damage and discoloration. The rudder remained attached by its hinges and exhibited impact damage on the trailing edge consistent with tree impact. The stabilator and stabilator trim remained intact. The stabilator trim jackscrew was extended about nine threads above the drum, which corresponded to a partial nose up trim setting.

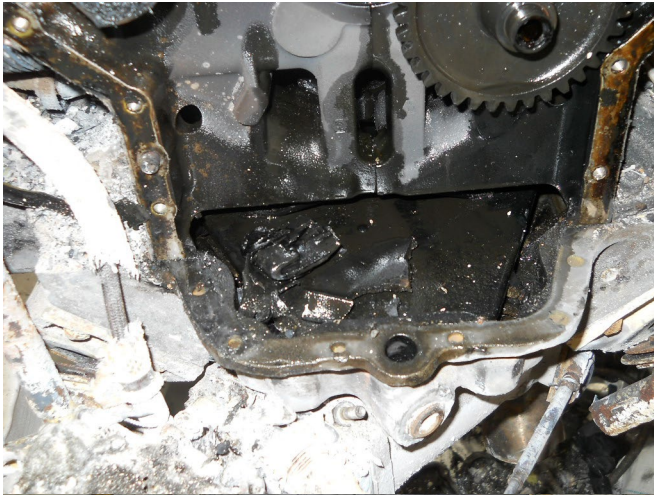
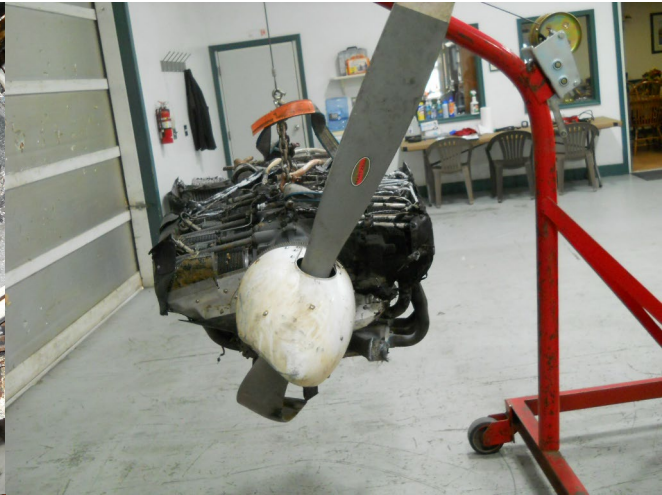
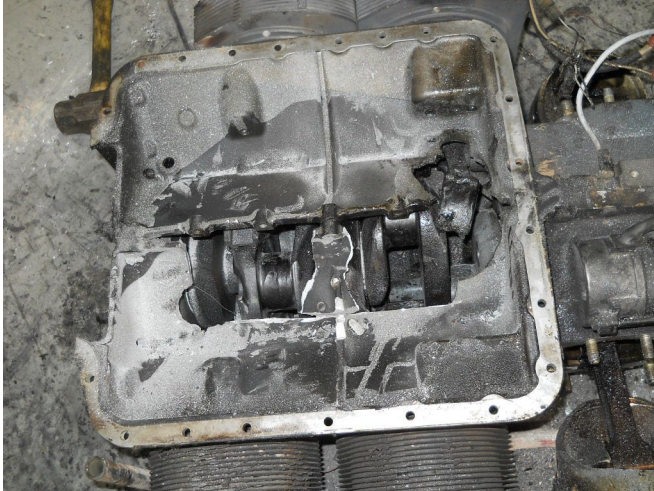
The engine was subsequently examined at a recovery facility. The crankshaft could not be rotated by hand. Removal of the rear accessory case housing revealed fragments of connecting rod cap on top of the oil sump baffling. Removal of the oil sump revealed about 1 quart of oil remaining in the sump with additional metal fragments. The Nos. 1 and 2 cylinders were removed and their respective connecting rods remained intact. The remaining four cylinders could not be removed from the engine case. An access hole was cut through the oil sump baffling to facilitate visual examination. The remaining four connecting rods had fractured. The visual examination revealed that the crankshaft remained intact. The engine was retained for further examination.
