ERA22FA418

## INVESTIGATION PHOTOGRAPHS

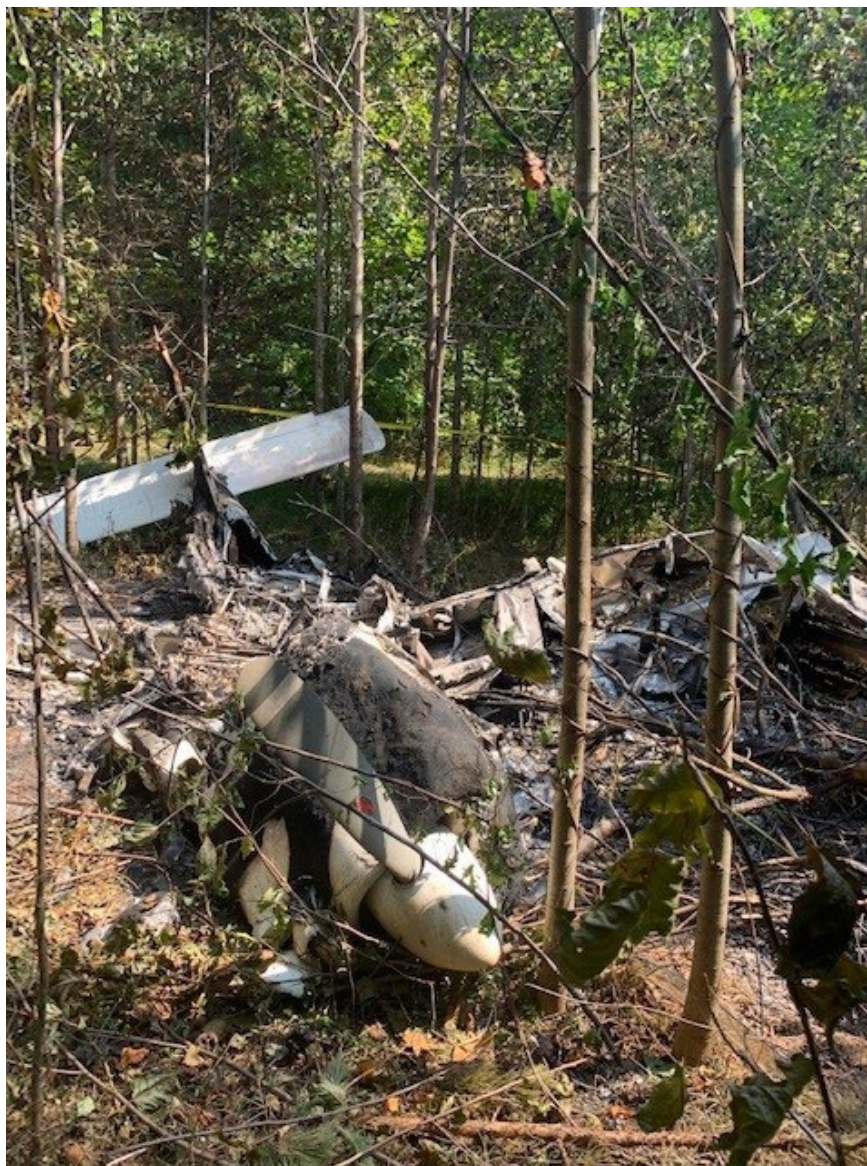
**Photograph 1 - Main Wreckage**

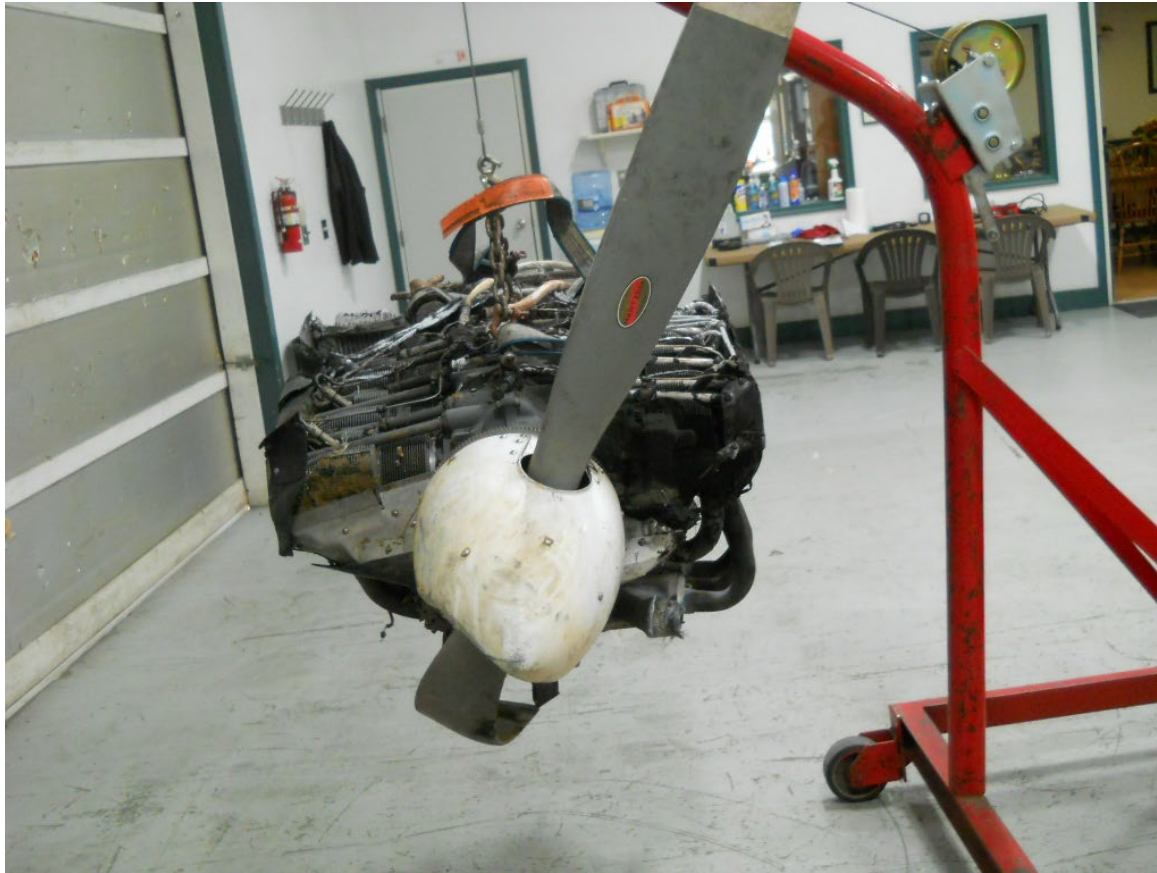
**Photograph 2 - Engine And Propeller**

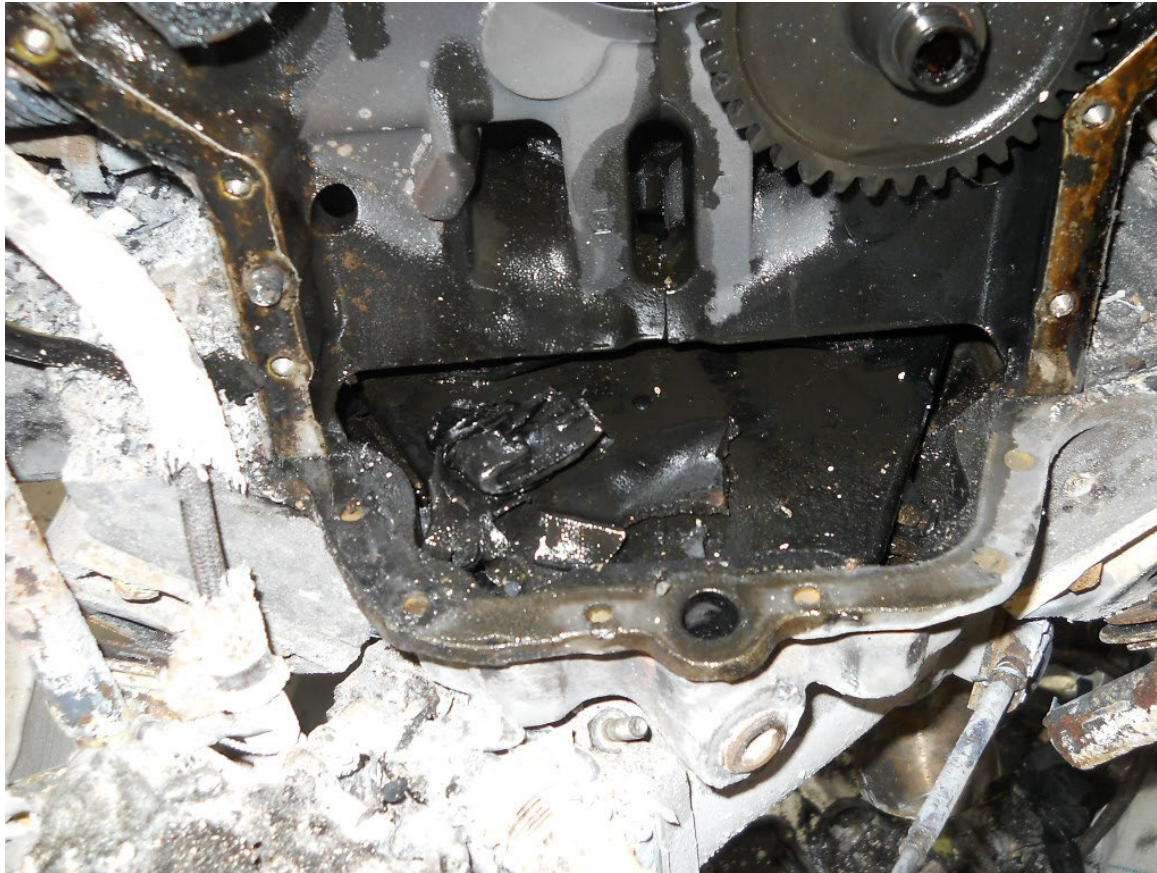
**Photograph 3 - Metal Fragments in Oil Sump**

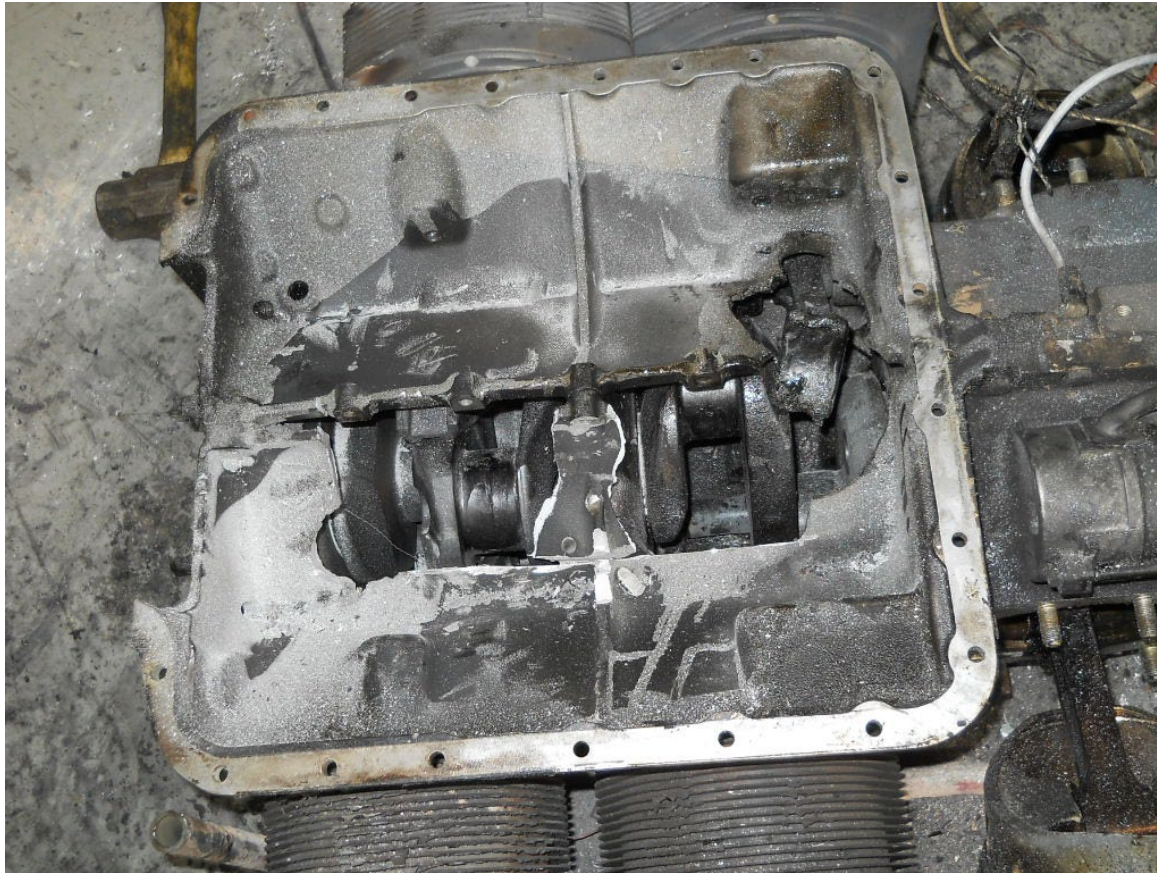
**Photograph 5 - View of Crankshaft Through Oil Sump**

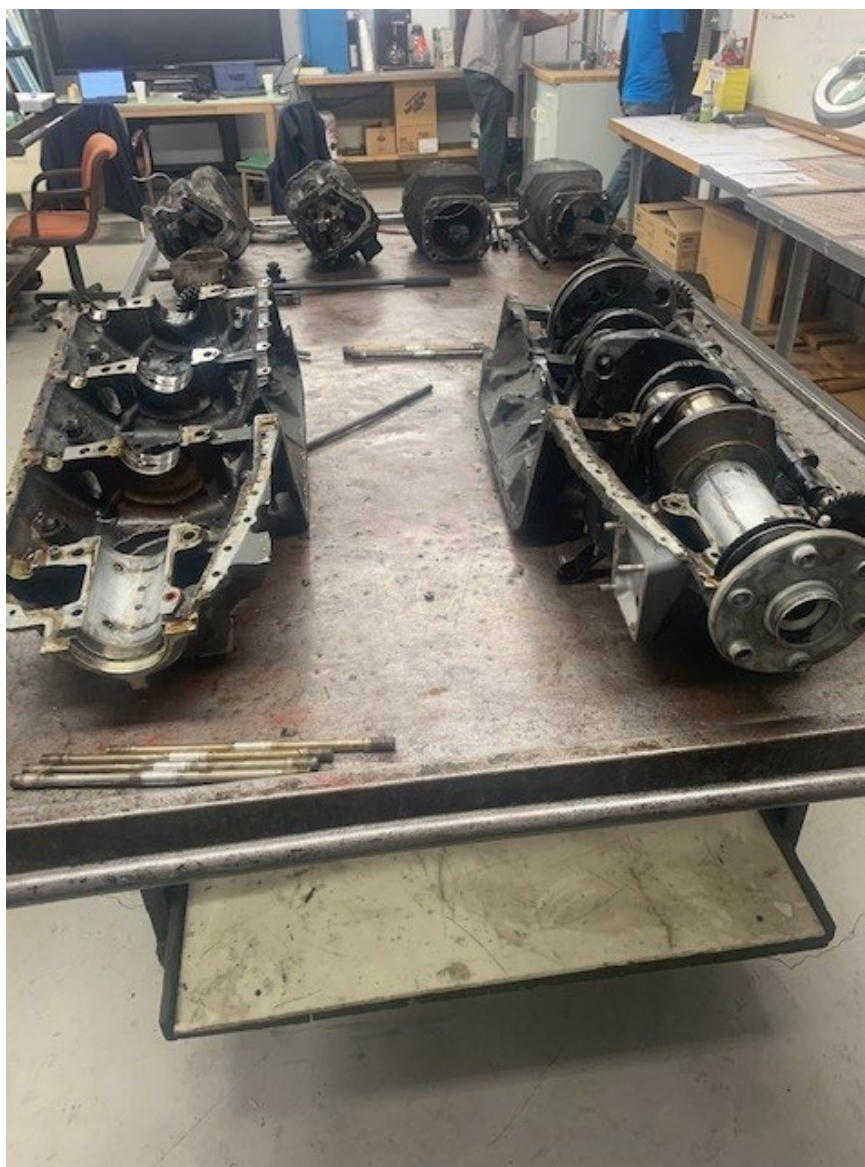
**Photograph 5 - Engine Teardown Examination**

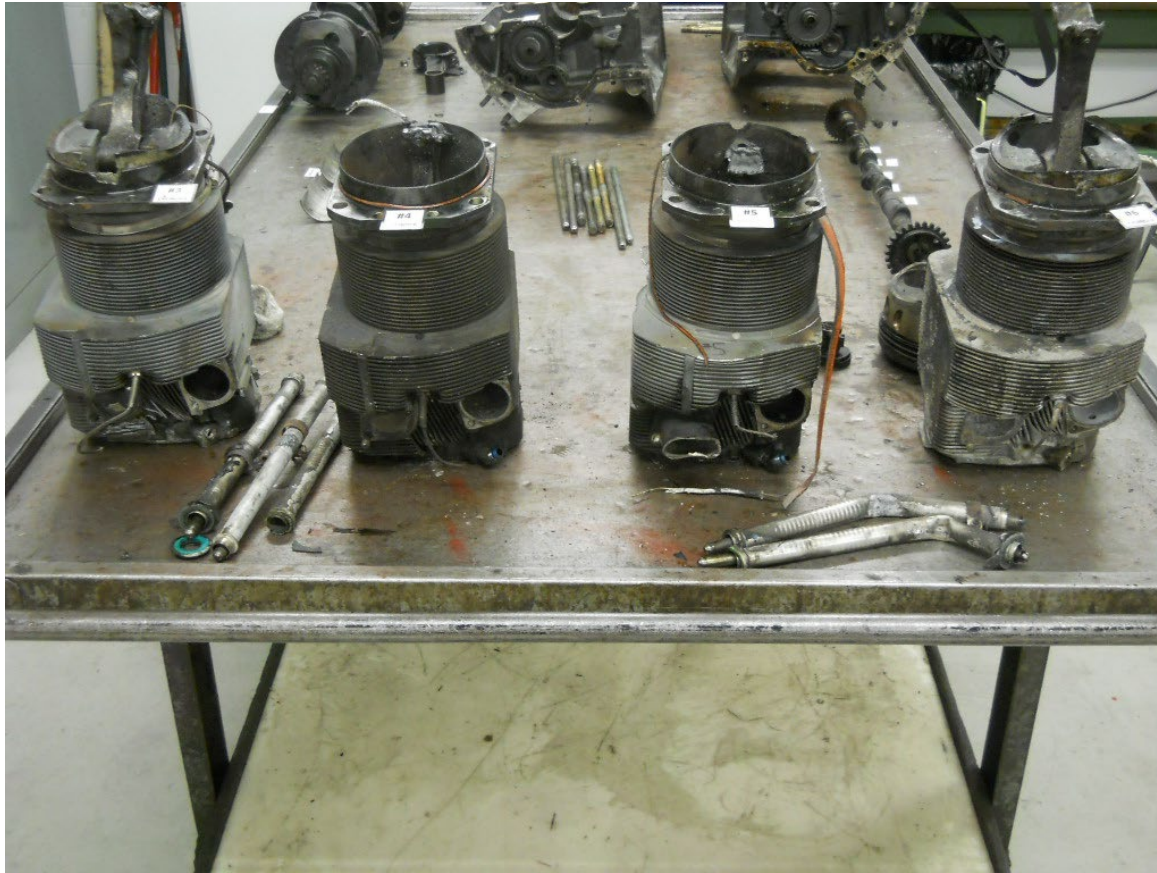
**Photograph 6 - Fractured Connecting Rods**
