**Subject:** ERA22FA418

**Contact:** Engine Teardown Examination, Lycoming, Williamsport, PA

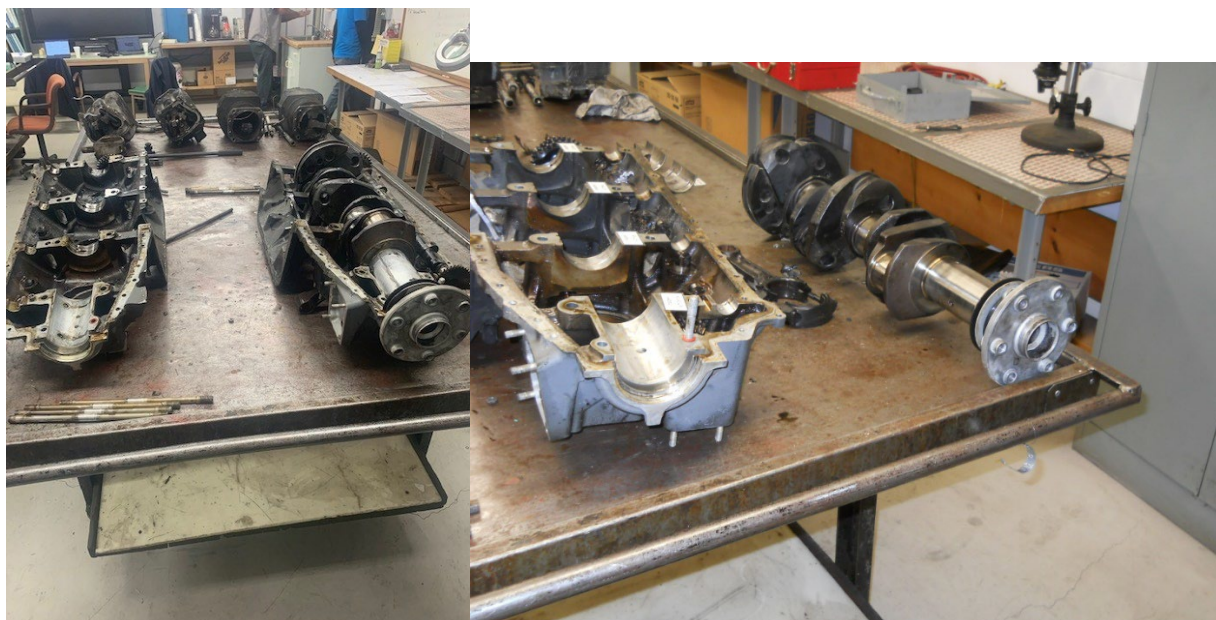
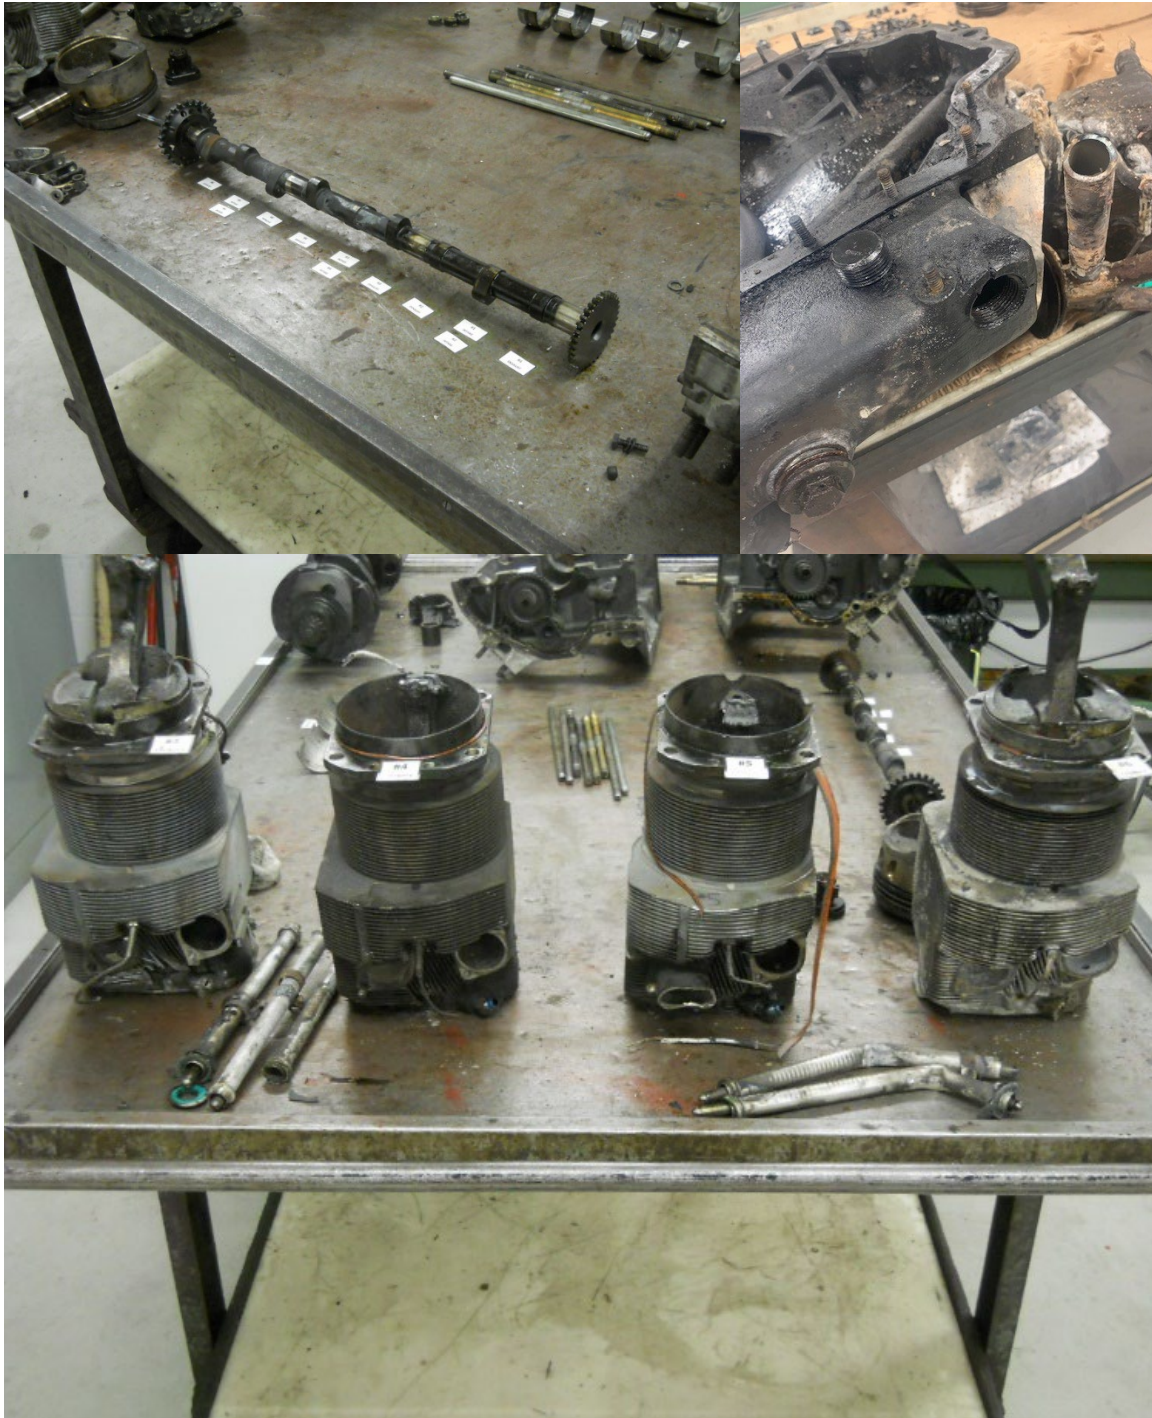
The remaining four cylinders were removed at the Lycoming factory on October 25, 2022. The case halves were then separated. The crankshaft, crankshaft bearings, and camshaft remained intact. One area of note is a plug in the oil sump. The port would be used for oil return if the engine had a turbocharger. It looks like it was repaired at one point with a helicoil. The top section of the port exhibited a fracture, and the remainder of the oil sump does not exhibit impact damage. The oil sump and crankshaft were retained for metallurgical examination.
