## Allen Mains - Incident Report

### Wingtip damage 996LM at LRO airport

10-18-2021

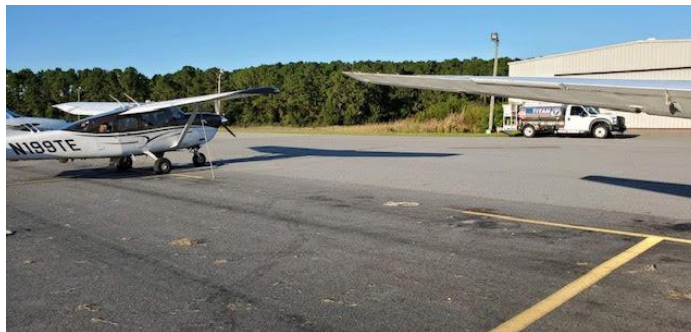
At the time of startup evaluation, I assessed that I had enough room to egress the parking area. No safety markings/cones around the fuel truck, marshaling assistance or warnings were provided by the FBO. After I had started movement, I noticed a small single-engine aircraft to my immediate left pulling into the spot adjacent to me. As I was making my left turn the single-engine aircraft (N199TE) kept inching forward. I instinctively hesitated as I was making my sharp left hand turn and "shallowed out" my direction to avoid any type of contact with a running engine, approximately 6 feet off my left-hand wingtip, as it was apparent to me that the aircraft was not going to stop and allow me to have more movement area. The attached photo of the aircraft (tied down after the incident) shows that the aircraft overran its tie-down position, reflecting the movement I described above.

This short hesitation and probably six feet of movement caused a contact of the right wing tip of my aircraft with the fuel truck parked on the other side of the ramp to my right. My first thought was that I had ran over something on the taxiway itself. As I leaned forward and looked towards the right wing I could see a small amount of damage to the end of the wingtip, and I realized that the wingtip had made contact with the fuel truck. I immediately stopped my taxi procedure. I pulled the plane back around the corner into the original parking spot that I had pulled out of, shut down the engines and egressed the passengers. I evaluated that all passengers were safe, and that no injuries had been incurred, and they departed the airport to continue their workday.

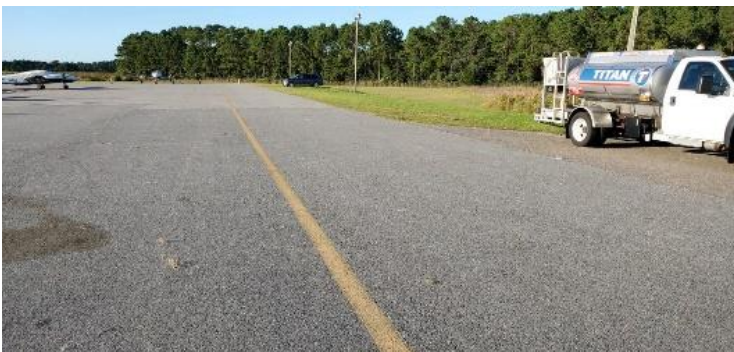
Actual fuel truck placement

The South Carolina Aeronautics Commission has provided an assessment of the taxilane object-free safety areas requirements for LRO Airport. The assessment is provided on the next page and shows that the truck was roughly 20' from the center line, or roughly 37.5' inside of the required 57.5' object-free area. Furthermore, the assessment has highlighted that the light poles along the taxilane (see photo below) also encroach the 57.5' object-free area (at 42' line). The Google Earth photo also shows another fuel truck well within the object-free area. The actual fuel truck location from the incident is illustrated below, even closer to the center line (~20').

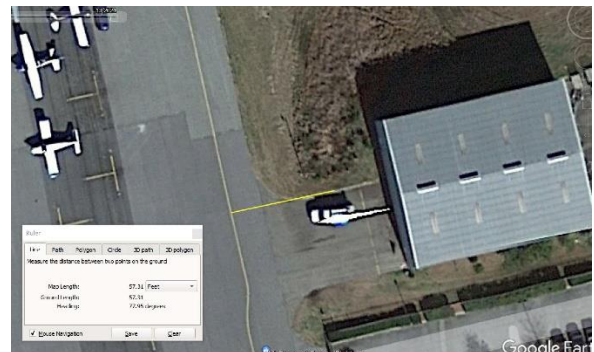
SC Aeronautics Google Earth with measurement

The geometry requirements for taxiways are found in [AC 150/5300-13A](#) Table 4-2. The LRO apron taxilane along the east edge of pavement appears to be Taxiway Design Group (TDG) 2 because the centerline stripe measures 17.5' from pavement edge (corresponding to a 35' wide taxiway). The safety areas associated with taxiways come from the same AC, Table 4-1 and for LRO are Airplane Design Group (ADG) II. According to the guidance, the taxilane object free area width at LRO should be 115', or 57.5' each side of centerline.

It appears that not only is the fueling truck too close to the edge of pavement, but also the light poles are too close. The light poles look like they were designed for ADG I, which is 79' wide or 39.5' each side of centerline. The light poles appear to be about 42' from taxilane centerline. Even if the taxilane was intended to be ADG I, the fuel truck was still too close to the taxilane centerline.

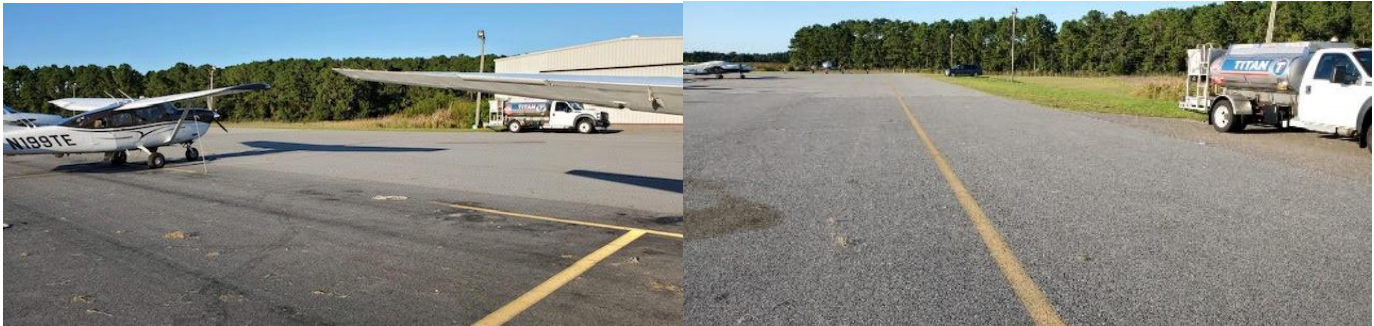
During the start of taxi, immediately in front of me, there was an unmanned and parked fuel truck on the far side of the taxiway, less than 20 feet from the center line taxiway guidance marking.

After the incident, the following information was discovered. I was not aware of this information until after the incident. On Dec. 17 2020, the South Carolina Aeronautics Commission performed a yearly Safety Inspection at LRO and clearly identified the truck position above as a safety issue, with respect to its location. SC Aeronautics provided the Safety Inspection Report with the truck location finding to the FAA Airport District Office in Atlanta, as well as to Charleston Airport executive management and personnel. As an FAA-funded airport, LRO is also routinely visited by the South Carolina FSDO 13 for inspections, pilot check rides and ramp checks. On October 19, 2021 the South Carolina Aeronautics Commission performed another assessment on the fuel truck location at the time of the incident. The SC Aeronautics Commission assessment found that the truck should have been a minimum of 57.5' from the taxiway centerline, to be compliant with the FAA AC 150/5300-13A (table 4.2 and 4.4) object-free area regulations. The truck location at the time of the incident was approximately 20' from the taxiway centerline and 40' from the front of the hangar building. Furthermore, the assessment found that all light poles along the taxiway (located 42' from the taxiway centerline) also infringe on the 57.5' object-free required by a FAA AC 150/5300-13A. Despite what we now know were identified safety hazards, LRO airport personnel requested on numerous occasions that pilots do not taxi in front of the FBO or maintenance hangar, which means that pilots would have to take the taxiway direction I followed. This direction was given to pilots to avoid having aircraft departing the apron area taxi in front the FBO building and maintenance hangar, due to multiple complaints of exhaust smell going into the FBO building and propellor wash blowing debris into the maintenance hangar (that keeps its hangar doors open). Besides the request of LRO airport personnel to avoid taxing in the FBO and hangar direction to exit the apron (which I followed), the FBO provided no additional safety markings or cones around the fuel truck, marshaling assistance or warnings. Please note

from the photo above that, additionally, a minivan was also parked in the object-free area at the time of the incident.

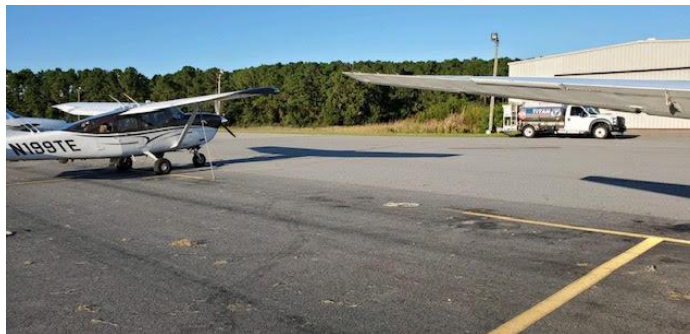
At the time of startup evaluation, I assessed that I had enough room to egress the parking area and turn to my left onto the taxiway. As discussed, turning right onto the taxiway wasn't an option due to the request from the LRO airport personnel. After I had started movement, I noticed a small unmarshalled single-engine aircraft to my immediate left pulling into the spot adjacent to me. As I was making my left turn, the single-engine aircraft (N199TE) kept inching forward. I believed that the aircraft was going to hit my left-hand wing tip with its propeller. To avoid a collision, I instinctively hesitated as I was making my sharp left hand turn and "shallowed out" my direction to avoid any type of contact with a running engine, approximately 6 feet off my left-hand wingtip, as it was apparent to me that the aircraft was not going to stop and allow me to have more movement area. The attached photo of the aircraft (tied down after the incident) shows that the aircraft overran its tie-down position, reflecting the movement I described above.

This short hesitation and probably six feet of movement caused a contact of the right wing tip of my aircraft with the fuel truck parked on the other side of the ramp to my right. My first thought was that I had ran over something on the taxiway itself. As I leaned forward and looked towards the right wing I could see a small amount of damage to the end of the wingtip, and I realized that the wingtip had made contact with the fuel truck. I immediately stopped my taxi procedure. I pulled the plane back around the corner into the original parking spot that I had pulled out of, shut down the engines and egressed the passengers. I evaluated that all passengers were safe, and that no injuries had been incurred, and they departed the airport to continue their workday. Upon having time to investigate the damage to the aircraft I noticed that the aircraft wingtip had come into contact with the ladder handle on the fuel truck (slightly bended, see photo below). On the King Air 200, the last two-foot section of the wingtip is attached by a rivet line: that rivet line had sheared off. In the King Air 200, the third outboard aileron anchor point is also attached to the wingtip assembly: as a result of the wing tip shearing, the last attach point of the aileron was sheared, and the aileron was damaged. Although the aileron is still attached to the aircraft, it is loose from the third anchor point, causing control surface damage but still attached to the aircraft by the other two hinge points.

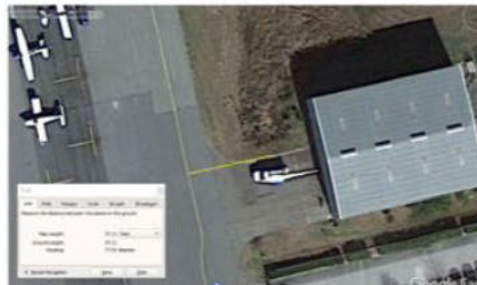
The geometry requirements for taxiways are found in [AC 150/5300-13A](#) Table 4-2. The LRO apron taxilane along the east edge of pavement appears to be Taxiway Design Group (TDG) 2 because the centerline stripe measures 17.5' from pavement edge (corresponding to a 35' wide taxiway). The safety areas associated with taxiways come from the same AC, Table 4-1 and for LRO are Airplane Design Group (ADG) II. According to the guidance, the taxilane object free area width at LRO should be 115', or 57.5' each side of centerline.

It appears that not only is the fueling truck too close to the edge of pavement, but also the light poles are too close. The light poles look like they were designed for ADG I, which is 79' wide or 39.5' each side of centerline. The light poles appear to be about 42' from taxilane centerline. Even if the taxilane was intended to be ADG I, the fuel truck was still too close to the taxilane centerline.
