# National Transportation Safety Board

ERA22LA027

## **BRAKE CONTROL UNIT**

Specialist's Factual Report

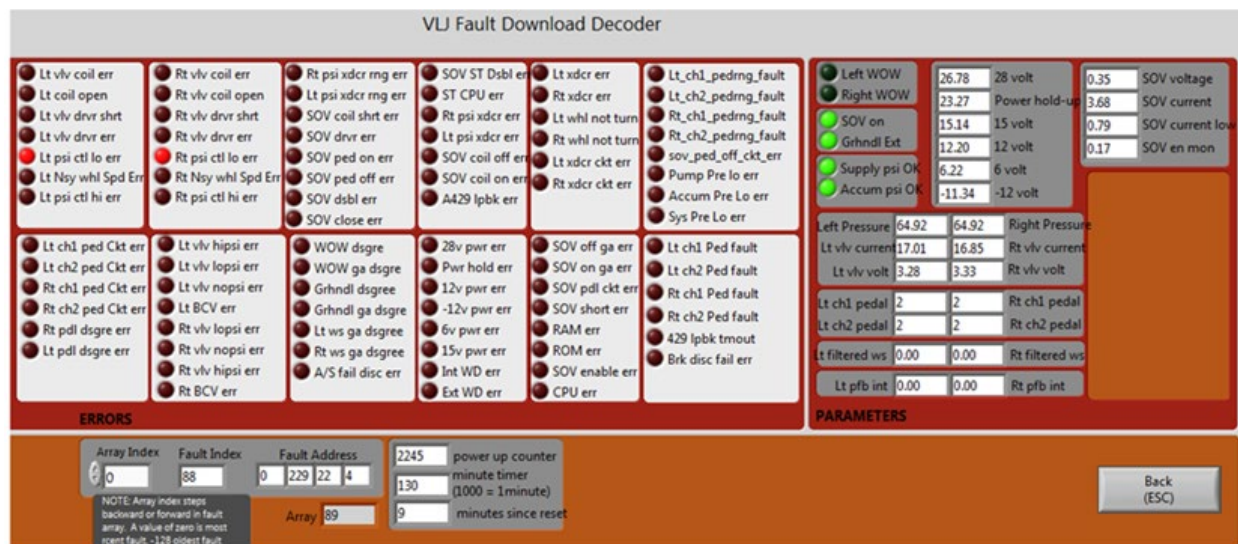
Meggitt stated that the most recent fault entry in the NVM occurred at power up cycle 2245 (see Figure 1). A complete power up cycle is when the OFF voltage level and ON voltage level and timing is such that the micro controller in the BCU performs a power on reset. At this time the BCU runs initialization code that will read and increment a register in the NVM, effectively keeping track of the amount of power up cycles the BCU has had. The NVM does not contain a time stamp, so the power up counter must be used to determine fault timing. To determine the power up counter cycle associated with the accident flight, Meggitt performed a second NVM download after running the FTI. The FTI will itself create faults that are logged in the NVM. The NVM download after running the FTI showed that a new fault was logged during the FTI that was recorded at power up cycle 2413 (see Figure 2). It is unknown when during the FTI this fault was recorded, but the FTI had approximately 61 power up cycles associated with it.<sup>1</sup> Therefore, the accident flight power up cycle would have been in the approximate range of (2413 minus 1) to (2413 minus 61 minus 1), or 2412-2351. Using this same logic, the fault that occurred at power up cycle 2245 would have occurred between approximately 167 and 106 power up cycles before the accident flight. It is noted here that the BCU power up cycle does not necessarily correlate to flight legs, as it is possible that the aircraft/BCU power may be cycled for maintenance or other reasons.

The fault associated with power up cycle 2245 was a left and right "Pressure Control Low Error" fault that occurred 9 minutes after the BCU was powered on. This fault occurs when the pressure transducer reading is 200 psi less than commanded for 750 milliseconds, and other criteria are met. Meggitt stated that this fault is commonly observed during production testing or in maintenance testing when the shutoff valve may be forced closed during a maintenance test/check. When this fault occurs in service, a *Brake Fail* indication is set and alerted to the crew.

**Figure 1:** Fault recorded in NVM at power up cycle = 2245 (from NVM download obtained at the beginning of the FTI)

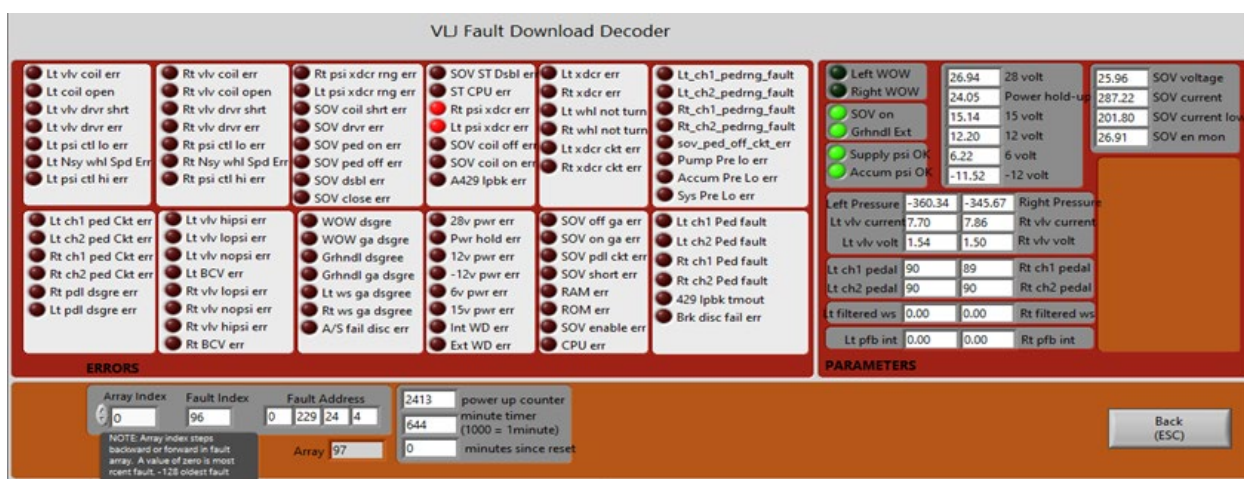
**Figure 2:** Fault recorded in NVM at power up cycle = 2413 (from NVM download obtained after running the FTI)
