## **RECORD OF CONVERSATION**

**Date: March 17, 2022**  
**Person Contacted: John A Pless**  
**NTSB Accident Number: ERA22LA045**

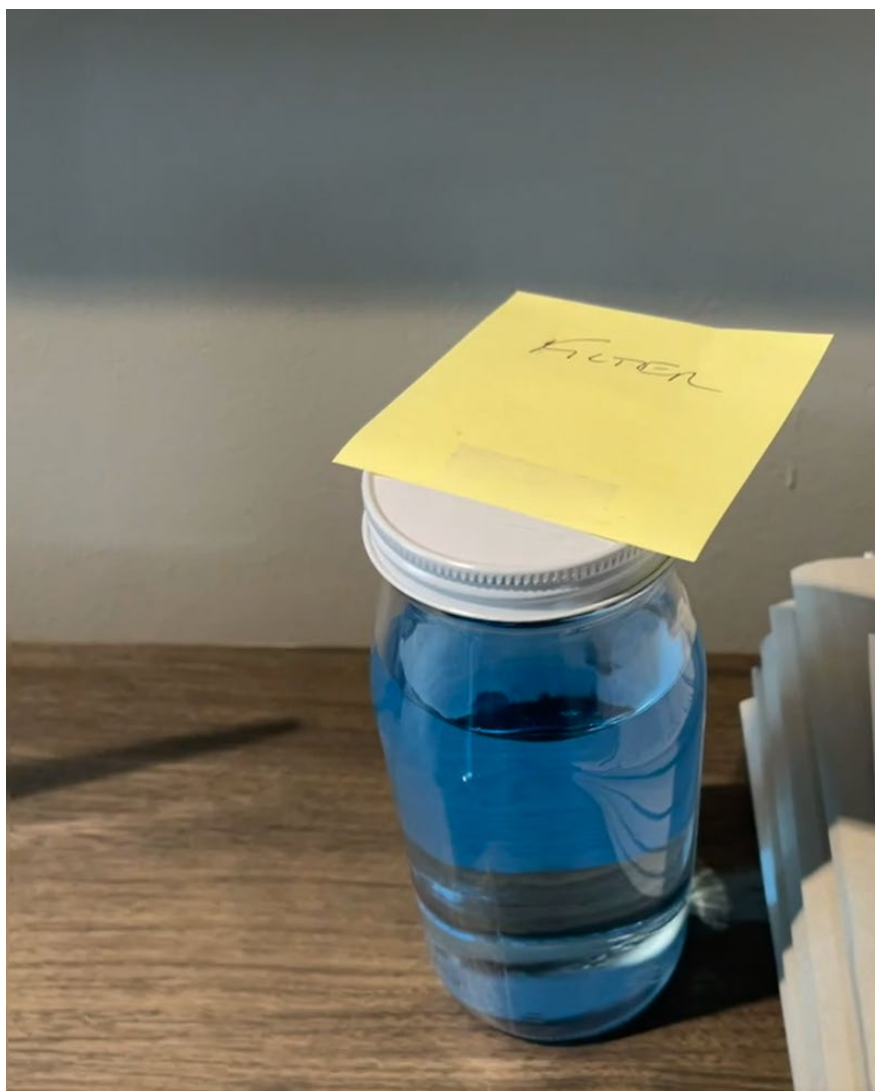
He indicated that there was no fuel contamination from the facility that fueled the airplane (Figures 1 and 2). He noted fresh oil covering the bottom fuselage skin.

Figure 1: ScreenShot from FAA Video. View of Fuel Sample Taken From Filter that Fueled the Accident Airplane.

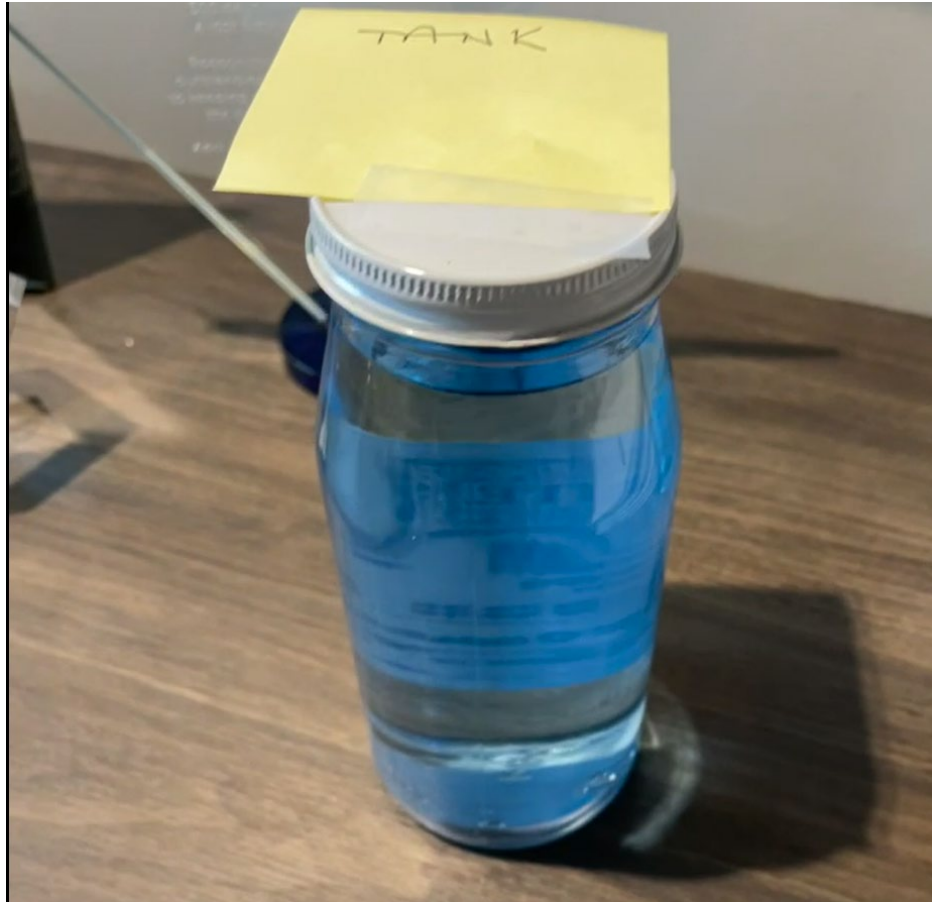
Figure 2: ScreenShot from FAA Video. View of Fuel Sample Taken From Tank that Fueled the Accident Airplane.

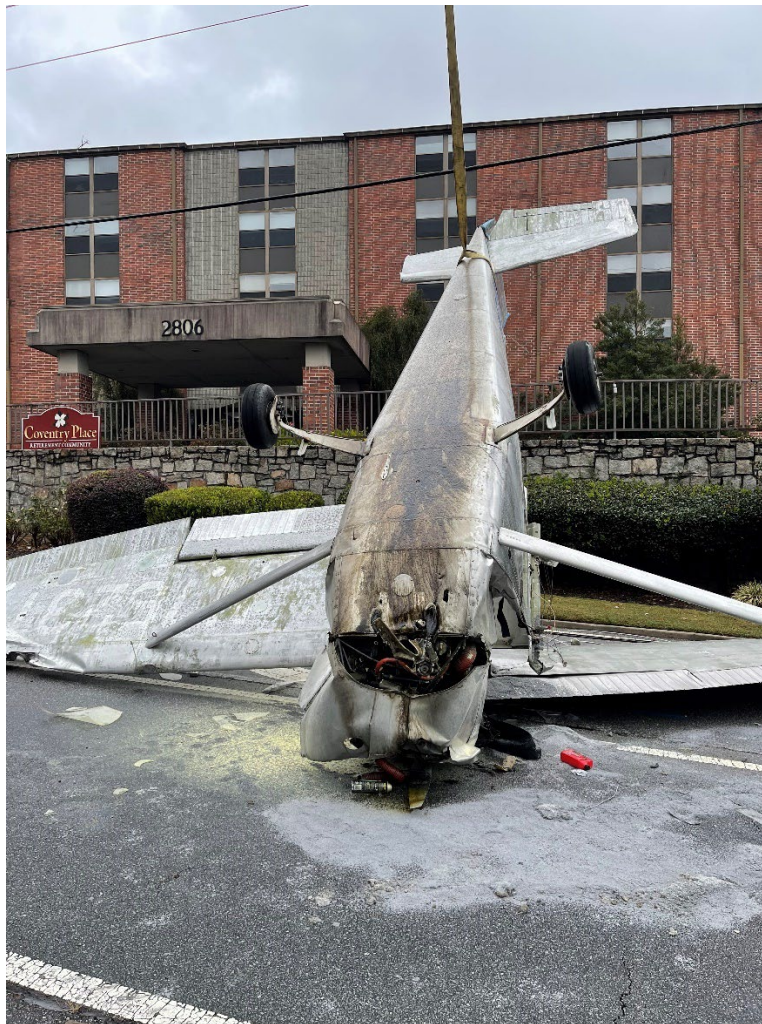
During his inspection of the airframe, he noted oil on the belly of the airplane (Figure 1). The airplane was not equipped with shoulder harnesses. Both fuel tanks contained 100 low lead fuel. A fuel sample from the left fuel tank did not contain any contaminants, while the right fuel tank contained some sediment but no water. The left horizontal and elevator were cut by powerlines. Fresh oil was noted in the cockpit floor behind the firewall. The airframe fuel strainer was empty but there was some debris inside. The bottom engine cowling had evidence of old and fresh oil. An emergency locator transmitter was not installed. There were 2 or 3 full quarts of engine oil in the airplane.

Figure 1: FAA Digital Photograph. View of the Airplane at The accident site. Note the oil covering the bottom of the Fuselage.
