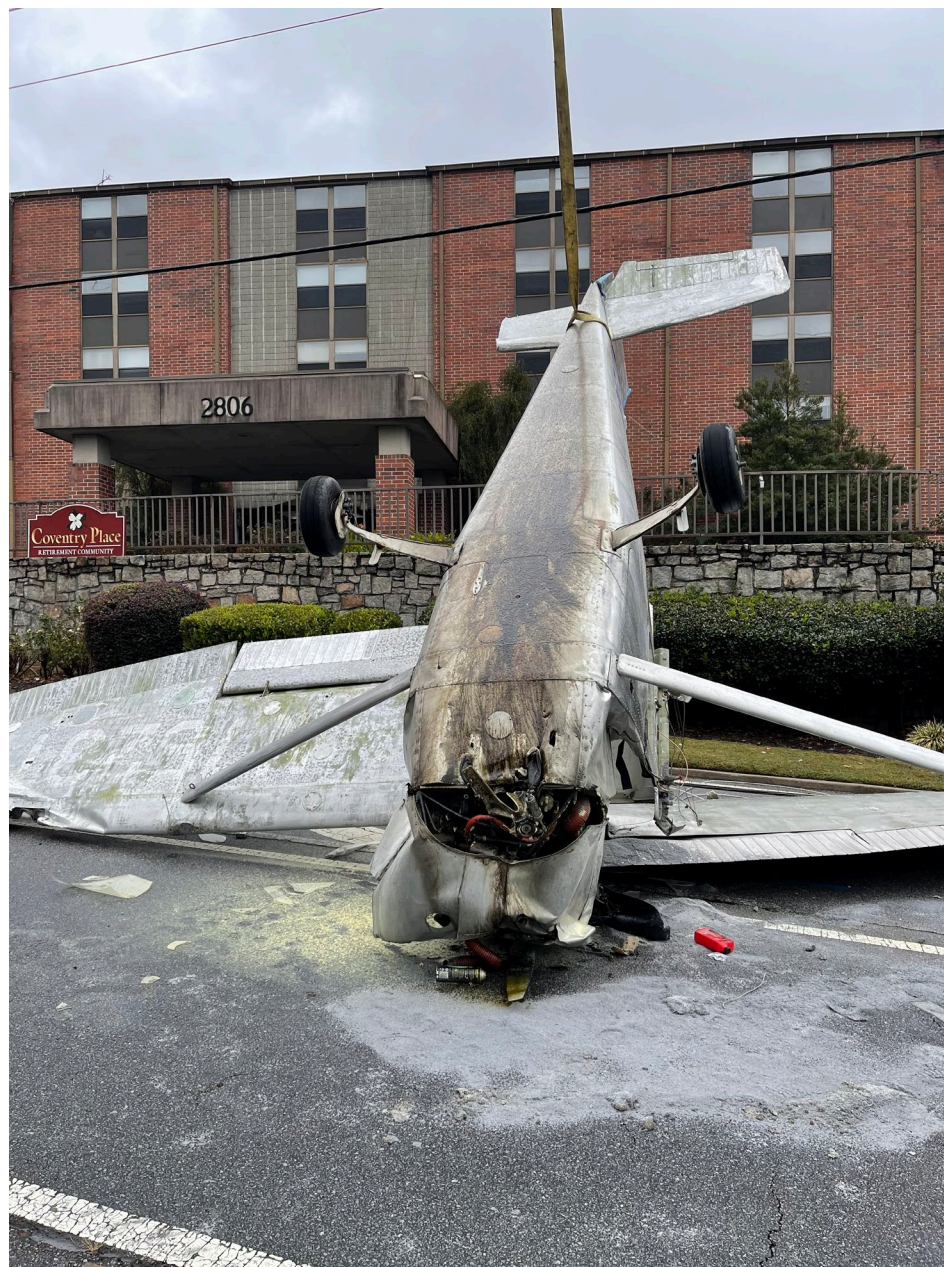
**Photo 1 – FAA Digital Photograph. View of the Airplane at the Accident Site. Note the oil Covering the Entire Length of the Exterior of the Bottom Fuselage Skin, and the Damaged Left Horizontal Stabilizer and Elevator.**

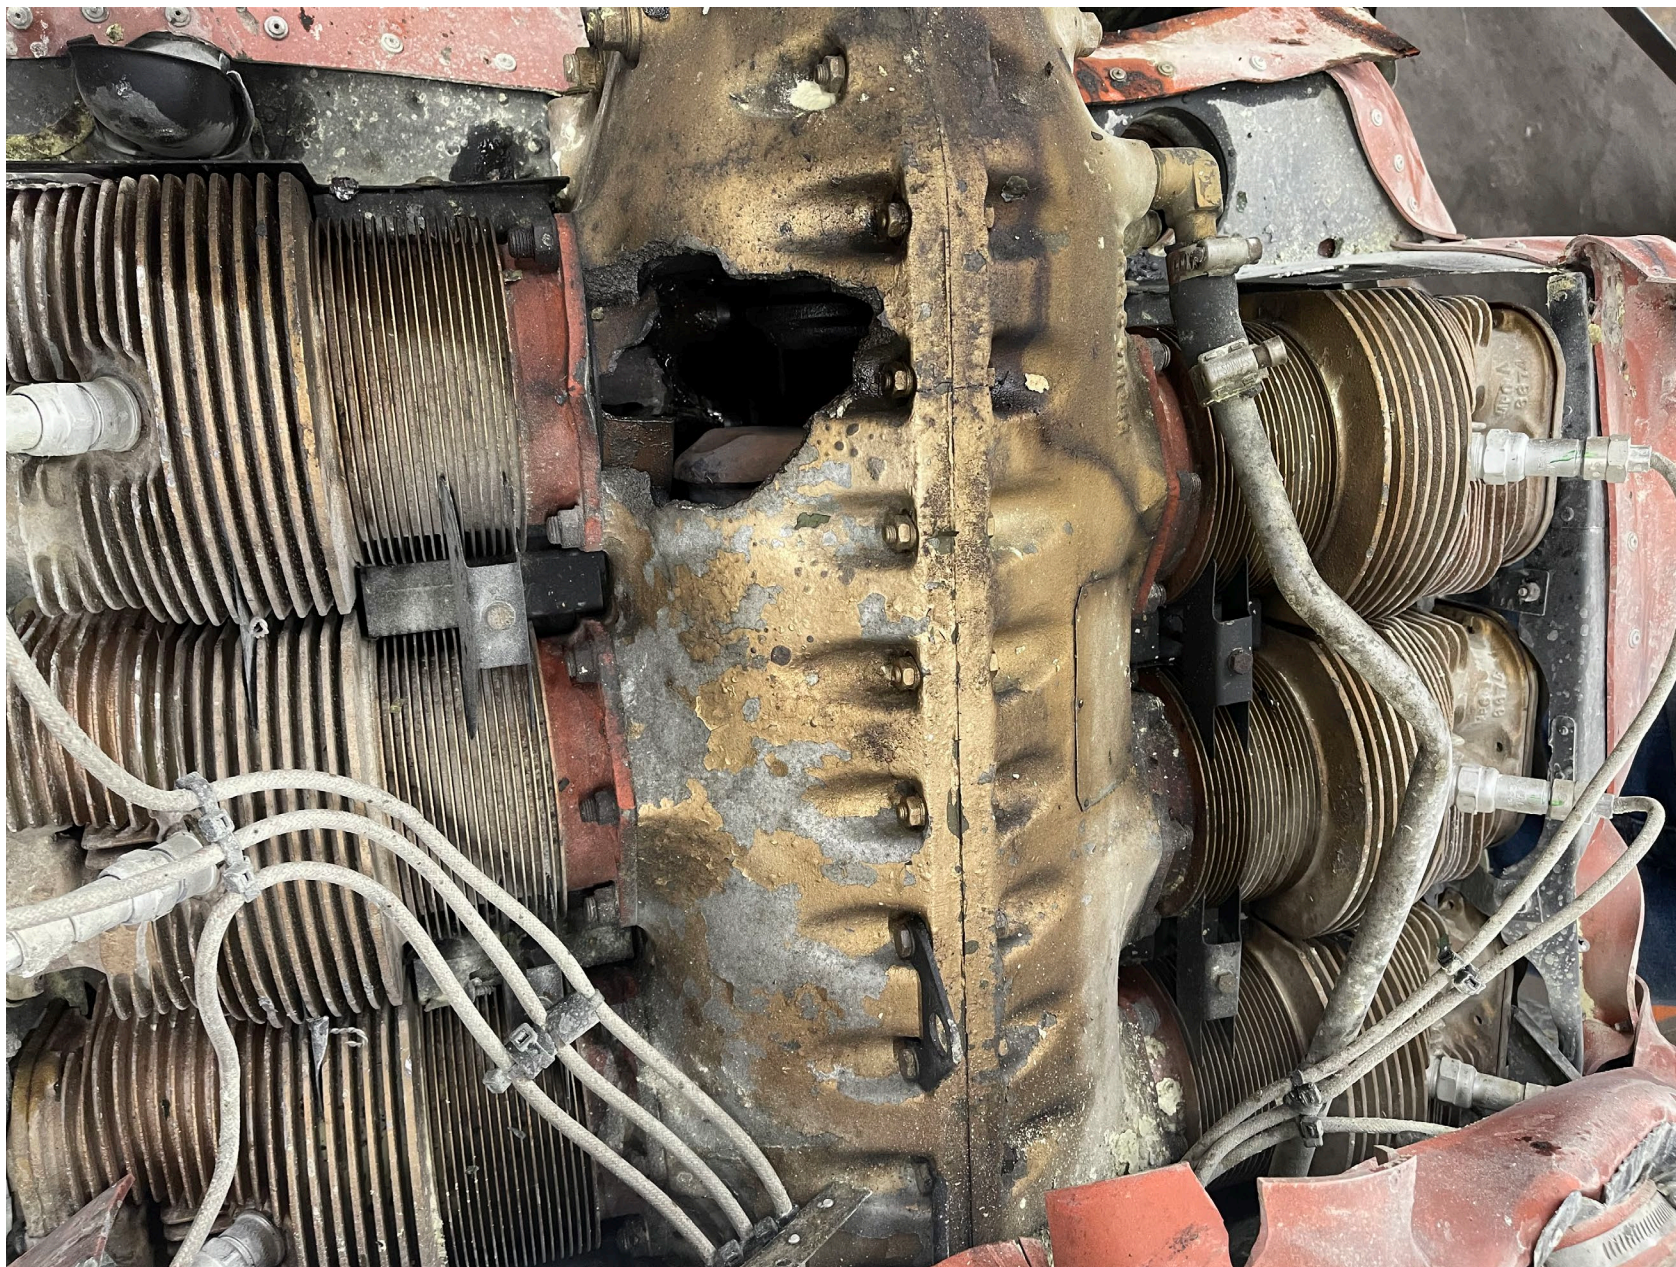
**Photo 2 - FAA Digital Photograph. View of the Hole in the Engine Crankcase Above the No. 6 Cylinder.**

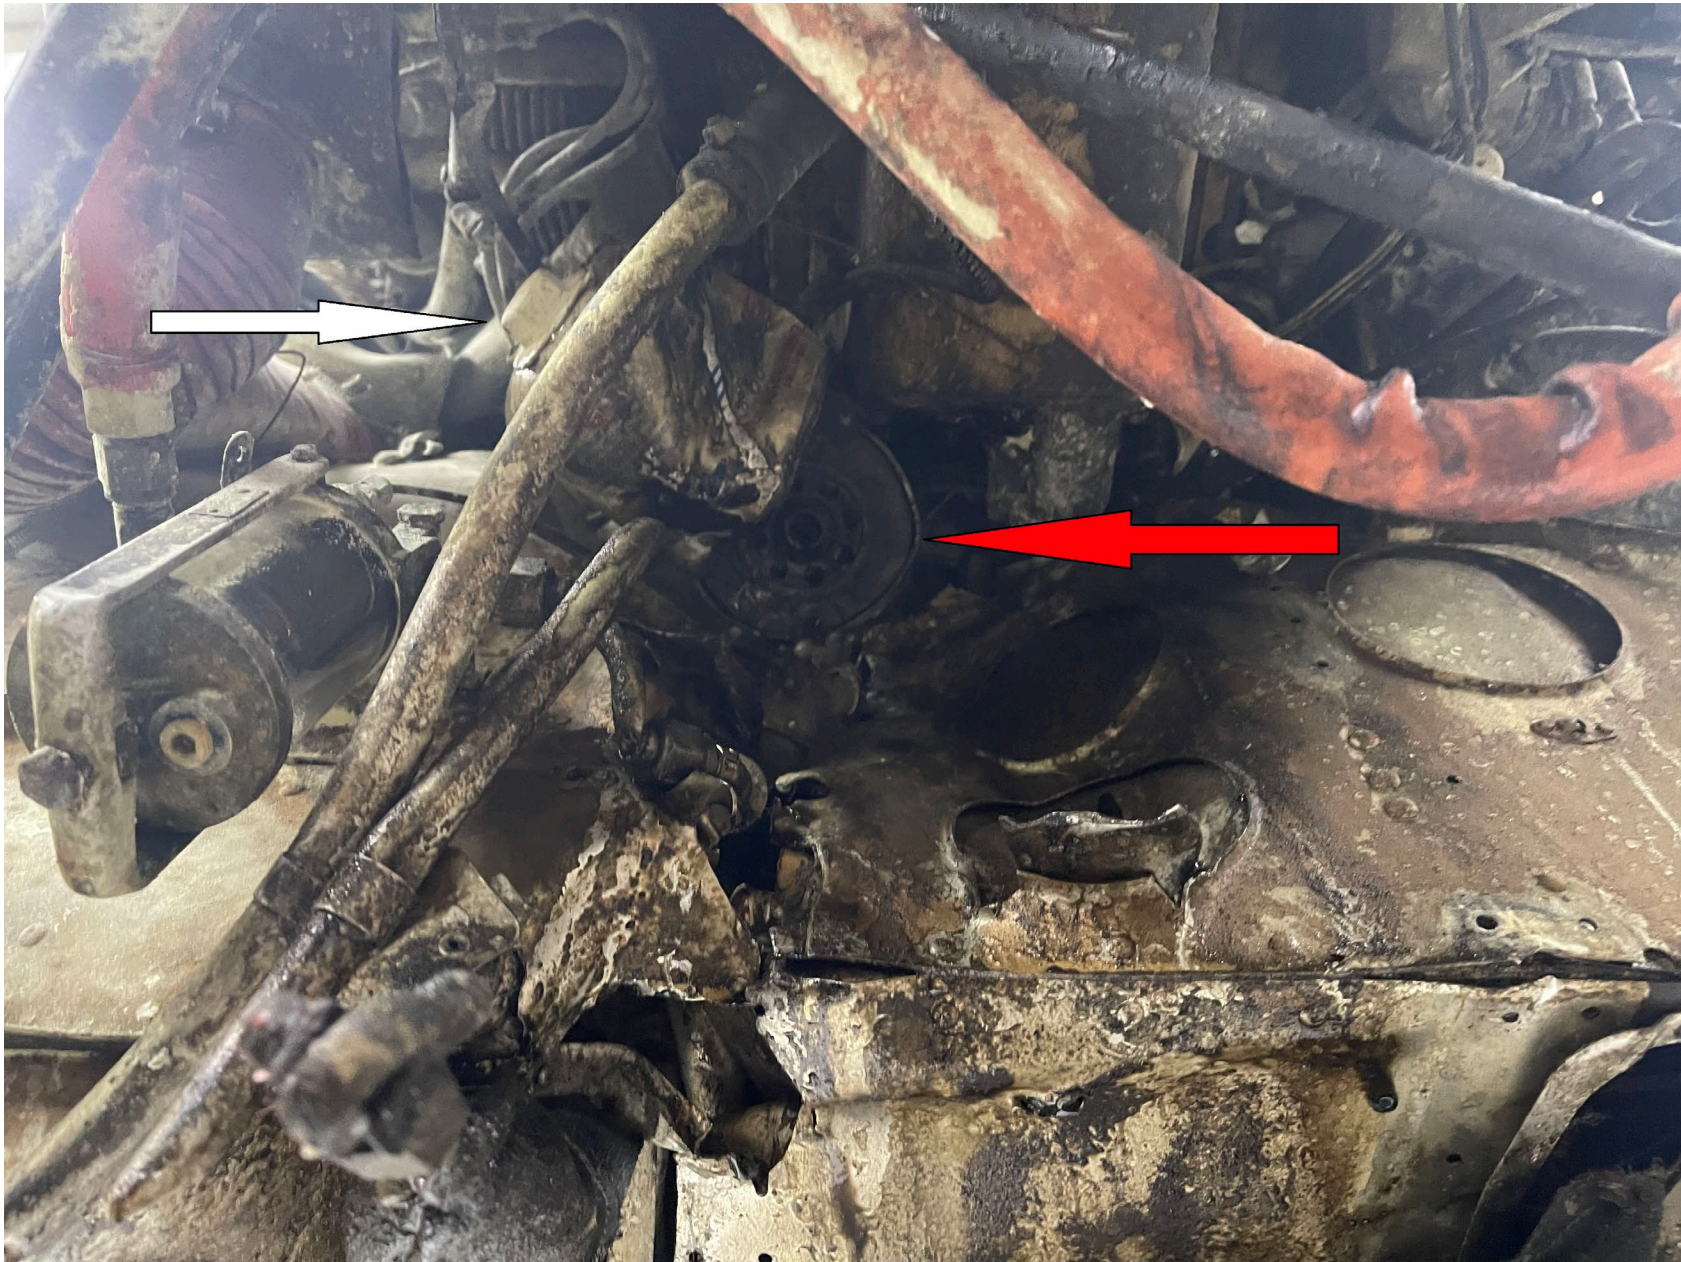
**Photo 3 – Annotated FAA Digital Photograph. White Arrow Depicts upper Portion of the Separated Oil Filter and Red Arrow Points to Base of the Oil Filter Attached to the Oil Filter Adapter. Note the Impact Damaged Oil Filter.**

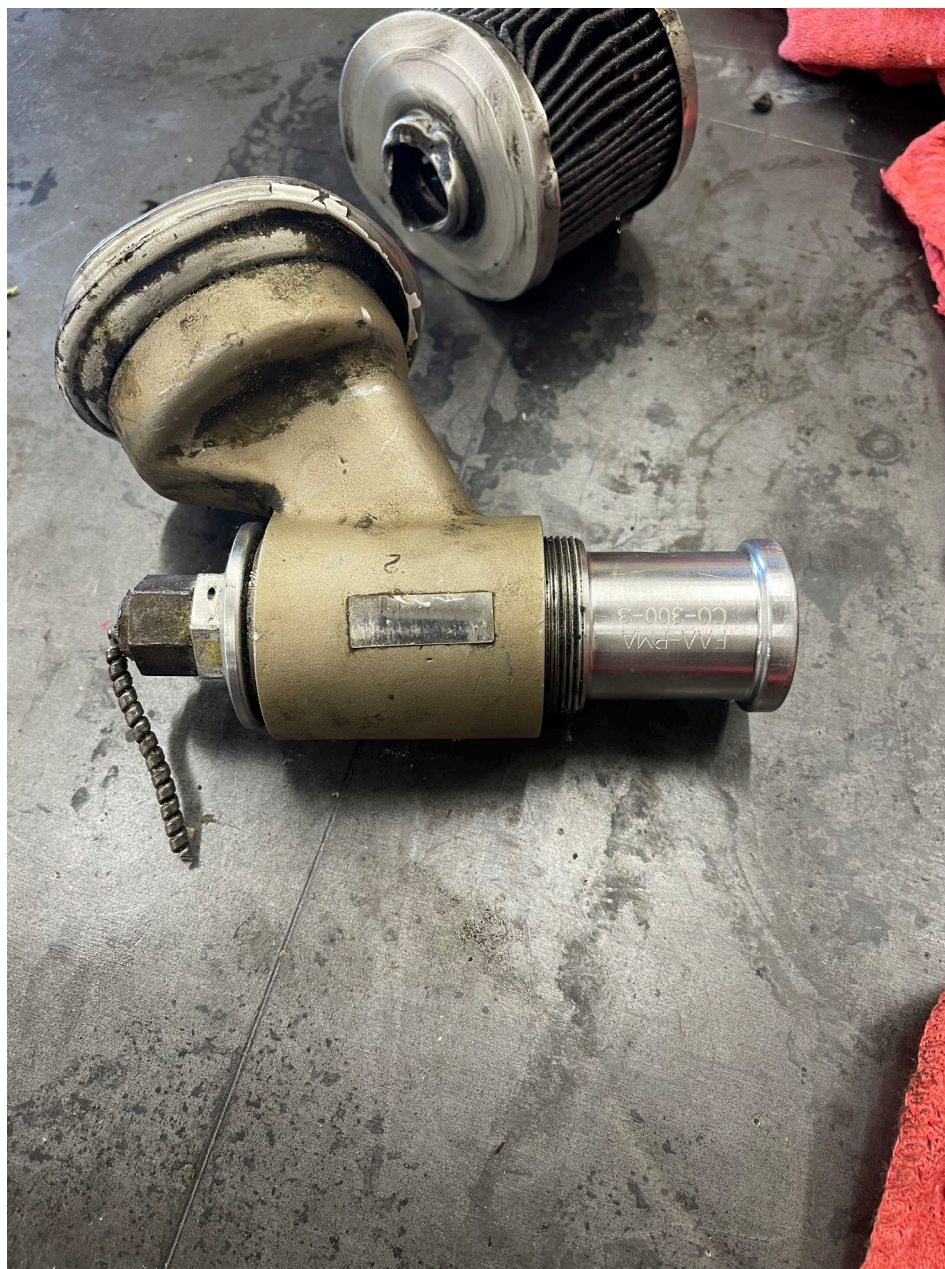
**Photo 4 - FAA Digital Photograph. View of the Oil Filter Adapter and Installed Base of Oil filter, and also Oil Filter Element Separated For the Investigation.**

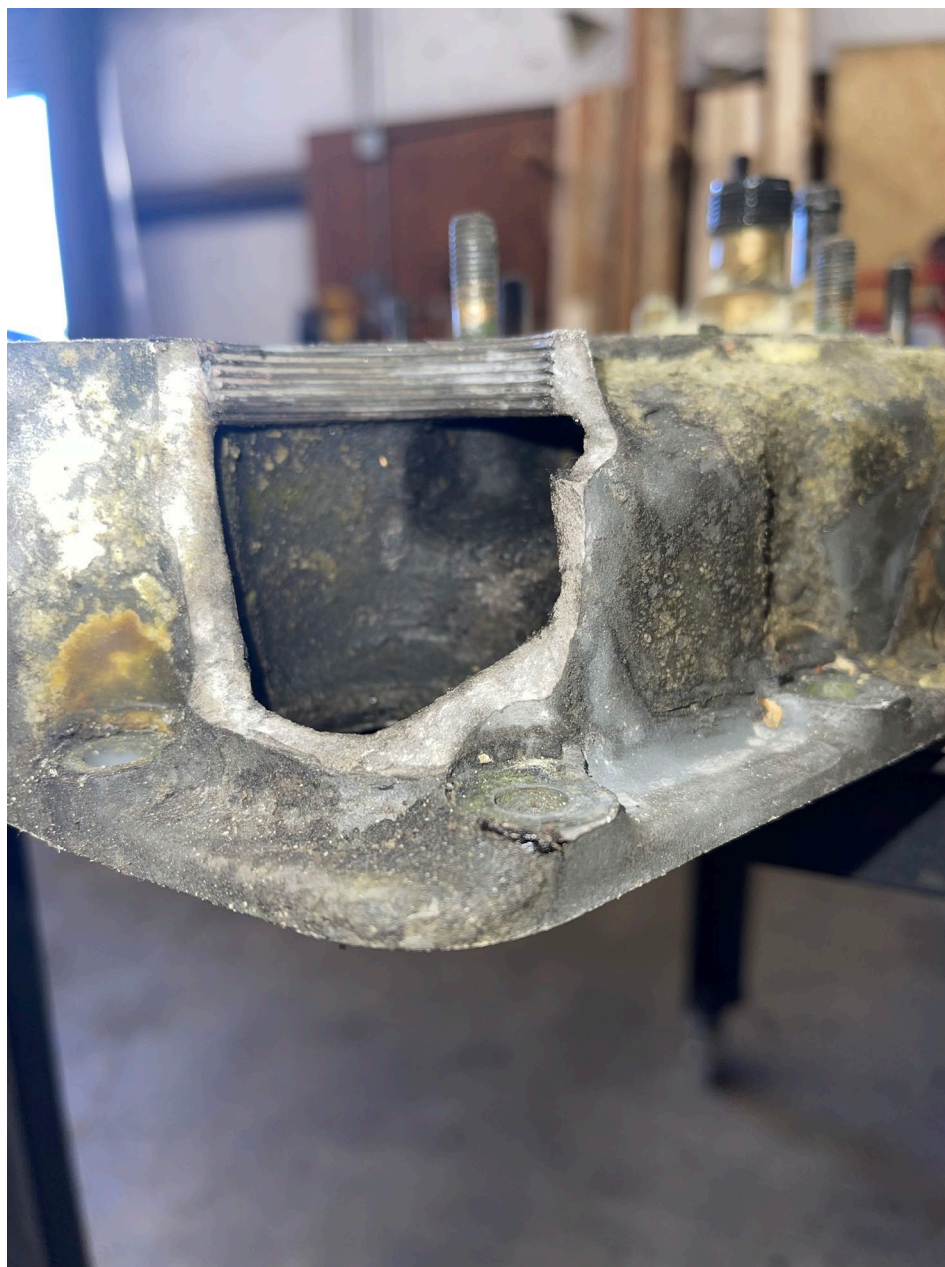
**Photo 5 - FAA Digital Photograph. View of the Fractured Lower Portion of the Accessory Case that Accepted the Threaded Portion of the Oil Filter Adapter.**
