**ERA22LA046**

**Margarettsville, North Carolina**

**Cessna 150M**

**NTSB ENGINE EXAMINATION REPORT**

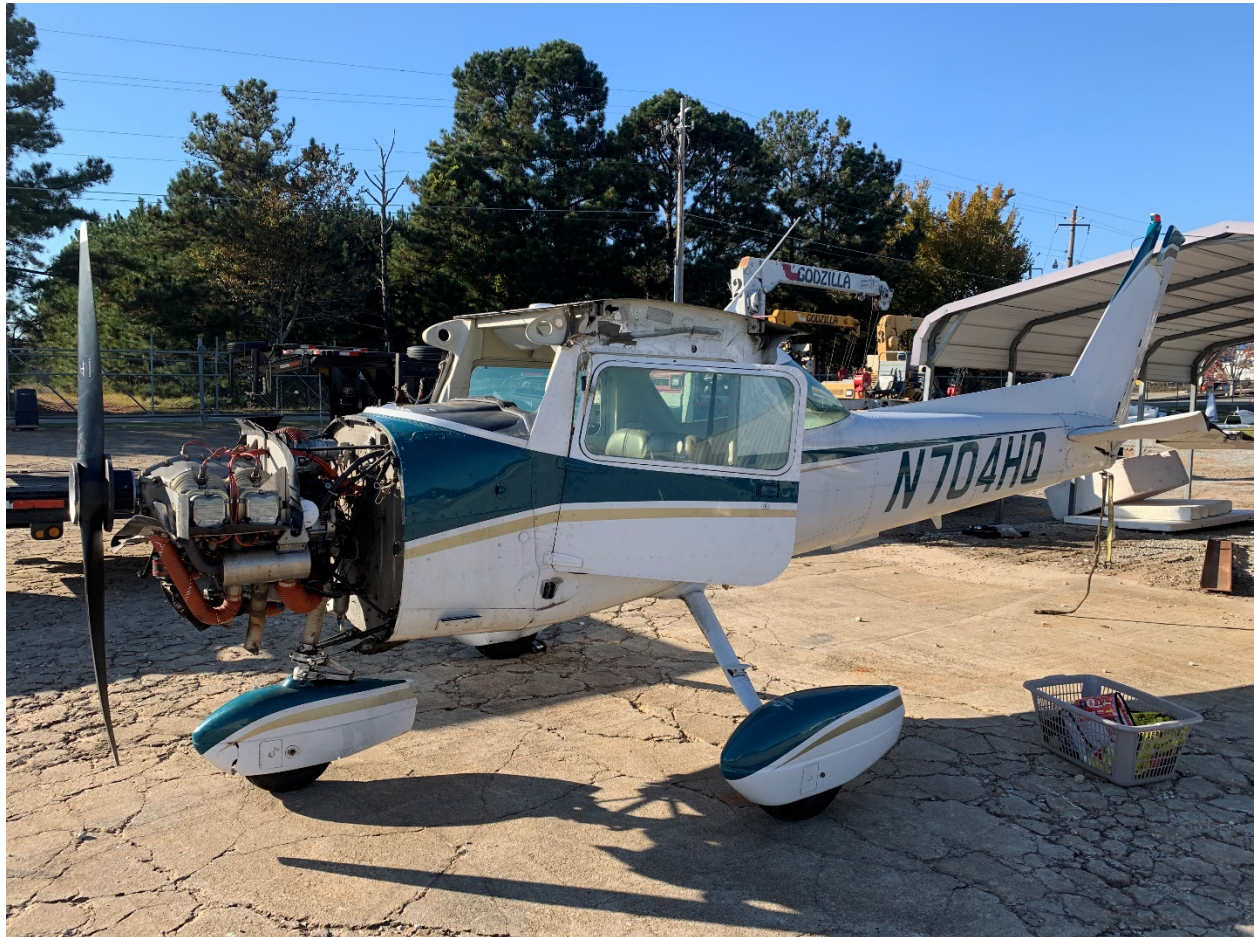
Figure 1. Airplane at salvage yard.

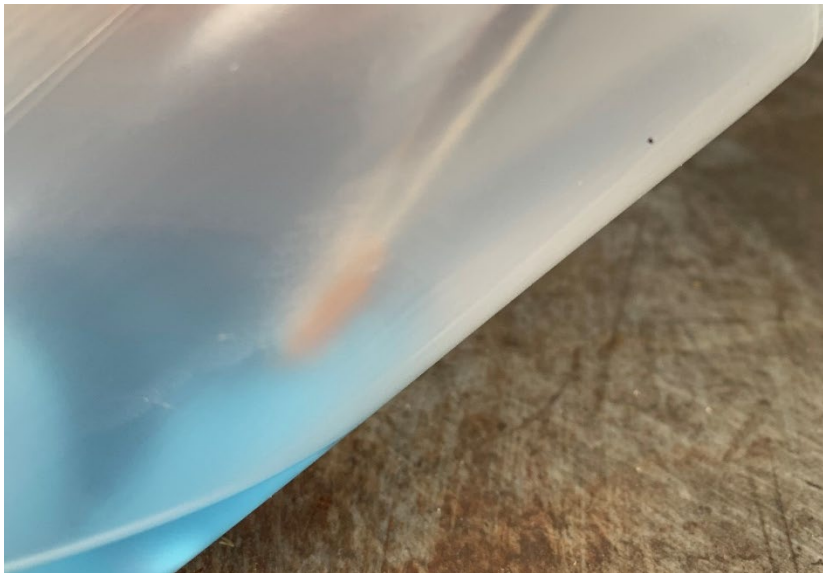
The carburetor heat control cable remained attached to the carburetor heat box and operated when the control in the cockpit was moved by hand. The contents of the carburetor was drained and was tested for water with water finding paste. There was no presence of water in the fuel and it was free of debris. The carburetor heat hose remained attached to the carburetor heat box and was removed to facilitate examination of the carburetor.

Figure 2. View of fuel from carburetor being tested for water.

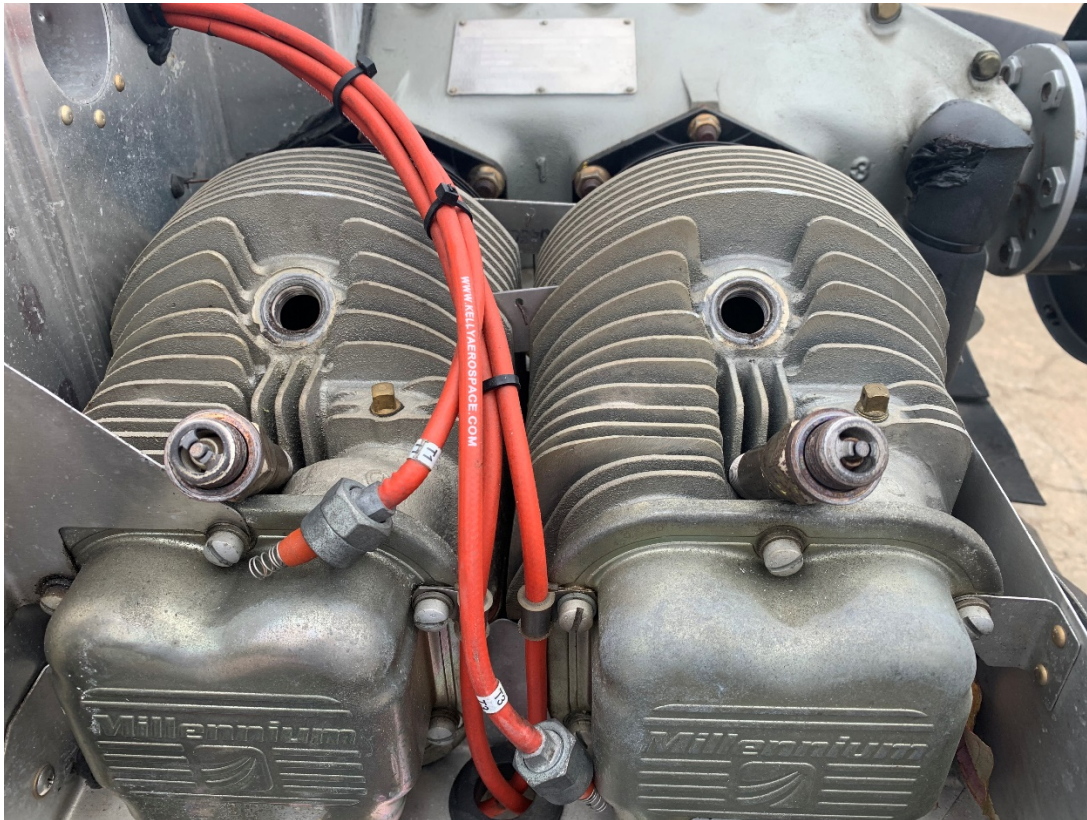
The top spark plugs were removed from the engine and they were the massive electrode type. They were light grey in color and exhibited “normal wear” when compared to the Champion Check-A-Plug Chart.

Figure 3. View of Nos. 1 and 3 top spark plugs.

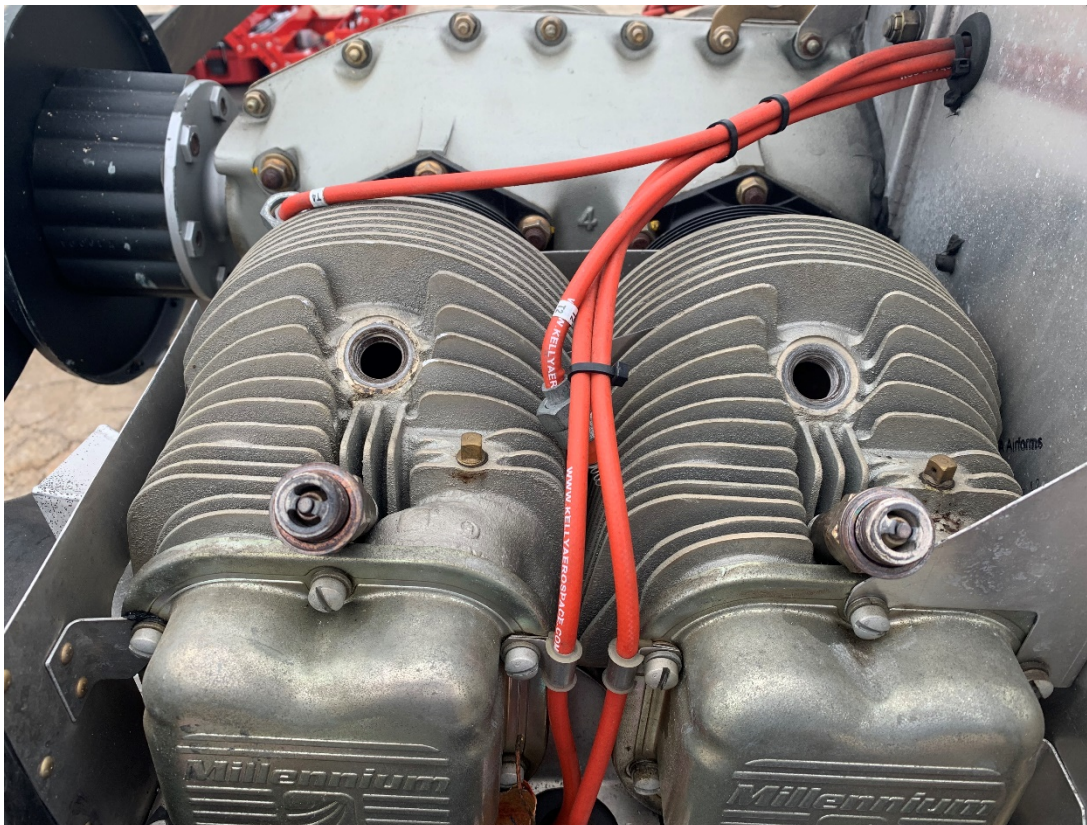
Figure 4. View of Nos. 2 and 4 top spark plugs.

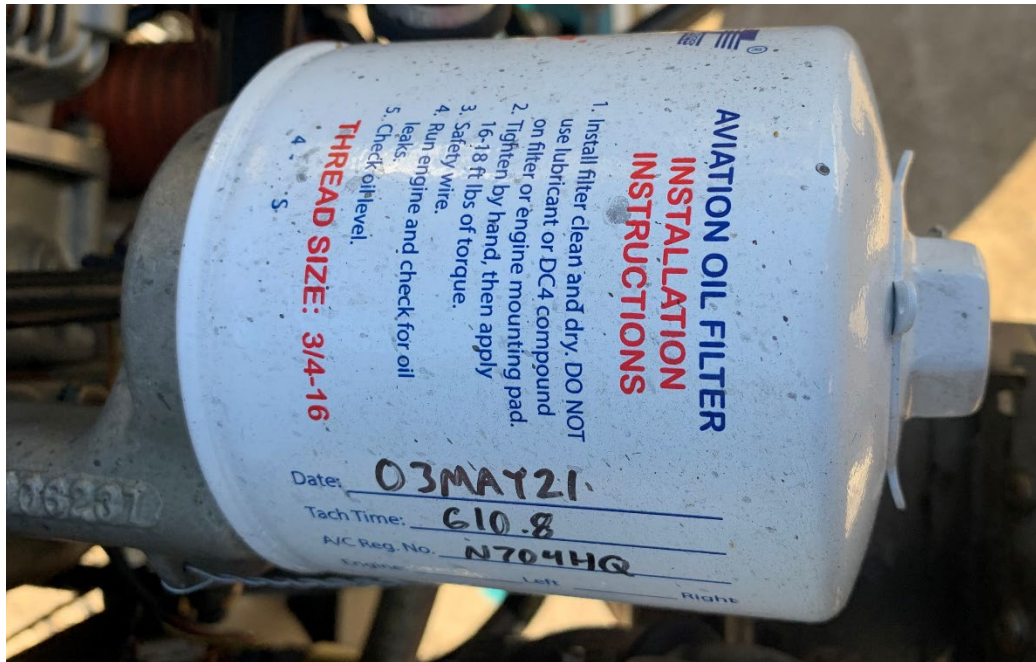
The oil filter remained attached to the engine. The date on the oil filter was May 3, 2021, with a tach time of 610.8 hours.

Figure 5. View of oil filter.
