**NTSB ERA22LA048**

N3VM, PA31-350

Photo Array

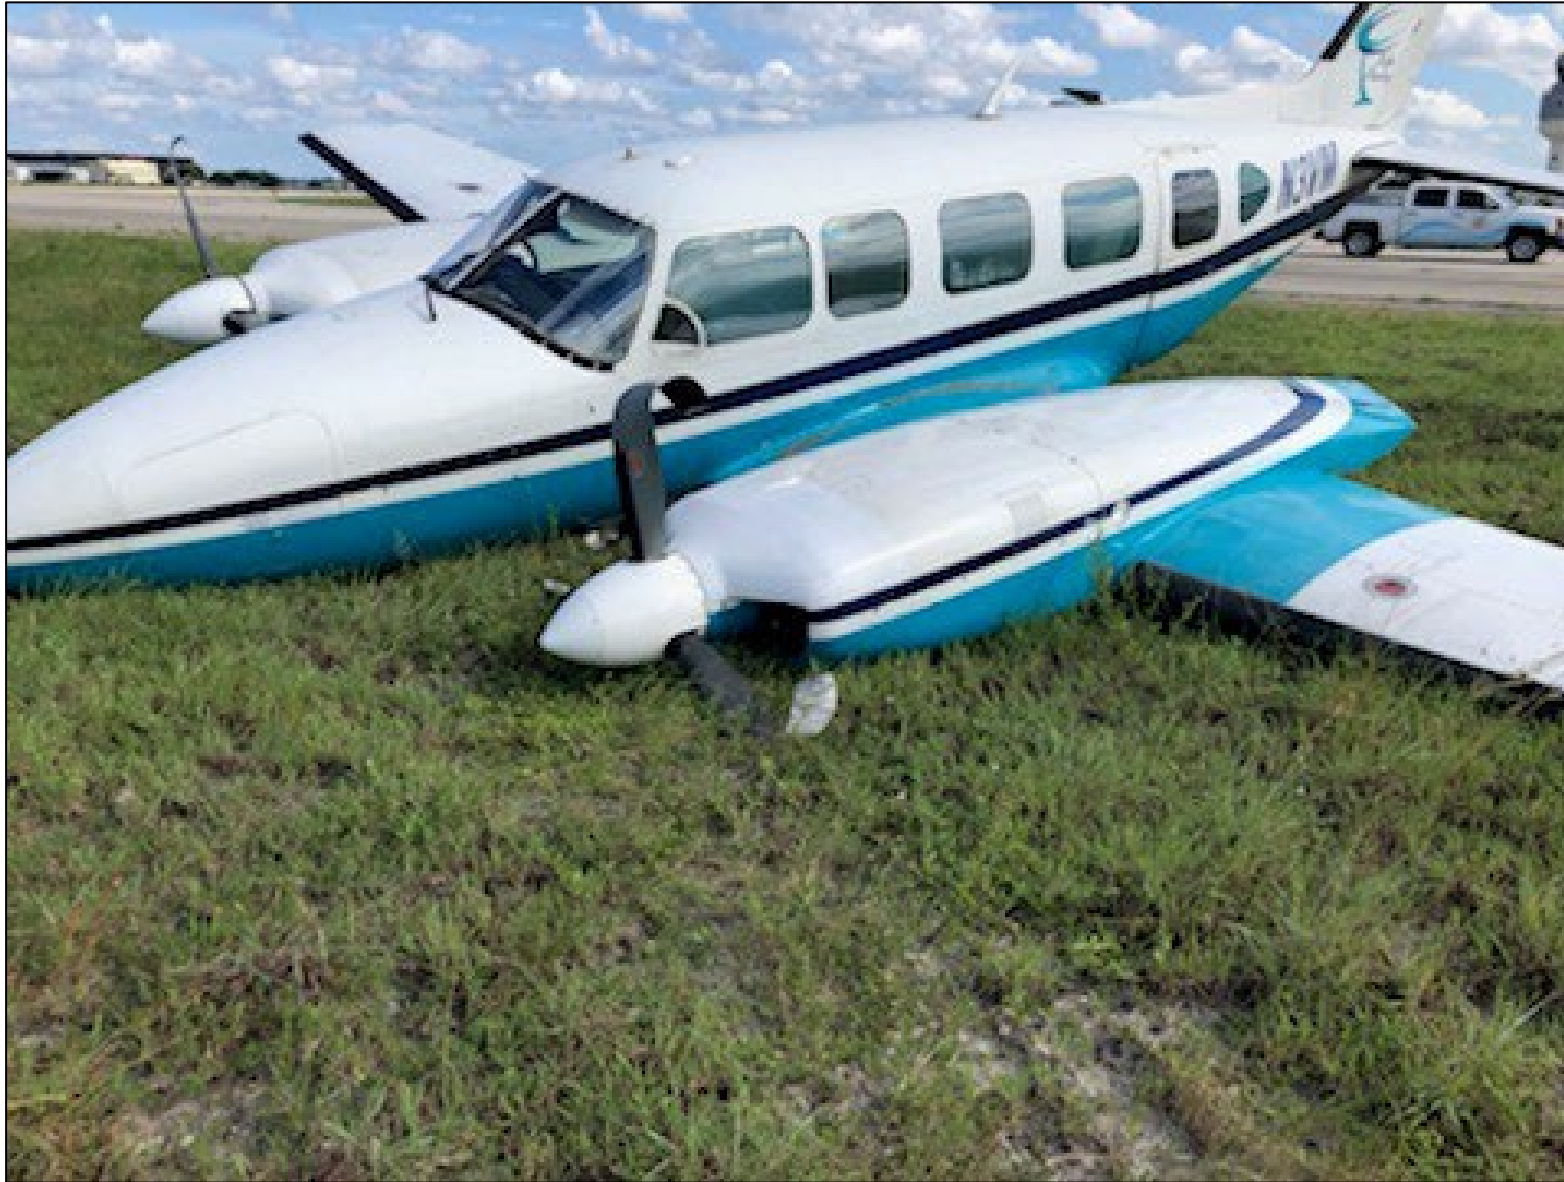
Photo 1 – View of the accident airplane at the accident site (Photo Courtesy of FAA)

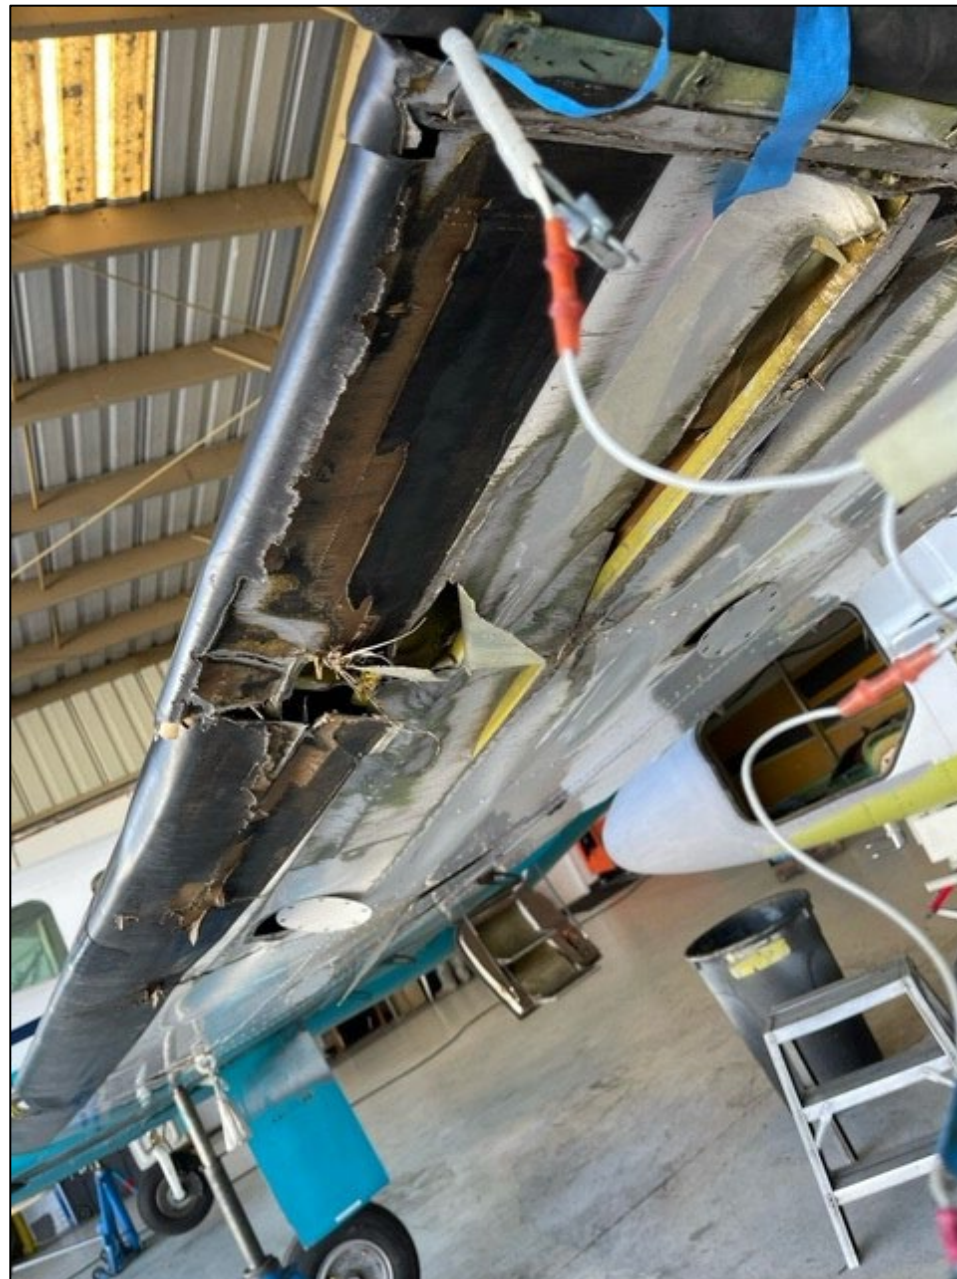
Photo 2 – View of the left-wing damage (Photo Courtesy of FAA)

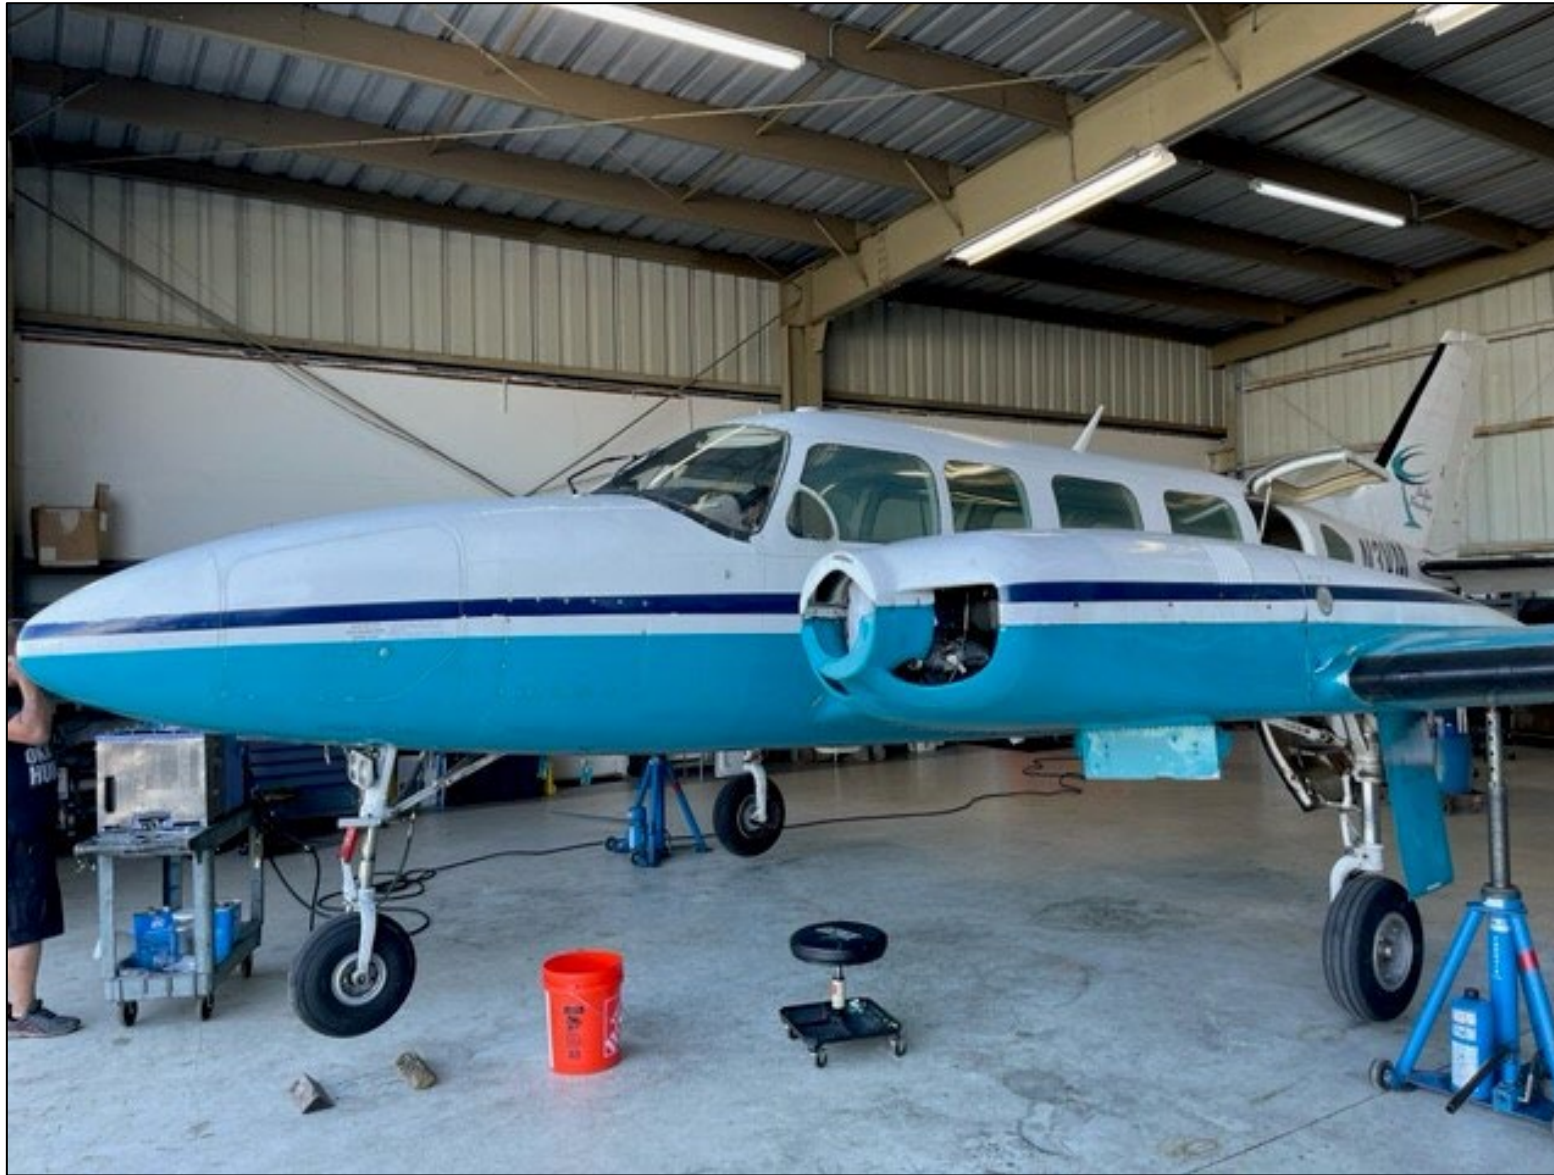
Photo 3 – View of the airplane postaccident with the landing gear retracted during functional testing (Photo Courtesy of FAA)
