# National Transportation Safety Board

ERA22LA054

## **MATERIALS LABORATORY**

Factual Report 22-088

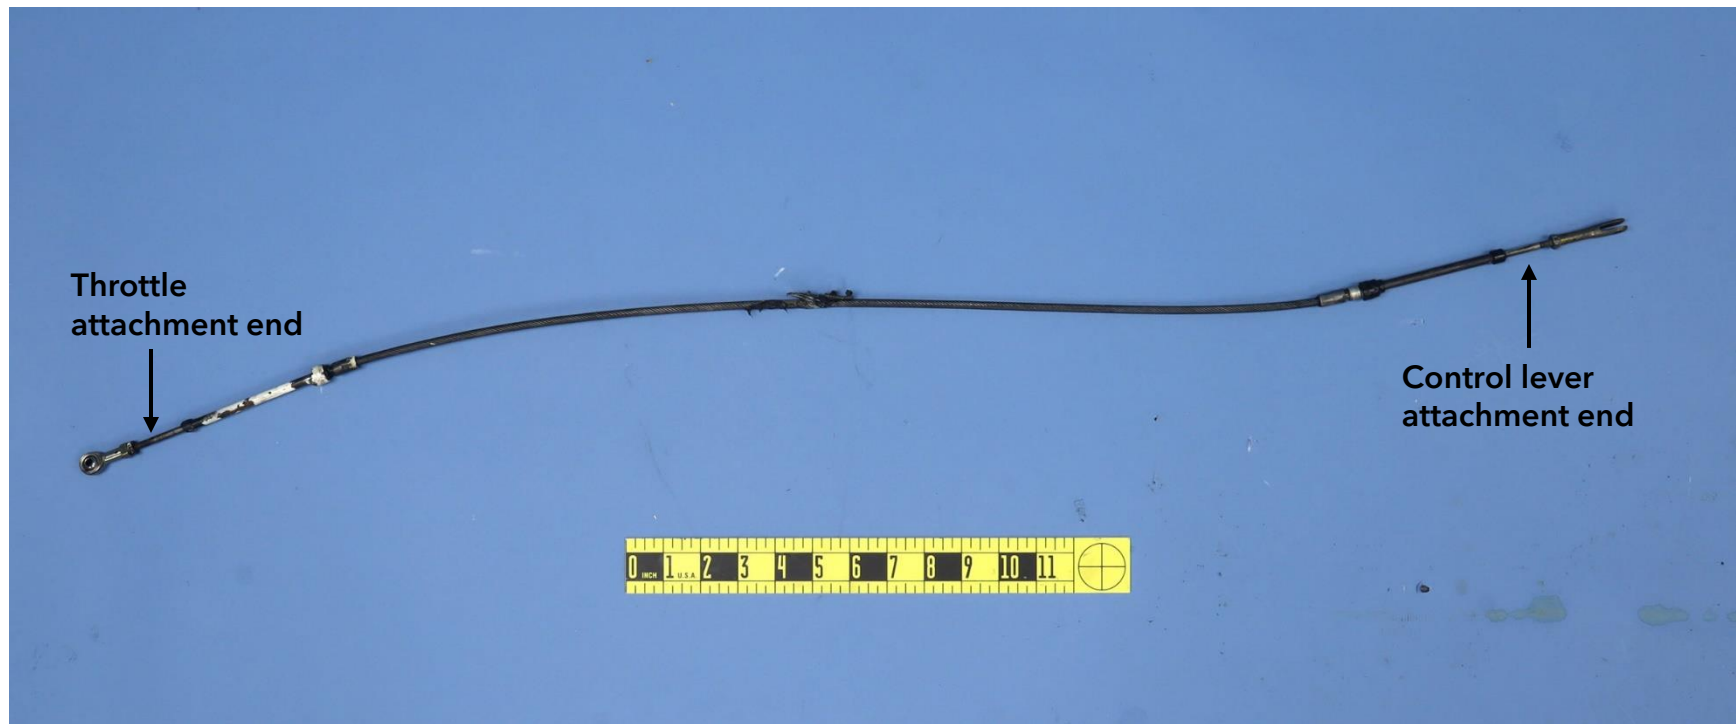
A throttle cable assembly was submitted to the NTSB Materials Laboratory for examination as shown in figure 1. The cable had seized and no longer moved in the longitudinal direction. The two ends of the assembly are shown in figure 2 and a cross section through the cable is shown in figure 3. By design, one end of the cable was connected to an arm on the throttle assembly, used to control a butterfly valve, by means of a spherical bearing rod end, as shown in figure 2a. The opposite end was connected to the throttle control lever in the cabin by means of a clevis fitting, shown in figure 2b. Each end fitting was attached to a solid guide rod that travelled inside a sleeve. The end of each guide rod was connected to an inner cable (described below) that travelled inside a cable housing. A ferrule at each end of the housing joined the sleeves to the housing. Polymeric boots covered both ends of the sleeves: one where the guide rod entered the sleeve and the other at the sleeve/ferrule transition. As seen in figure 3, the cable assembly consisted of the 7-wire inner cable, an inner lining, a flexible helical winding, and an outer protective layer of helical wires.

**Figure 1.** Image of the as received throttle cable assembly.

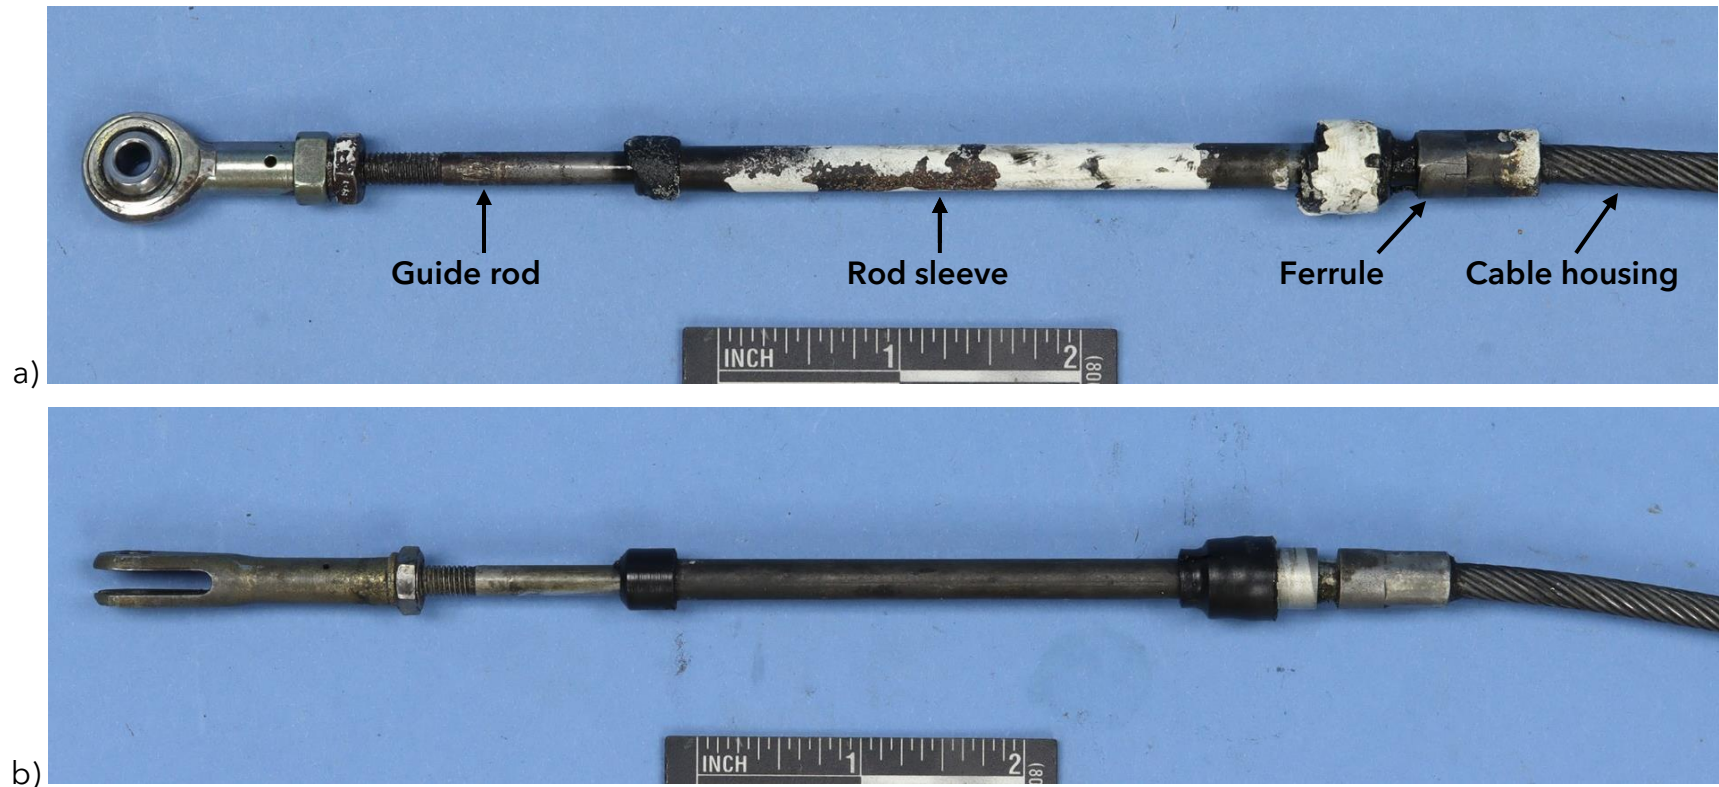
**Figure 2.** The ends of the throttle cable assembly; a) end attached to the throttle and b) end attached to the throttle control lever.

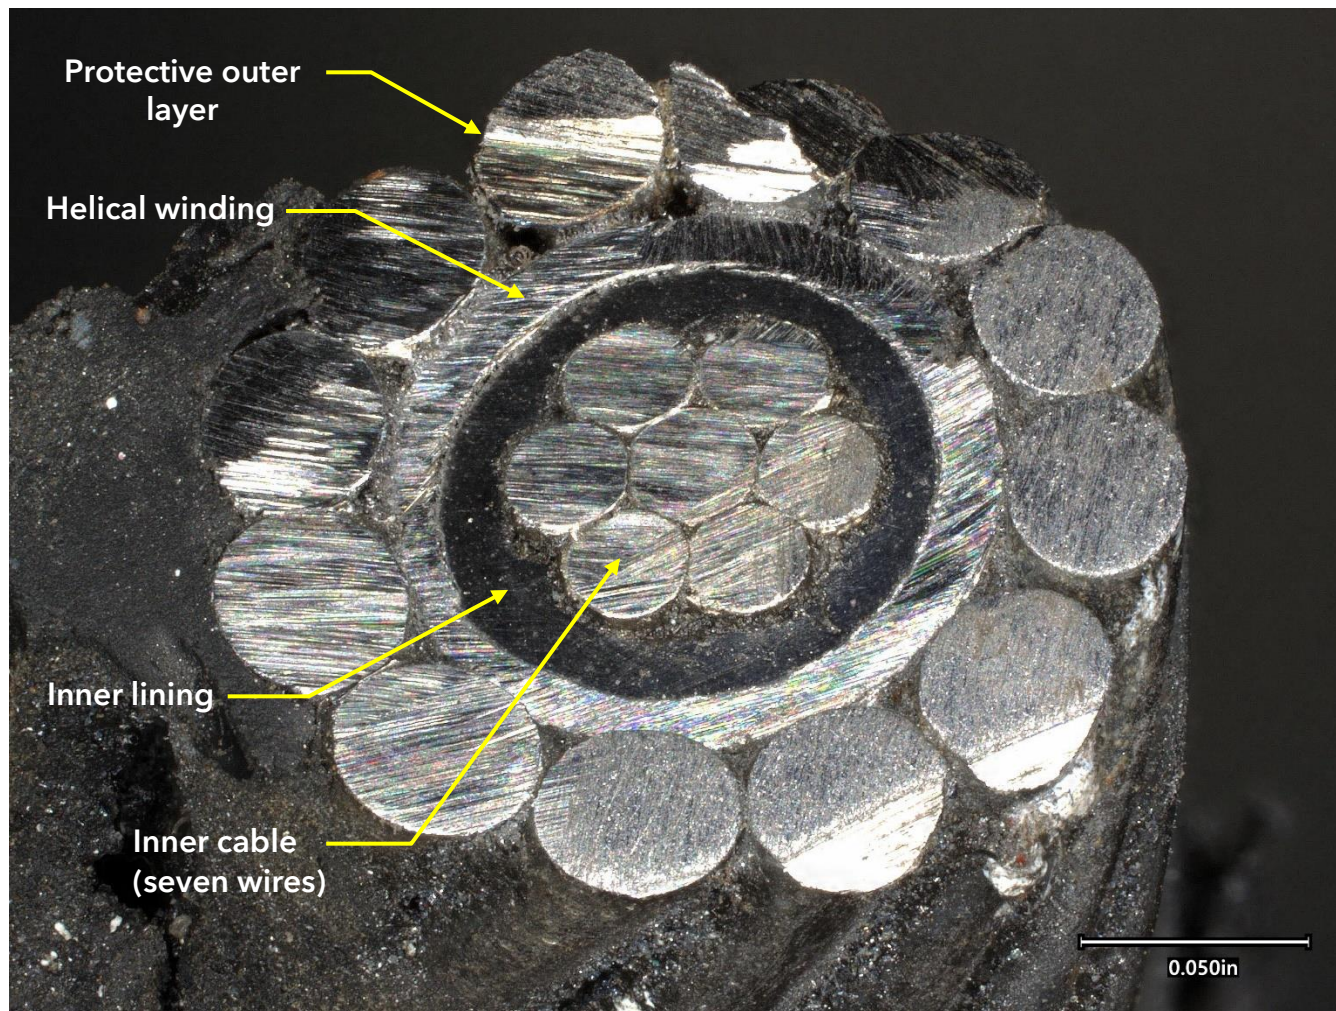
**Figure 3.** Cross section through the middle of the cable assembly showing the layers in the construction of the cable.

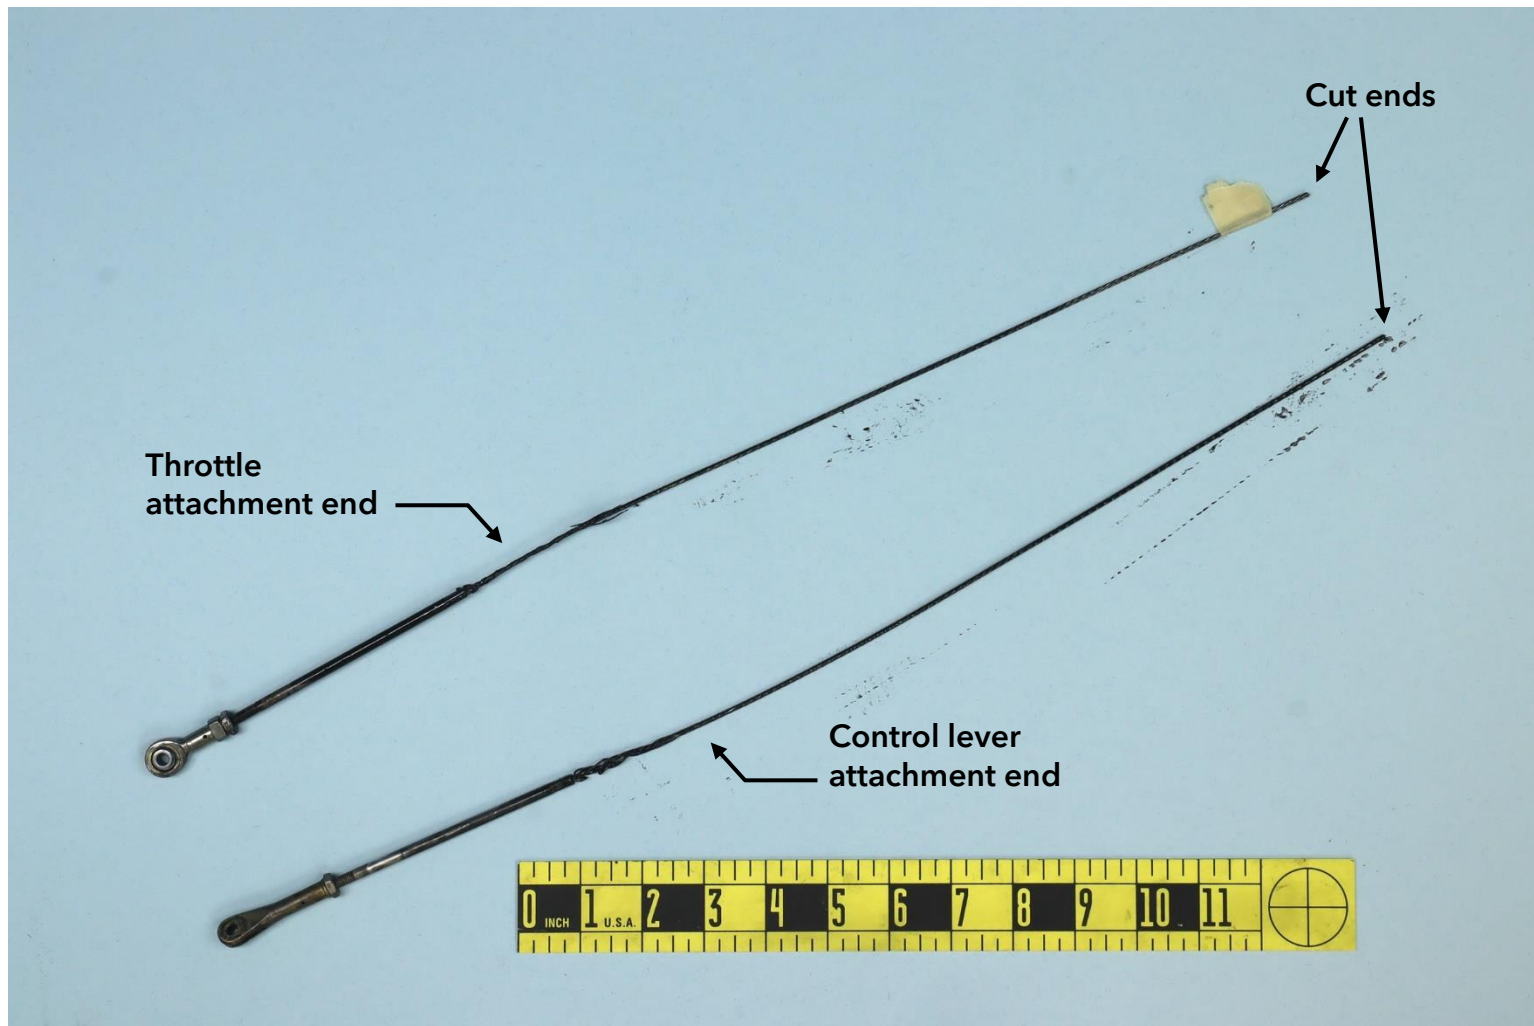
The cable was sectioned through the midpoint and the two inner wire sections were pulled free of the housing, as shown in figure 4. The cables were covered with oil and grease and were subsequently cleaned with organic solvents. A close-up image of the two ends after cleaning is shown in figure 5. Near the throttle attachment end, six of the seven wires had separated, with only the central wire still intact. Four of the wires, anchored by the guide rod, were separated approximately 2-3/4 inch from the rod end. The wire ends tapered to a knife's edge, consistent with separation due to wear. Closer to the end of the guide rod, two additional wires (5<sup>th</sup> and 6<sup>th</sup> wires) were separated, as shown in the top image of figure 6. One separation, indicated by the yellow square, was located approximately 0.35 inch from the rod

**Figure 4.** The inner cable and end assemblies after sectioning through the middle of the cable and removing the outer layers.

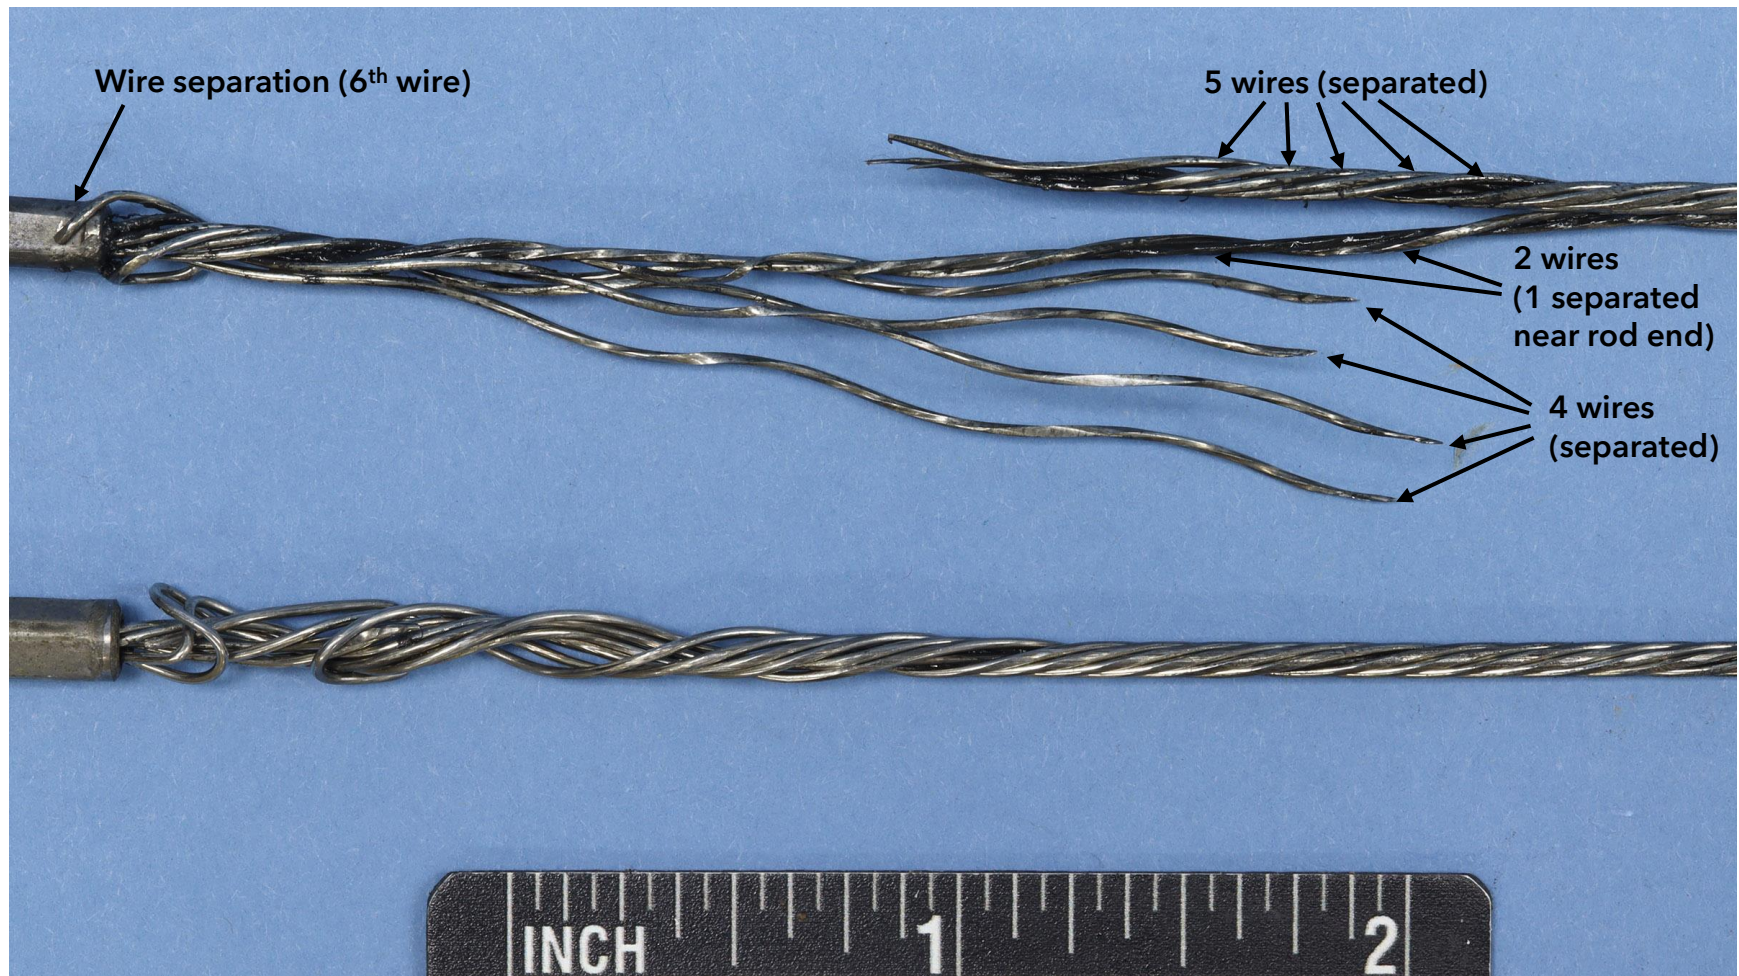
The opposing separated wire ends, on the side leading to the throttle control lever, were also examined. As indicated in figure 5, approximately 1-3/4 inch from the end of the guide rod there were 5 separated wire ends that exhibited knife edge separation, similar to the four knife edge separations previously described. As seen in the image, the opposing knife edge separations overlapped one another by approximately 1 inch. A sixth wire end, indicated by the yellow square in the lower image of figure 6, overlapped the end of the guide rod by approximately 0.10 inch. The section profile of this separated wire most closely matched the fractured end indicated by the yellow square in the top image (0.35 inch from the rod end). A length of one wire, from the fractured end indicated by the yellow circle in figure 6 to one of the five knife edge separations, was unaccounted for.

An image of the inner cable at the opposite end (near the throttle control lever), is shown in the lower part of figure 5. Some wires were buckled and the cable had partially unfurled (ballooned).

**Figure 5.** Top: End of cable near throttle attachment exhibiting separated and deformed wires. Bottom: End of cable near throttle control lever exhibiting unfurling and buckling of wires.

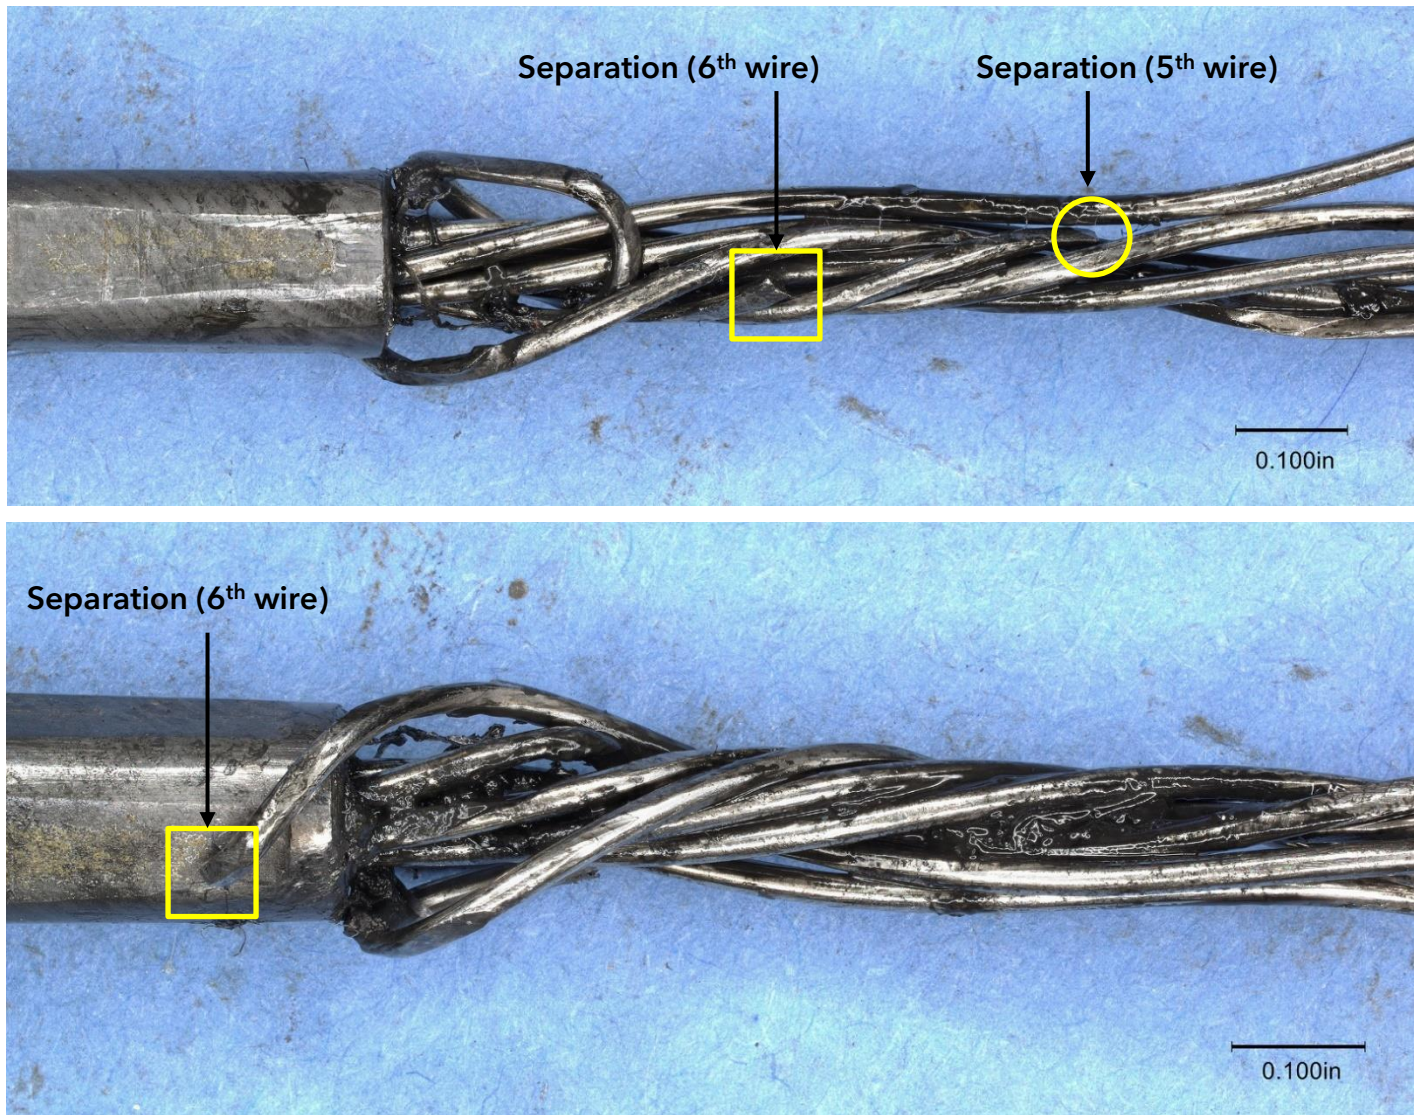
end and the other separation, indicated by the yellow circle, was located approximately 0.63 inch from the rod end. The wires were flattened on one side, consistent with wear, but were also fractured in the transverse direction.

**Figure 6.** Wire separations near the connection to the guide rod. Top image: One side with one separation indicated by a yellow square and another separation indicated by a yellow circle. Bottom image: Opposite side of the rod, with a separated wire end indicated by a yellow square, corresponding to the separated end indicated by the yellow square in the top image.

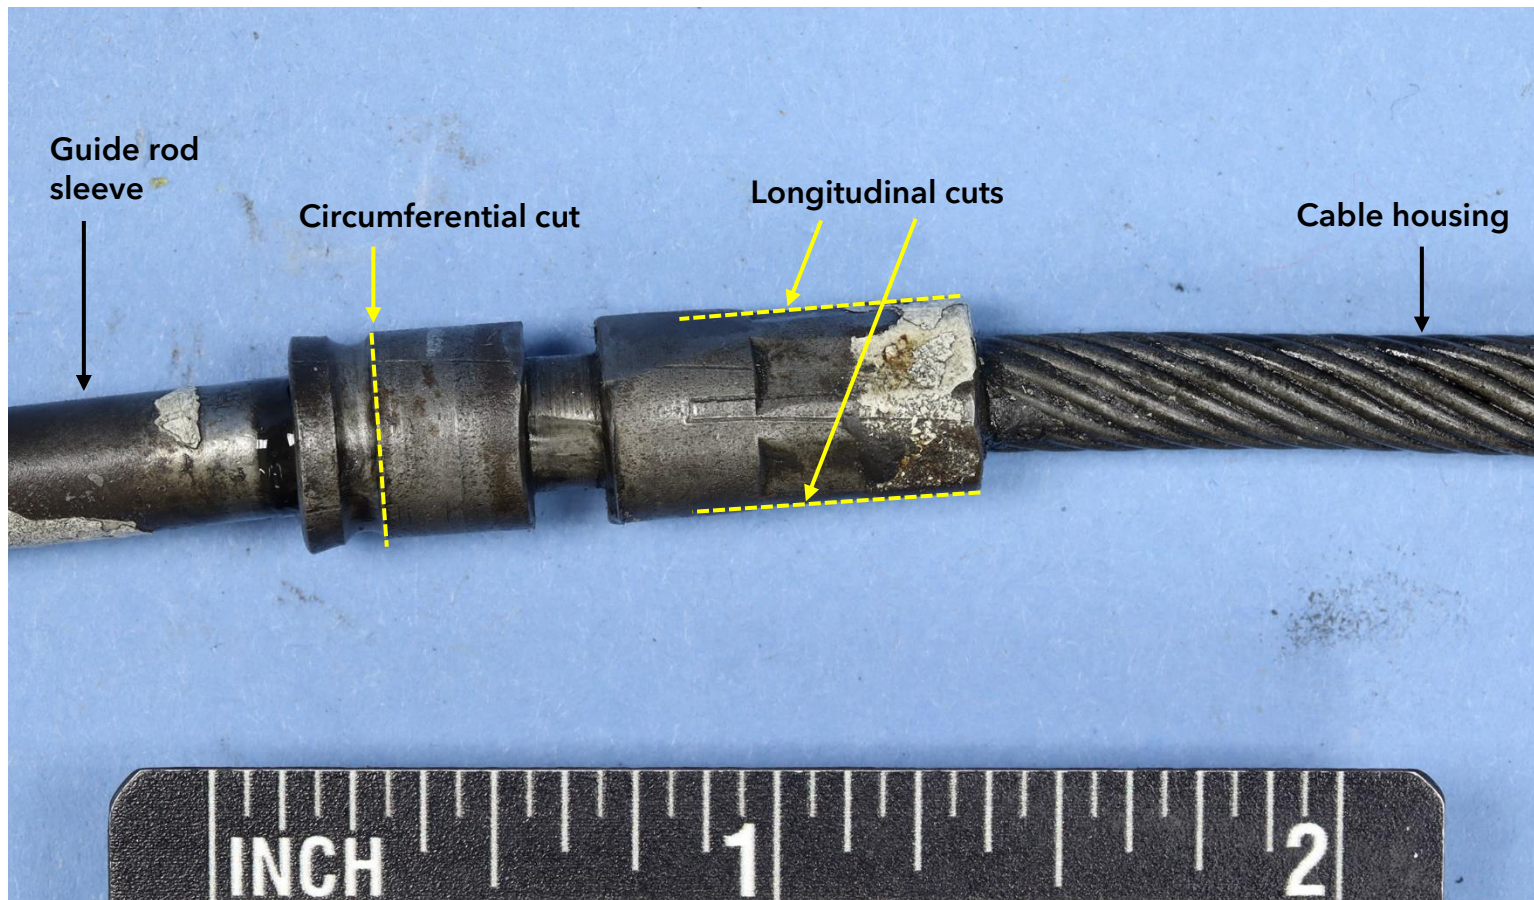
The ferrule at the end of the cable leading the throttle arm was sectioned and removed to examine the inside of the guide rod sleeve and the cable housing. An image of the ferrule with the polymer boot removed is shown in figure 7. Yellow-dashed lines indicate the location of the cuts. A circumferential cut was made adjacent to a crimp along the outer diameter used to capture the guide rod sleeve and two longitudinal cuts were made along the crimp used to capture the cable housing. The ferrule was pried open and the cable housing was removed. Figure 8 shows the guide rod sleeve and cable housing after sectioning and removing the ferrule. As shown in figure 9a, the flared end of the guide rod contained pieces of a black plastic material and a wire fragment. As shown in figure 9b and compared with the cross section in figure 3, the inner lining was missing at the end of the housing.

**Figure 7.** Image of the ferrule at the end of the cable housing (end of cable attached to the throttle). The ferrule joins the outer cable housing to the guide rod's outer sleeve. The ferrule was cut at both ends so as to examine the guide rod sleeve and cable housing.

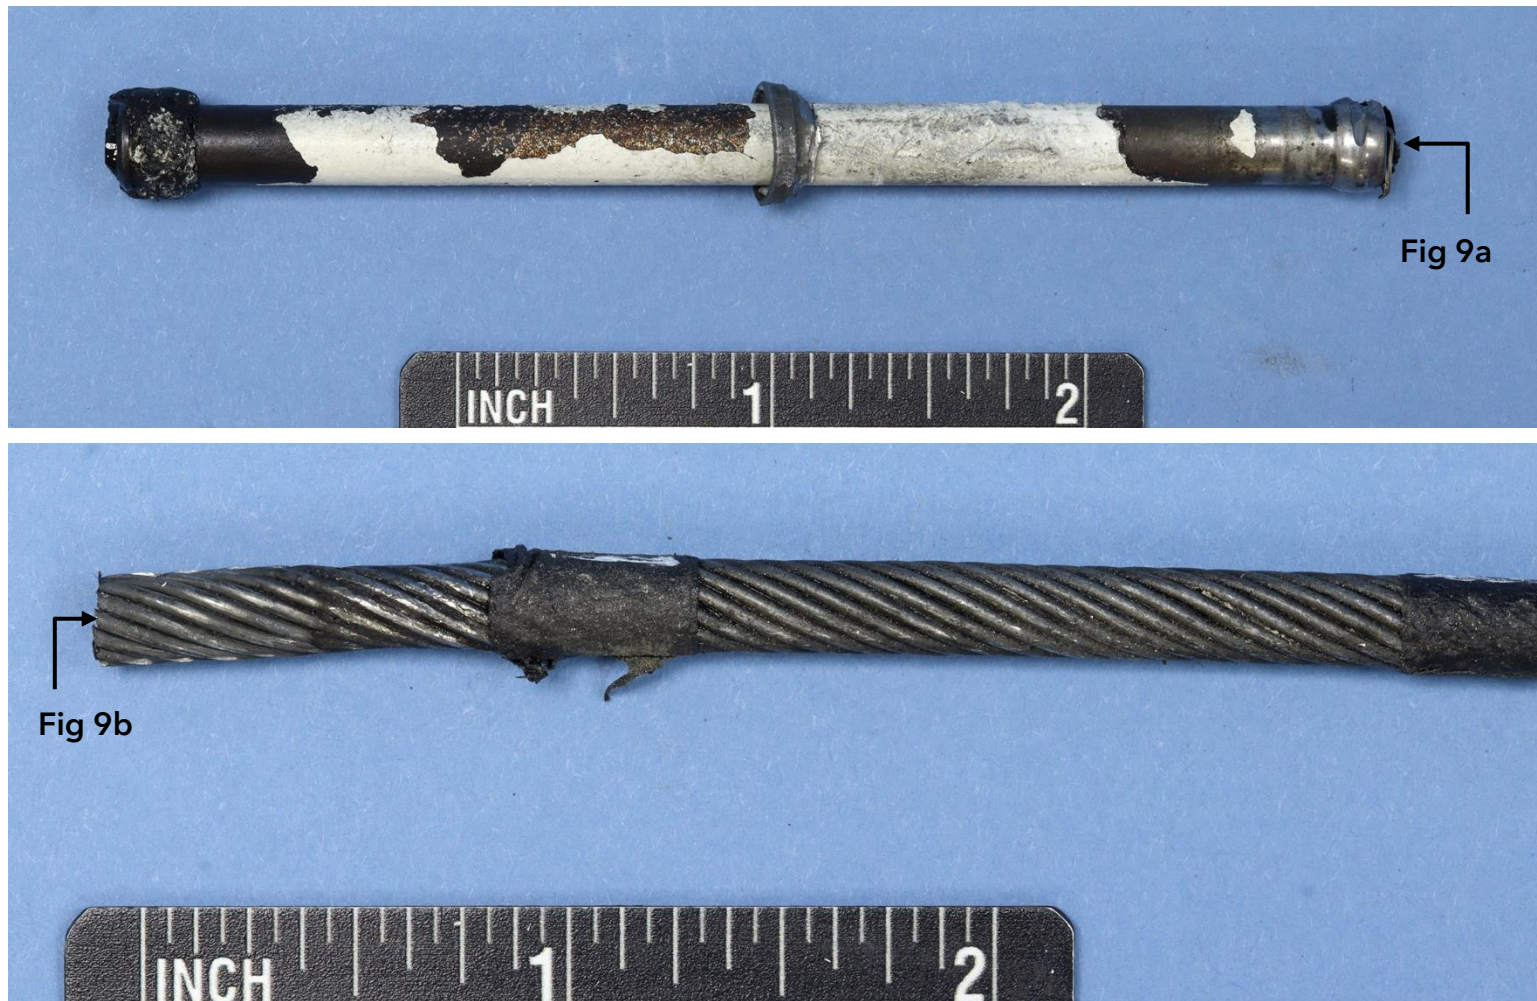
**Figure 8.** Top image: Guide rod sleeve after sectioning the ferrule. Lower image: Cable housing after removing the ferrule.

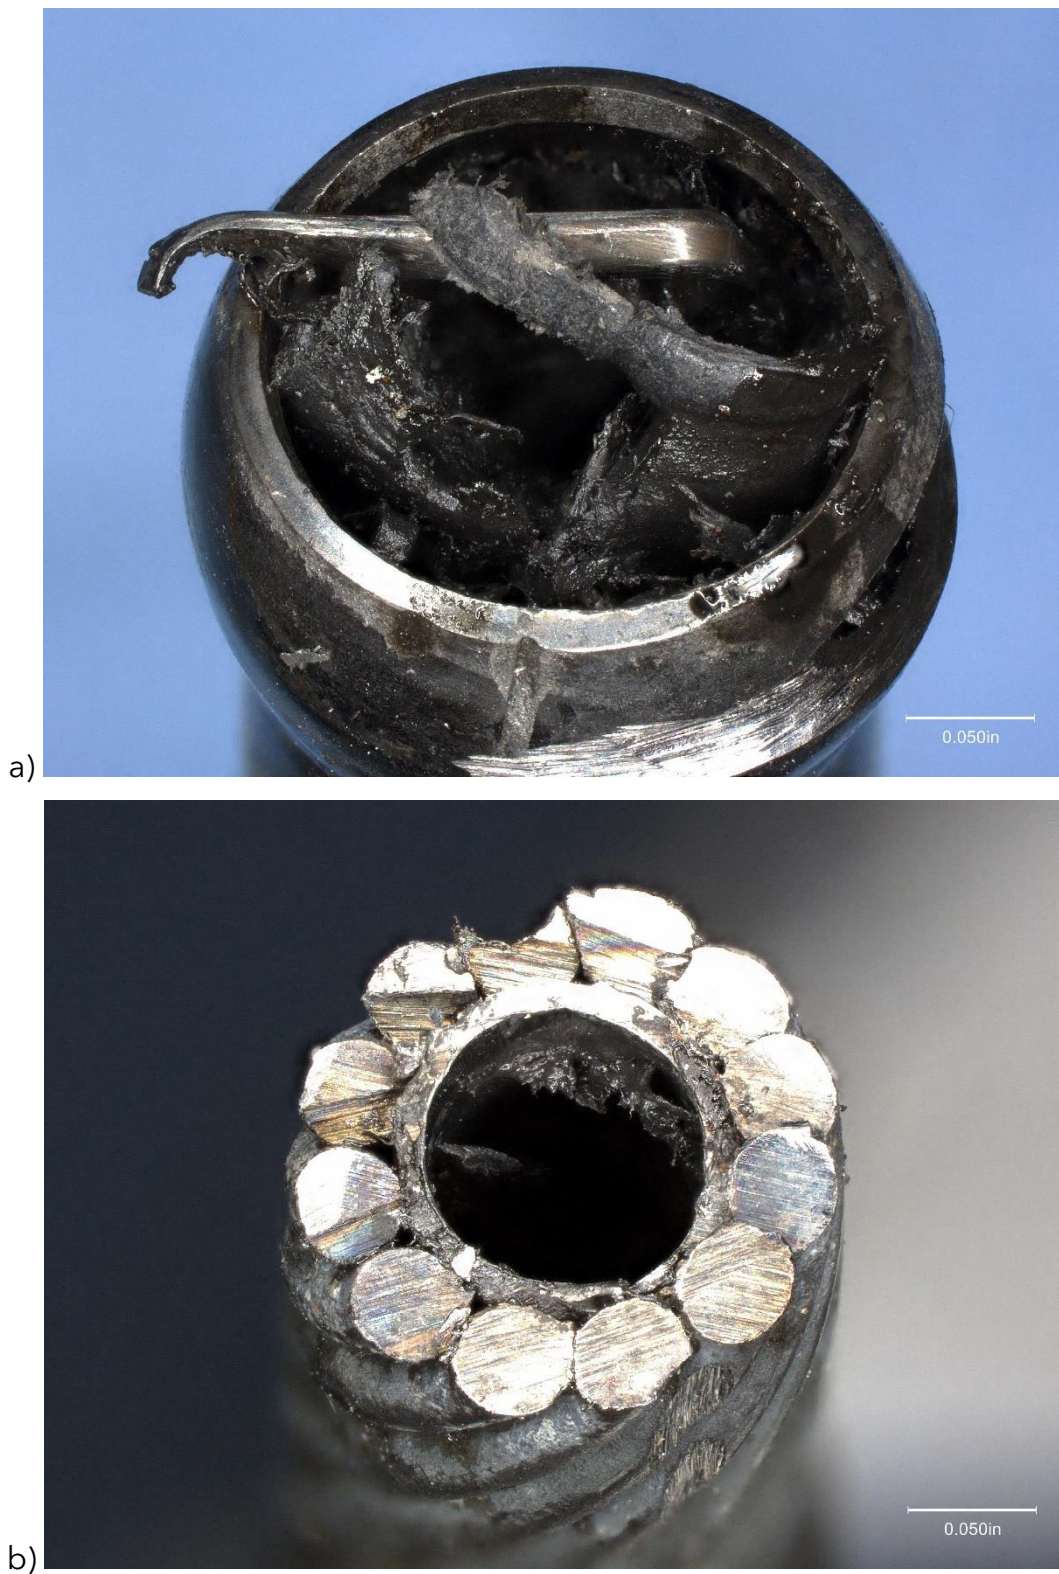
**Figure 9.** a) Image at end of guide rod sleeve showing remnant wire fragment and black plastic material and b) image at end of cable housing showing lack of inner lining.

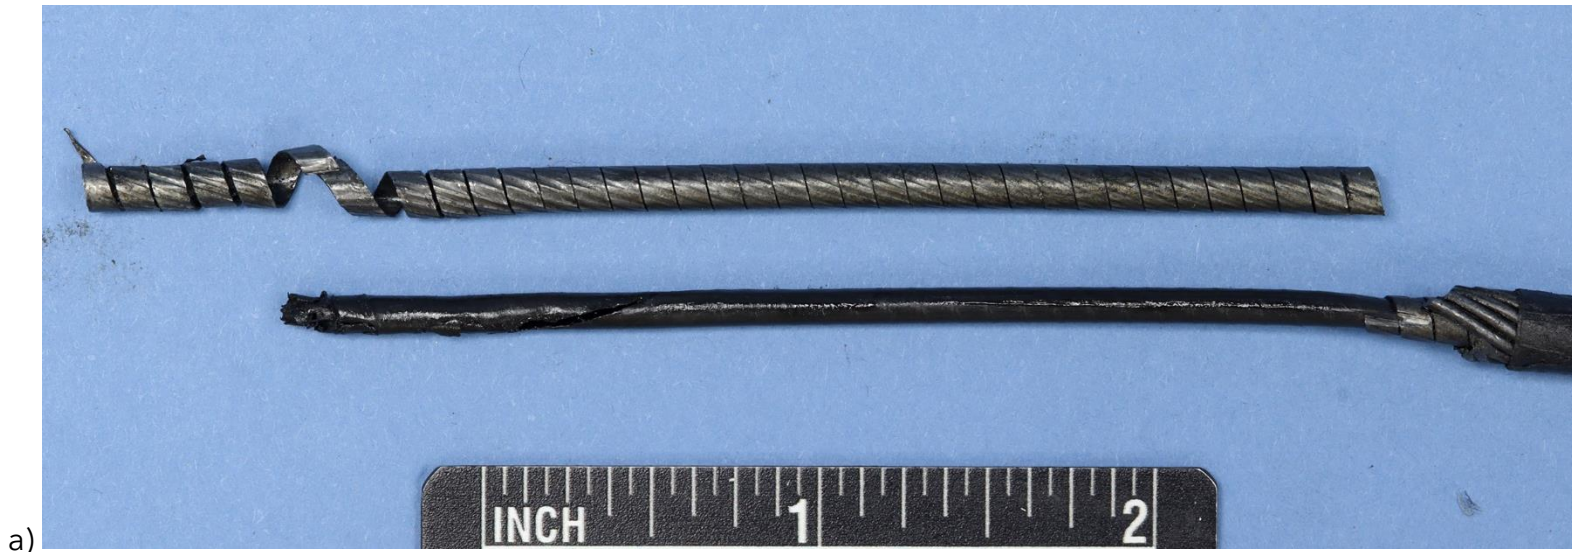
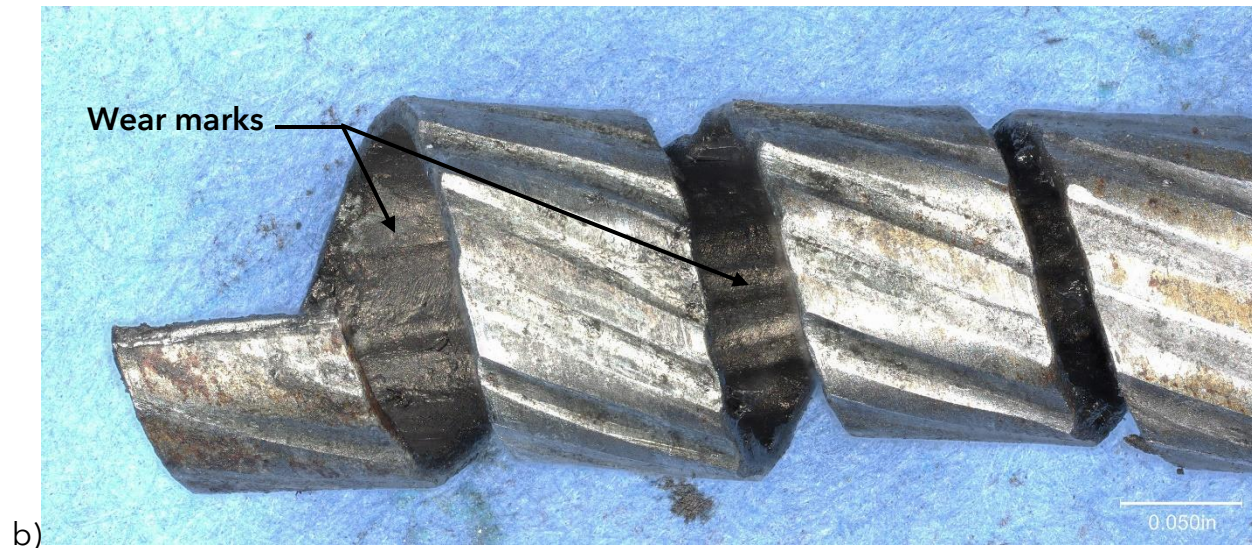
The cable housing was then disassembled. The outer wires were unwound from the helical winding and cut back with an abrasive disk approximately 3-3/4 inch from the end. The helical winding was sectioned with the abrasive disk near the location of the wire cuts. The winding was then pulled off the inner liner. The disassembled housing is shown in figure 10a.<sup>1</sup> As shown in figure 10b, the inner surface of the helical winding exhibited wear marks. The inner liner no longer extended to the end of the housing but rather ended approximately 0.32 inch before the end (estimated on a calibrated image). As seen in figure 11, the liner was split

<sup>1</sup> The helical winding was expanded in torsion near the end in order to observe the condition of its inner diameter surface. This caused the deformation to and fracture of the winding seen in the image.

**Figure 10.** a) Image of disassembled cable housing (outer wires not shown). Deformation and fracture of the helical winding was caused during disassembly; b) image of the helical winding at the end of the cable housing with the windings spread apart to show the wear marks on the inner diameter surface.

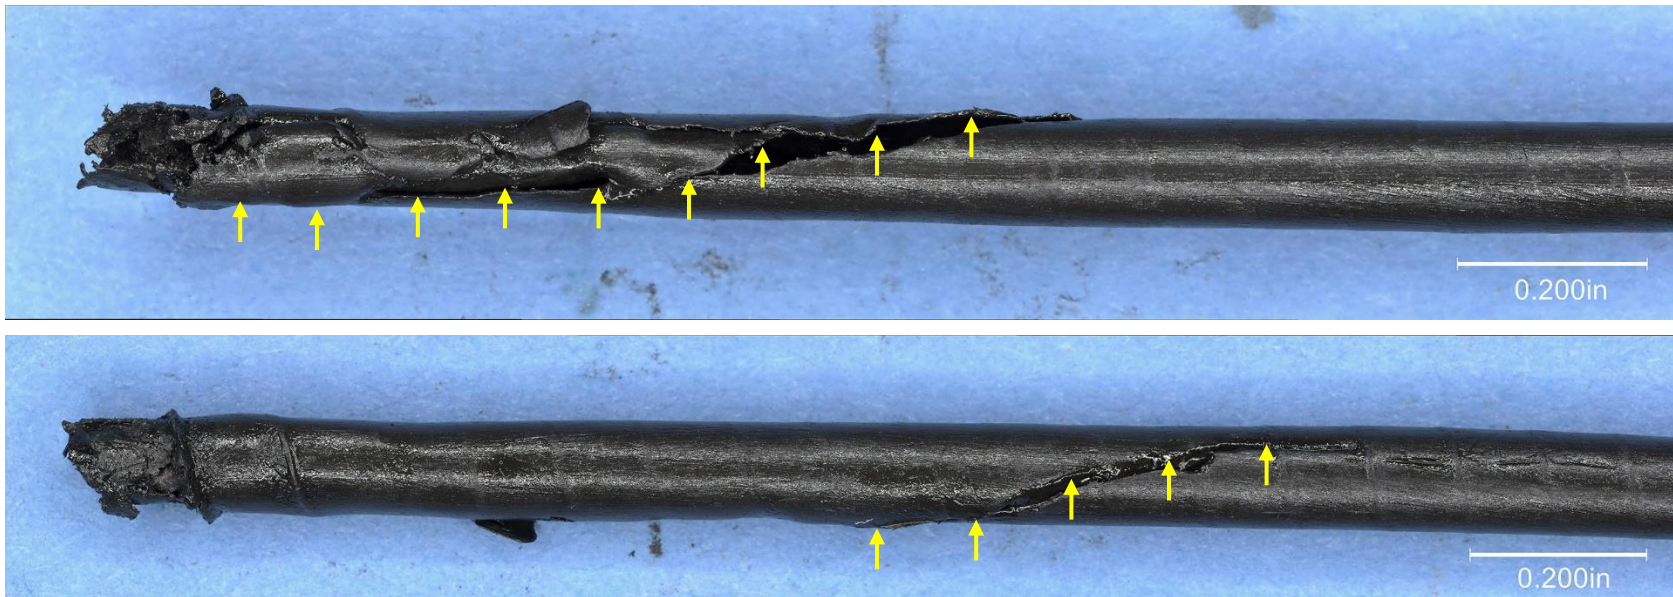
along a helical path extending approximately 1.36 inch from the end of the remnant liner end.

**Figure 11.** Two images of the inner polymeric liner rotated 180° relative to one-another with yellow arrows indicating the location of a helical split in the liner.
