## **NATIONAL TRANSPORTATION SAFETY BOARD**

Office of Aviation Safety  
Eastern Region

**Photo Array**

**ERA22LA061**

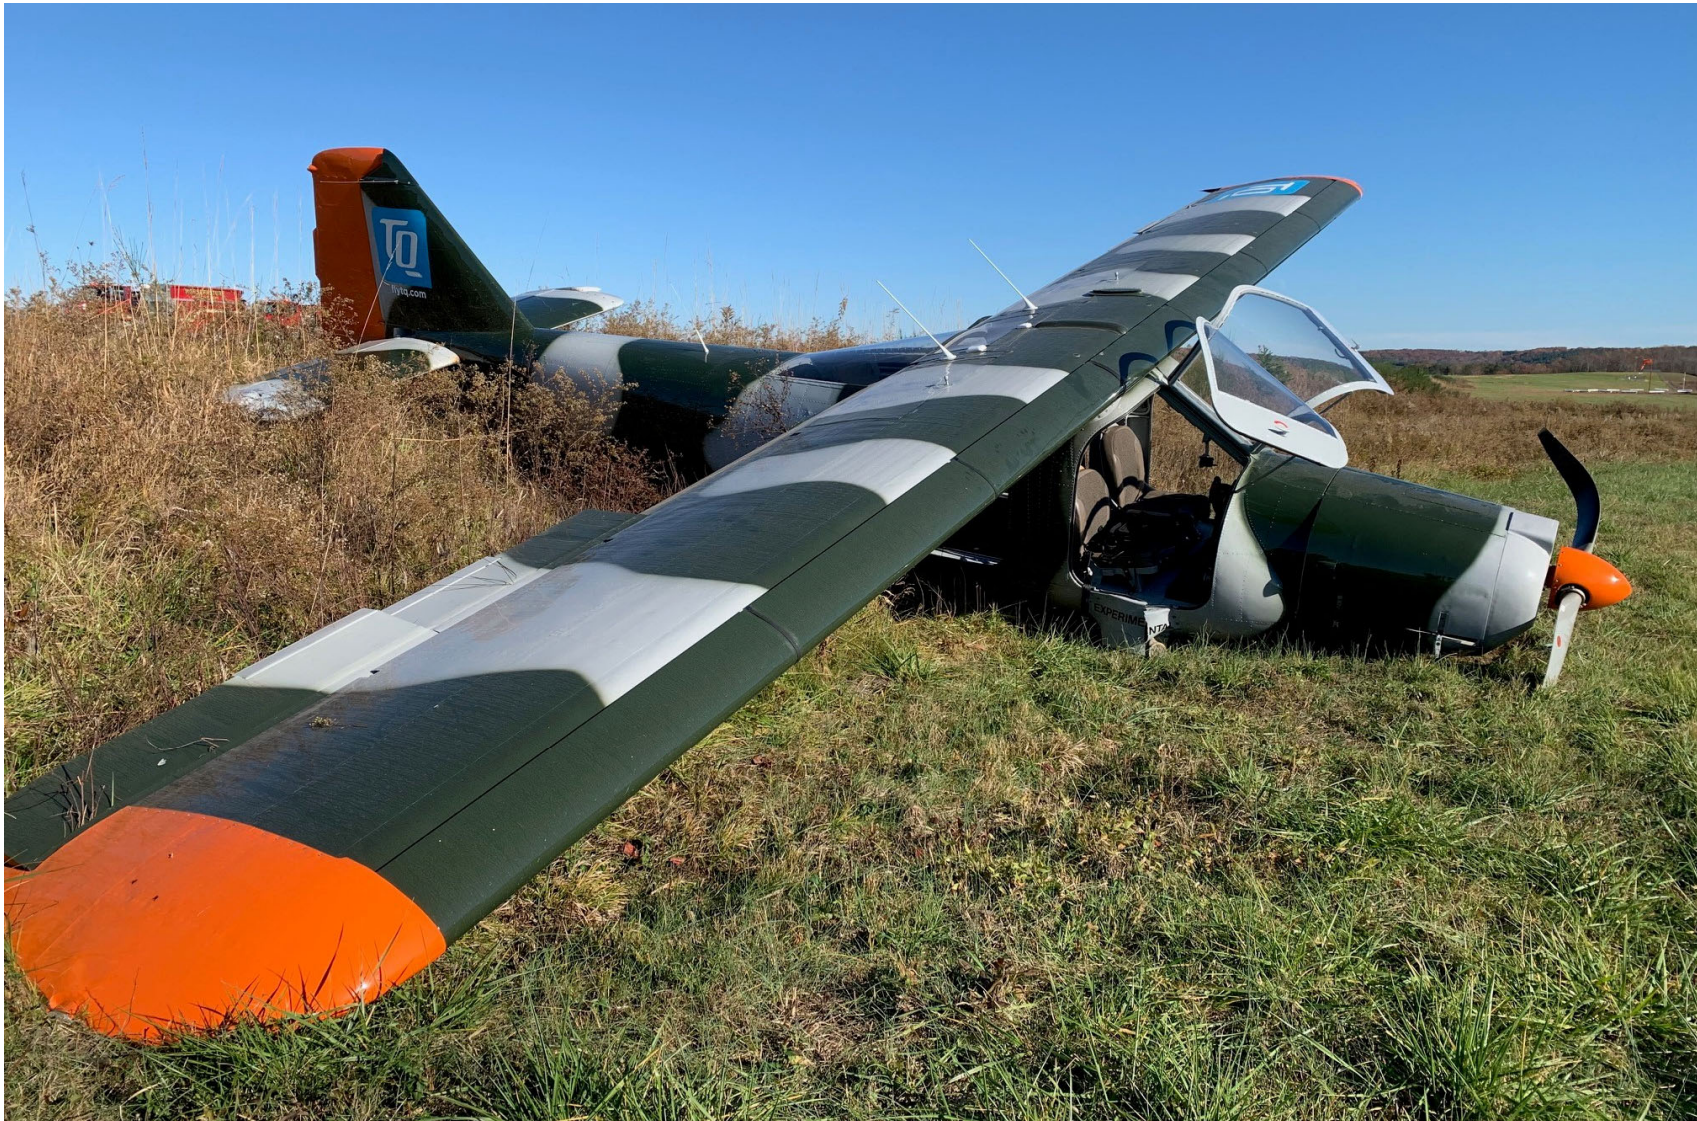
**Photo 1 – View of airplane from the right wing. (Photo Courtesy of FAA)**

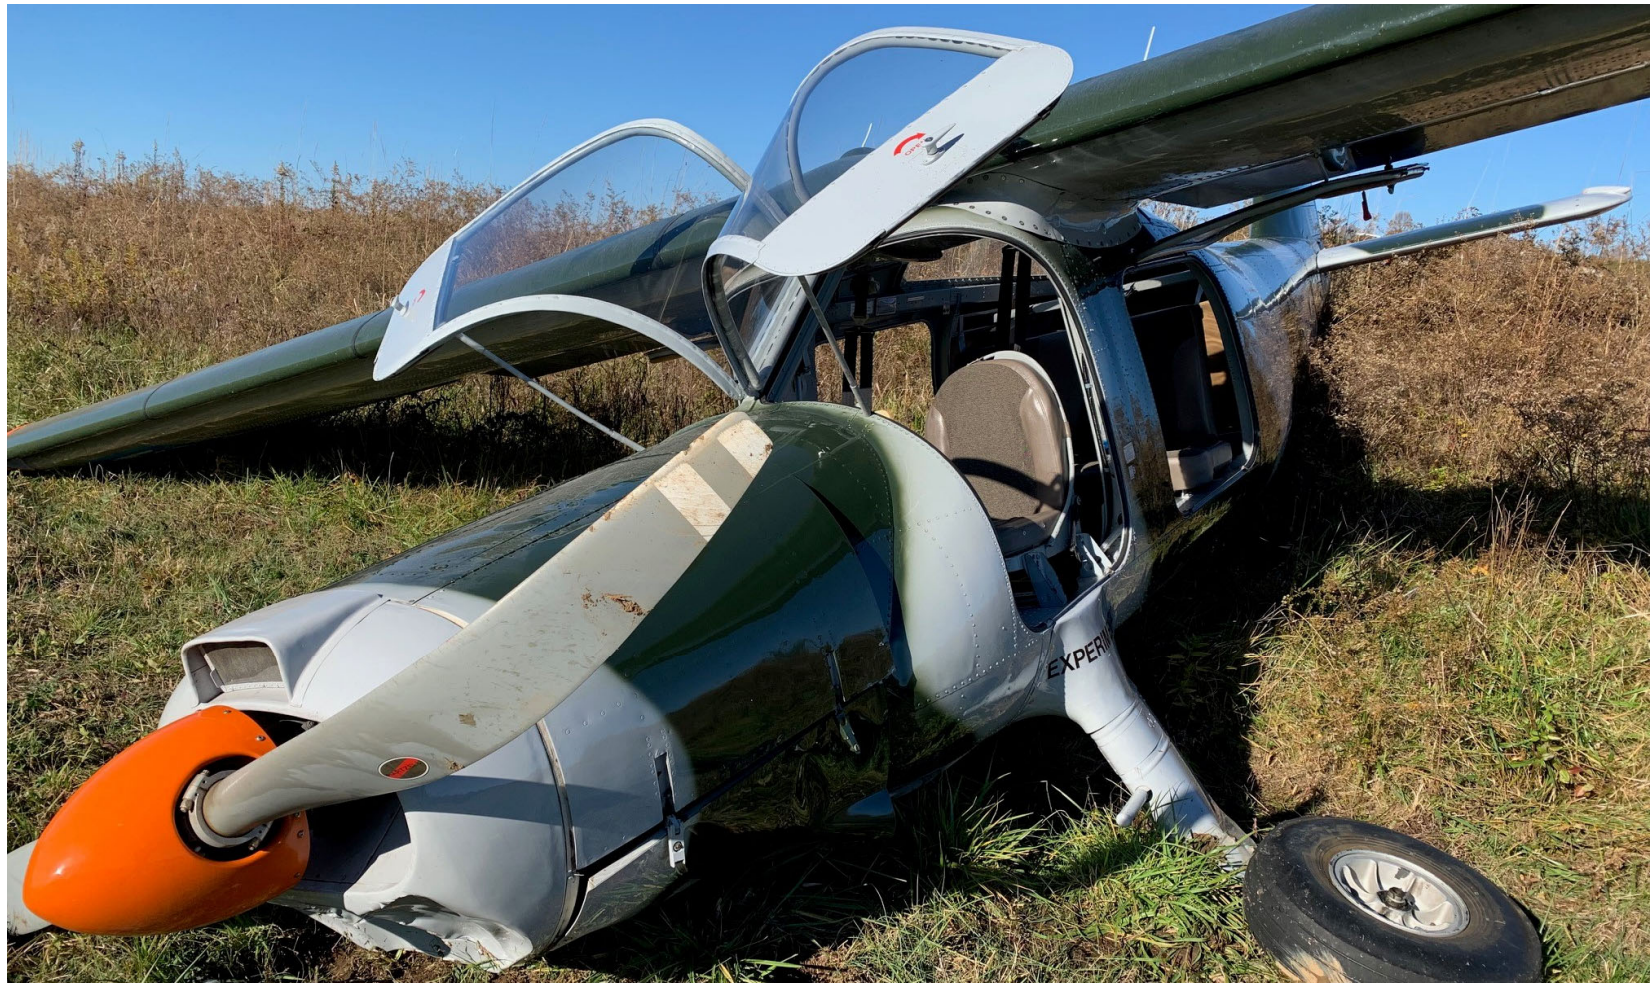
**Photo 2 – View of airplane from front. (Photo Courtesy of FAA)**

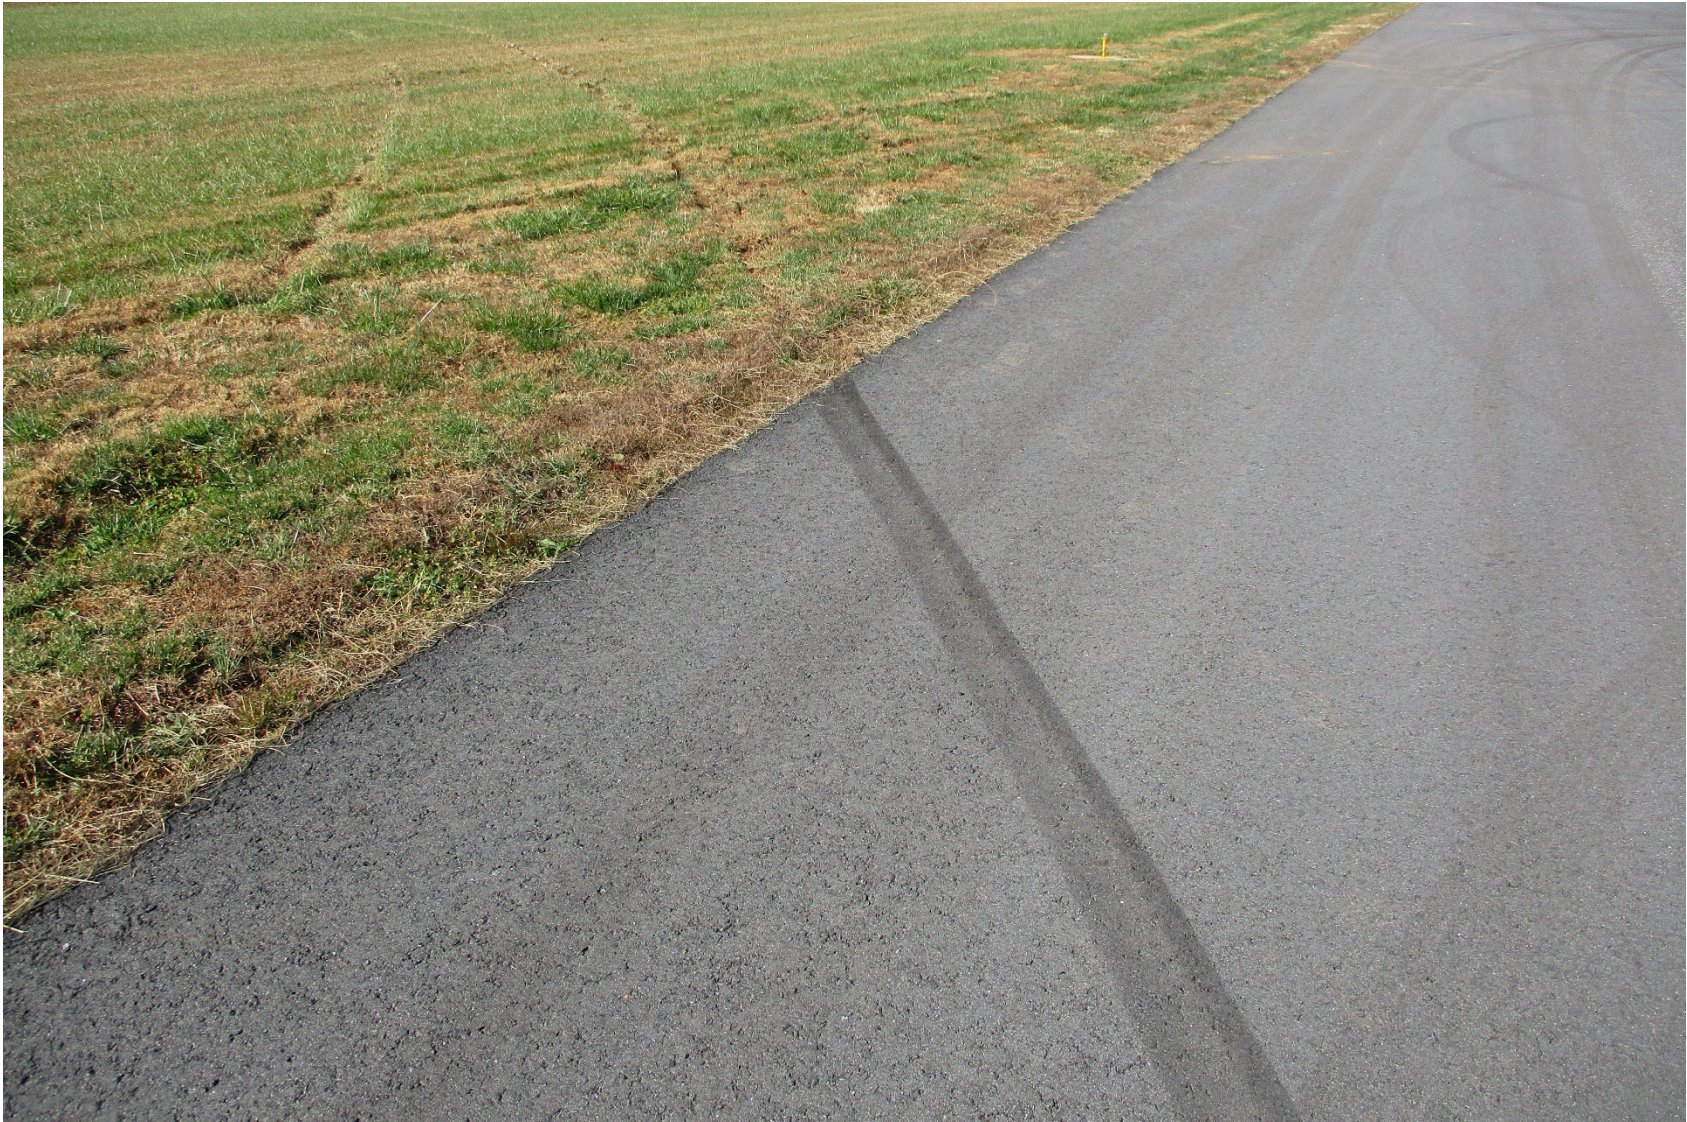
**Photo 3 – View of runway scars. (Photo Courtesy of FAA)**

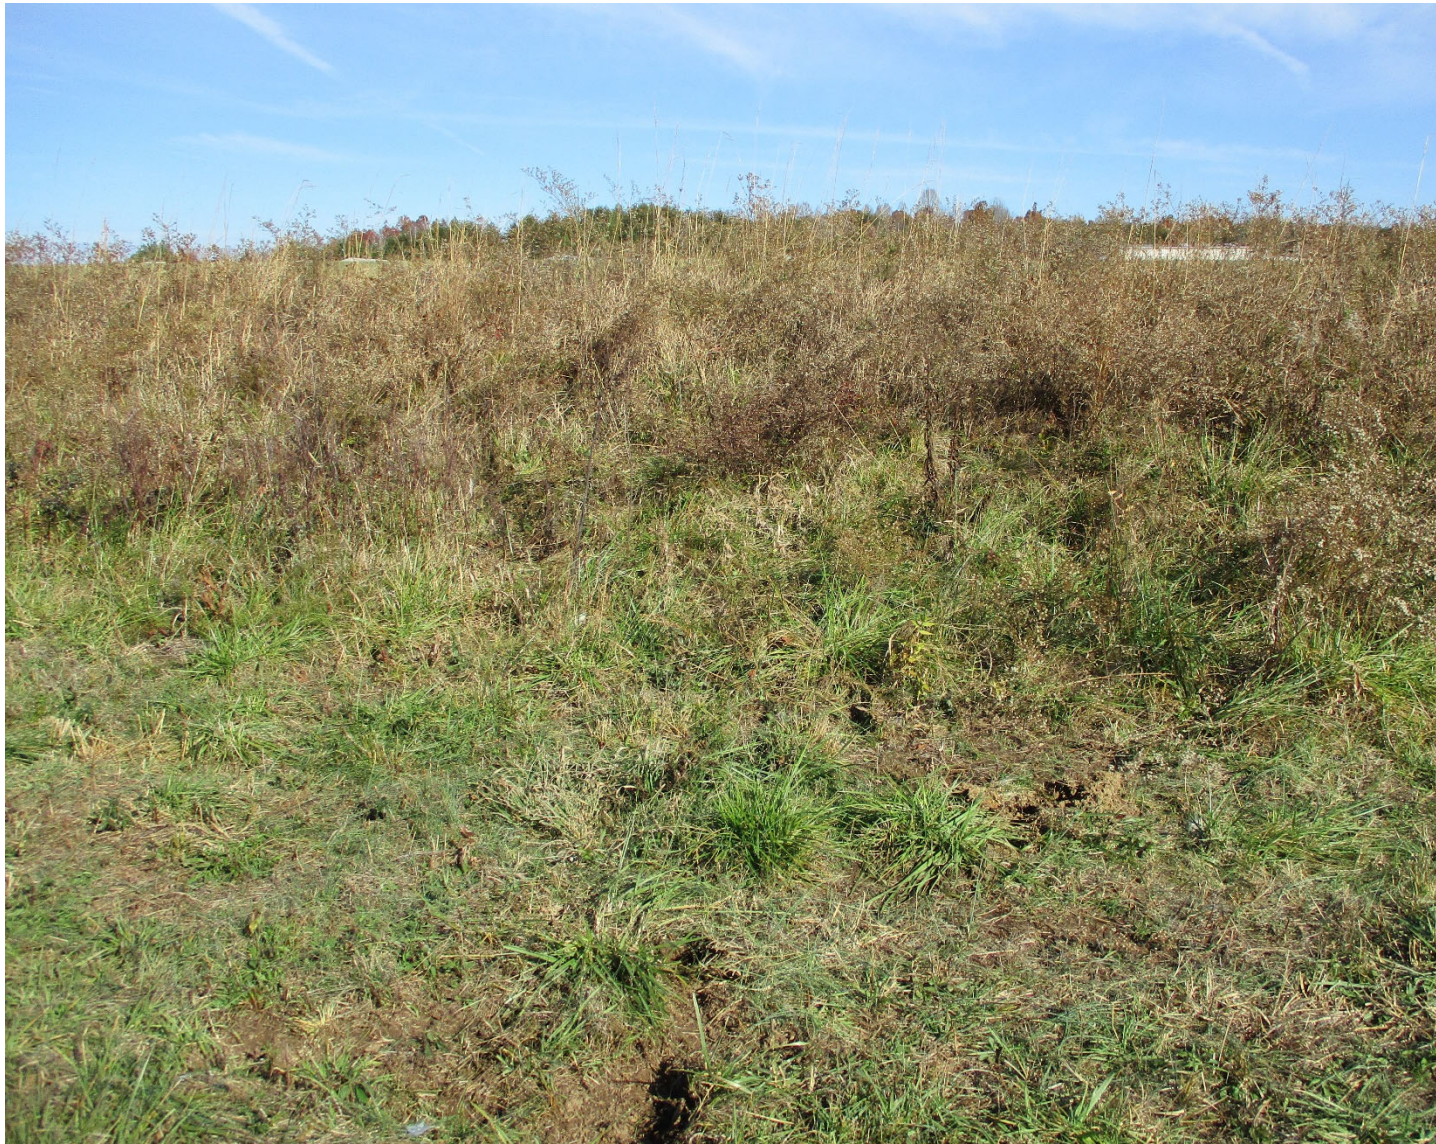
**Photo 4 – View of tall grass and ground scars near embankment. (Photo Courtesy of FAA)**

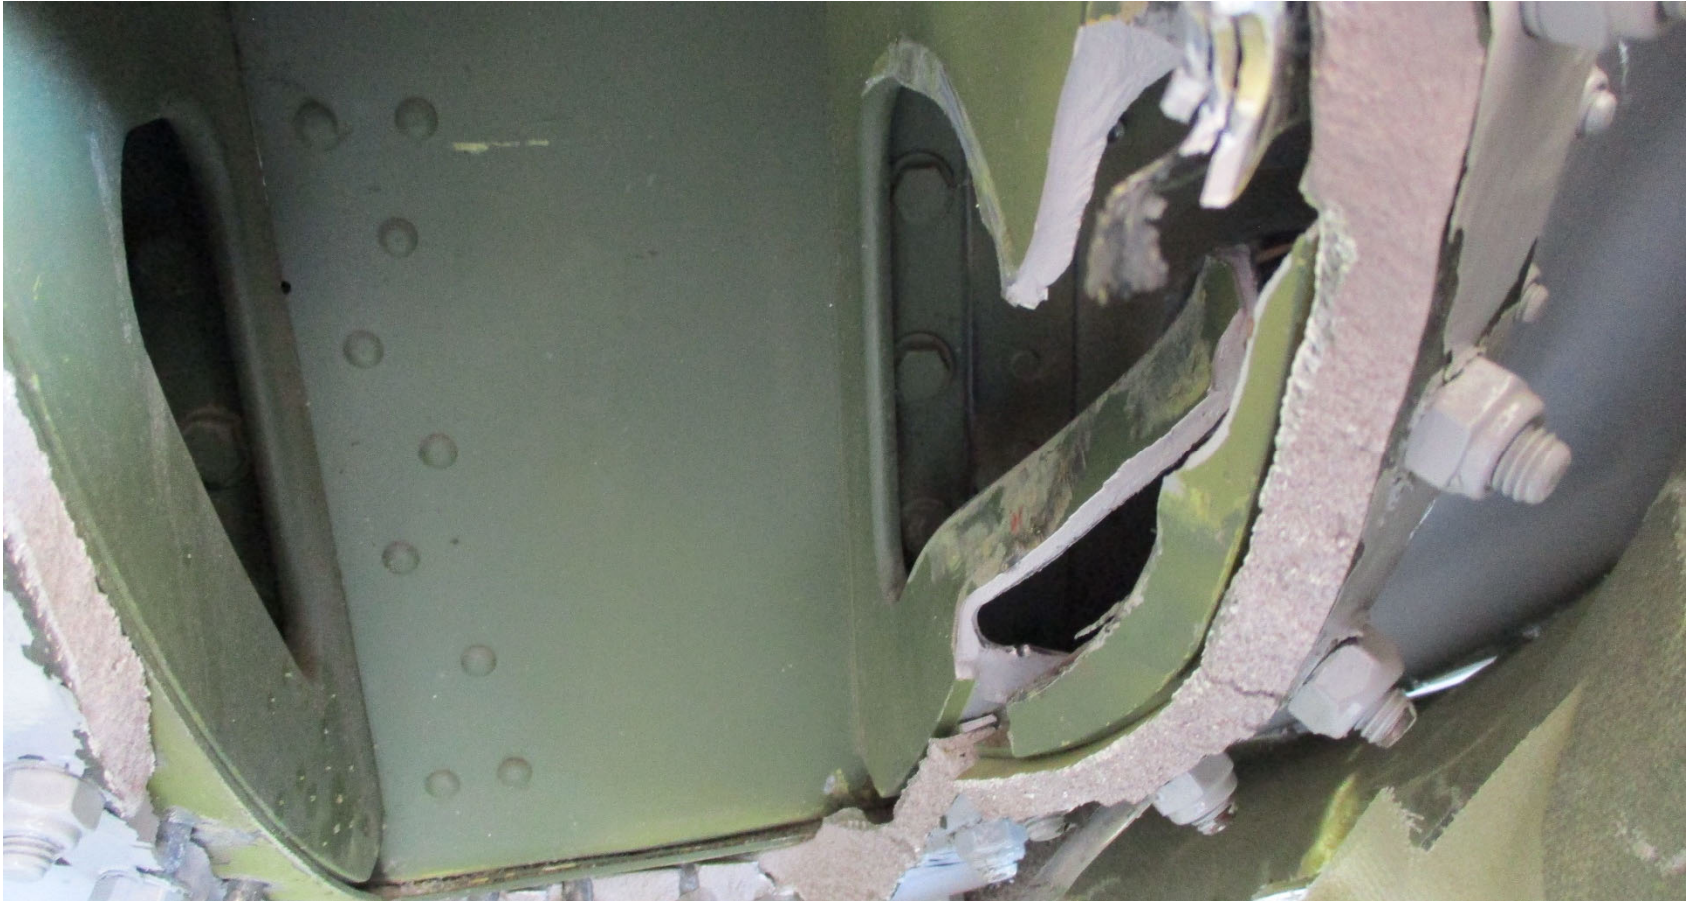
**Photo 5 – View of substantial damage at landing gear attachment area. (Photo Courtesy of FAA)**
