## RECORD OF CONVERSATION

**Date: December 15, 2021**  
**Person Contacted: Robert L. "Lynn" McNorton**  
**NTSB Accident Number: ERA22LA064**

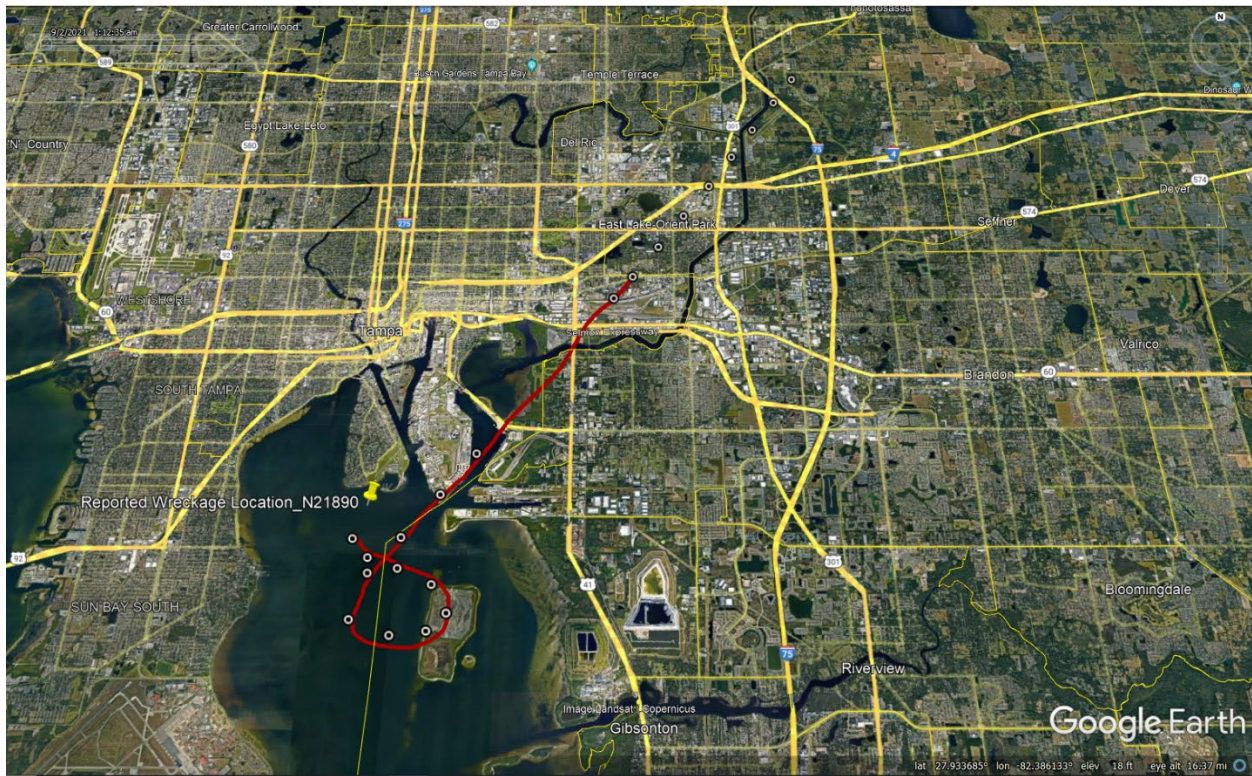
<sup>2</sup> Plotting of Flight Aware targets on Google Earth depicted he made a 270° left turn.

<sup>3</sup> According to the plotted data, on the downwind leg he was about 1 nautical mile abeam the runway and descended from 2,100 to 1,400 ft before starting the left turn. The average calculated groundspeed while on the downwind leg between 1006:22 and 1007:26, was about 160 knots.

Figure 1: Google Earth Plot of Flight Aware Targets of Accident Flight. Flight Path At End of Flight is Depicted in Red for Clarification.
