## Memorandum For Record

**Date: March 17, 2022**  
**NTSB Accident Number: ERA22LA064**

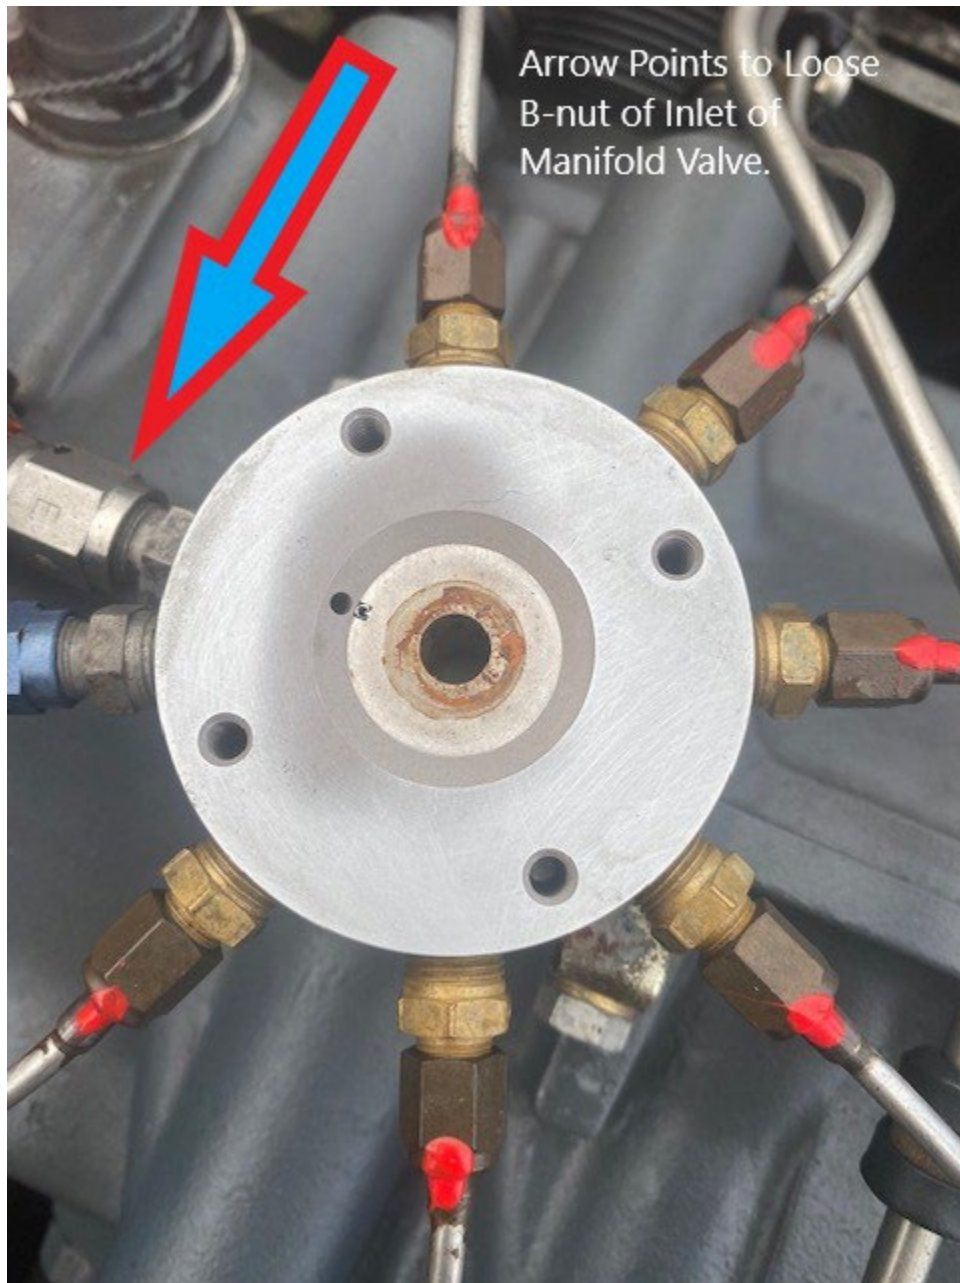
During a Virtual engine examination on December 17, 2021, at 1400 EST, with Matt Bartle of Florida Air Recovery and Storage (FAR), he reassembled the diaphragm, spring, and cover to the manifold valve that were disassembled during the previous engine examination by the Federal Aviation Administration inspector. He also placed the engine-driven fuel pump in the engine compartment and tightly connected the inlet and outlet flexible fuel hoses. In addition, he installed the inlet screen into the servo fuel injector. He confirmed that the loose b-nut at the inlet of the manifold valve (Figure 1) was not found during their previous engine inspection. He only noticed it when taking pictures for NTSB.

Figure 1: FAR Digital photograph. Arrow Pointed to Loose fuel supply line B-nut at the Manifold Valve inlet.

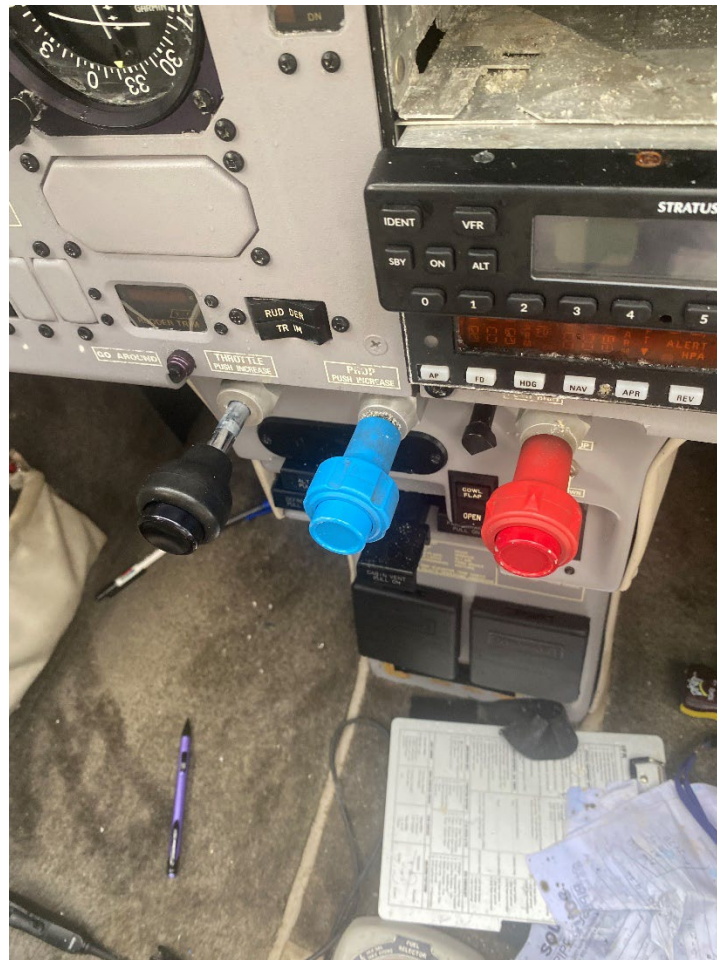
A 12-volt auxiliary fuel pump was utilized to pressurize the fuel system components in the engine compartment.<sup>1</sup> For testing 100 low lead fuel was used and the mixture control was full rich, and the throttle control was slightly out for testing (Figure 2).

Figure 2: View of the positions of the throttle and mixture Controls for pressure testing the engine compartment fuel System Components.

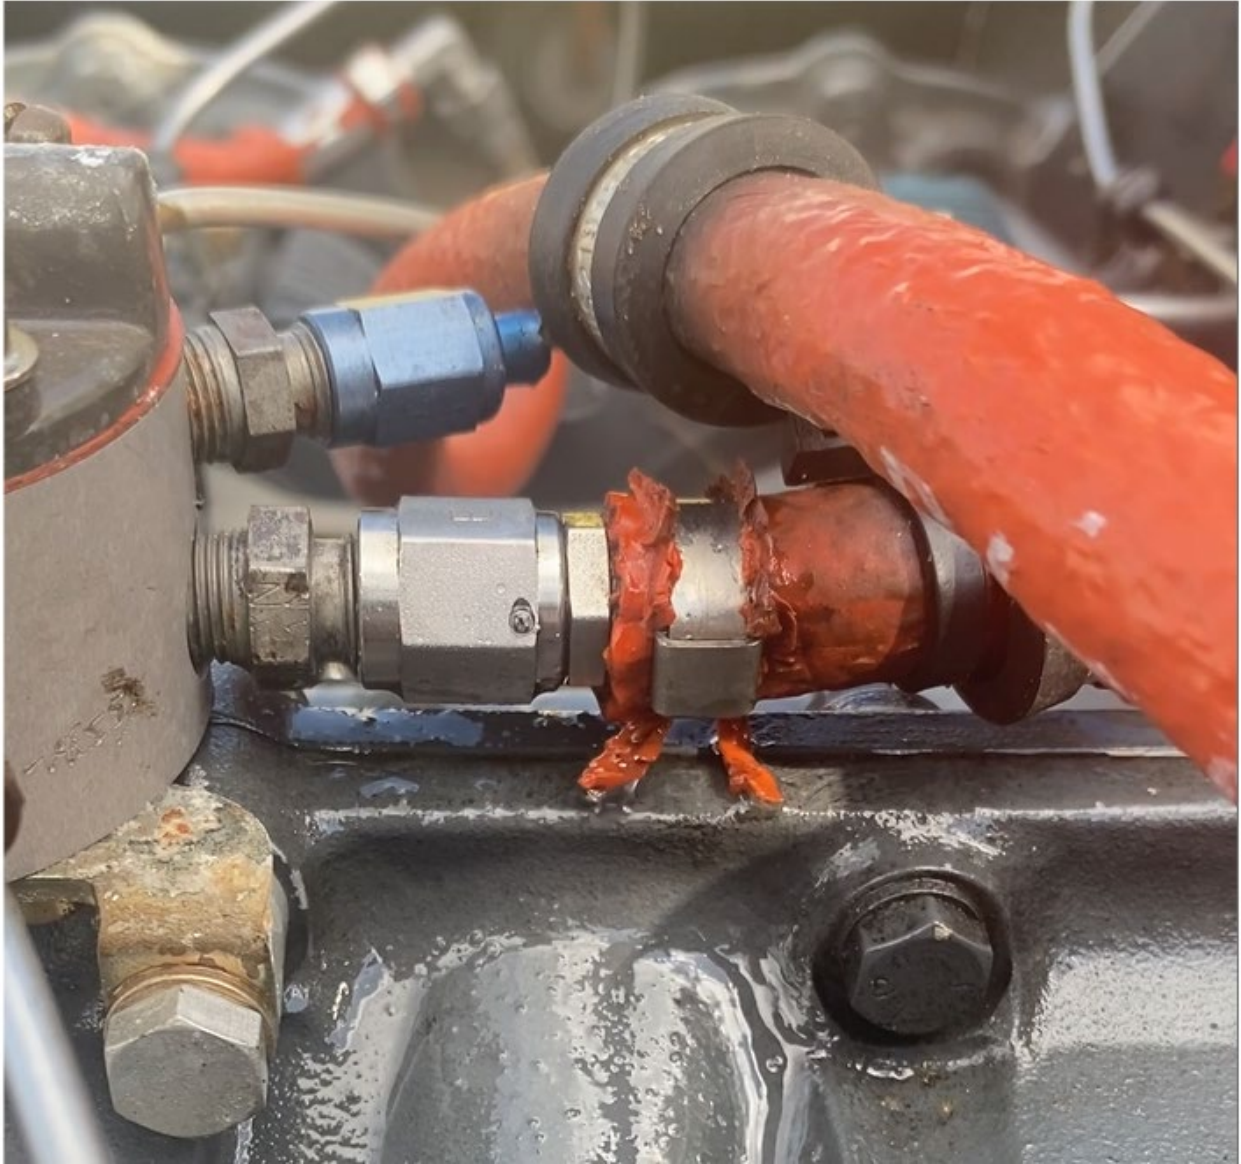
During testing, fuel leakage was noted at the loose b-nut at the inlet of the manifold valve (Figure 3). The leakage varied with movement of the line. No other leakage was noted in the fuel system components. The b-nut was determined to be 7.5 flats from being finger tight against the fitting and 15 flats from being completely separated. There was no provision to safety wire the b-nut and there was no torque stripe material on the b-nut or portion of the adjacent fitting like there was for each fuel injector line attached to each fitting of the manifold valve (Figure 2). The threads of the b-nut and inlet fitting were inspected and there was no damage noted. The b-nut was tightened, and the fuel system was pressure testing again with no leaks noted. Leakage began to occur when the b-nut was 7 flats loose.

Figure 3: Photo Depicting Fuel Leakage at Loose B-nut at Inlet of Manifold Valve During Pressure Testing
