## **NATIONAL TRANSPORTATION SAFETY BOARD**

# **EXAMINATION SUMMARY**

**ERA22LA071**

Location: Brent, Alabama  
Date: November 21, 2021  
Time: 0826 EST  
Airplane: Cessna 210K, N5779J

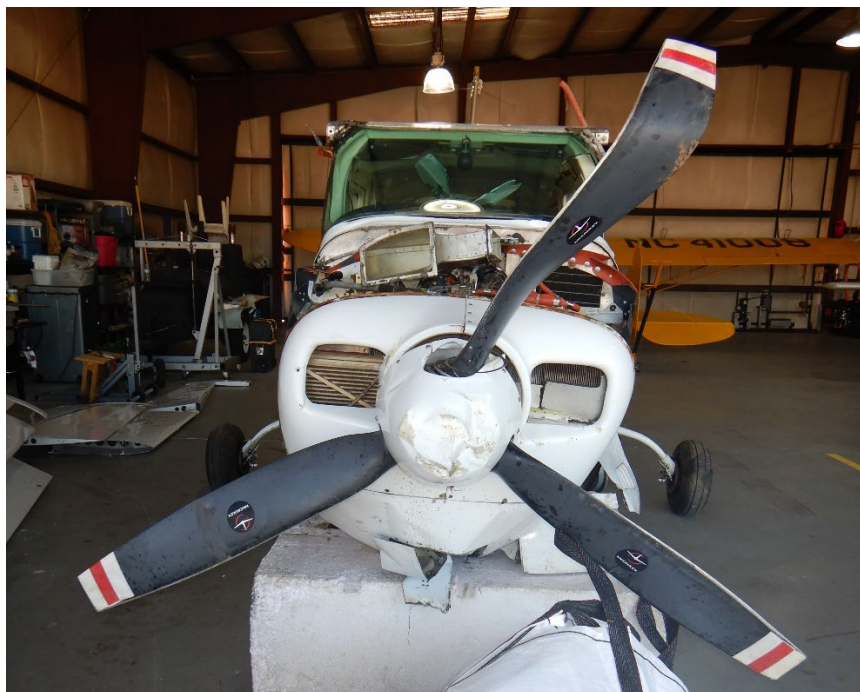
*Figure 1- View of recovered airplane from front*

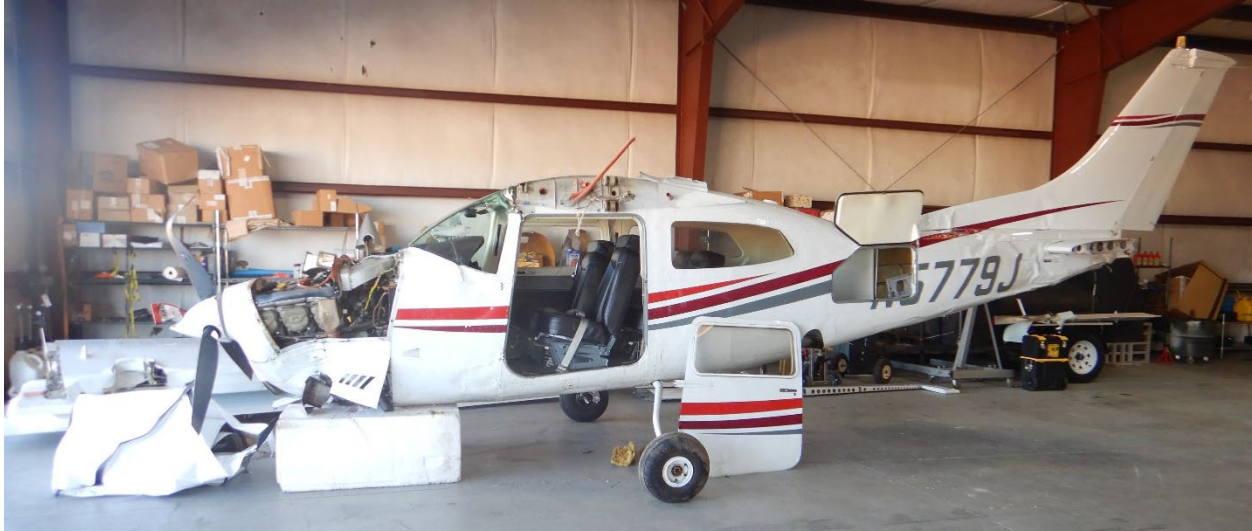
*Figure 2 - View of recovered airplane from left*

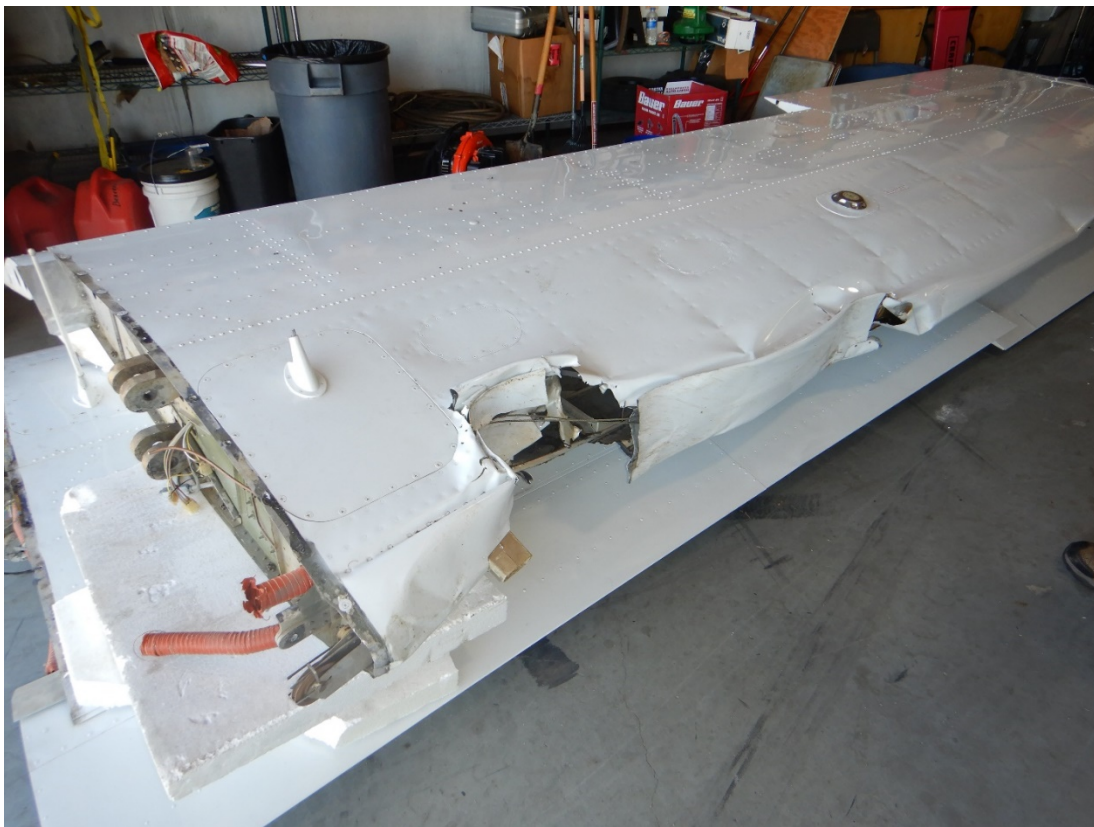
- The wings were removed during recovery.
- Both wings sustained substantial damage.
- Wing leading edge damage consistent with multiple impacts with road signs/trees.
- The tail cone exhibited compression wrinkling forward of the vertical stabilizer.
- Significant oil observed around the F&M oil adapter fiber gasket seal, in the engine compartment and on the underside of airplane's fuselage.
- Flap level: full flaps
- Landing Gear Lever: Gear Down
- Fuel Selector handle selected to left tank

*Figure 3- Leading edge damage of left wing (stored above right wing in hangar)*

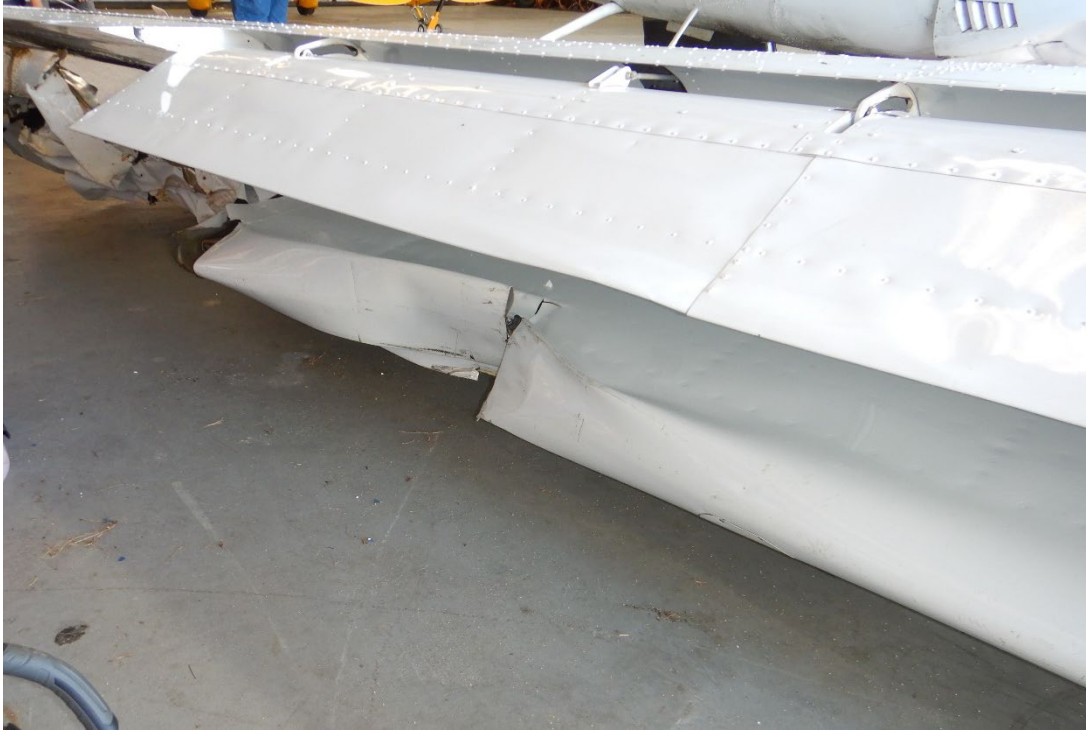
*Figure 4- Partial view of leading edge of right wing (under trailing edge of left wing)*

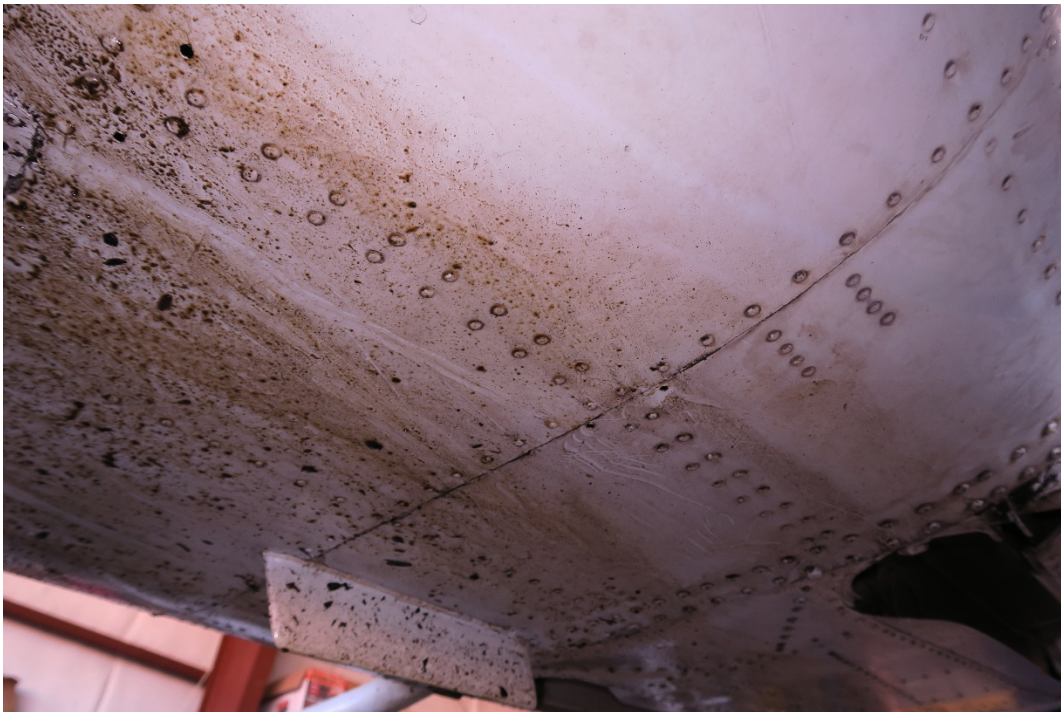
*Figure 5- Oil on underside of fuselage*

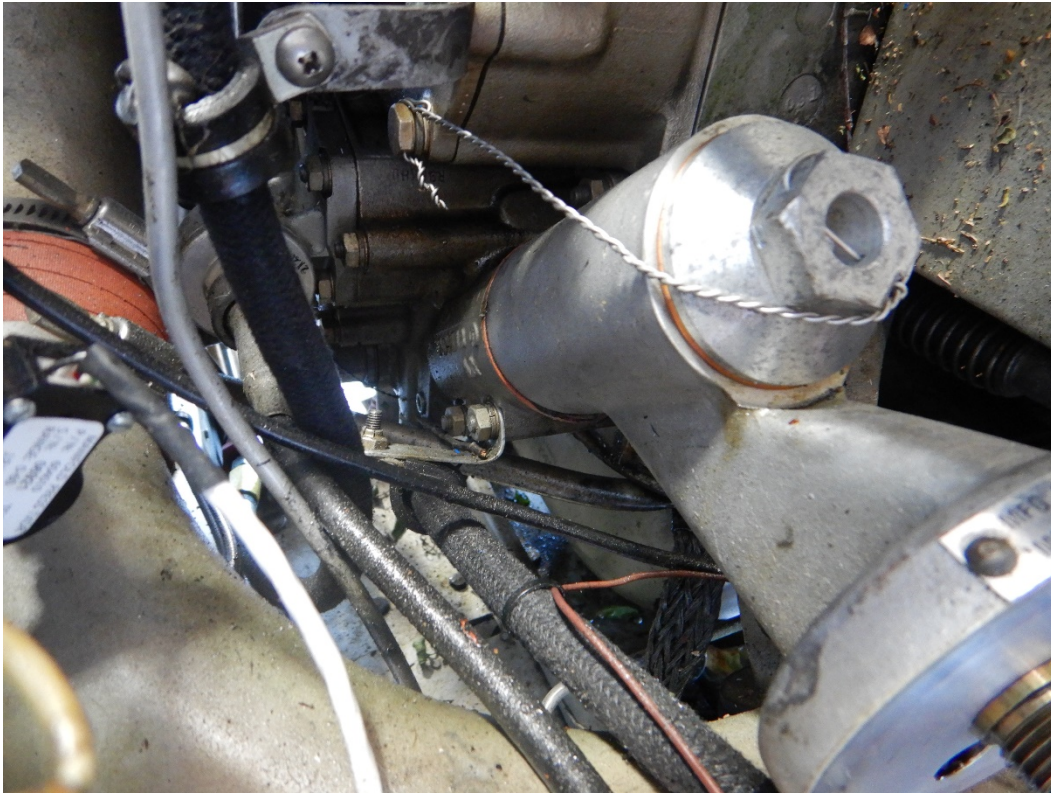
- Hobbs time 930.0
- Oil was observed beneath the F&M oil adapter fiber gasket seal, which was protruding from the oil filter adapter assembly.
- The F&M oil filter adapter torque was checked using a digital torque wrench. The tightening torque was measured at 38.5 ft-lbs. The loosening torque (breakaway torque) was measured at 34.0 ft-lbs.
- The Stratus Tools Technologies mandatory service bulletin SB-001 was referenced; the oil adapter transfer cylinder was to be installed at 65 ft-lbs.
- The oil filter adapter was removed, and the fiber gasket was found torn. A crescent mark was visible in the compressed fiber gasket material which confirmed the gasket had shifted off center and was protruding from the assembly.
- Review of the maintenance logs revealed that the oil filter had been replaced on November 3, 2021, during an annual inspection.

*Figure 6 - View of oil filter adapter*

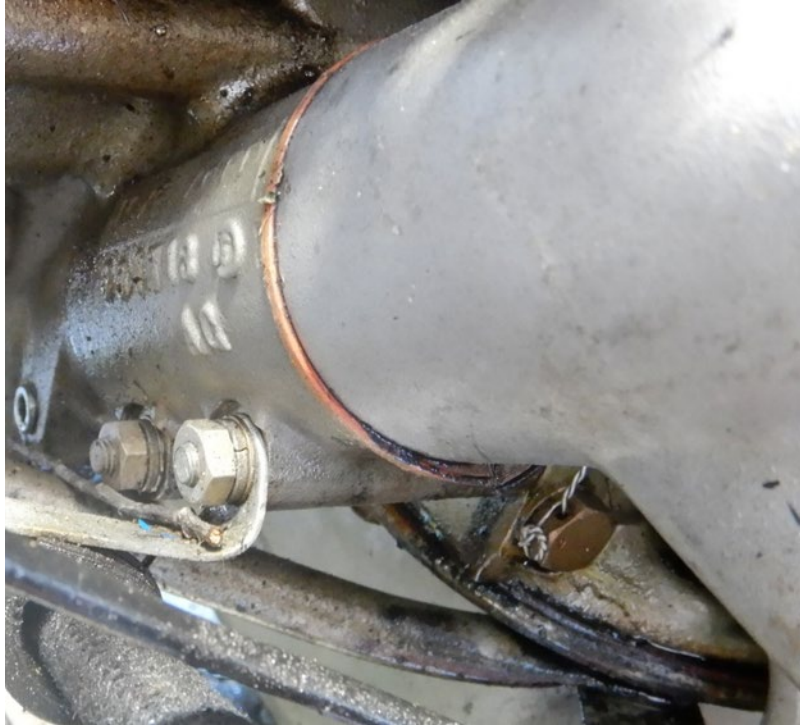
*Figure 7 – Close-up view of lower (fiber) gasket on oil filter adapter*

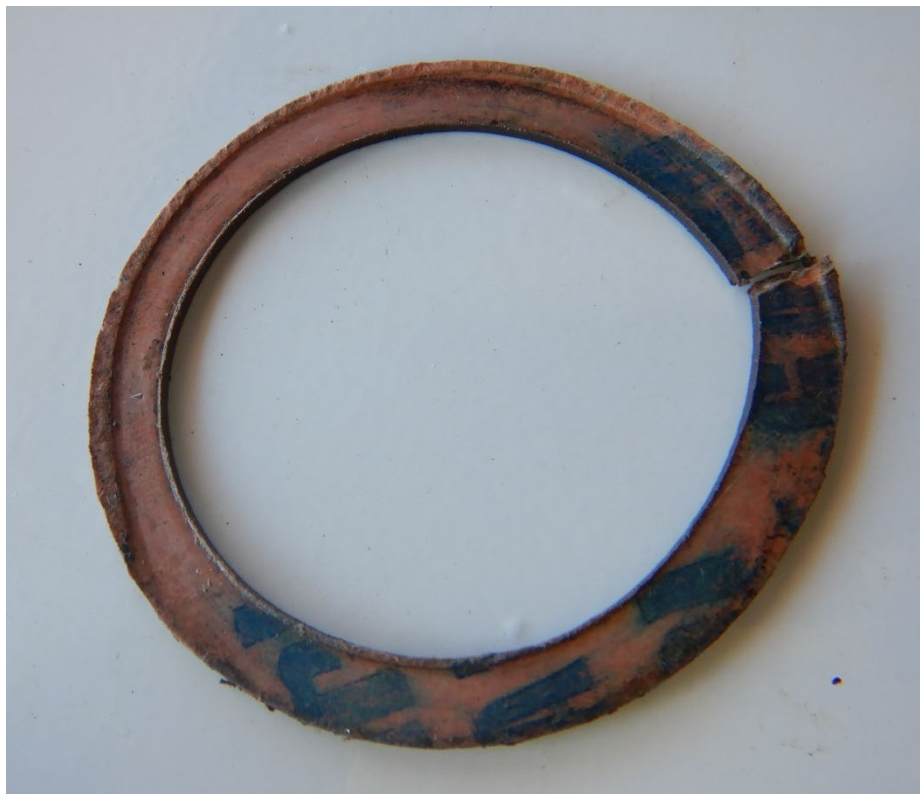
*Figure 8 - Close-up view of torn fiber gasket*

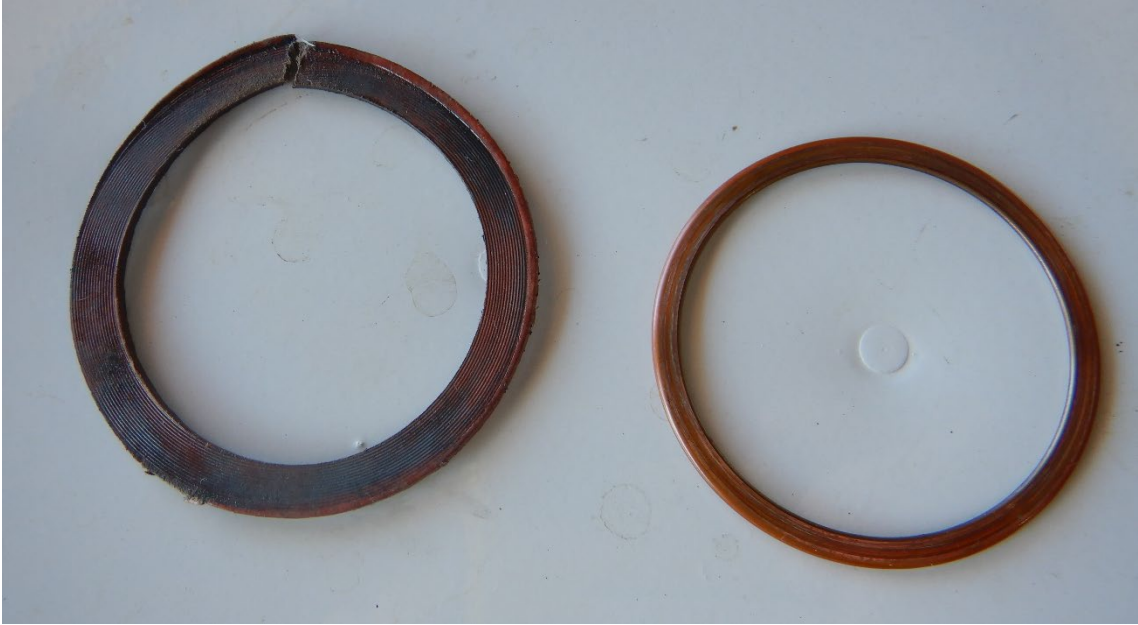
*Figure 9 - View of fiber and copper gaskets*
