**Stratus Tool Technologies, LLC**

**Service Bulletin: SB-001 Rev B**

**SUBJECT: OIL FILTER ADAPTER GASKETS**

**Applicability:** Continental aircraft engines having any of the following F&M or Stratus oil filter adapters installed in accordance with STCs SE09356SC, SE8409SW & SE10348SC.

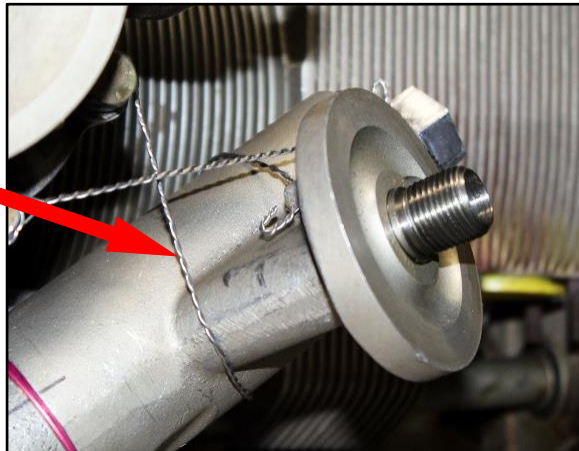
**Figure 4**

**SAFETY- WIRE**  
securing the body itself  
against CCW rotation

- d. If there is no safety-wire securing the sleeve itself against rotation, install safety-wire such that the wire will prevent the sleeve from rotating in a counter-clockwise (loosening) direction, see Figure 4. Secure the safety-wire to a suitable location **on the engine**. Do not secure any safety-wire from the adapter to the airframe.
