# NATIONAL TRANSPORTATION SAFETY BOARD

## MATERIALS LABORATORY FACTUAL REPORT

Report No. 22-055

Place : Cornelia, Georgia  
Date : November 29, 2021  
Vehicle : Piper PA-46-500TP, N172MA  
NTSB No. : ERA22LA079  
Investigator : Robert Gretz, AS-ERA

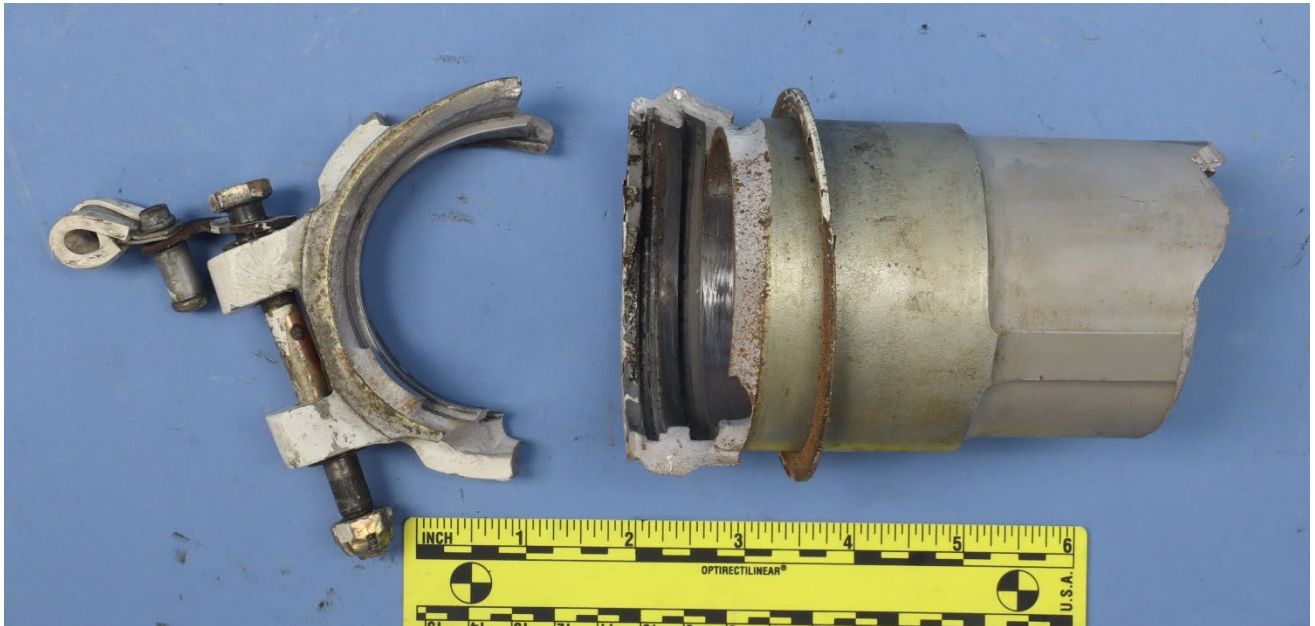
Figure 1 shows the remnants of the trunnion assembly, as received. The remnants consisted of two pieces of the trunnion cylinder, one of which was the cylindrical trunnion barrel that had fractured on each side, and a remnant of the slotted barrel edge and clamp. As demonstrated in Figure 2, the clamp remnant and slotted portion of the trunnion barrel mated at their respective fracture surfaces. The opposite side of the trunnion barrel also exhibited a fracture surface, as shown in Figure 3.

Figure 1 – View of the fractured remnants of the trunnion, as received.

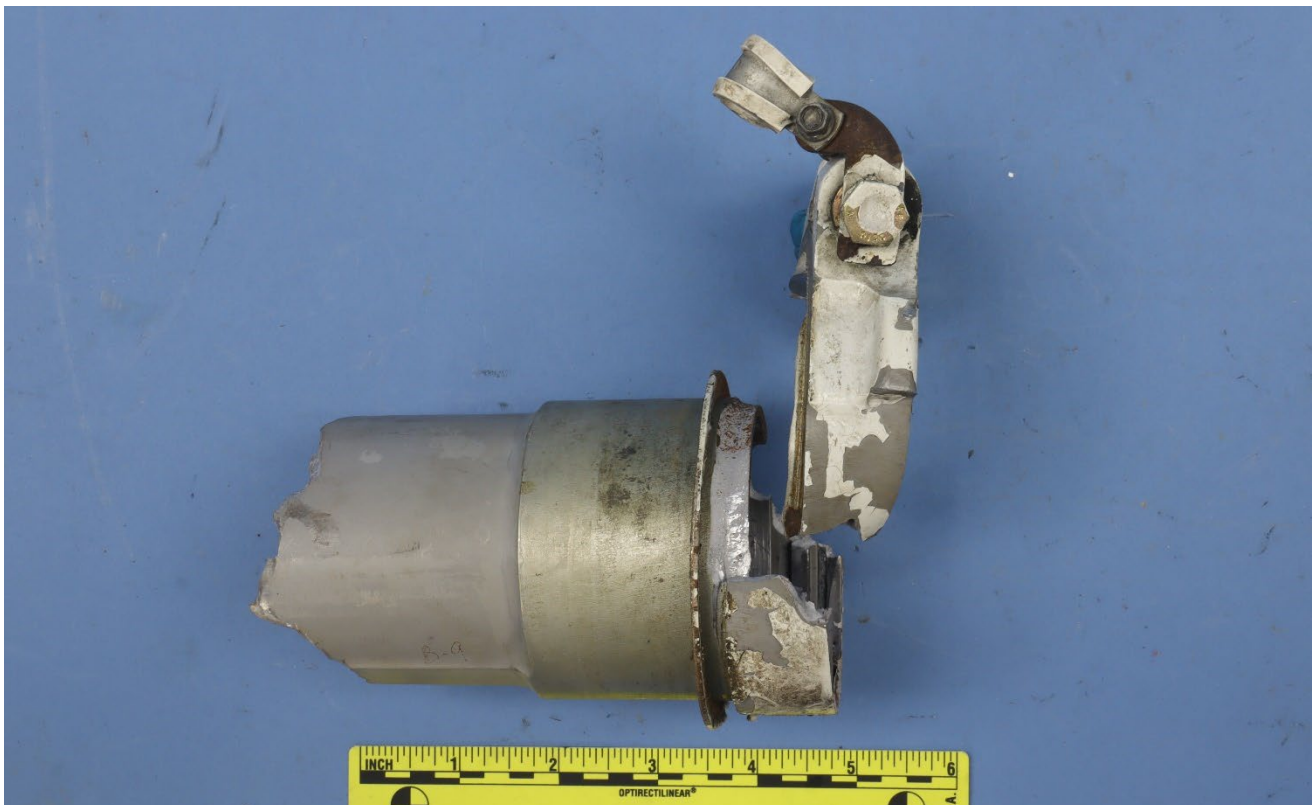
Figure 2 – Side view of the trunnion remnants, aligned to show the orientation of the mating fracture surfaces on the slotted bore.

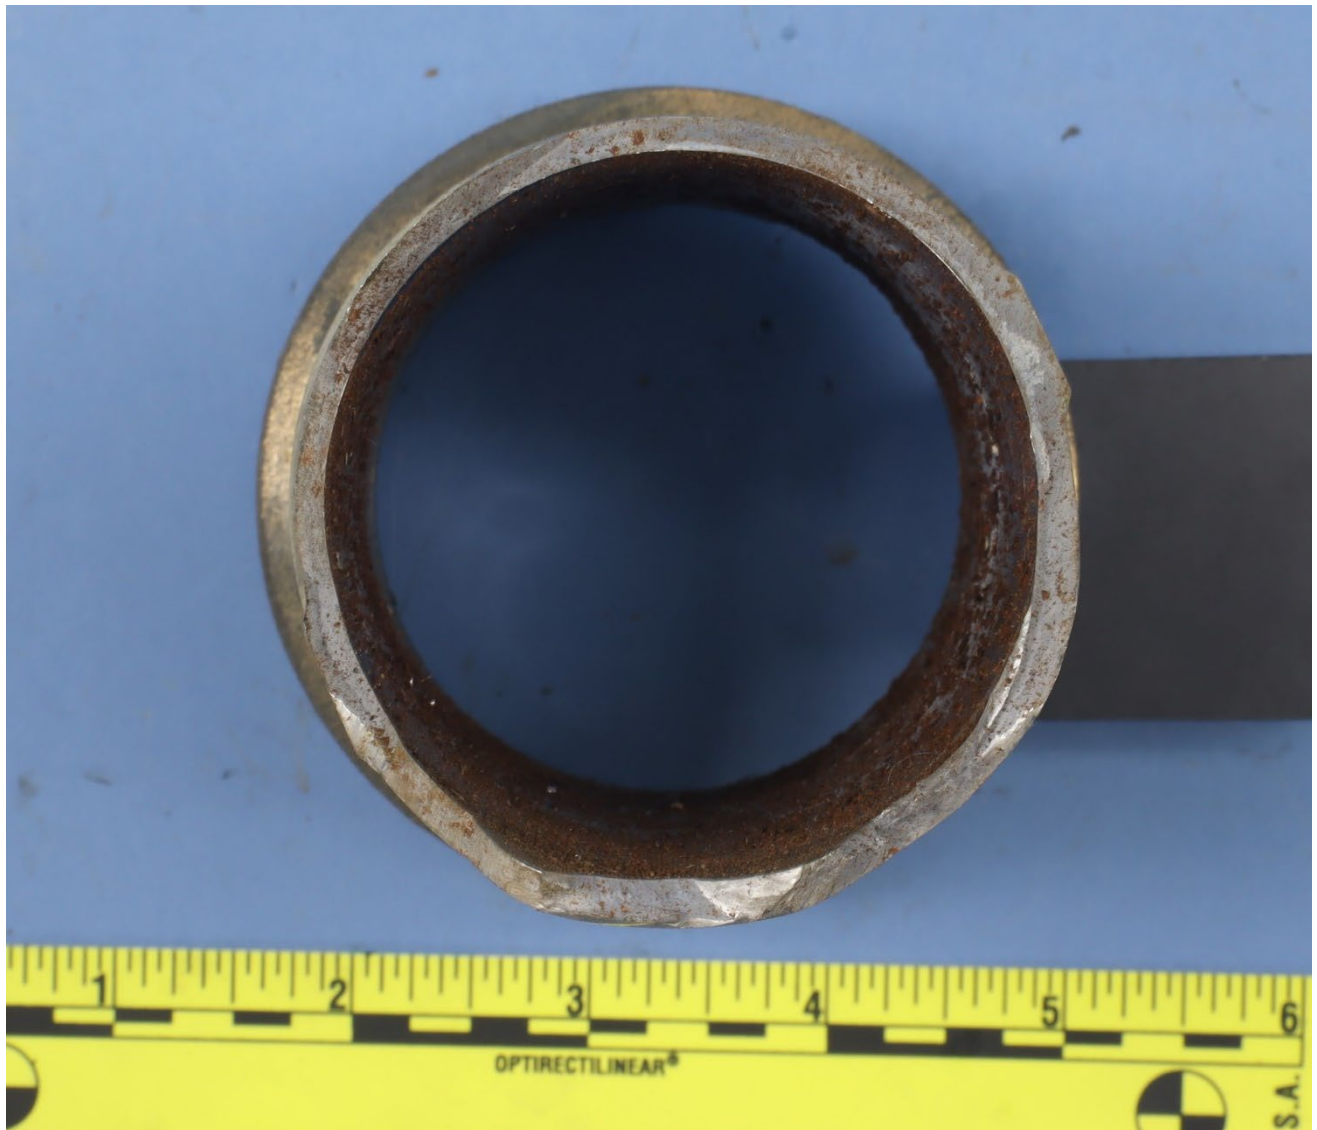
The opposite fracture surface of the trunnion remnant, shown in Figure 3, was examined closer. Unlike the fracture on the slotted edge, this fracture had proceeded around the entire circumference of the trunnion. As shown on opposite sides in Figures 1 and 2, this fracture was oriented in an angled direction, tapering to a point on one side, and undulating more on another side.

Figure 3 – View of the fracture surface from the trunnion bore, opposite side of the slotted fracture region.

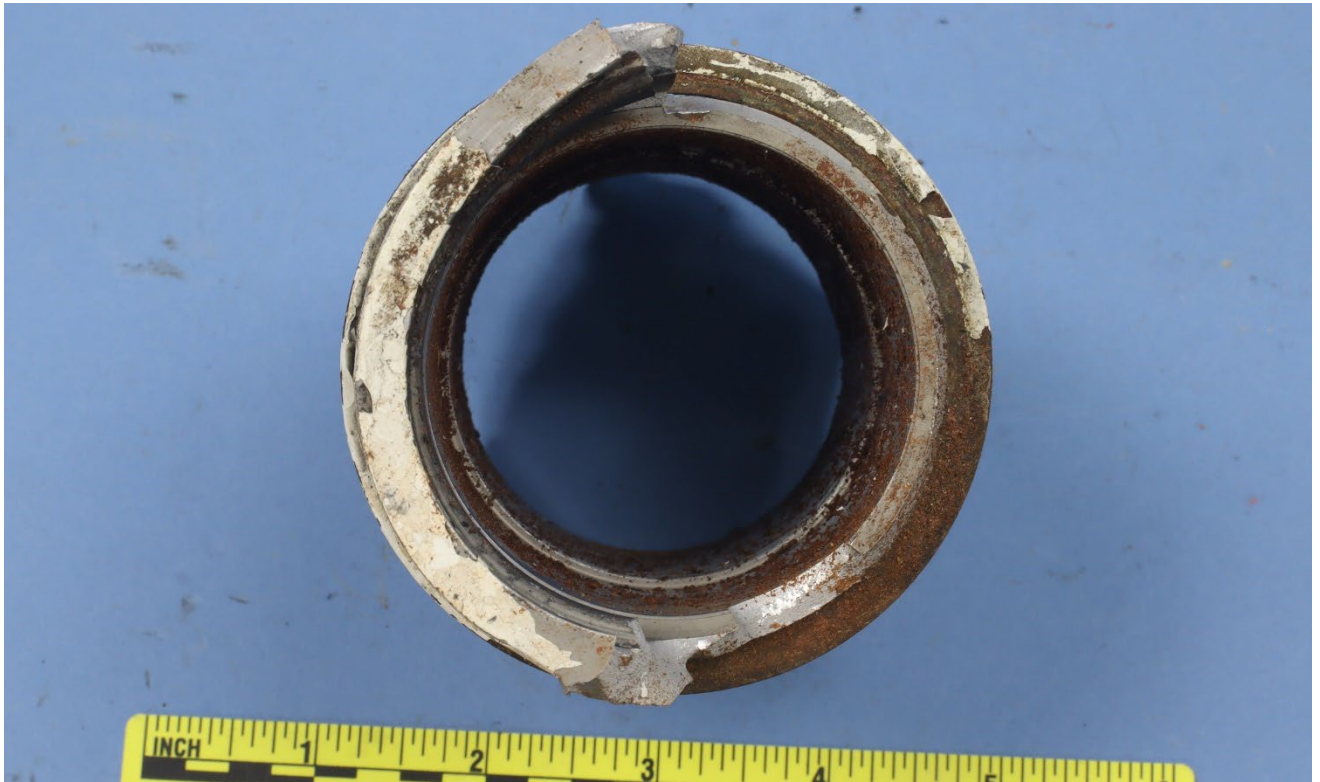
Figure 4 shows the circumferential portion of the fracture slotted side of the trunnion remnant, which mated to the slotted clamp remnant as demonstrated in Figure 2. The fracture proceeded around approximately half over the circumference of the trunnion barrel, with fractures running parallel to the trunnion barrel on opposite 180° locations. There were also indications of plastic deformation adjacent to several of the fracture

surfaces. The intact, but torn, portions of the trunnion edge had been deformed outward from the center of the part, as illustrated on the top and bottom of Figure 4.

Figure 4 – View of the fractured area along and around the slotted portion of the trunnion.

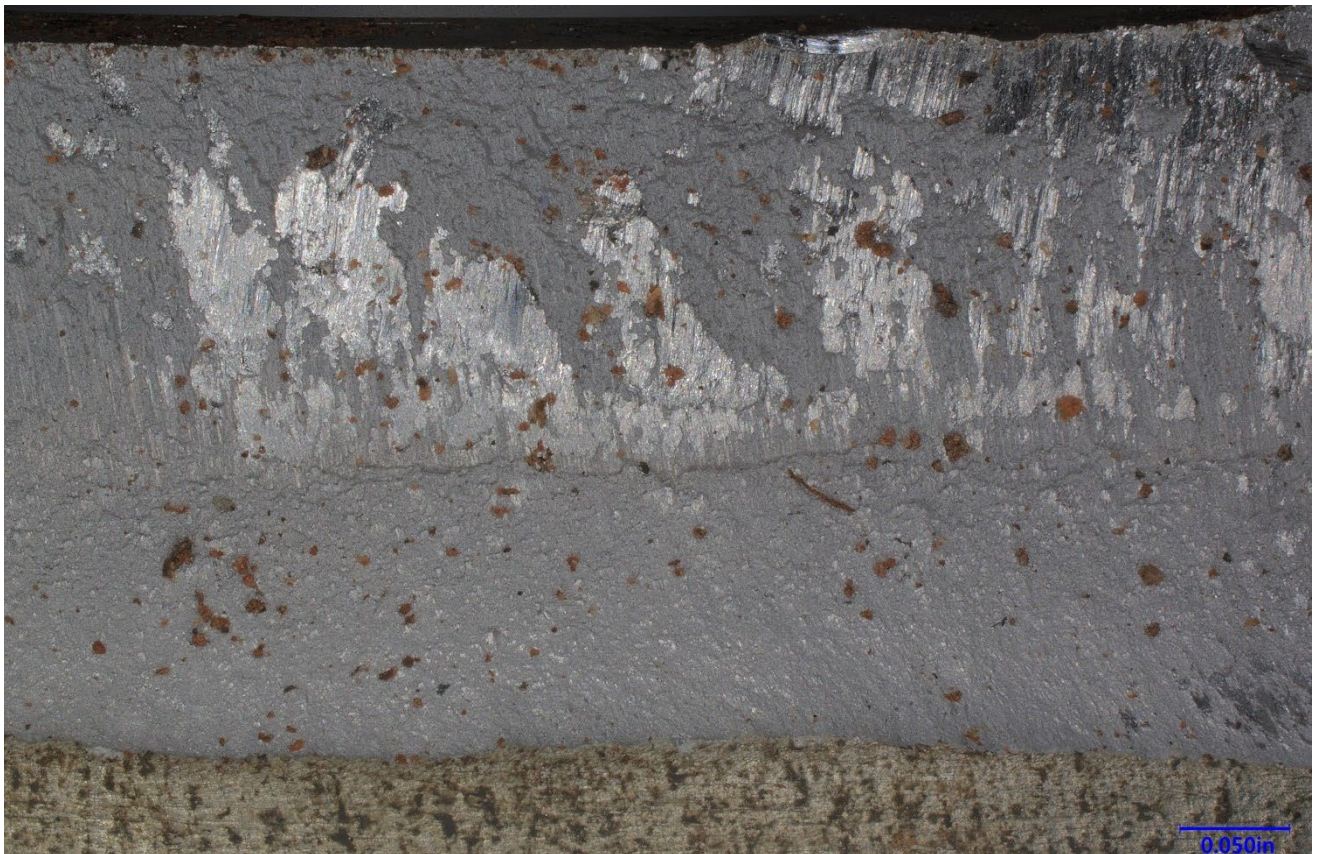
Figure 5 shows a closer view of a typical area of the circumferential fracture of the trunnion. The fracture surface was angled overall, with the outer half being oriented closer to 90° or perpendicular to the barrel direction, while the inner portion was angled closer to 45°. In all areas, the surface exhibited a dull gray luster with a rough texture. There were areas that were more reflective, with transverse-oriented parallel streaks—these regions were consistent with post-fracture damage (such as smearing) with adjacent components.

Figure 5 – Typical area of the trunnion circumferential barrel fracture.

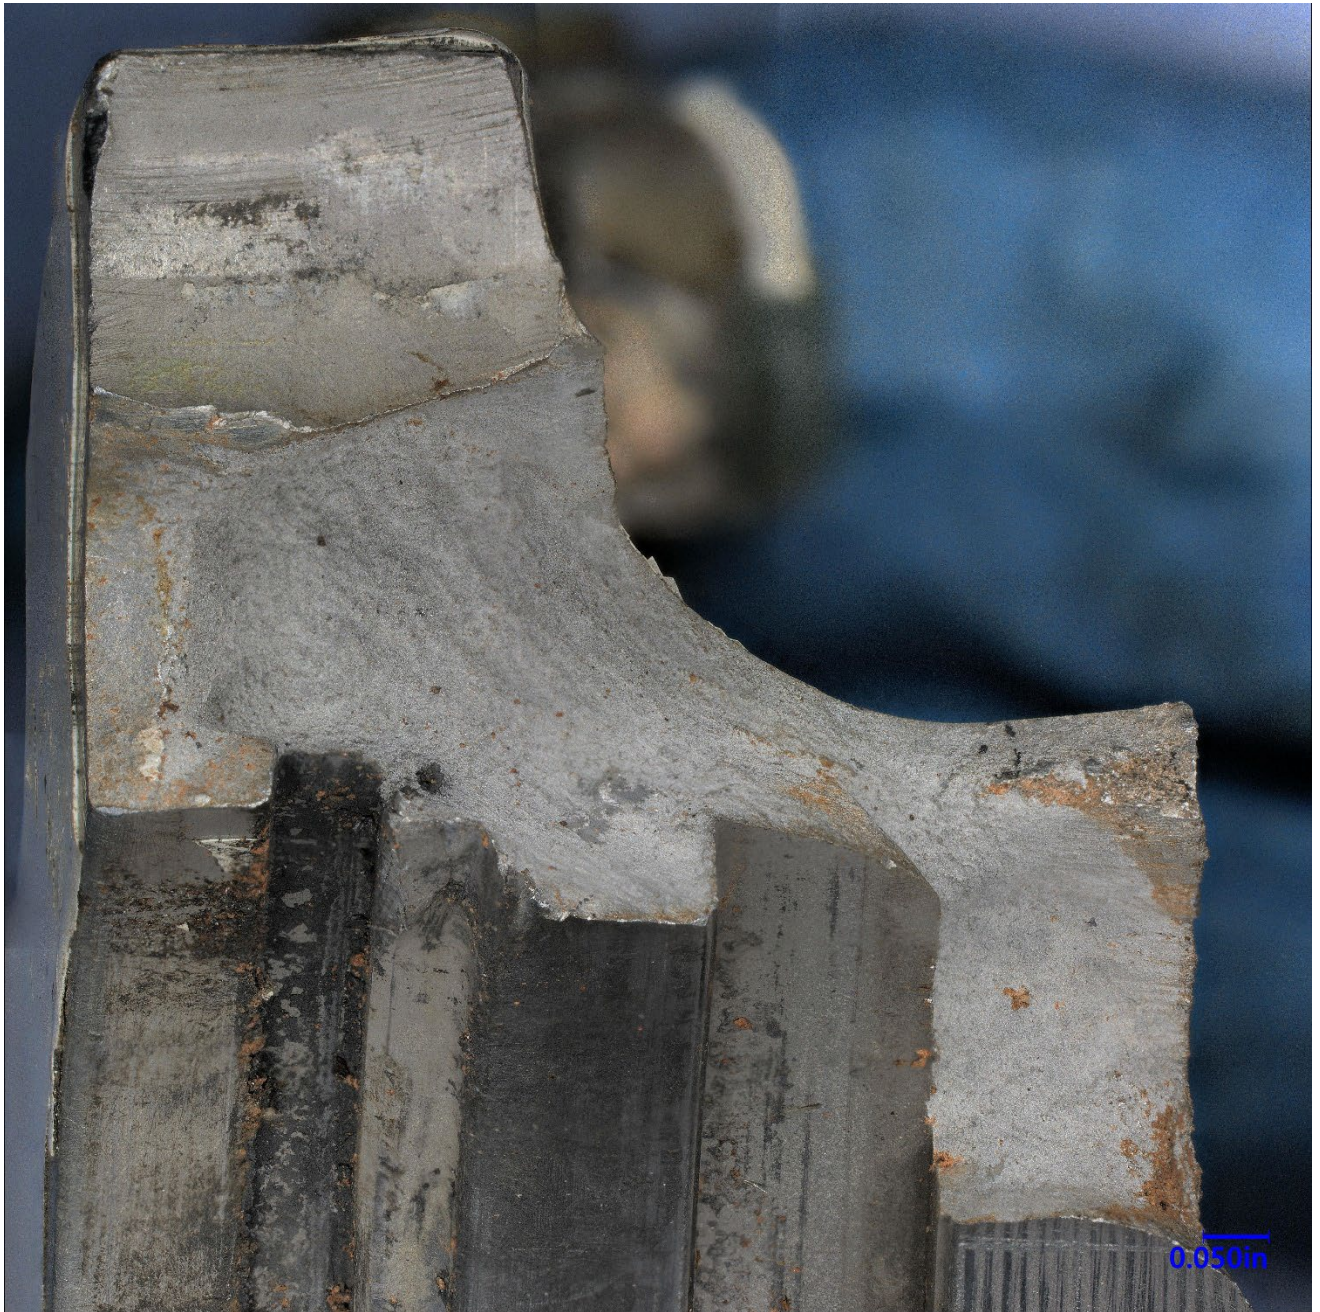
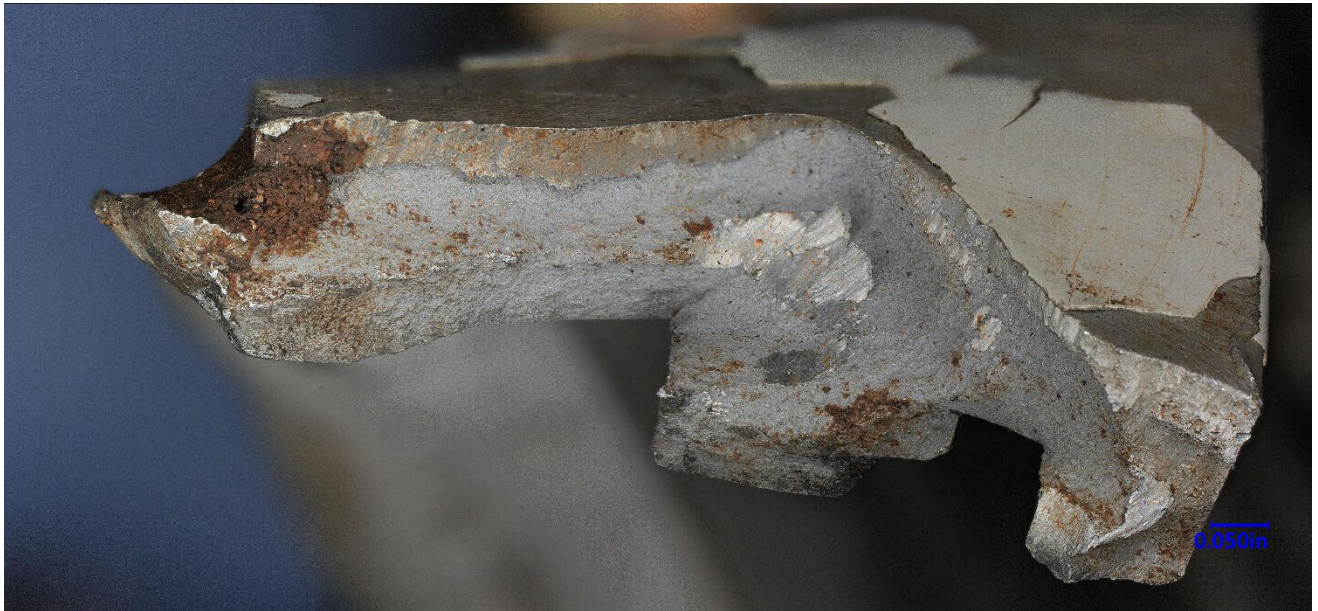
Figures 6 and 7 show the opposite edges of the trunnion fracture surface, viewed from the smaller clamp remnant. Like the circumferential fracture surface, these surfaces exhibited dull lusters and rough textures. The edge fracture surfaces did not exhibit an overall orientation, but they were erratic in elevation and inclination. The areas adjacent to the fracture exhibited localized plastic deformation, distorted out-of-plane from the overall direction of the fractures. These features were consistent with overstress fracture of this portion of the trunnion.

Closer examination of the corners and edges of these fracture surfaces did not reveal any indications of dissimilar fracture modes. There were no features consistent with pre-existing cracks, voids, or deep mechanical wear marks such as gouges.

Figure 6 – Montage of the one of the edges of the trunnion fracture surface along the slotted bore, viewed from the interior.

Figure 7 – Montage of the opposite edge of the slotted-side trunnion fracture.

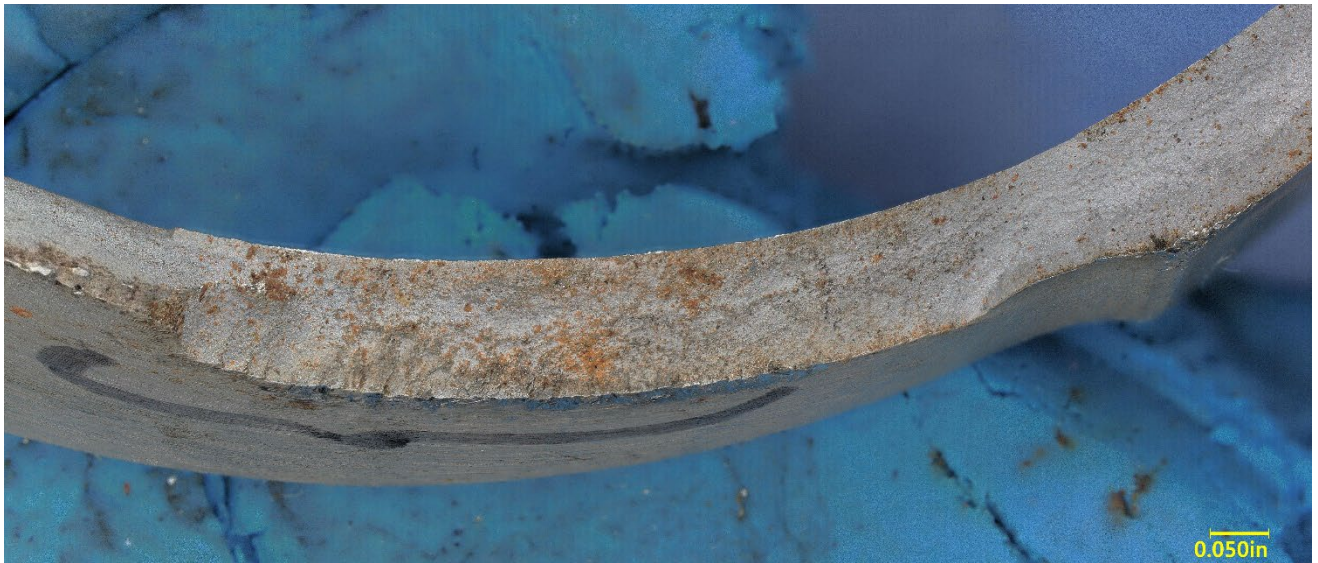
There was a portion of the opposite trunnion fracture surface that exhibited a relatively flatter orientation, as highlighted in Figure 8. This area exhibited river patterns and chevron marks emanating from it, consistent with this region being the start of this fracture surface. There were also a multitude of perpendicular linear ridge features adjacent to the outer edge of the fracture. Figure 9 shows a closer view of these features. The outer trunnion barrel had been partially deformed inward at each of these ridges, as shown in Figure 9 and Figure 10.

Figure 8 – View of a section of the non-slotted fractured surface of the trunnion cylinder, showing repeating parallel features near the outside edge.

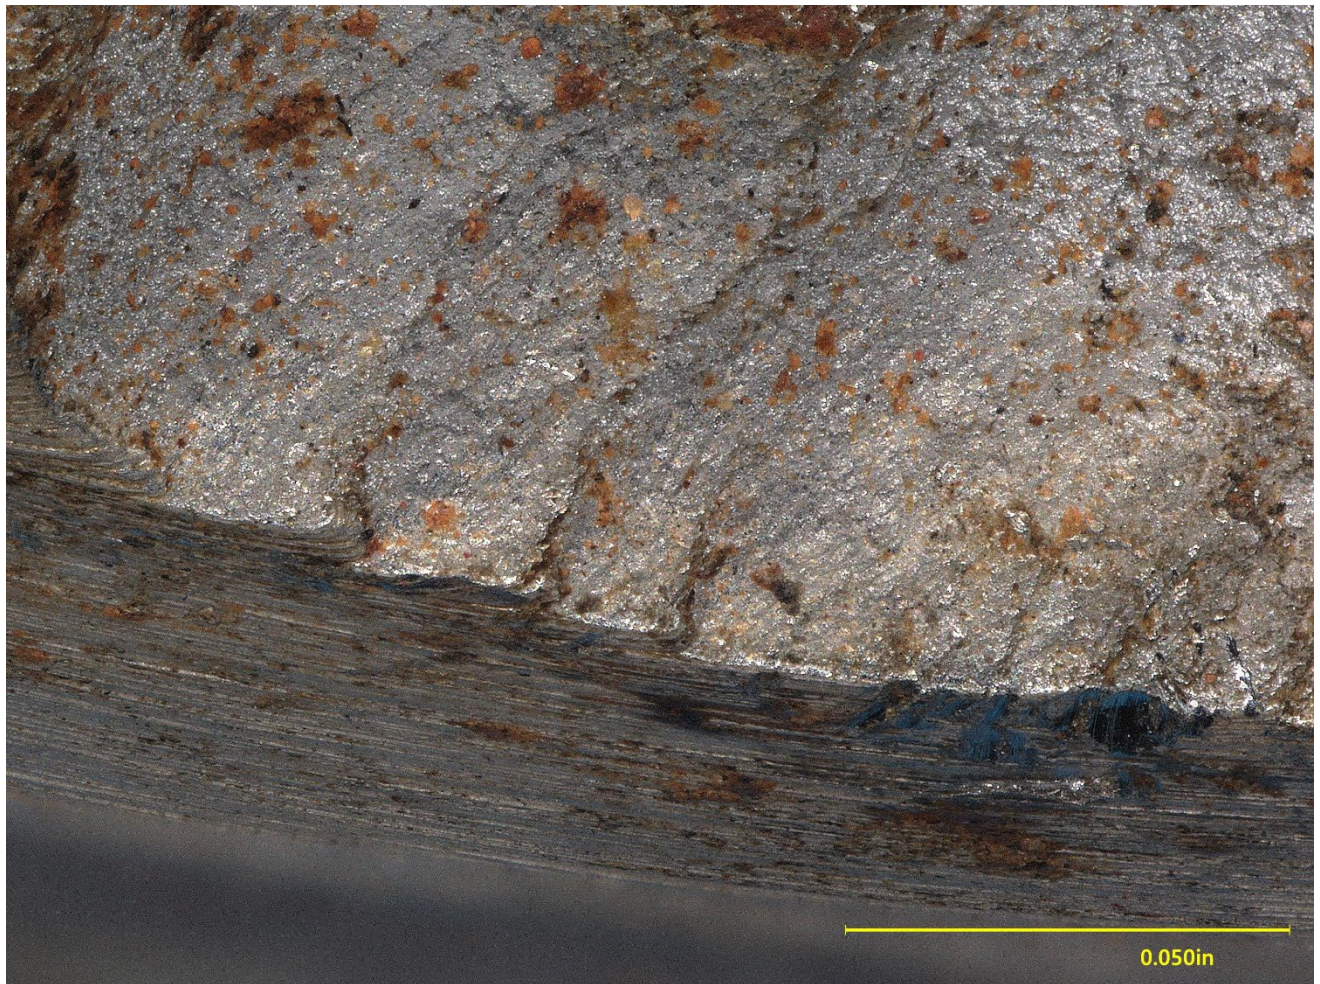
Figure 9 – Closer view of the outside edge in Figure 8, showing the parallel linear features.

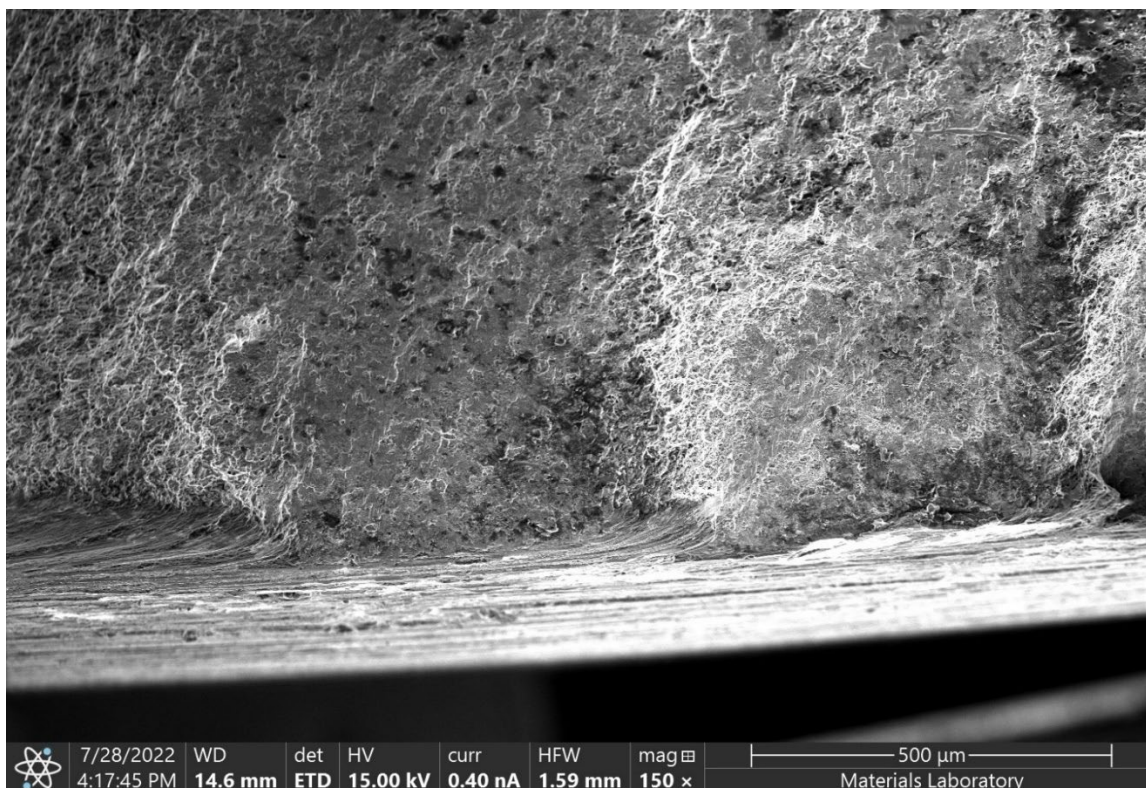
The fracture surface in Figure 8 was examined using a scanning electron microscope (SEM). One of the ridges along the outer edge of the fracture surface is shown in Figure 10. As mentioned above, the area of the ridge lip exhibited local plastic deformation inward, with the outer barrel surface machine marks bending inward.

Figure 10 – Secondary electron (SE) micrograph of the outside trunnion edge in Figure 9, showing inward material deformation at the linear ridges.

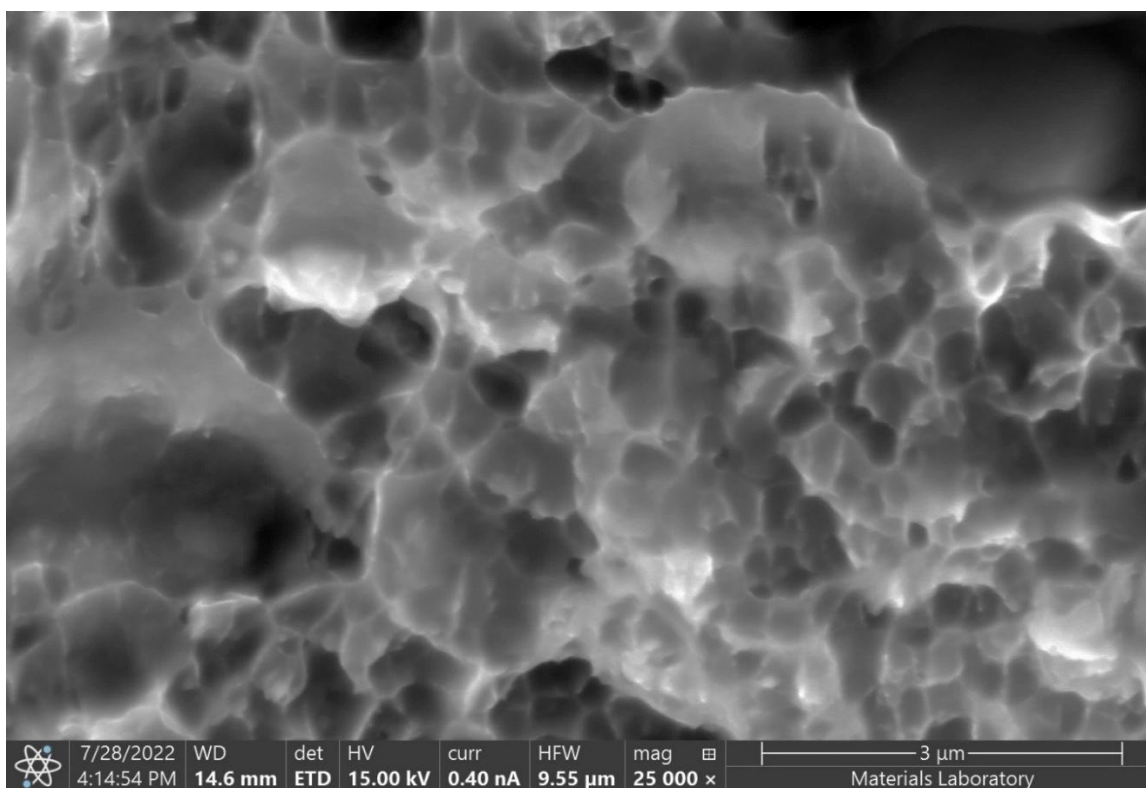
Figure 11 – SE micrograph of dimpled rupture near the edge in Figure 10.

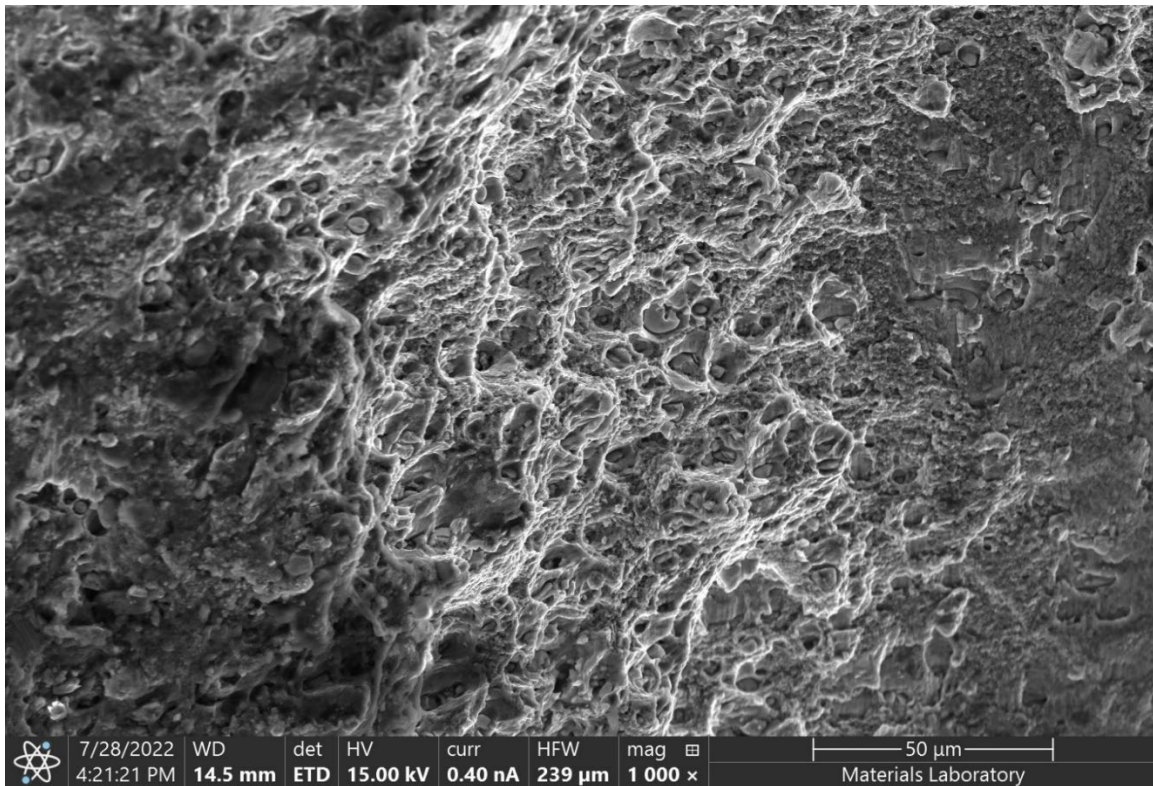
Figure 12 – SE micrograph of showing a closer view of one of the linear perpendicular features in Figure 10.

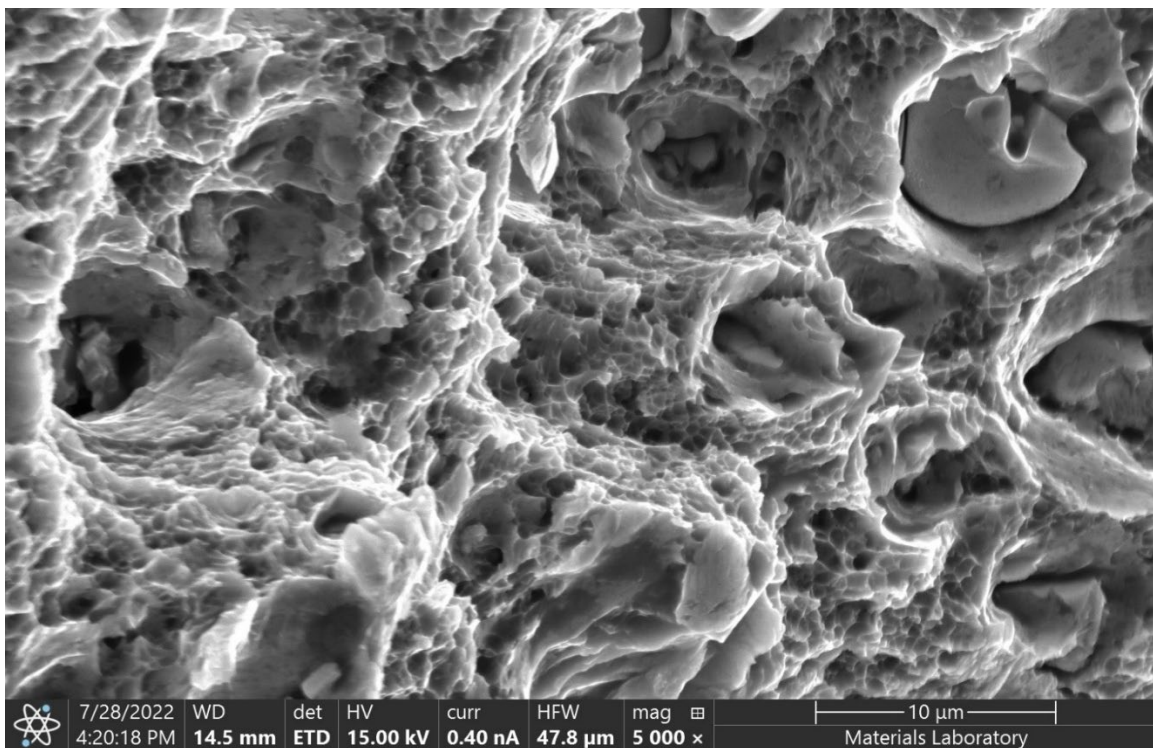
A closer examination of a typical area of the trunnion fracture surface revealed dimpled rupture, consistent with ductile overstress fracture. One of the ridges was also examined, to determine if it exhibited distinct fracture features (see Figure 12). As shown in Figure 13, these areas exhibited dimpled rupture as well. There were no other fracture features observed consistent with other failure modes.

These features were consistent with the trunnion having fractured from overstress in tension and bending. There were no indications of pre-existing cracking or damage in these remnants of the trunnion.

Figure 13 – SE micrograph of a closer view of dimpled rupture on the ridge in Figure 12.

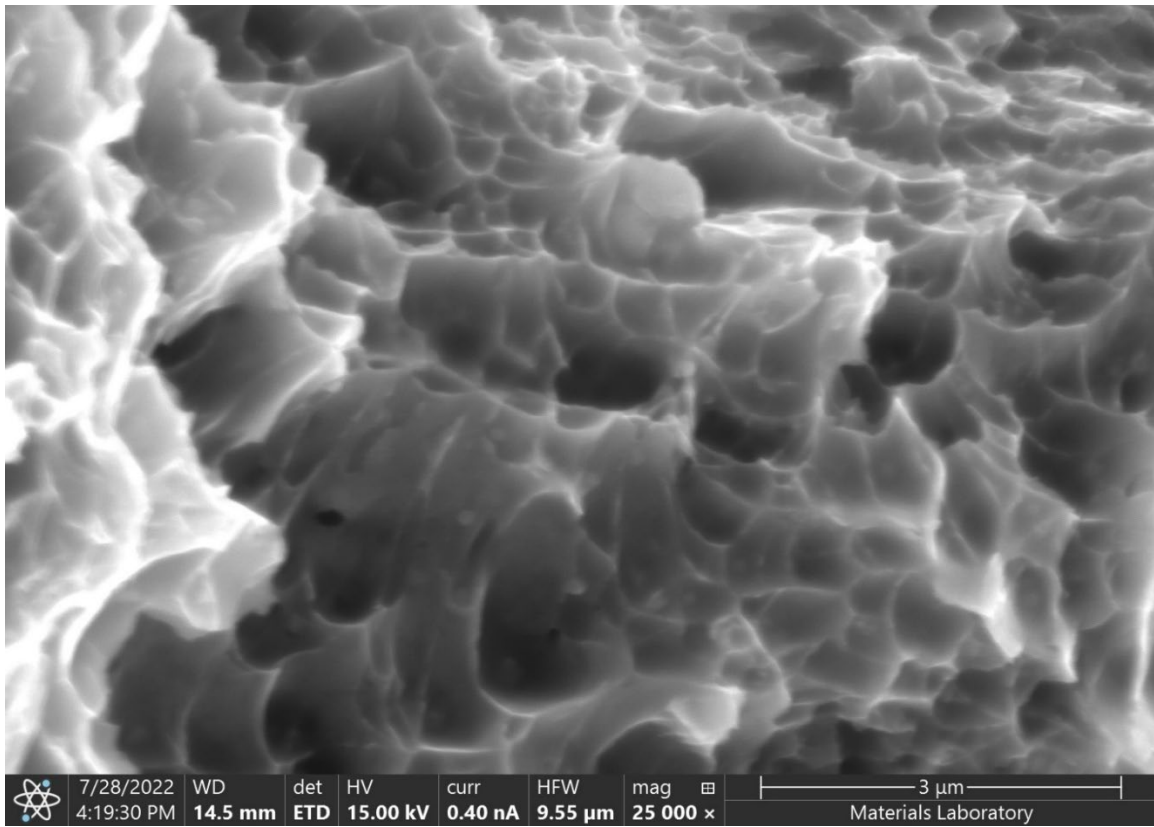
Figure 14 – SE micrograph of a closer view of dimpled rupture in Figure 13.
