# NATIONAL TRANSPORTATION SAFETY BOARD

## MATERIALS LABORATORY FACTUAL REPORT

Report No. 22-065

Place : Auburndale, FL  
Date : 12/17/2021  
Vehicle : AEROFAB LAKE LA-4-250, N1402C  
NTSB No. : ERA22LA090  
Investigator : Douglass Brazy

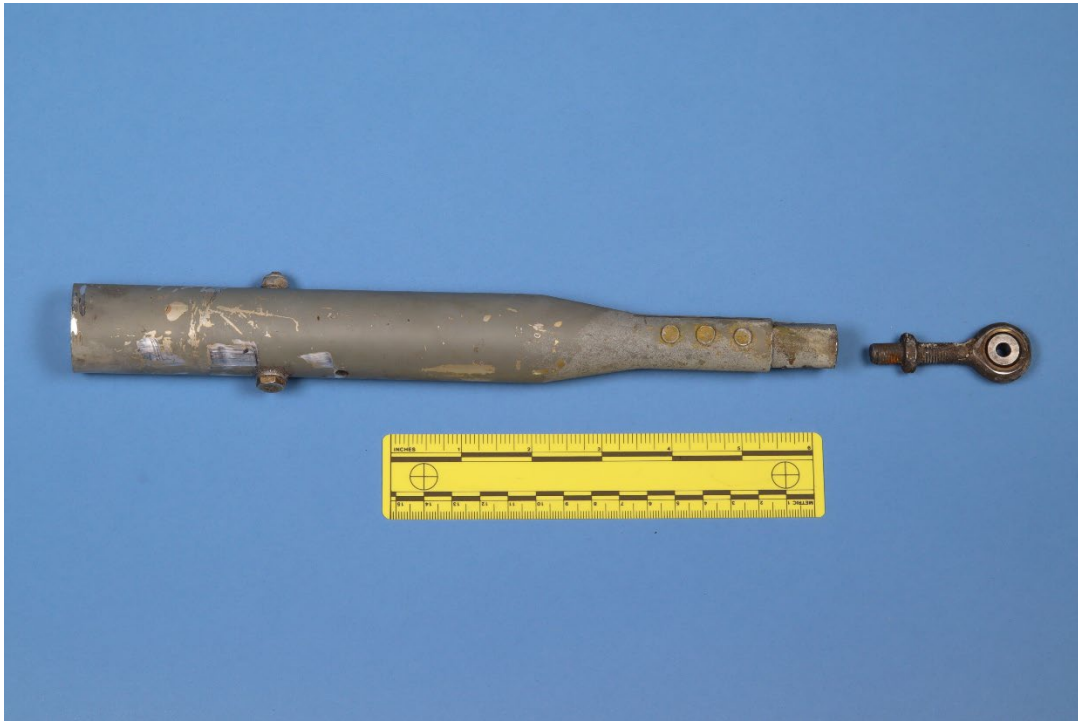
Rod end and section of push pull tube (Figure 1).

Figure 1: Accident parts as received.

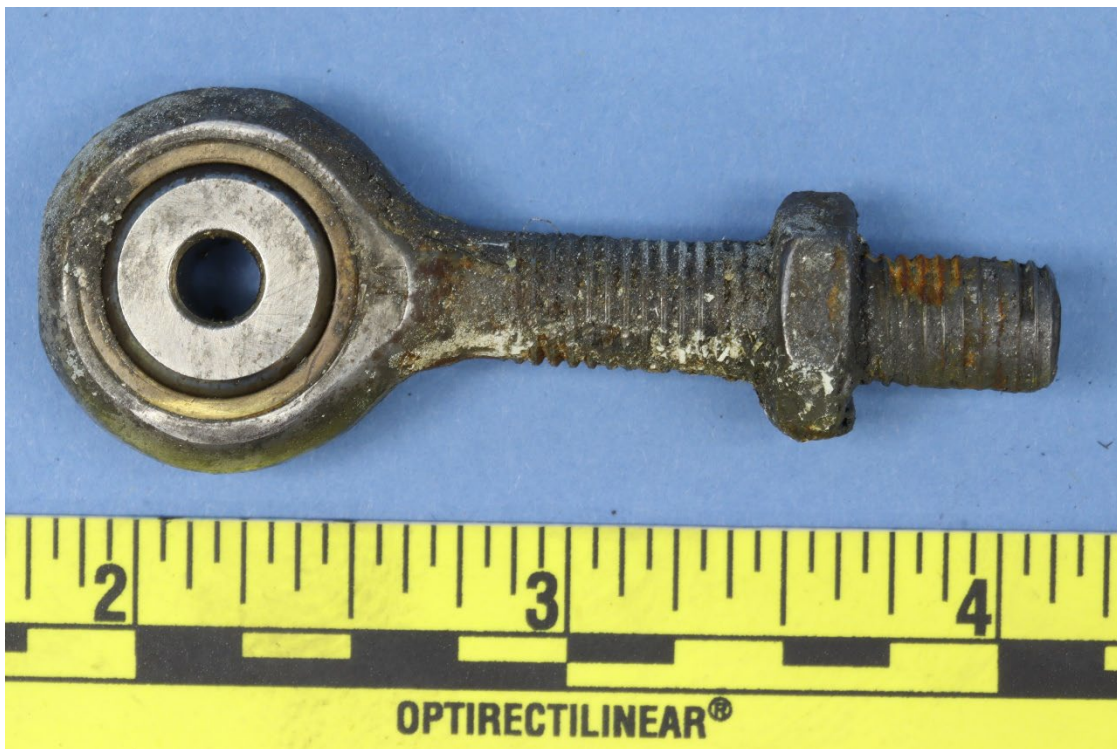
Figure 2: Rod end prior to cleaning.

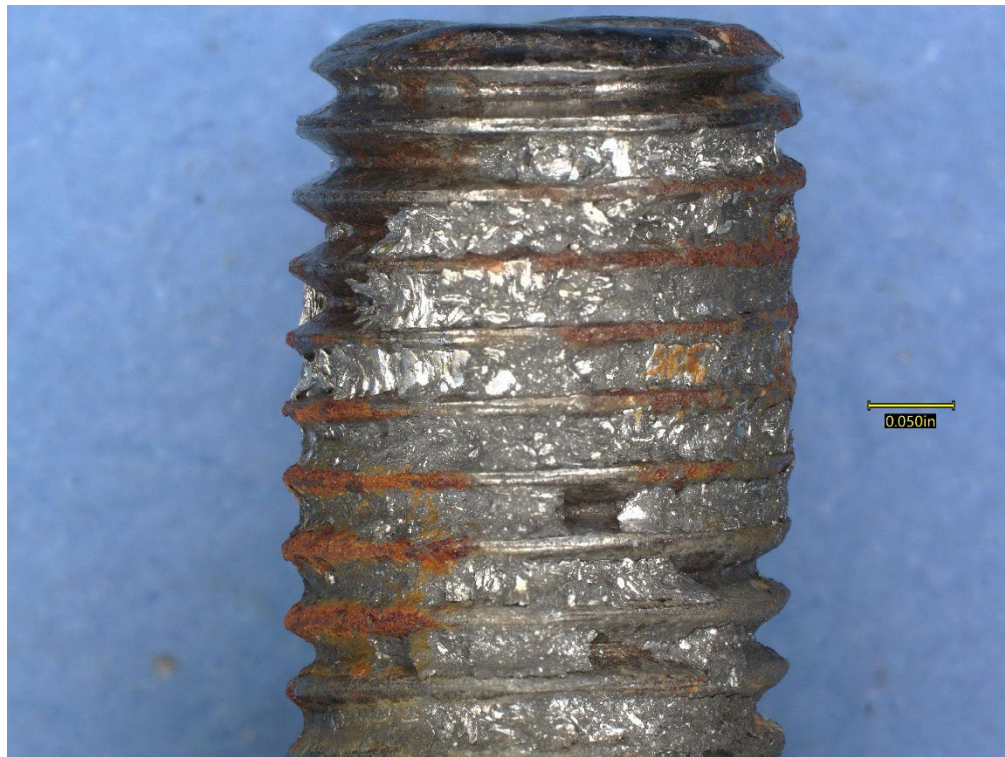
The steel rod end exhibited debris embedded within the threads (Figure 2). The embedded debris was present on both sides of the stop nut. The rod end was cleaned with acetone in an ultrasonic cleaner. Examination of the rod end threads after cleaning revealed a shiny metallic material embedded within the threads (Figure 3).

Figure 3: Threaded end of rod end after ultrasonic cleaning.

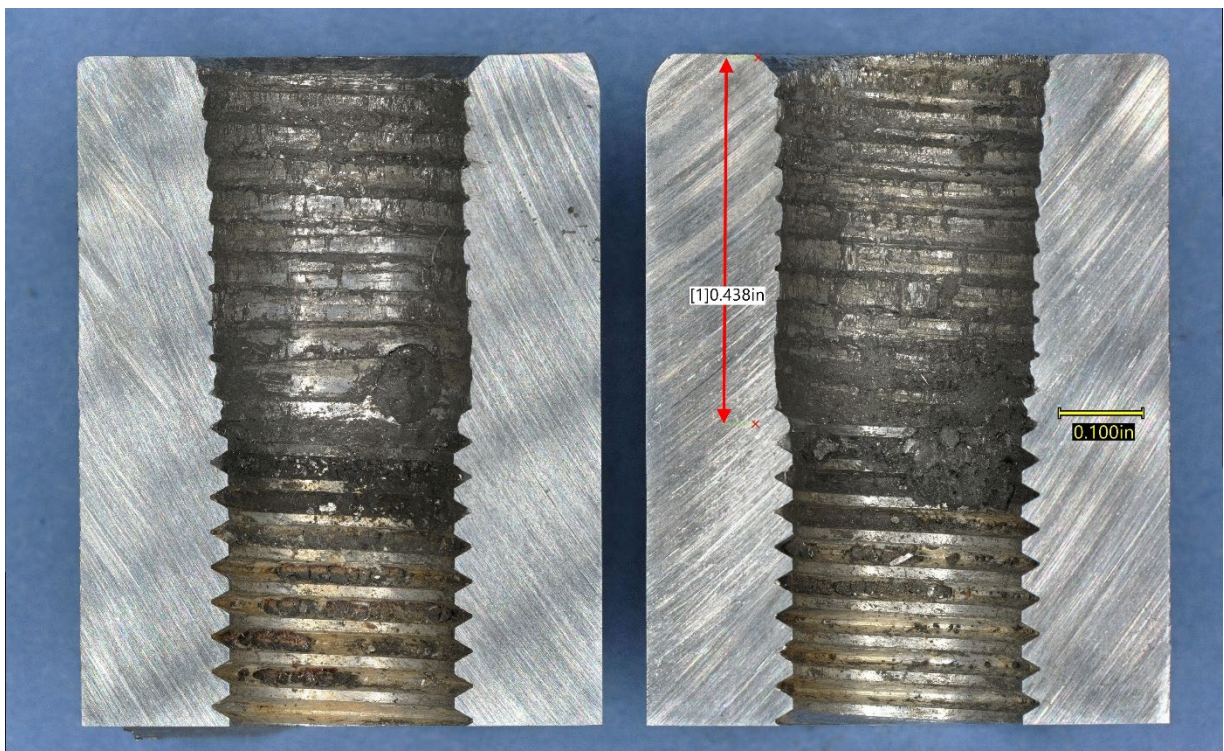
The female threaded aluminum end of the push pull tube was sectioned for examination of the internal threads. The examination revealed that the internal threads in the tube end had been fractured in shear overstress (Figure 4). The fractured threads extended for a depth of approximately 0.438 inch.

Figure 4: Threaded end of push pull tube after sectioning.
